Inspection Photos

Location Name: MARALEX RESOURCES INC SULFUR GULCH 9-98-22-69S98W /22NENW

Location ID: 312650

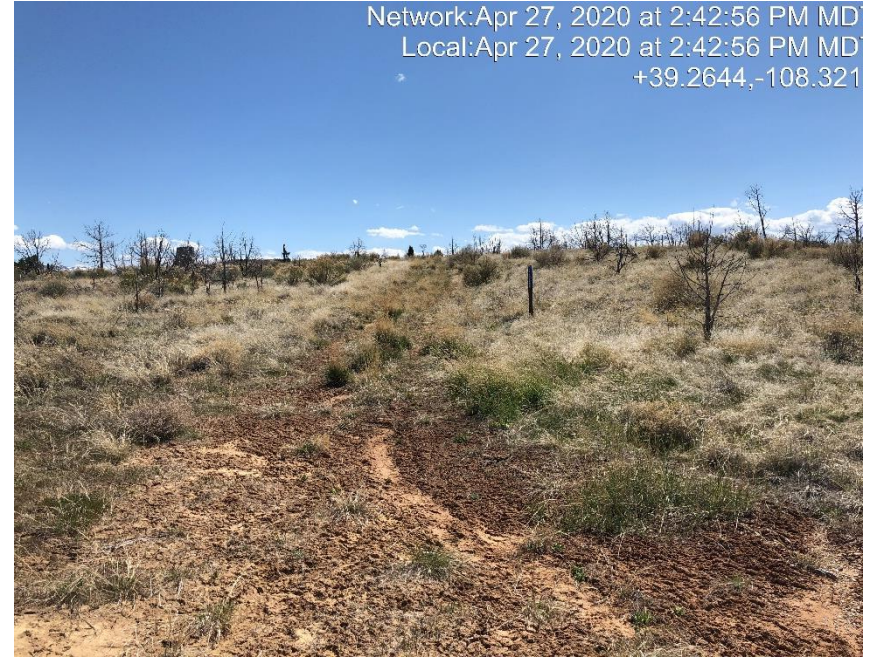
Photo #1073 Lease road has not been maintained.

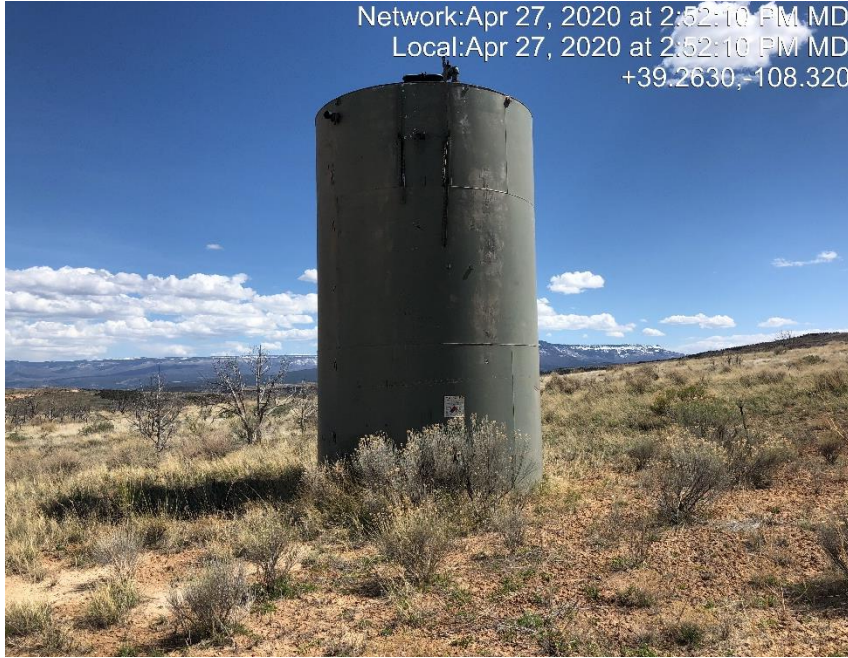
Photo #1076 Multiple places with unused equipment on location.

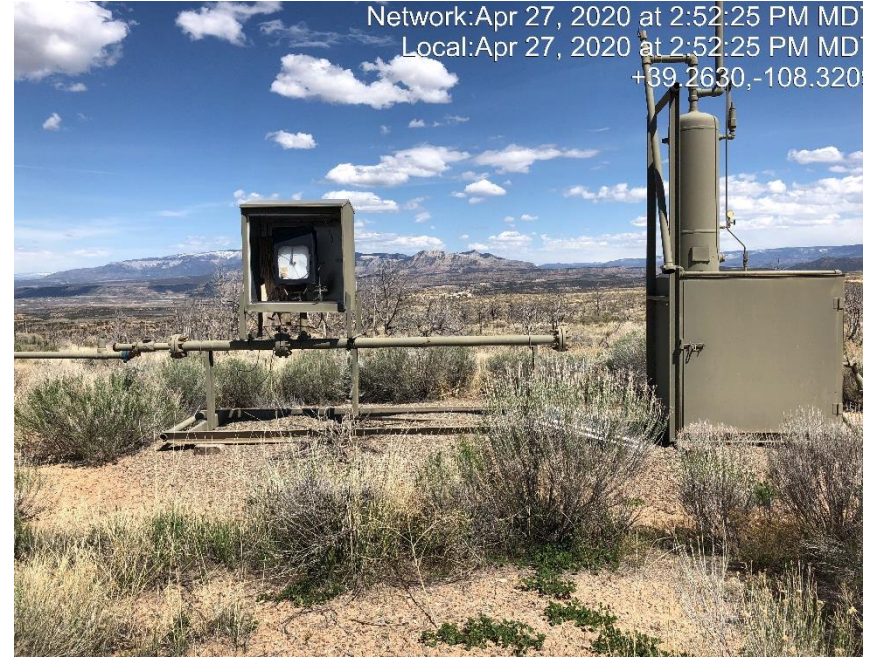
Photo #1077 Multiple places with unused equipment on location.

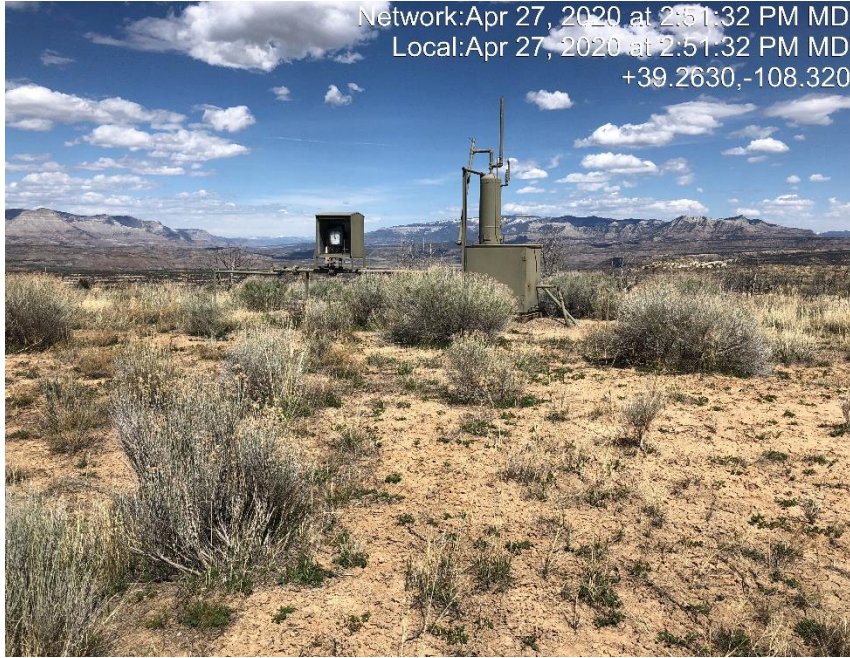
Photo #1074 Multiple places with debris on location

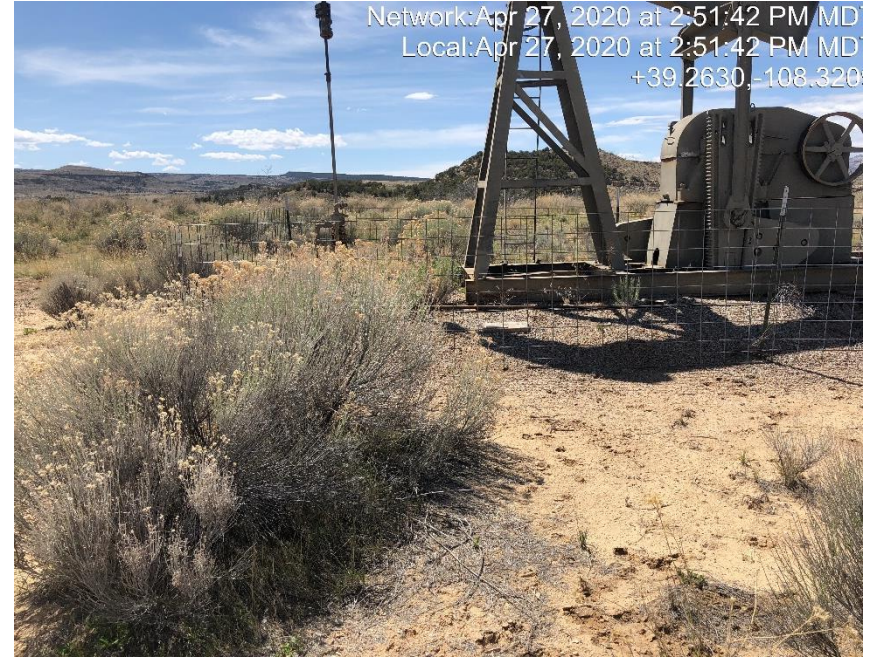
Photo #1075 Multiple places with debris on location
