# Inspection Photos

API: 043-06219

Operator: AUSCO PETROLEUM INC

Inspection Date: 4/27/2020

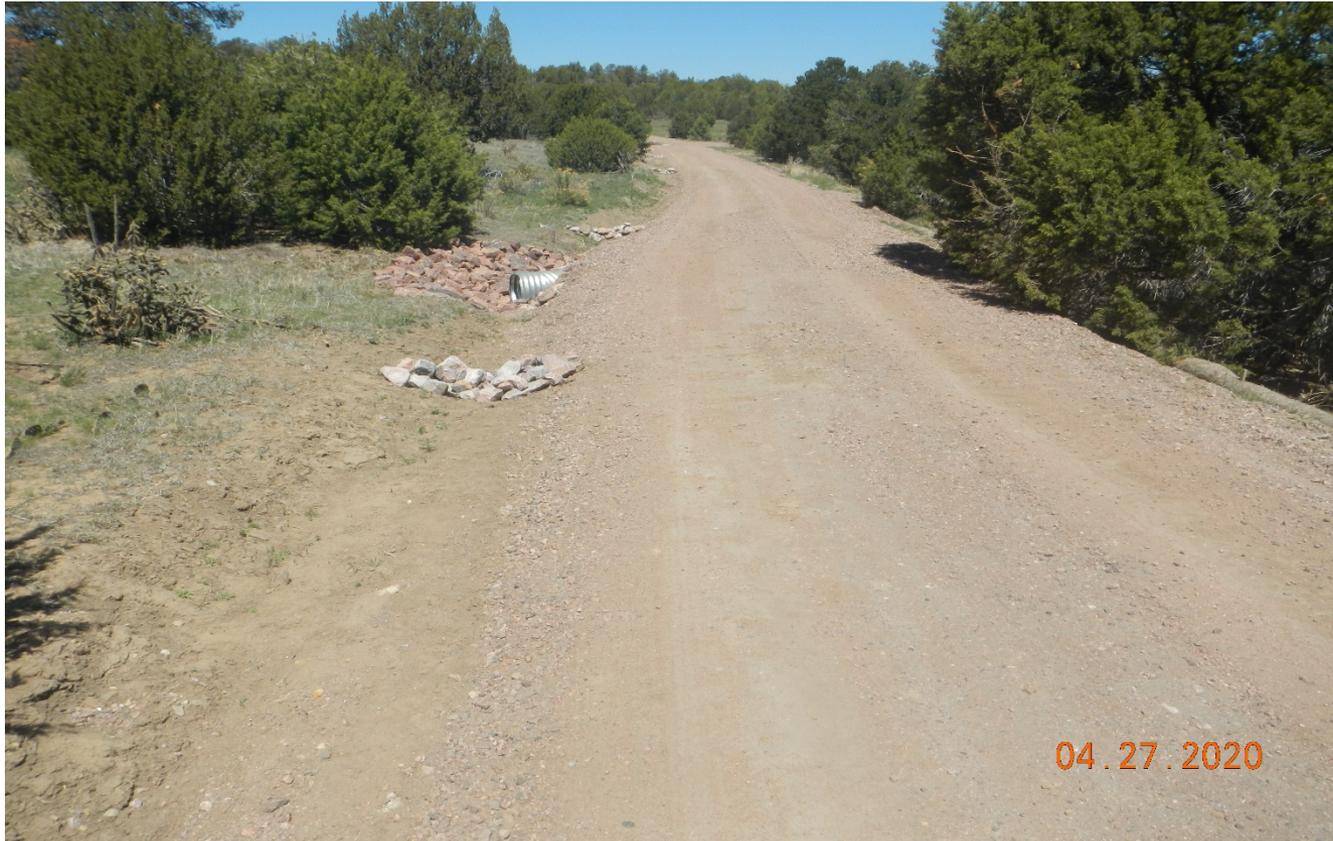
**Photo 1.** Facing northwest along the access road. Stormwater controls appear to be maintained.

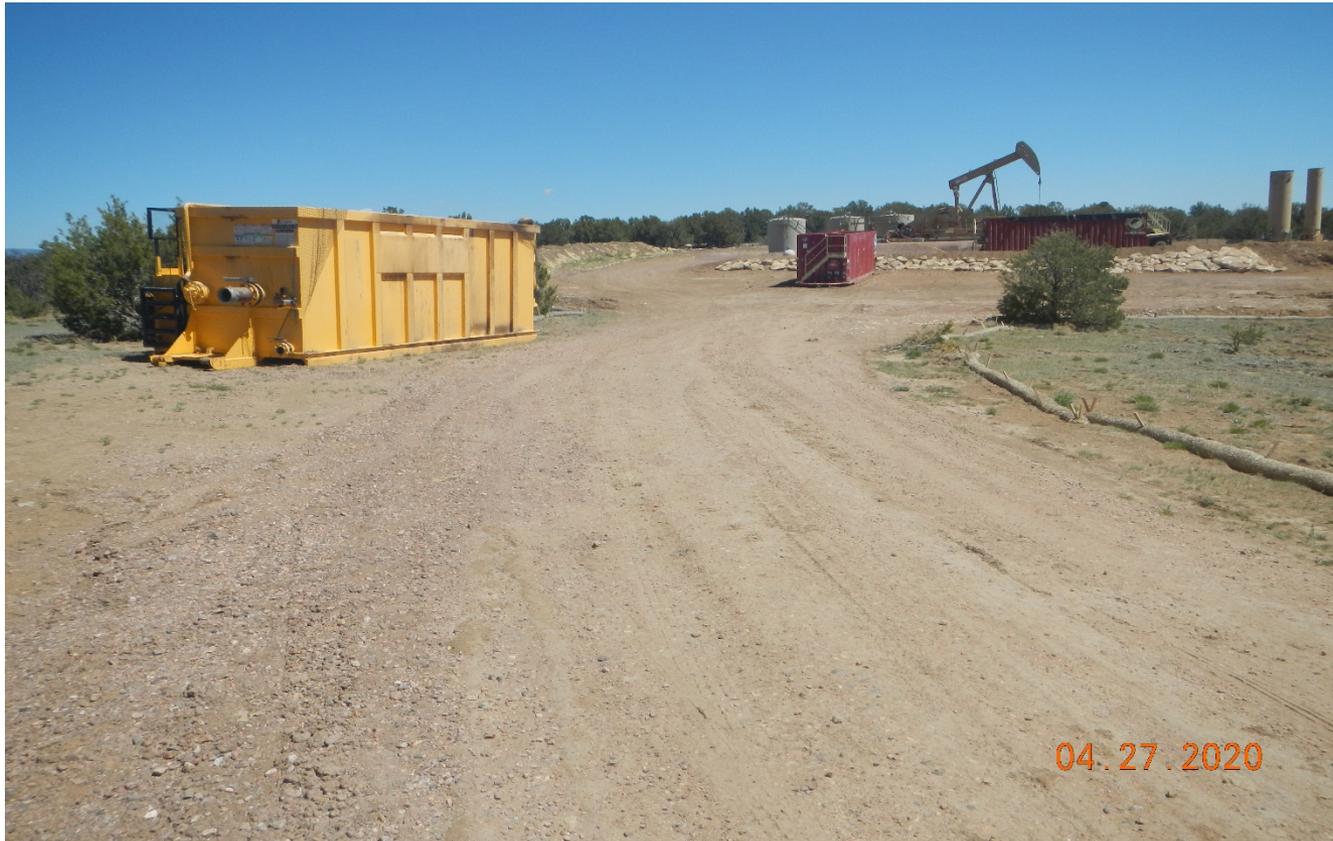
**Photo 2.** Facing north toward the location. The yellow open top tank which appears to contain oil remains at the location. Unused equipment has not been removed since previous inspection. Previous corrective actions have not been performed.

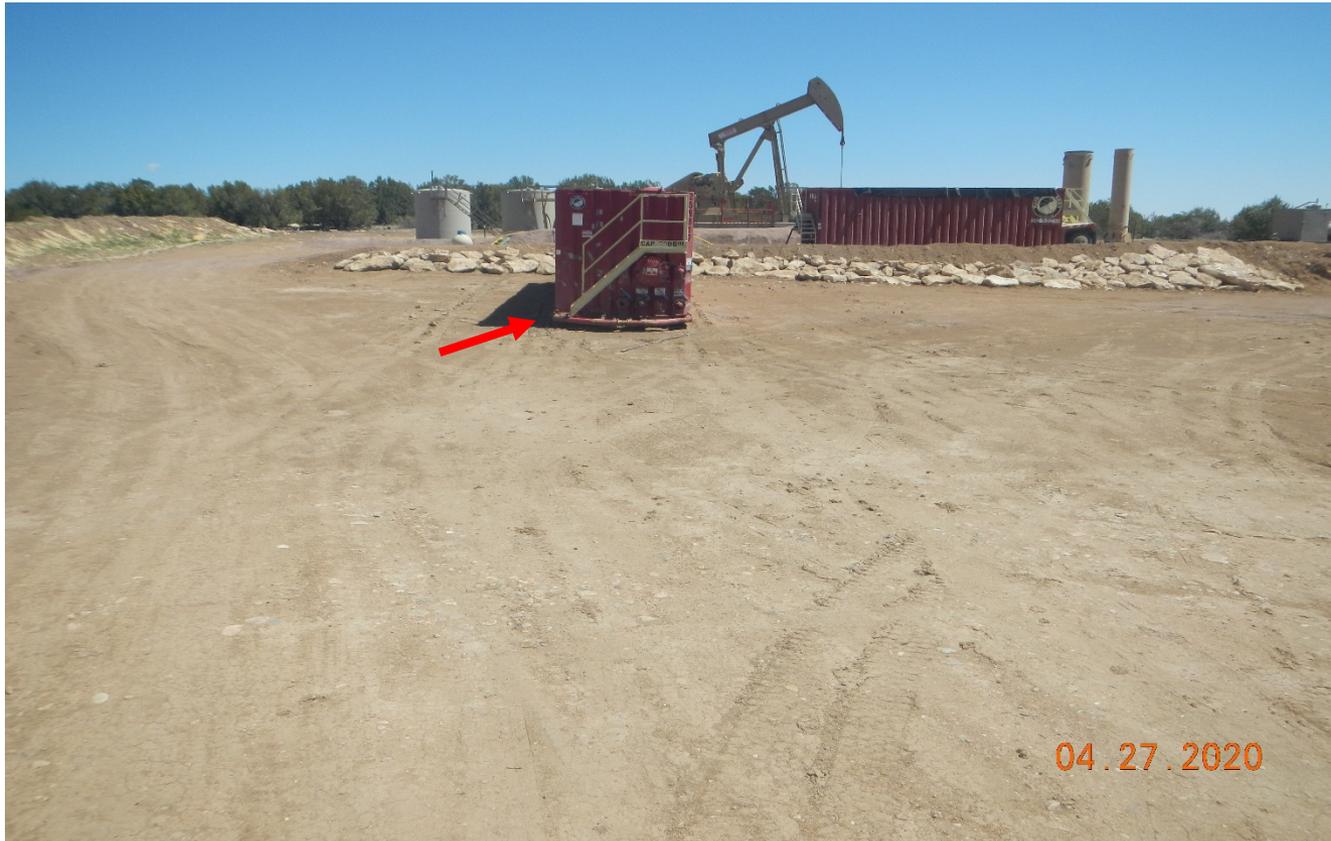
**Photo 3.** Facing north toward the location. This red tank shown by arrow has not been removed and this area has not been reclaimed. Previous corrective actions have not been performed.

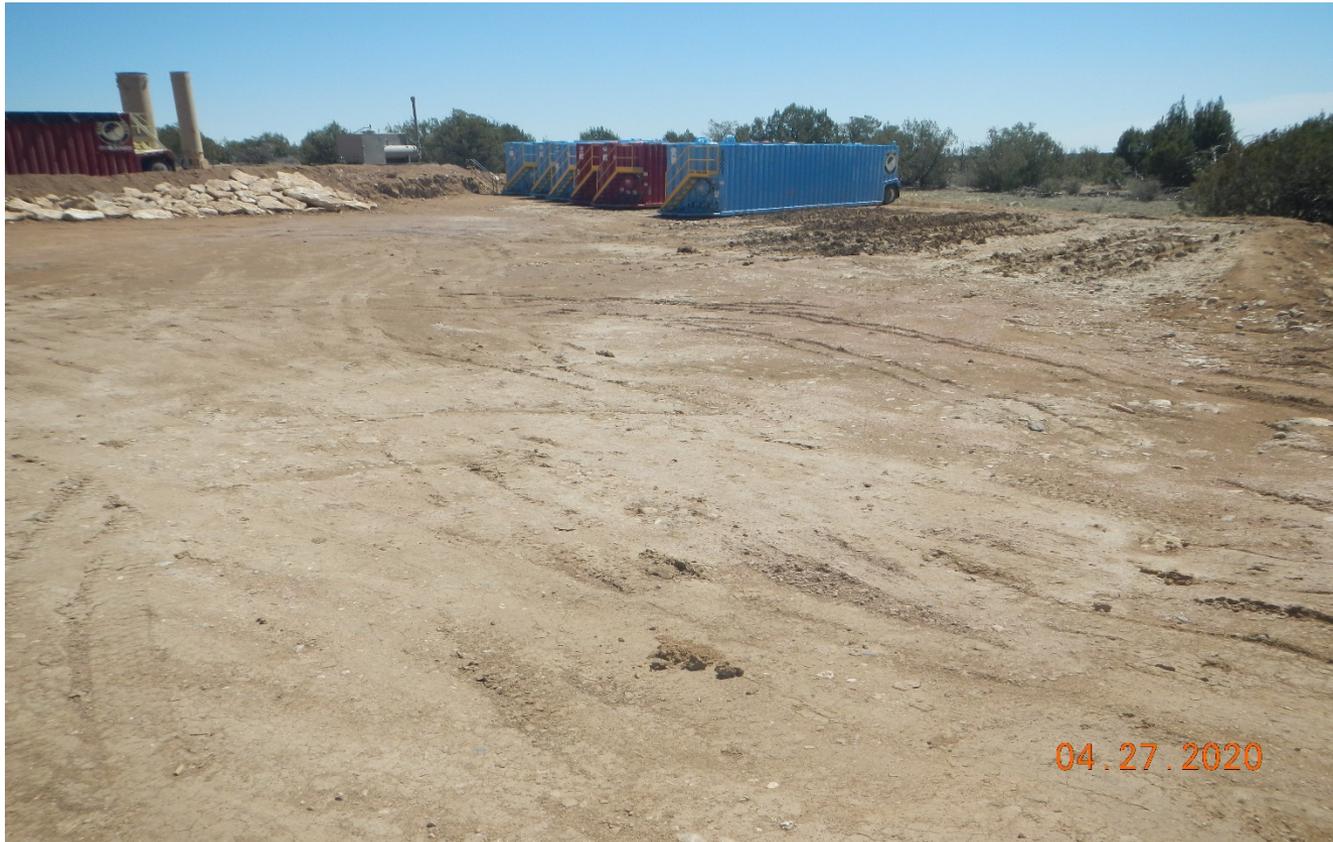
**Photo 4.** Facing northeast at the location. There is now 5 frac tanks staged at this area. The tanks need to be removed so interim reclamation can be performed in this area. Previous corrective actions have not been performed.

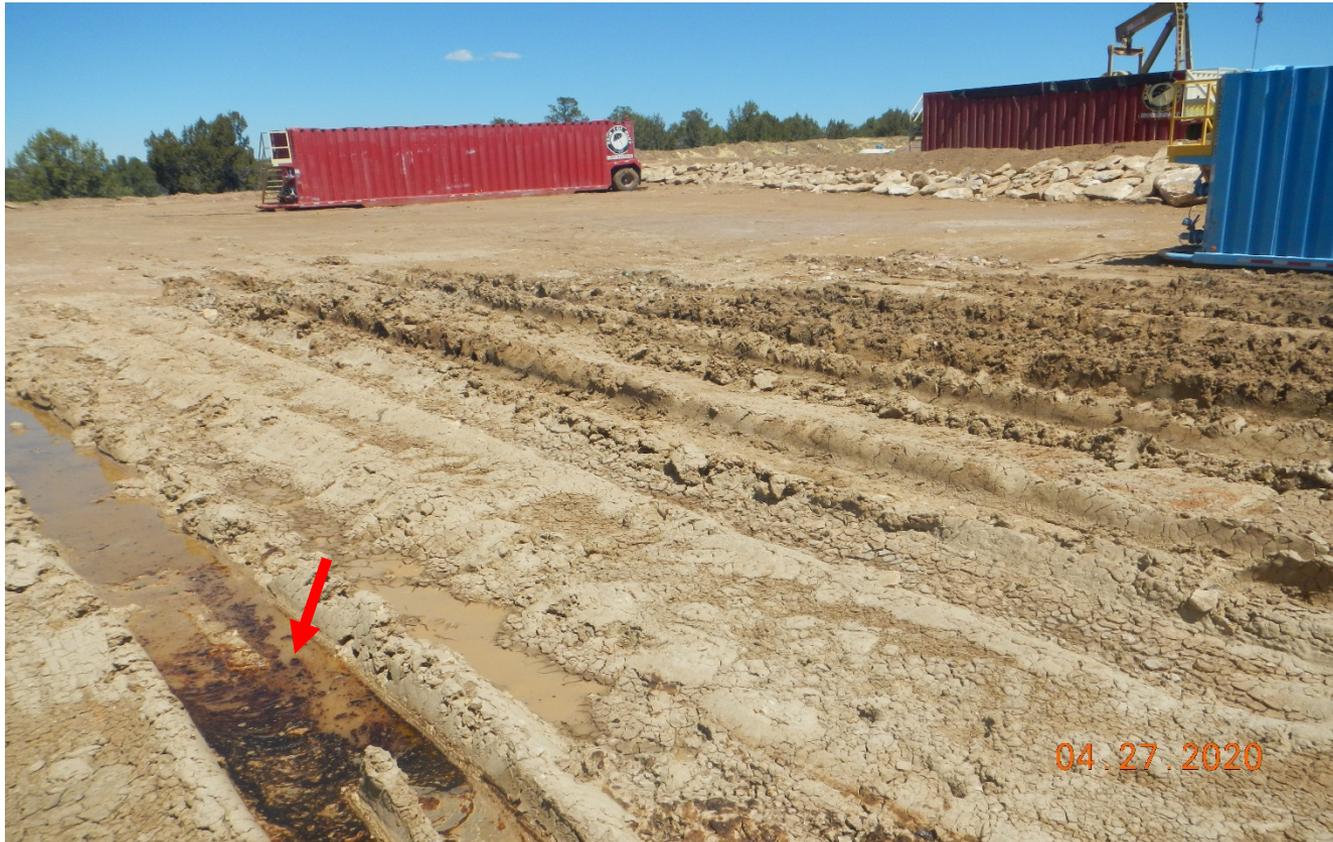
**Photo 5.** Facing northwest where tanks had been stored. There is deep vehicle rutting in this area which will create pooling of water. There is oily water in the ruts shown at red arrow. This area needs to be recontoured and reclaimed.

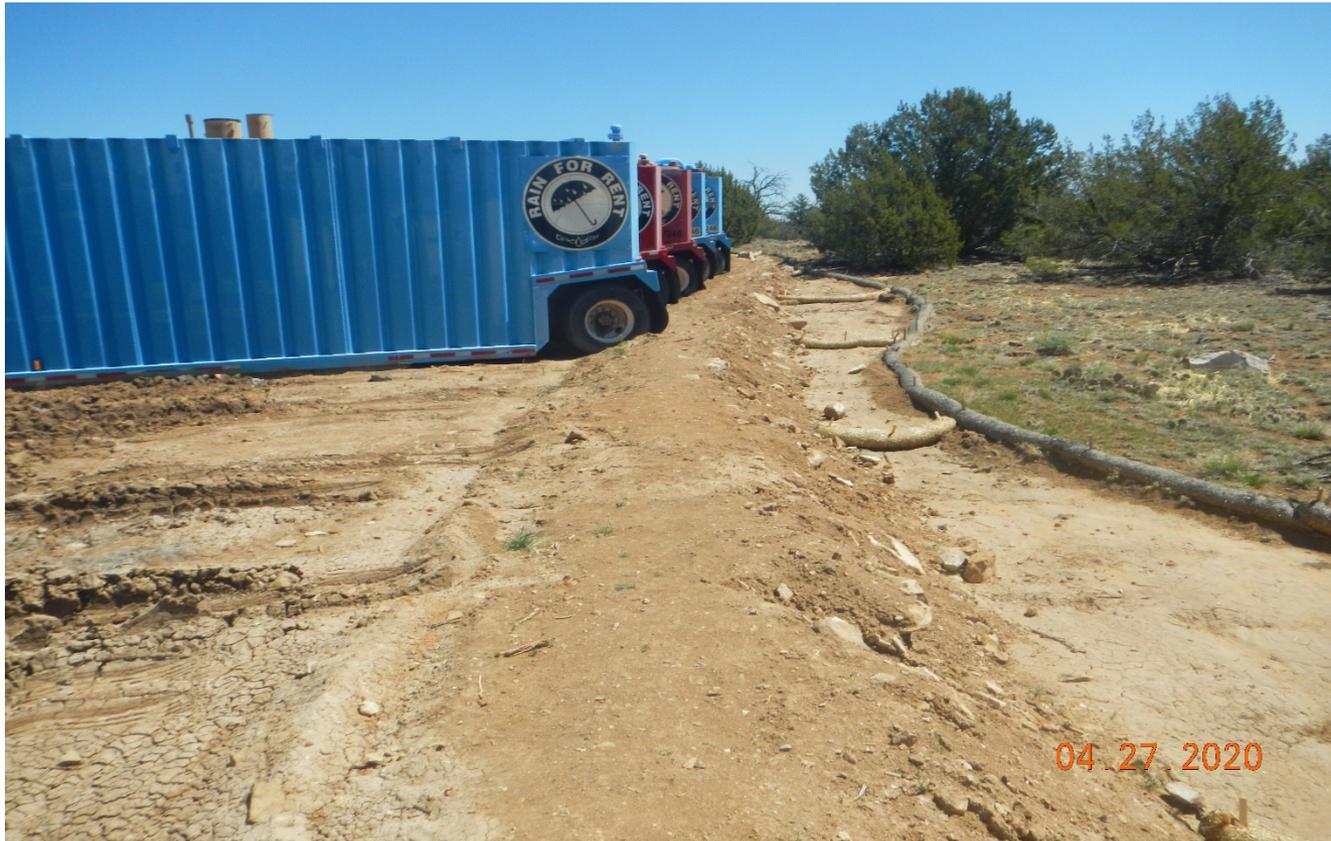
**Photo 6.** This berm along the backside needs to be leveled and recontoured for interim reclamation. There are wattles placed along the backside of the berm.

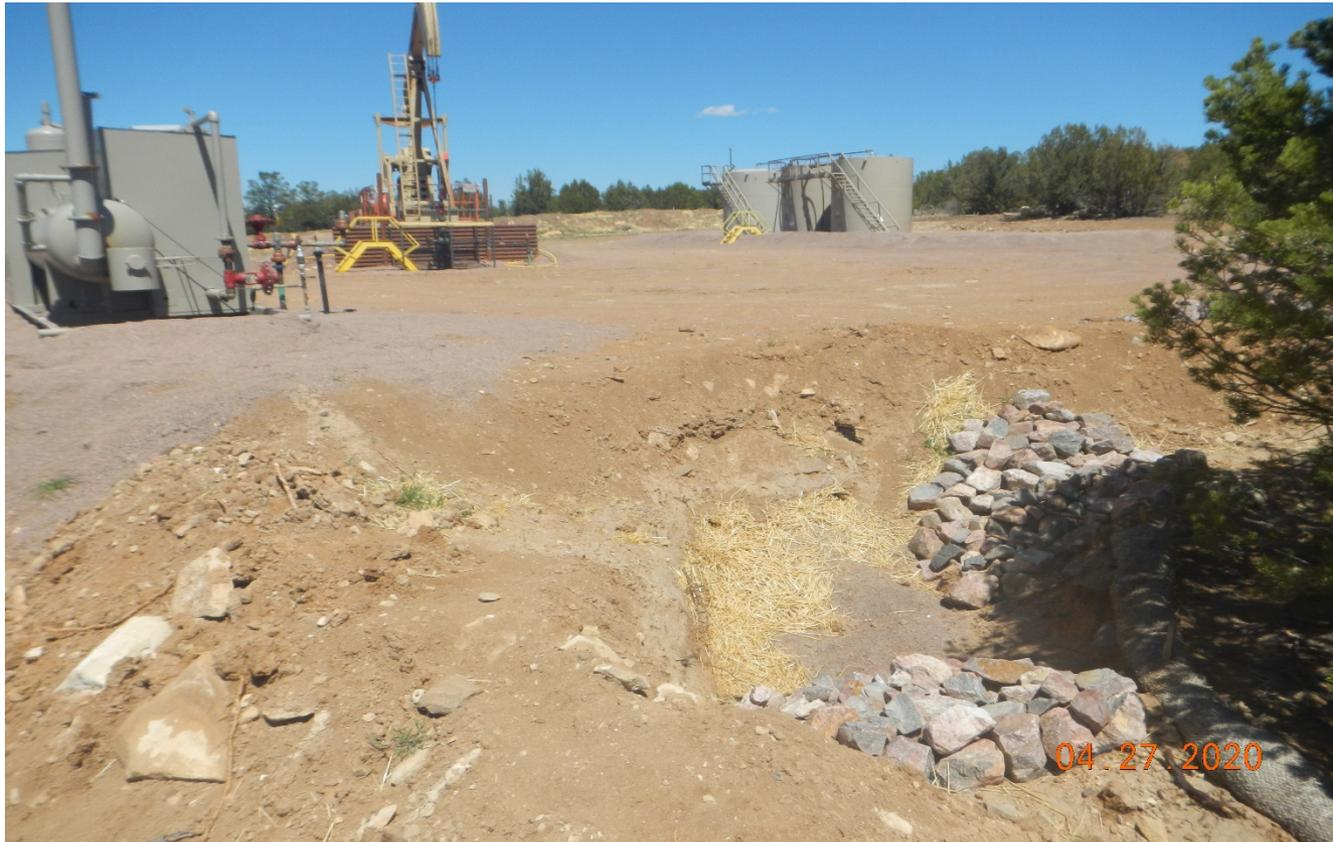
**Photo 7.** Facing northwest toward the well site. There is a sediment trap at this east side of the location.

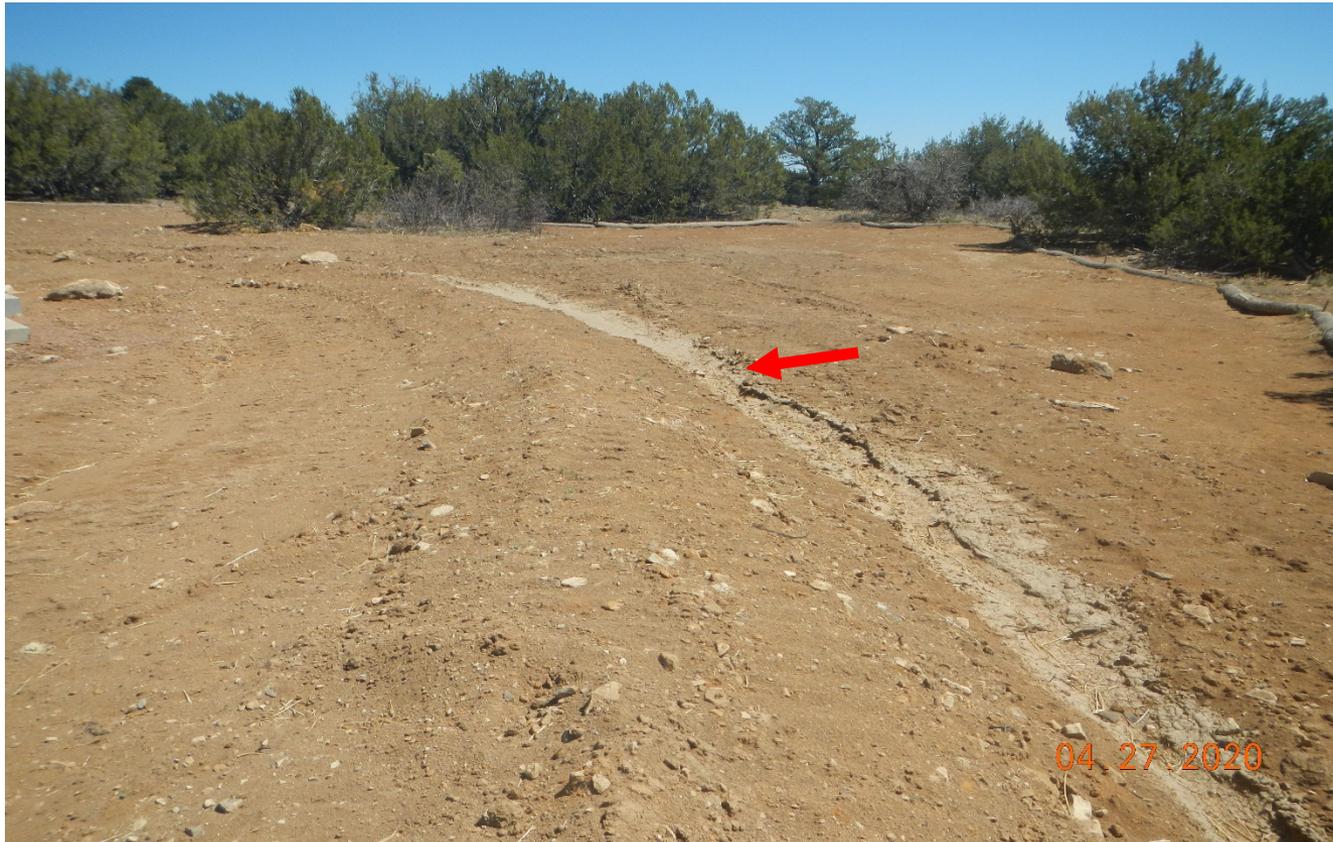
**Photo 8.** Facing toward the northeast area of the location. This area needs to be seeded and reclaimed. Additional BMP's may be needed along the stormwater diversion shown by red arrow.

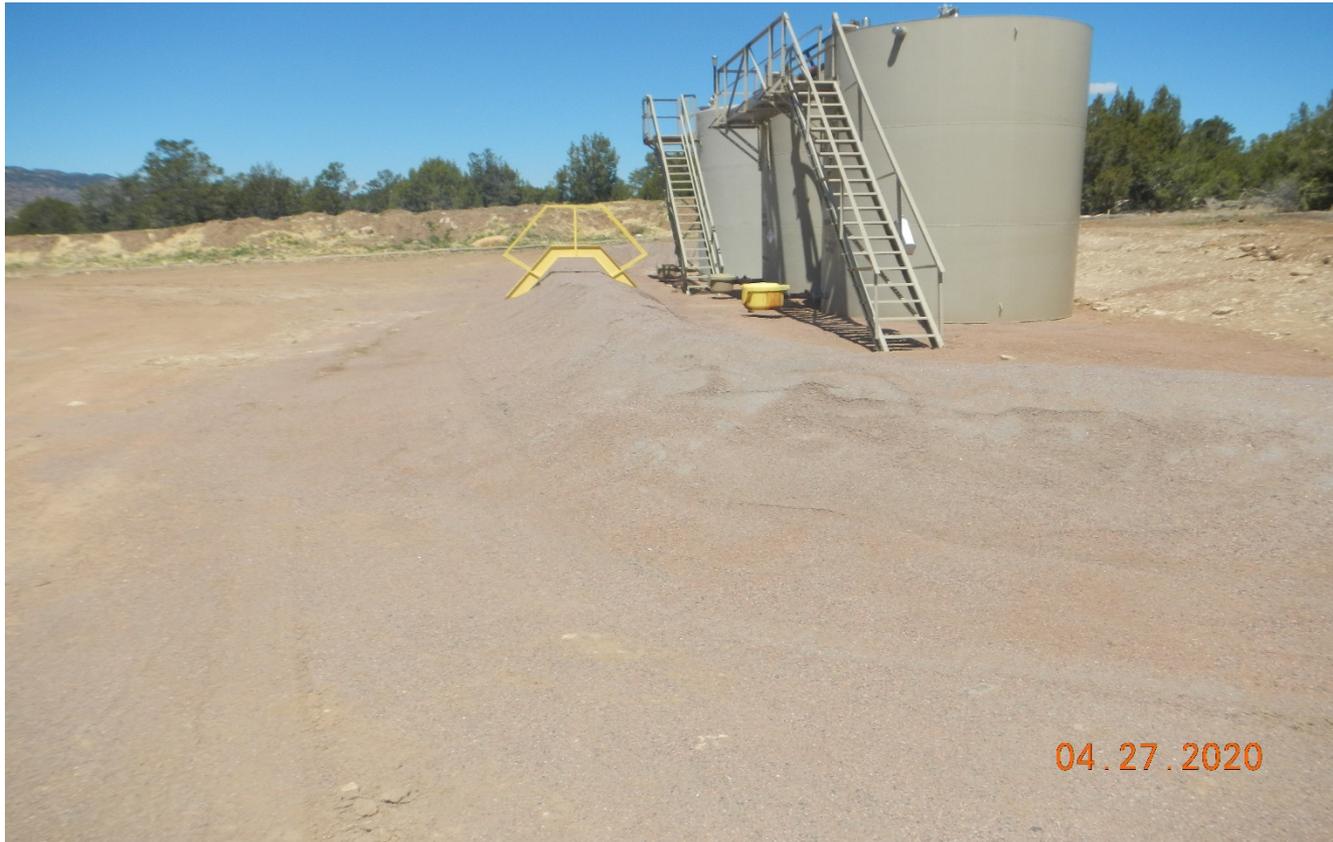
**Photo 9.** The berm around the tank battery has been compacted.

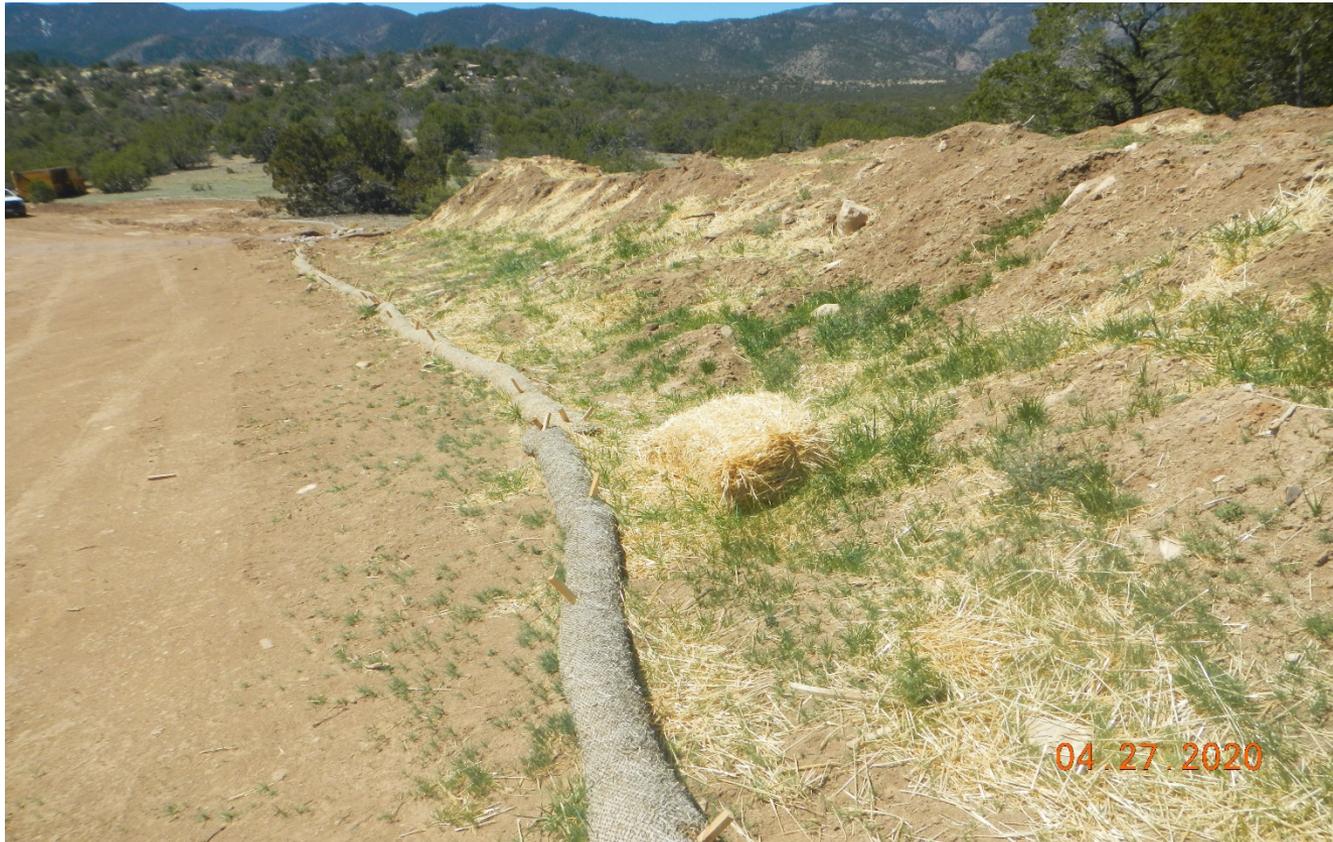
**Photo 10.** The wattles have been repaired along the topsoil pile. It appears the pile has been seed however, the topsoil pile should have been sloped and stabilized. There were weeds observed growing along the soil pile.

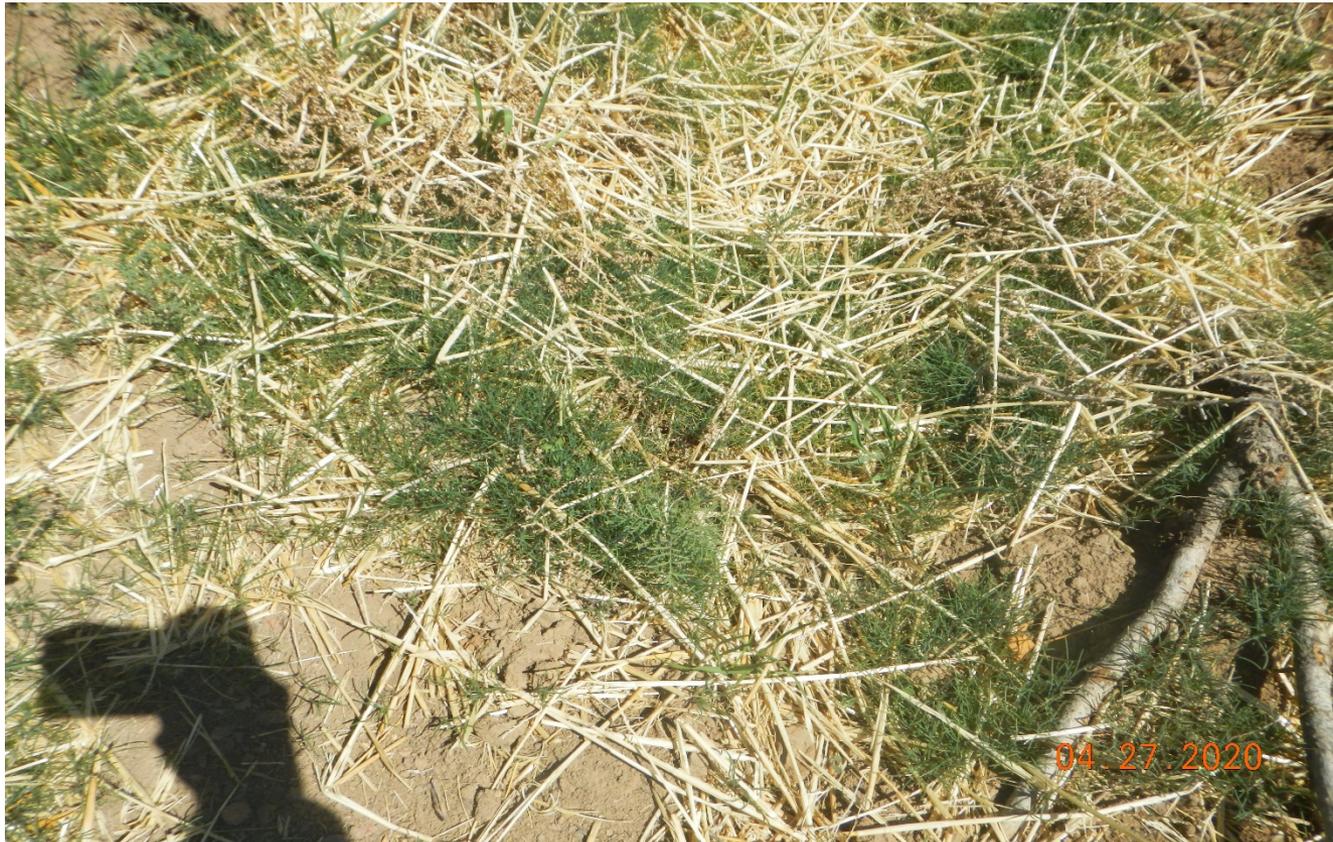
**Photo 11.** There is a dominance of Russian thistle beginning to emerge along the topsoil pile. The weeds will need to be controlled.

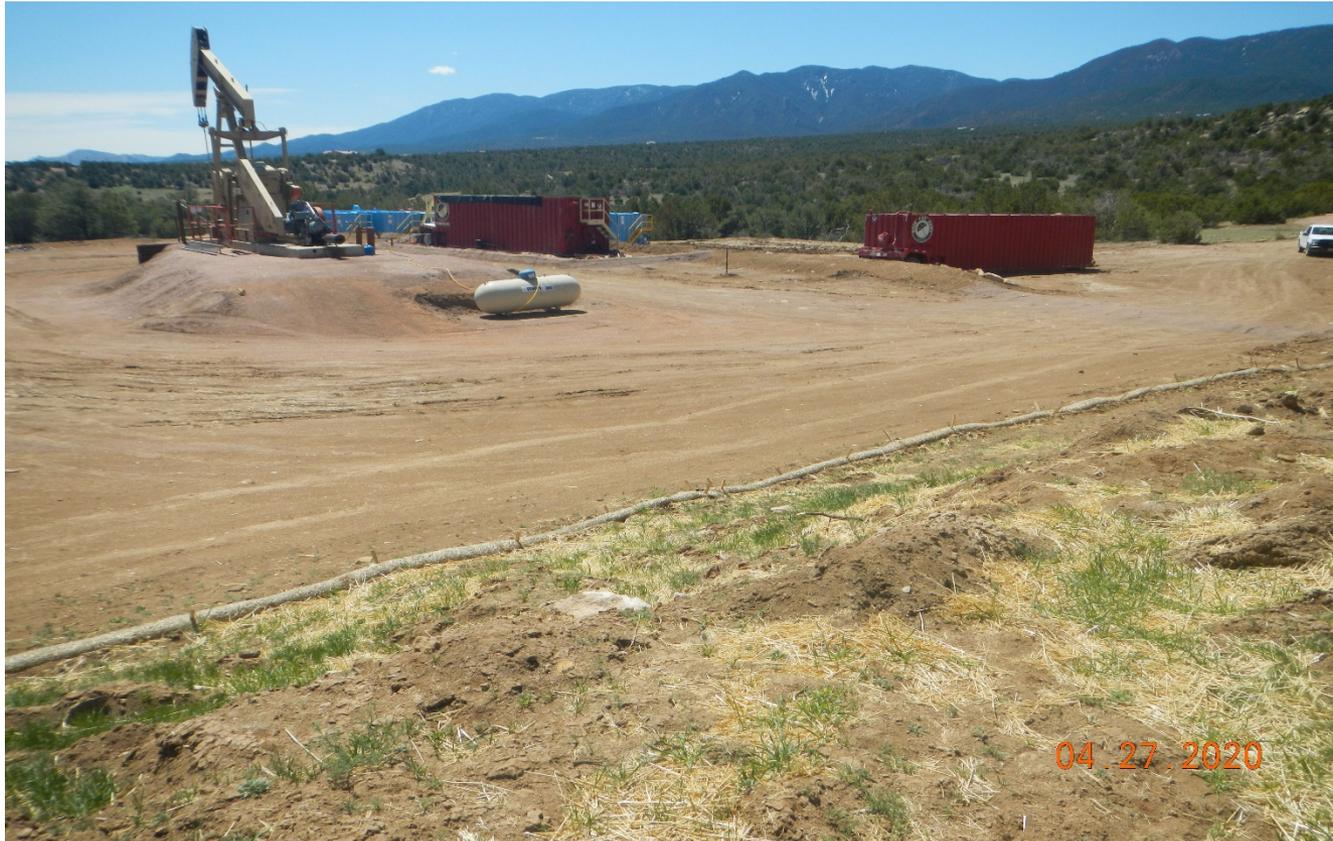
**Photo 12.** Facing southwest toward the location. A portion of the topsoil pile will need to be utilized for interim reclamation in the area where the frac tanks remain.

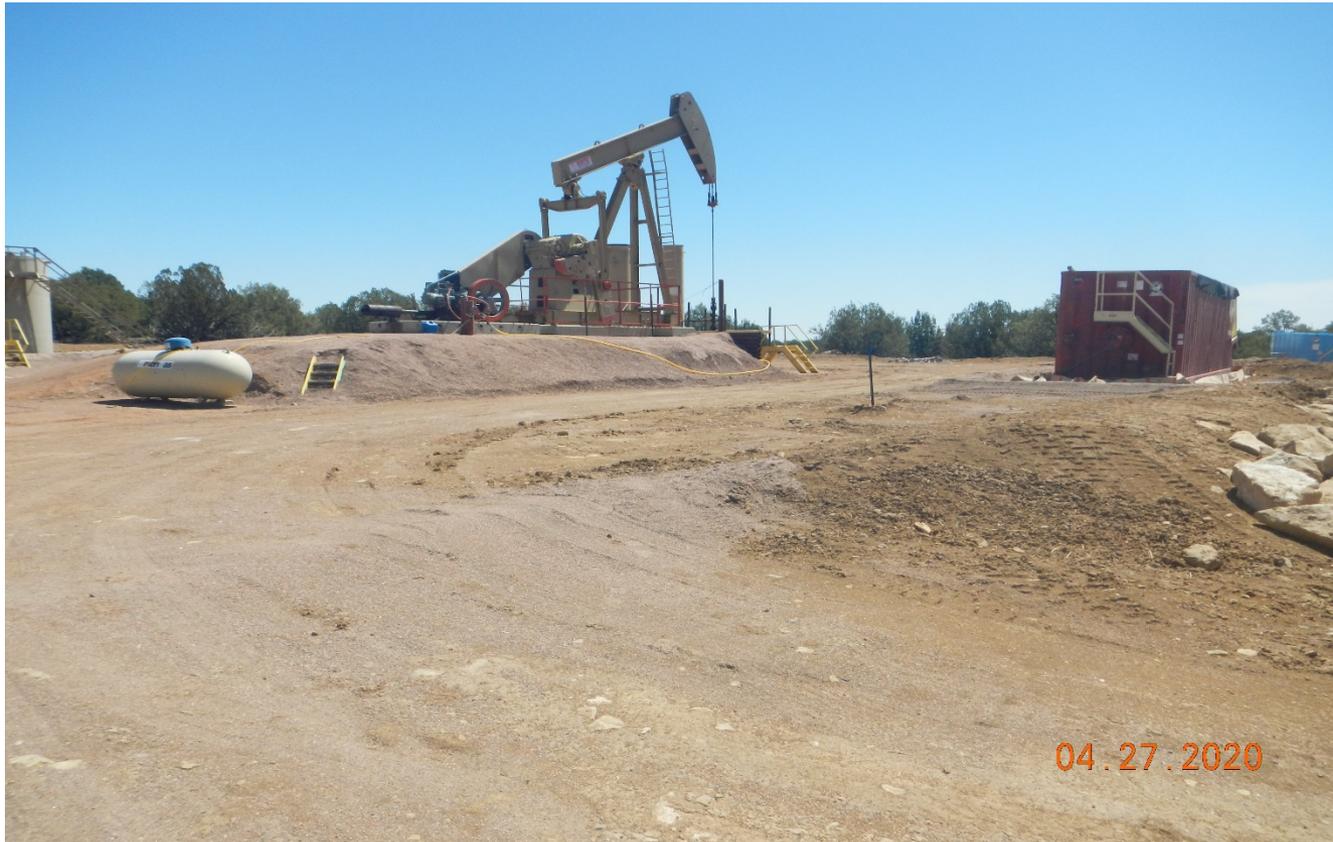
**Photo 13.** The northwest side of the location has been stabilized with rock rip/rap.

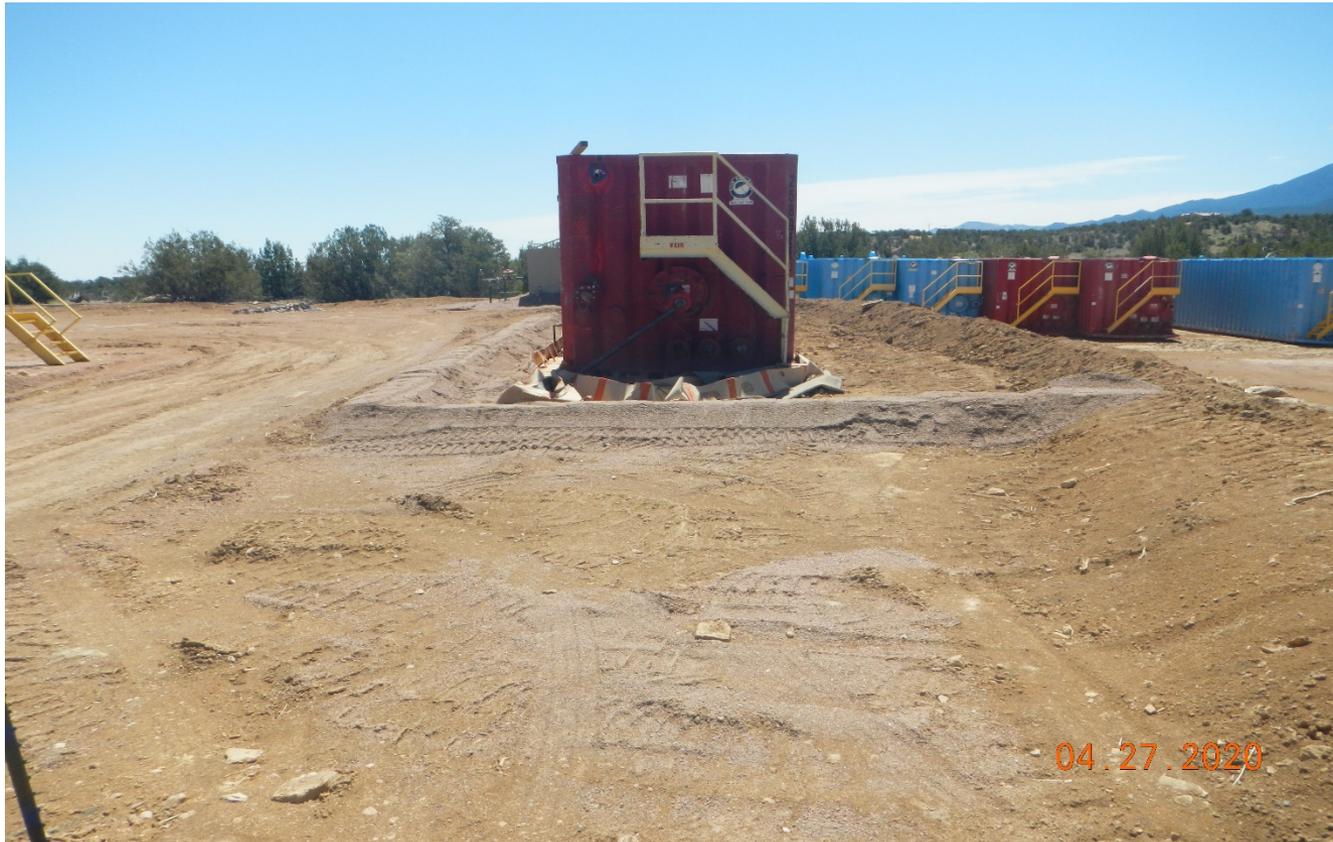
**Photo 14.** A compacted berm has been installed at the tank which appears to be in use.

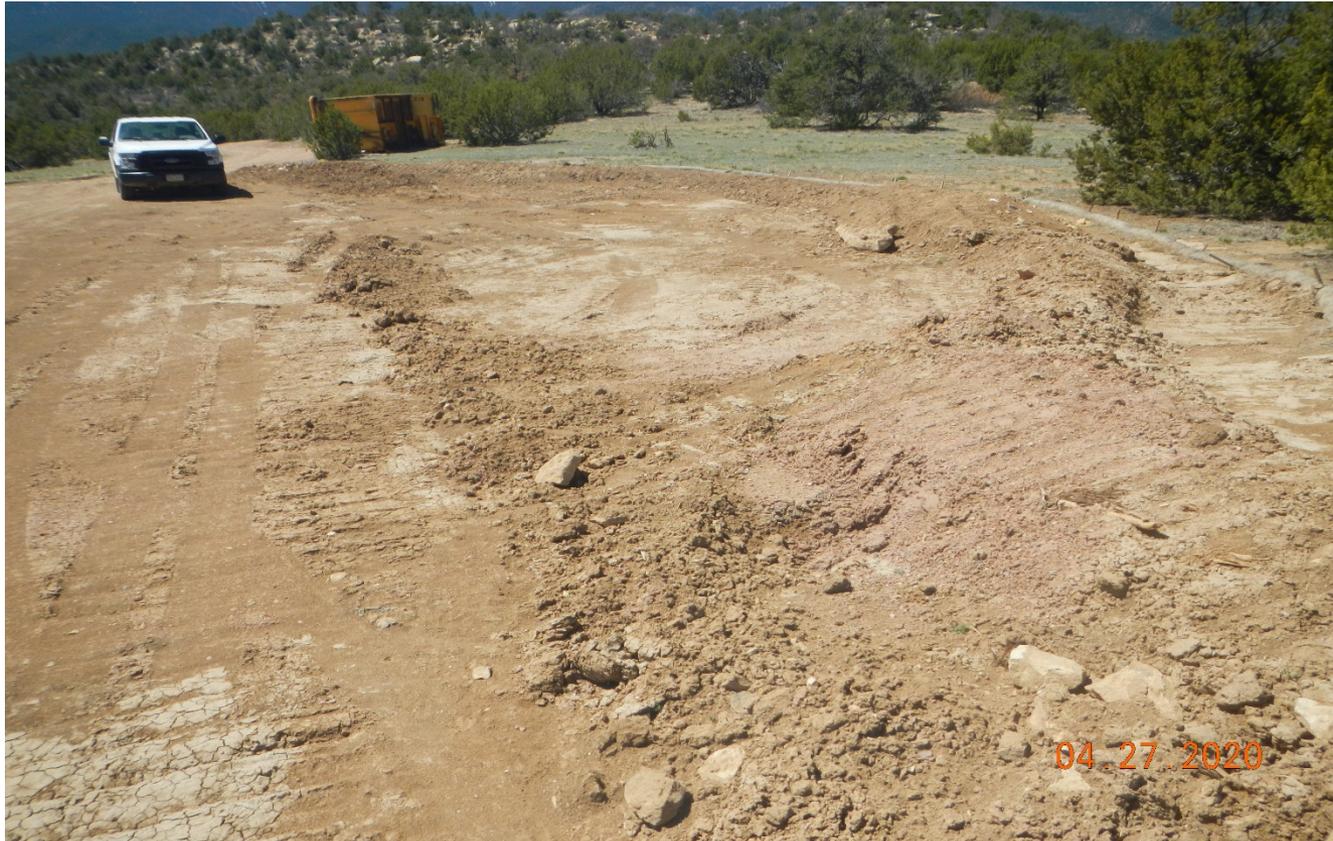
**Photo 15.** Facing toward the southwest side of the location. The pipe riser at this area appears to have been removed. This disturbance area needs to be reclaimed.

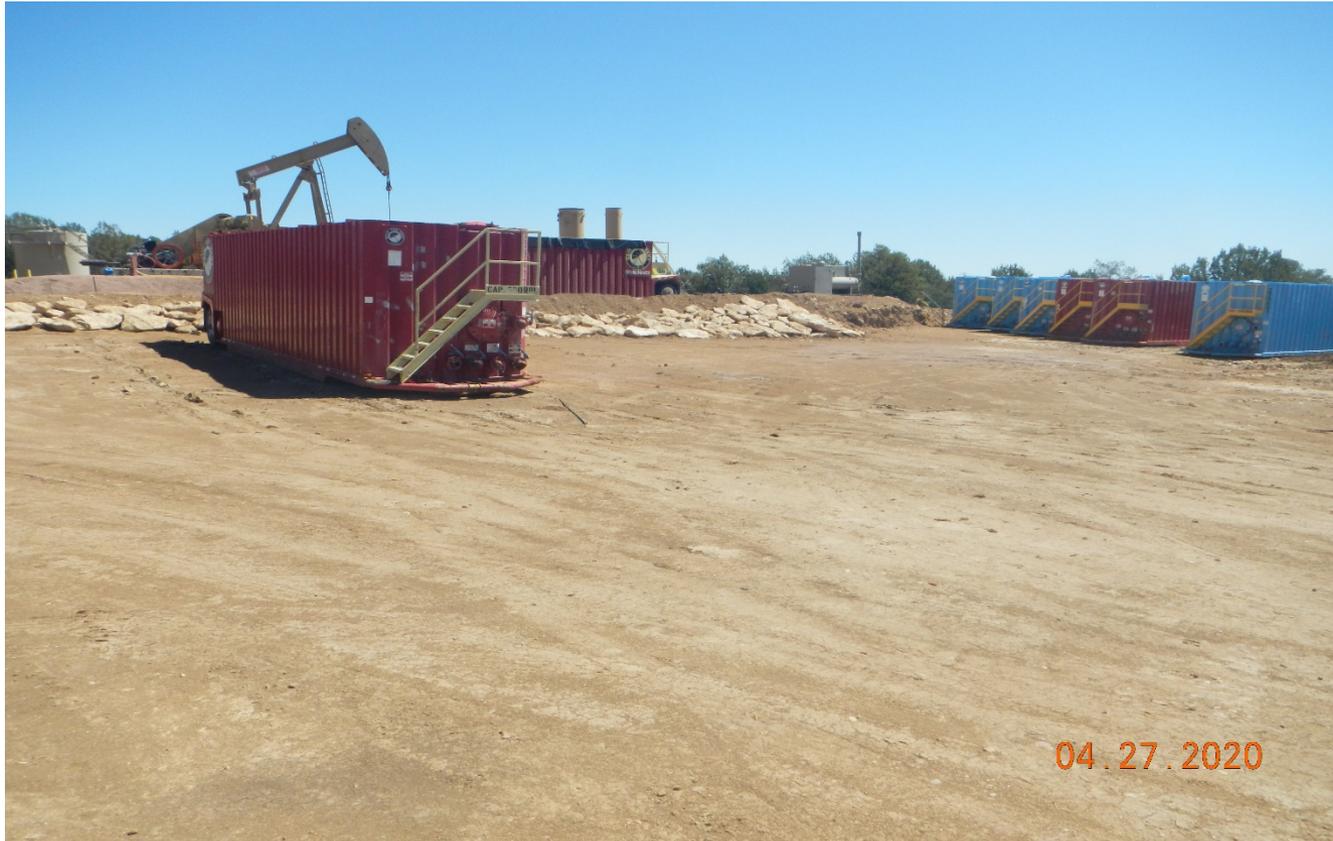
**Photo 16.** Facing northwest toward the location. The unused tanks need to be removed. This area needs to be recontoured and reclaimed. Previous corrective actions have not been performed.
