Inspection Photos

API: 043-40002

Operator: JAVERNICK OIL

Inspection Date: 4/27/2020

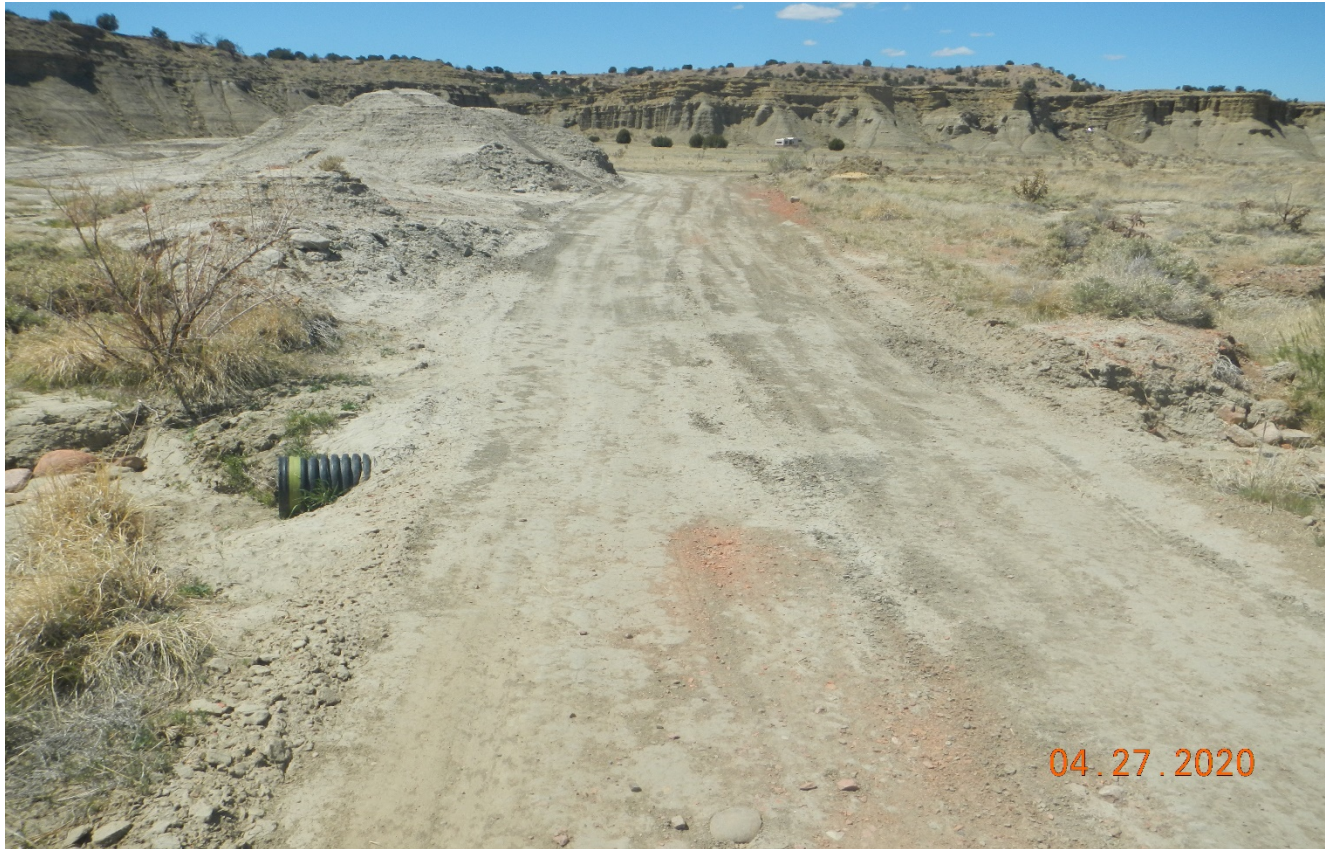
Photo 1. Facing northwest along the access road. This portion of the road has been regraded.

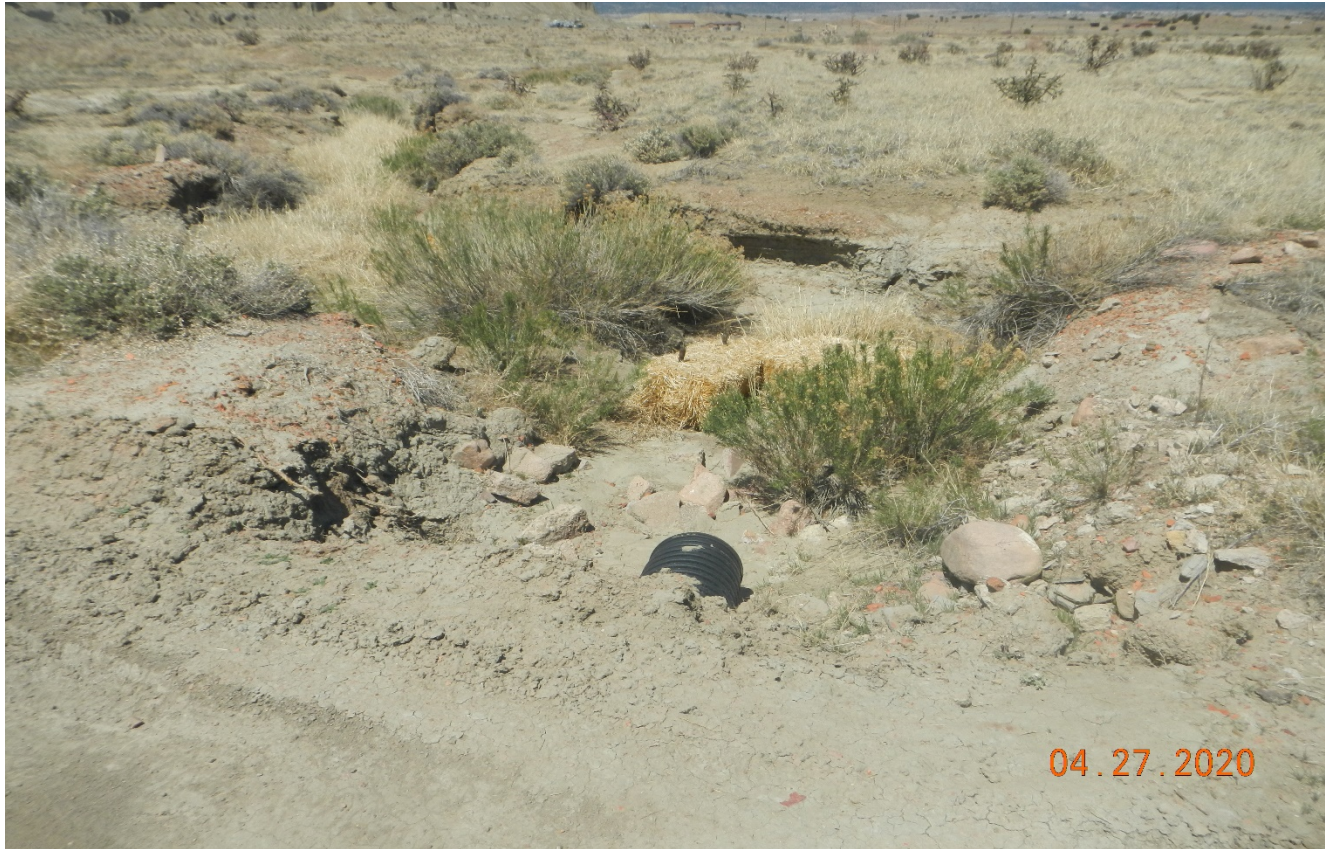
Photo 2. There are straw bales installed at culvert outlet however, this is not a long term BMP.

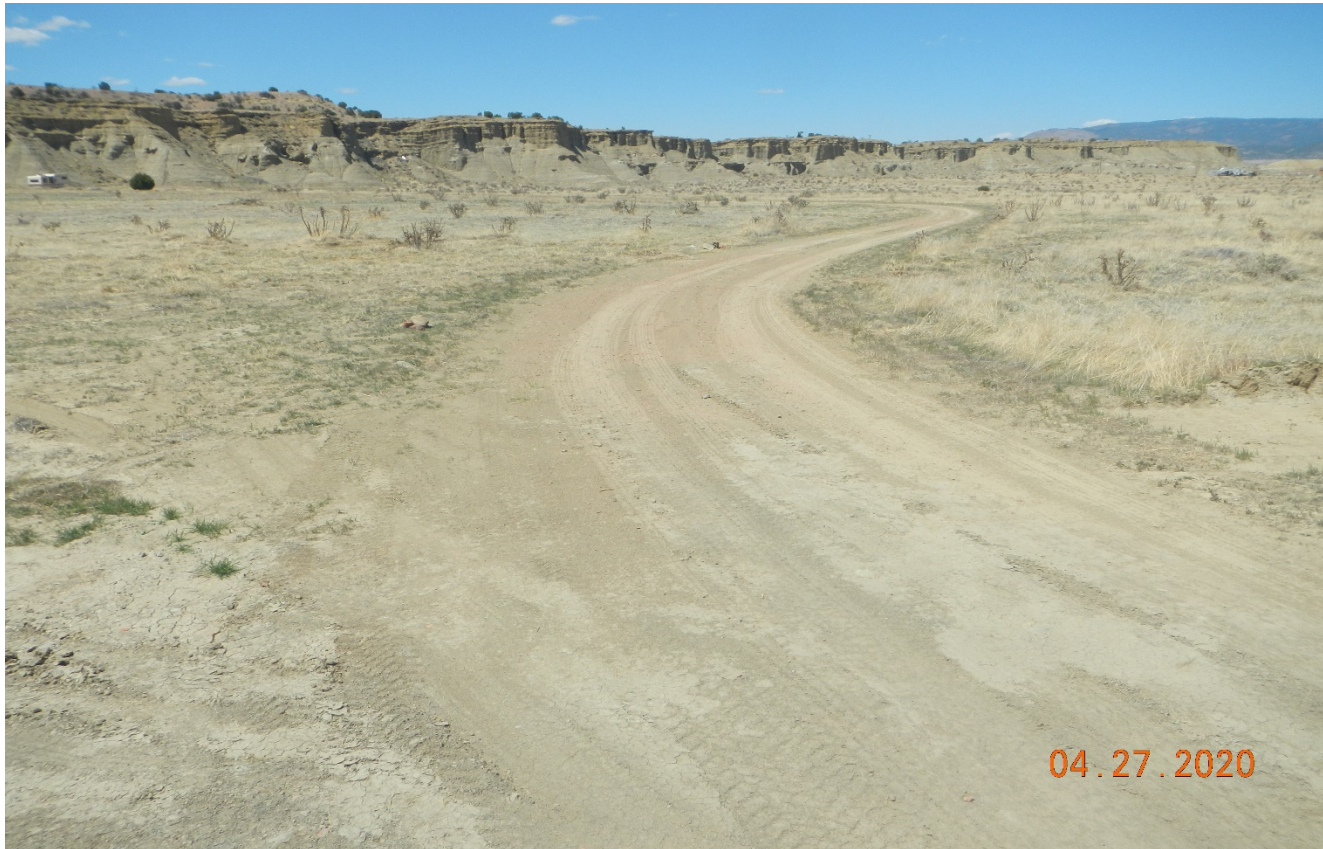
Photo 3. Facing northwest at the access road. This portion of the access road has not been reclaimed. Previous corrective action was not performed.

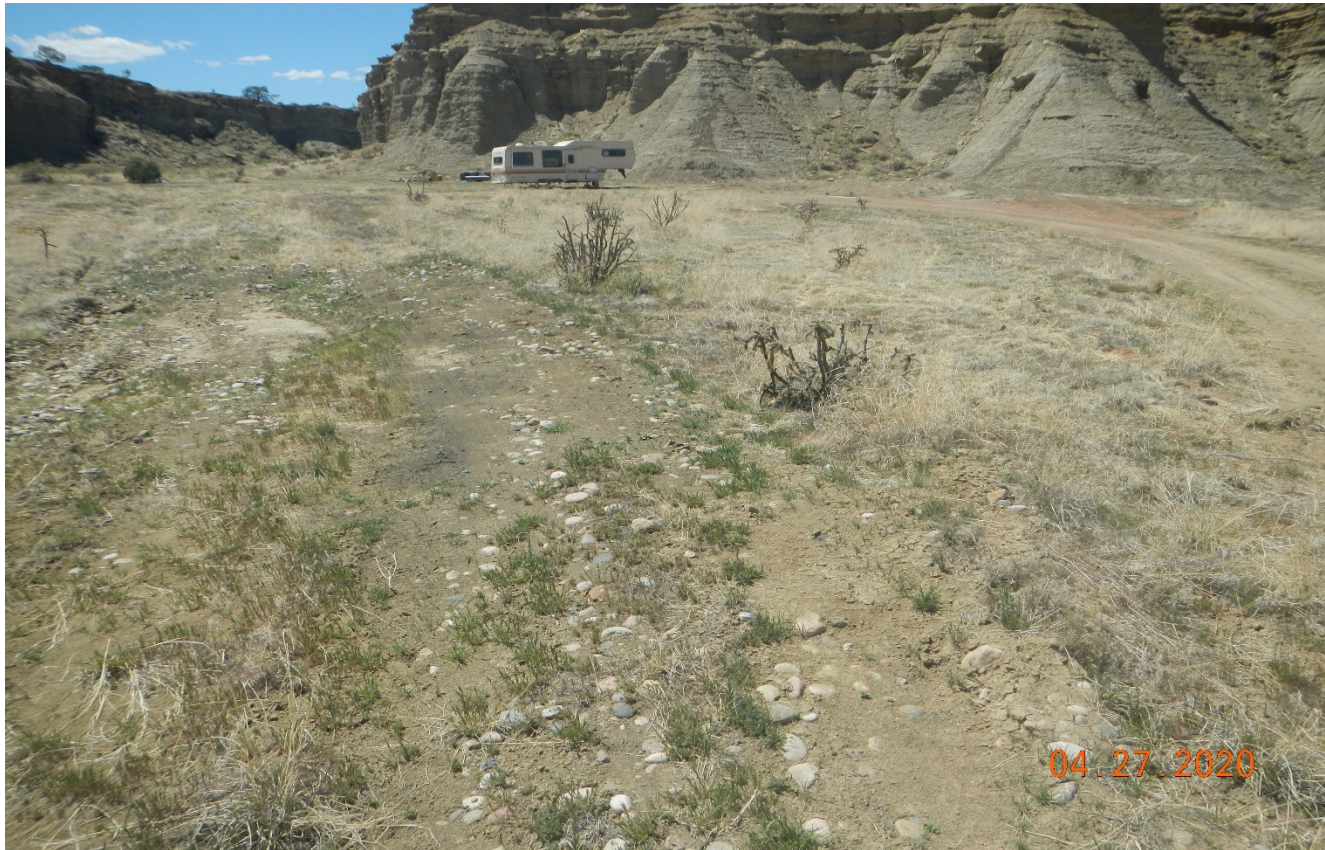
Photo 4. Facing west toward the location. The road circles the location and has not been reclaimed.

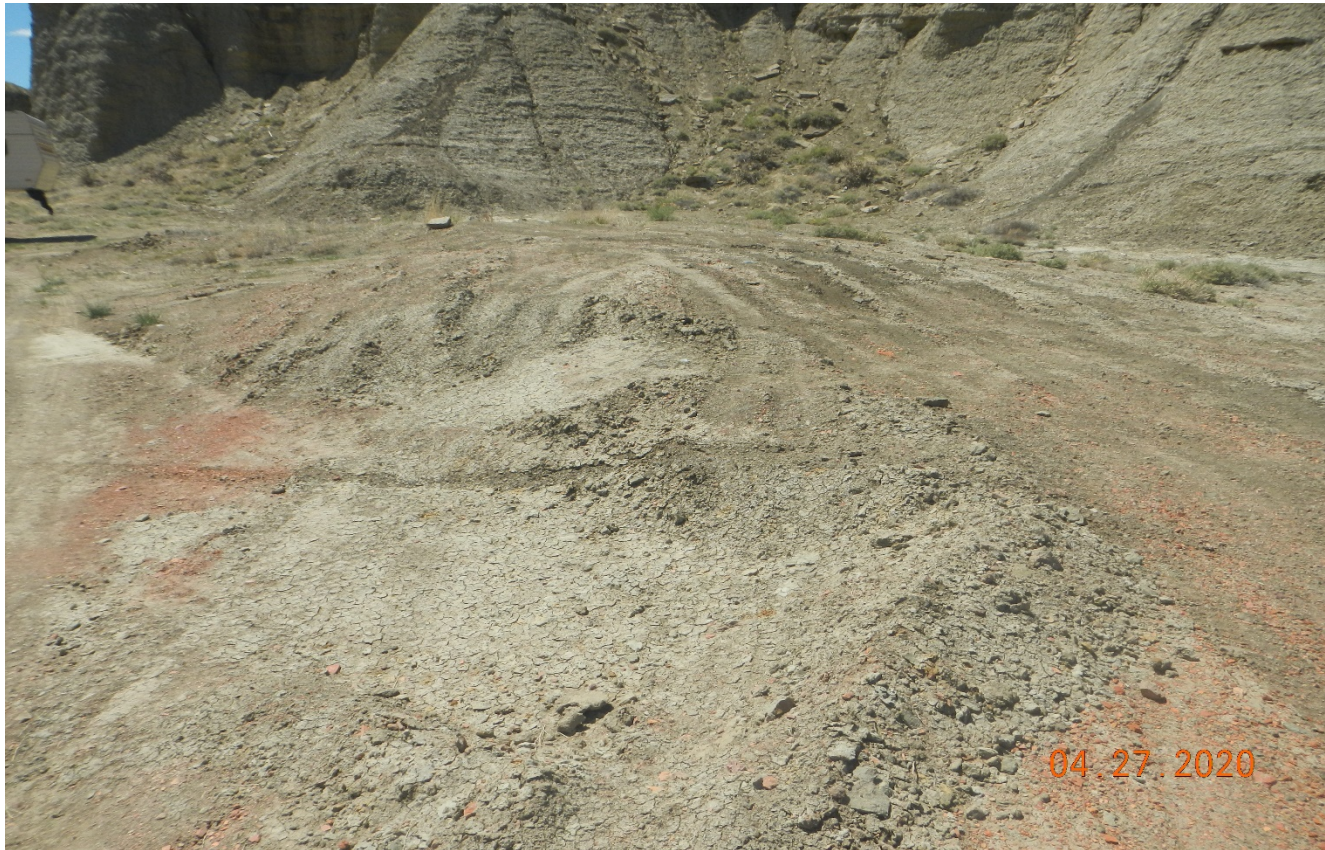
Photo 5. This is the approximate location of the well. This area has not been reclaimed.

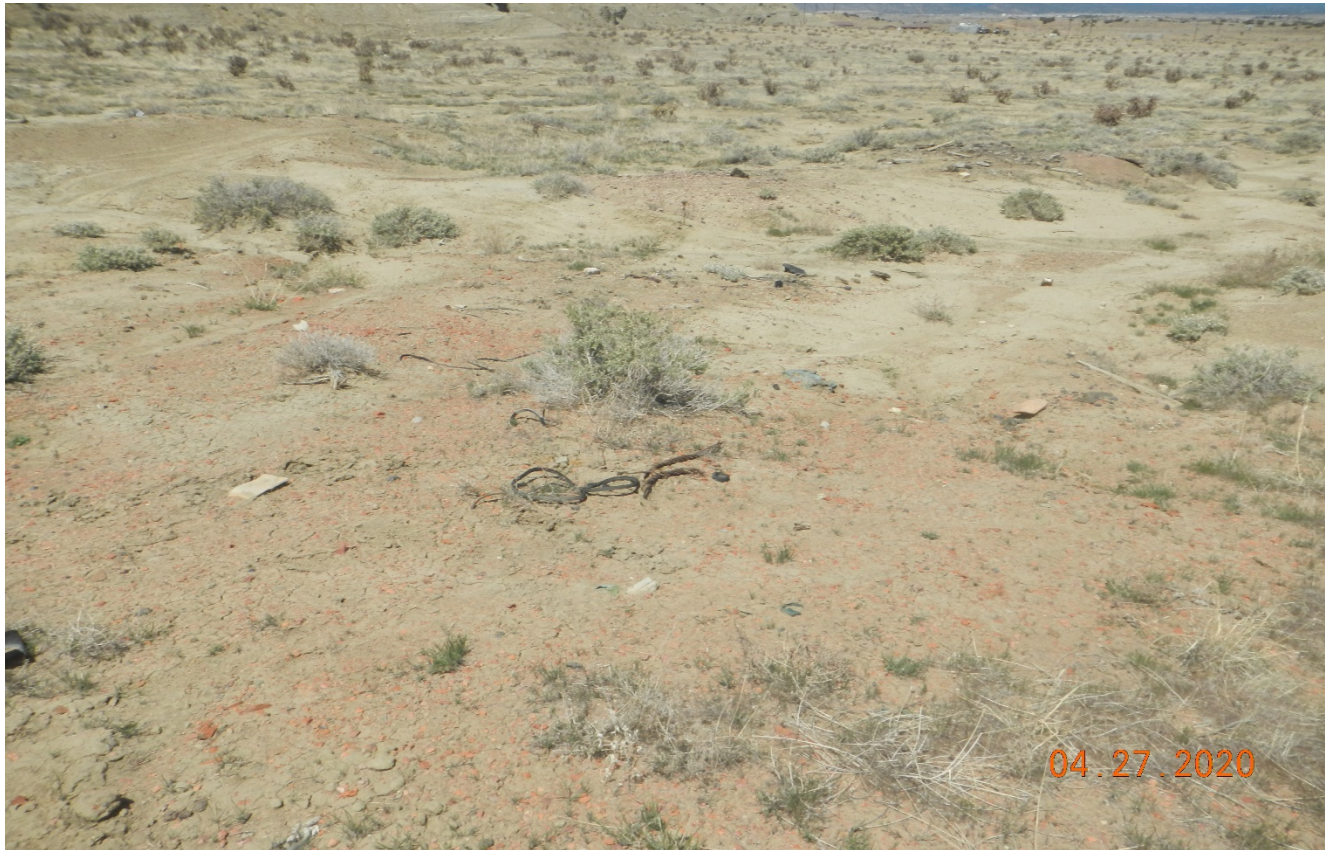
Photo 6. There is cable and debris that remain at the north side of the location.

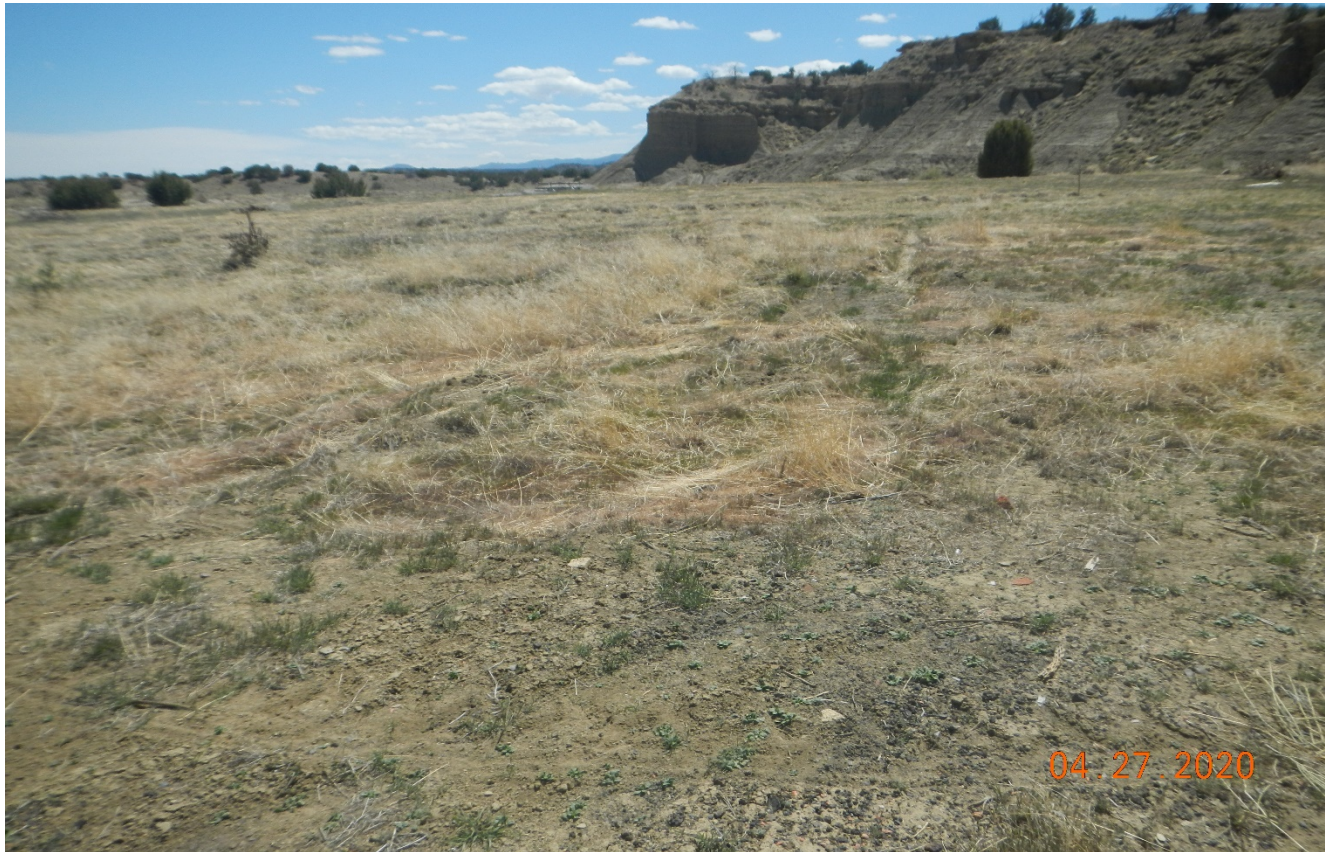
Photo 7. Facing south at the location. The pipe and debris appear to have been removed from this area.
