Pit Status Evaluation Form

Pit Name: MATHIESEN UNIT	Facility ID: 118567
Current Status: Unknown	Status Date: 9/23/1999
Current Operator: AMOCO PRODUCTION COMPANY / 2500	
Updated Operator:	
Form 15 Pit Permit Doc #: 582411	Permit Date: 4/30/1973
Related Facilities: JAMES H. MATHISEN UNIT B #1 (API 123-07760; Facility ID 239972; Loc ID 336256)

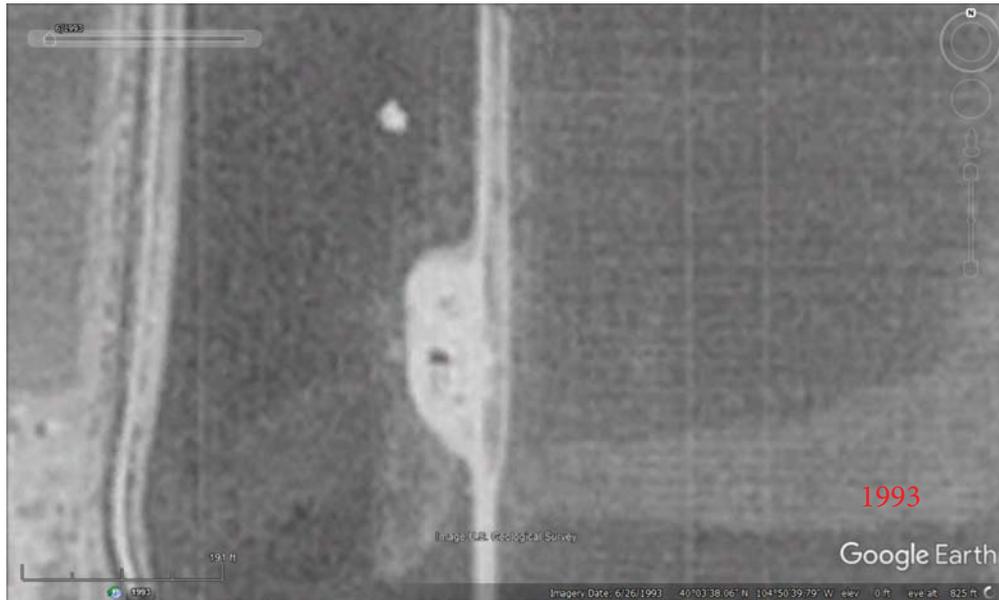
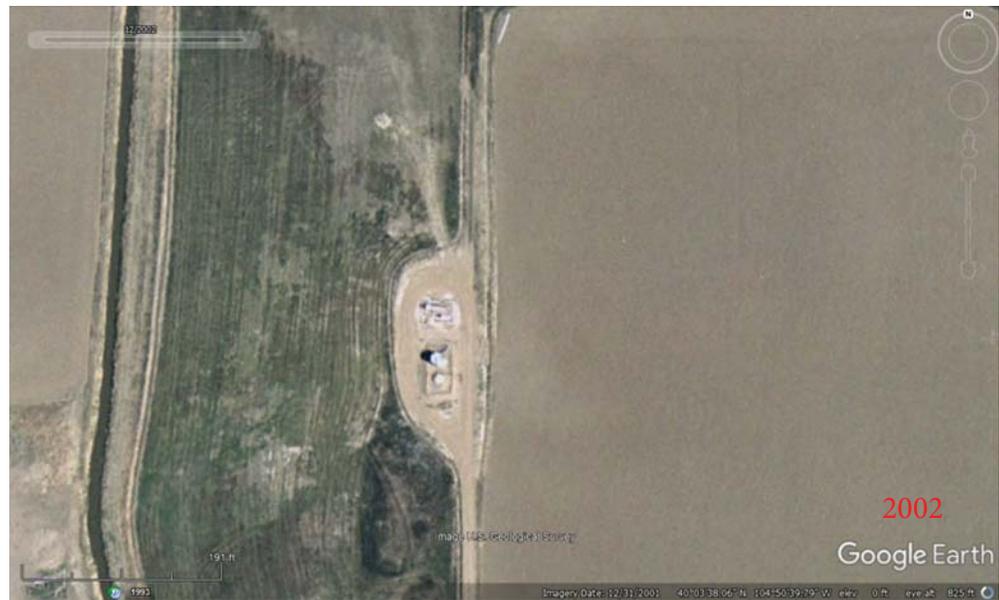
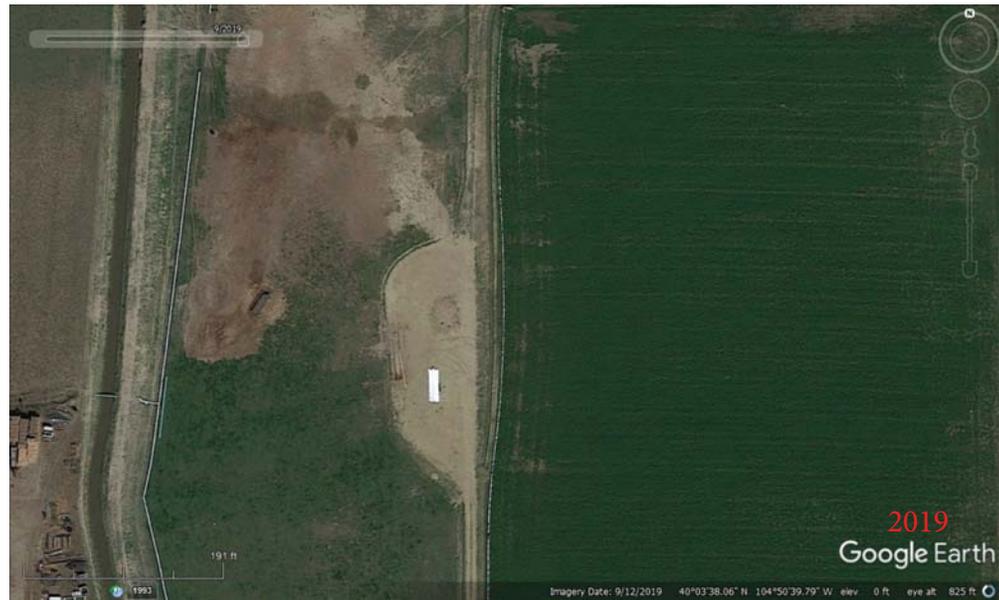
| <input checked="" type="checkbox"/> | Aerial Photo Verification (photos attached) | |

Based on records review and aerial imagery, any pits on location were replaced by a fiberglass tank prior to 8/21/1997 pit inventory report, which documents a 75bbl fiberglass tank on location. Remediation Project #4267 performed at tank battery (closed 11/23/2009). Pit status has been changed to closed.
