# Inspection Photos

API: 043-40006

Operator: JAVERNICK OIL

Inspection Date: 4/27/2020

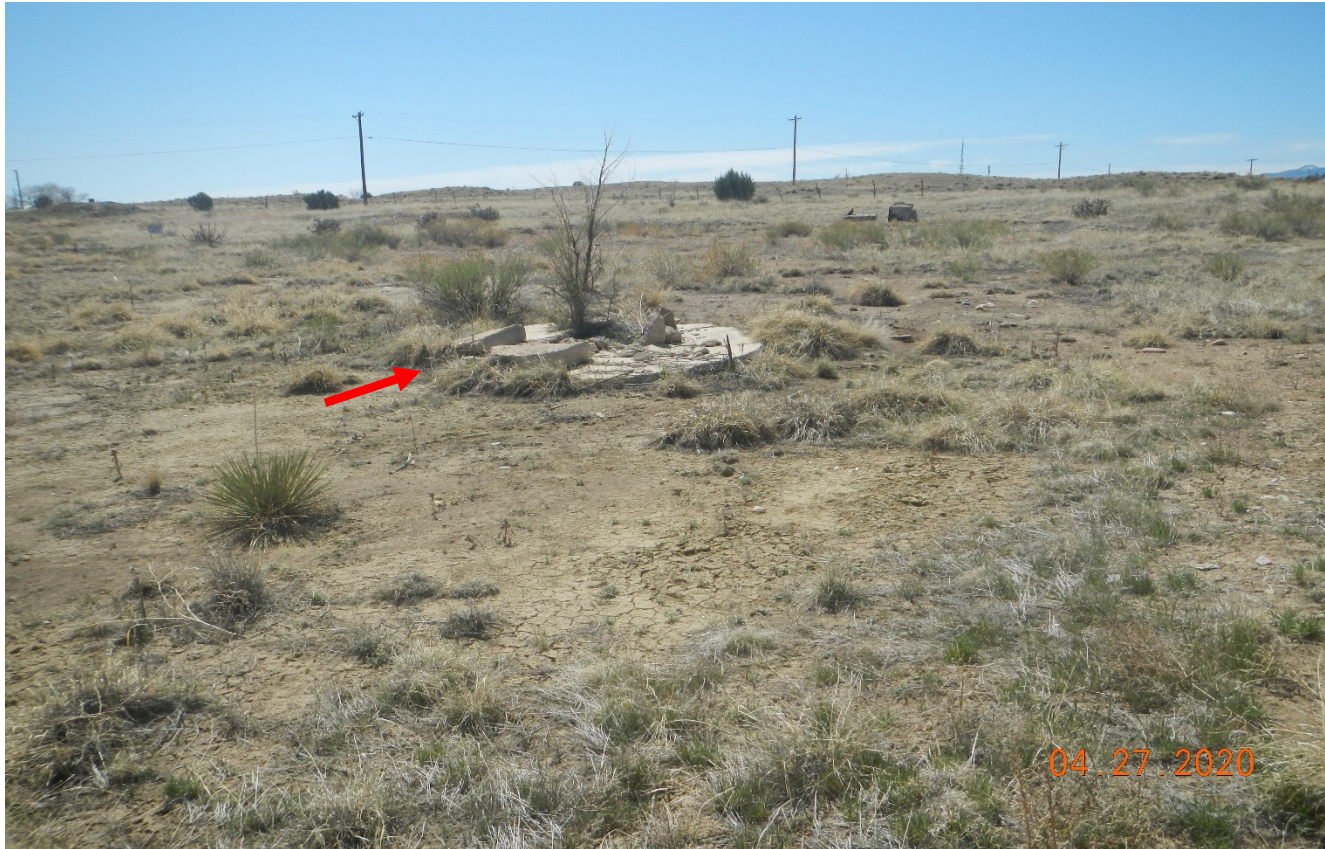
**Photo 1.** Facing southeast toward the location. There is cement debris that remains shown by red arrow.

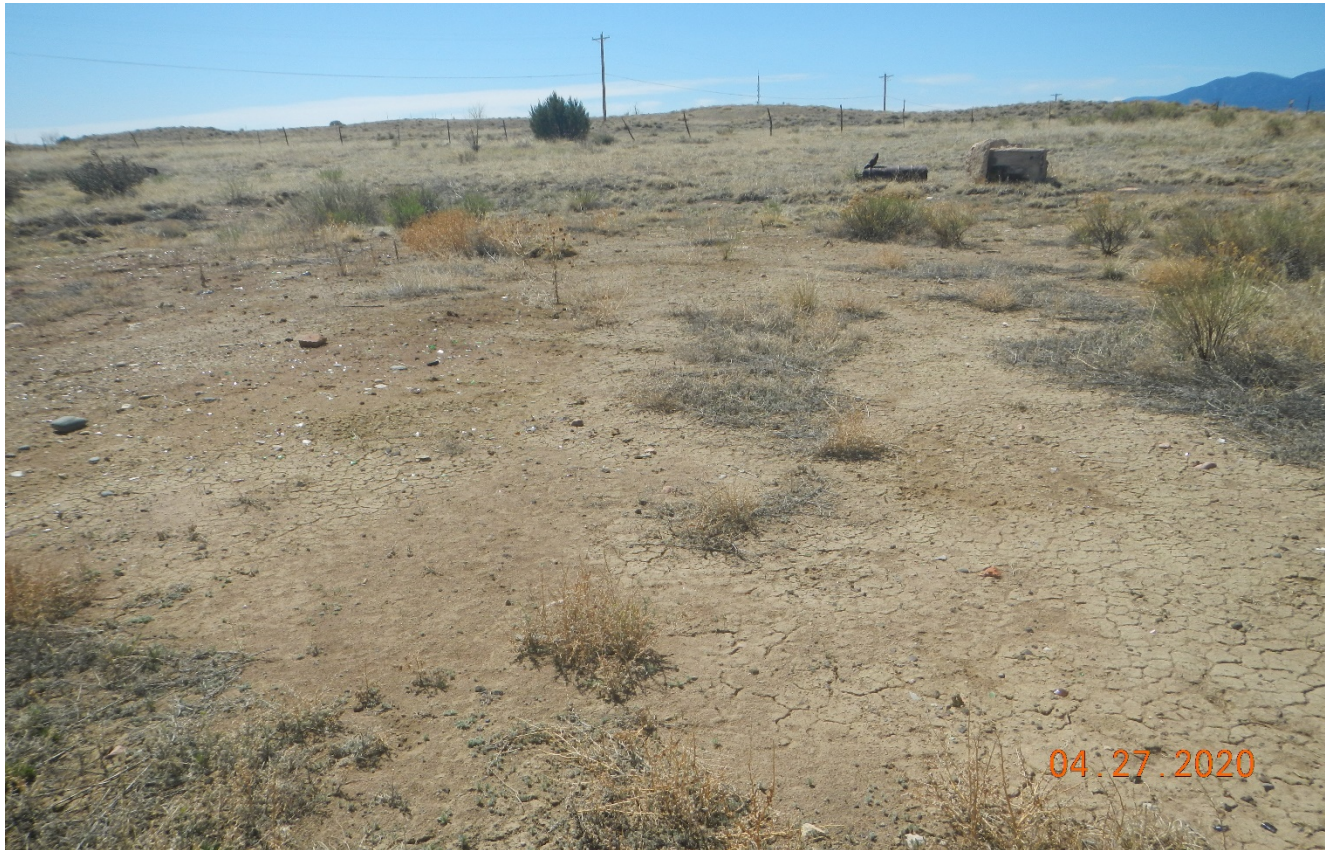
**Photo 2.** Facing south where well was located. This area is bare of vegetation and must be reclaimed. There is various debris along the ground.

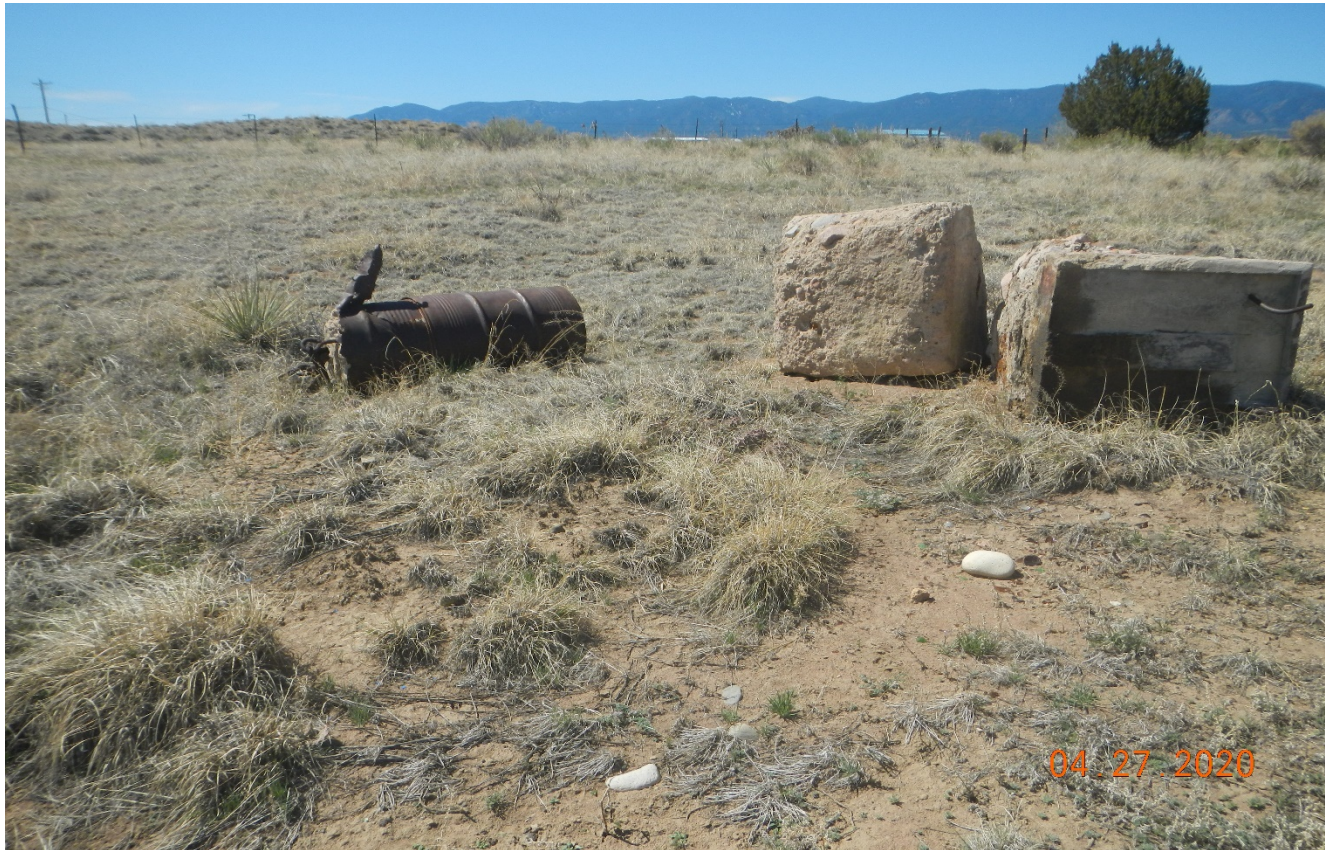
**Photo 3.** There are cement block and cemented anchor that remain at the south side of the location.

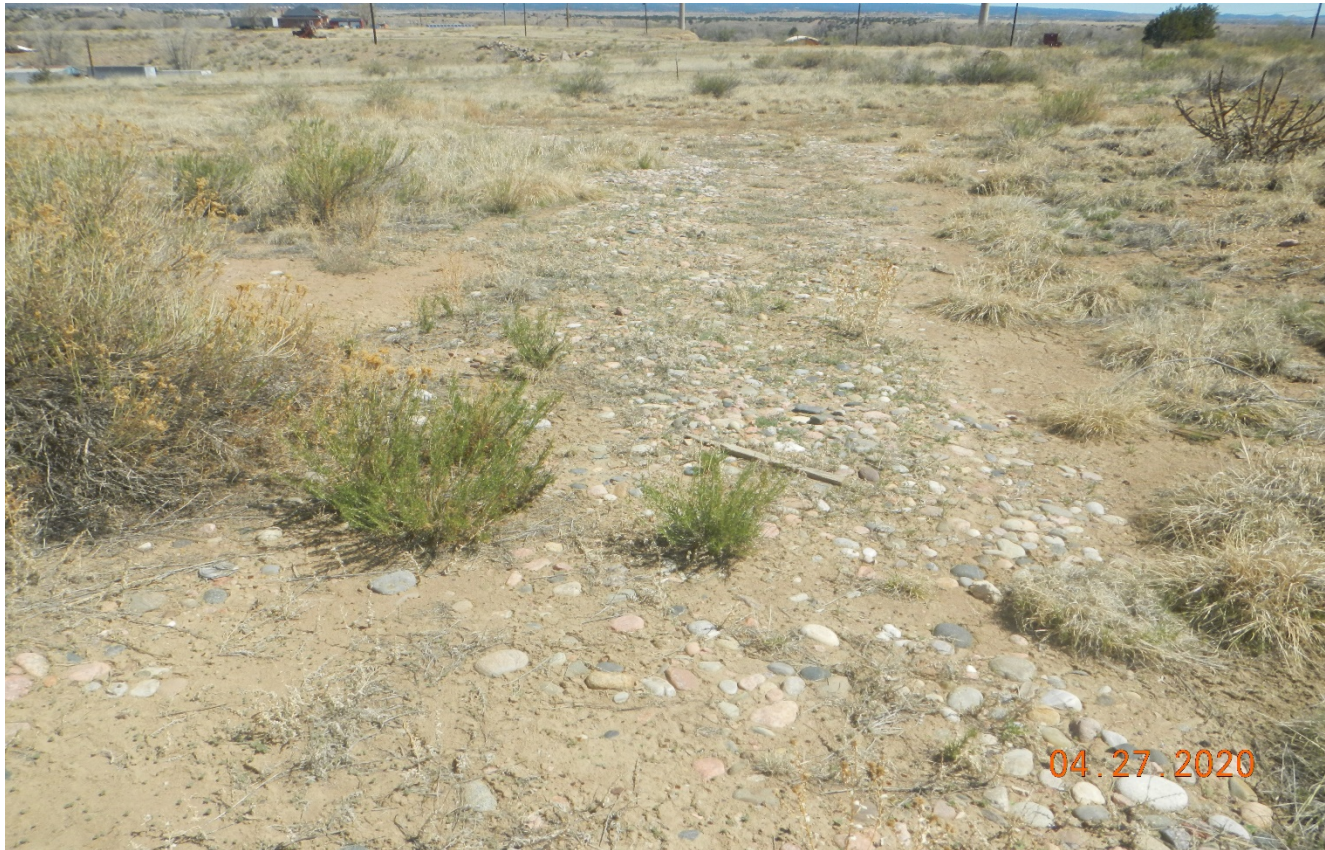
**Photo 4.** The access road made a circle around the well site. There is still gravel that remains and areas bare of vegetation along the former access road.

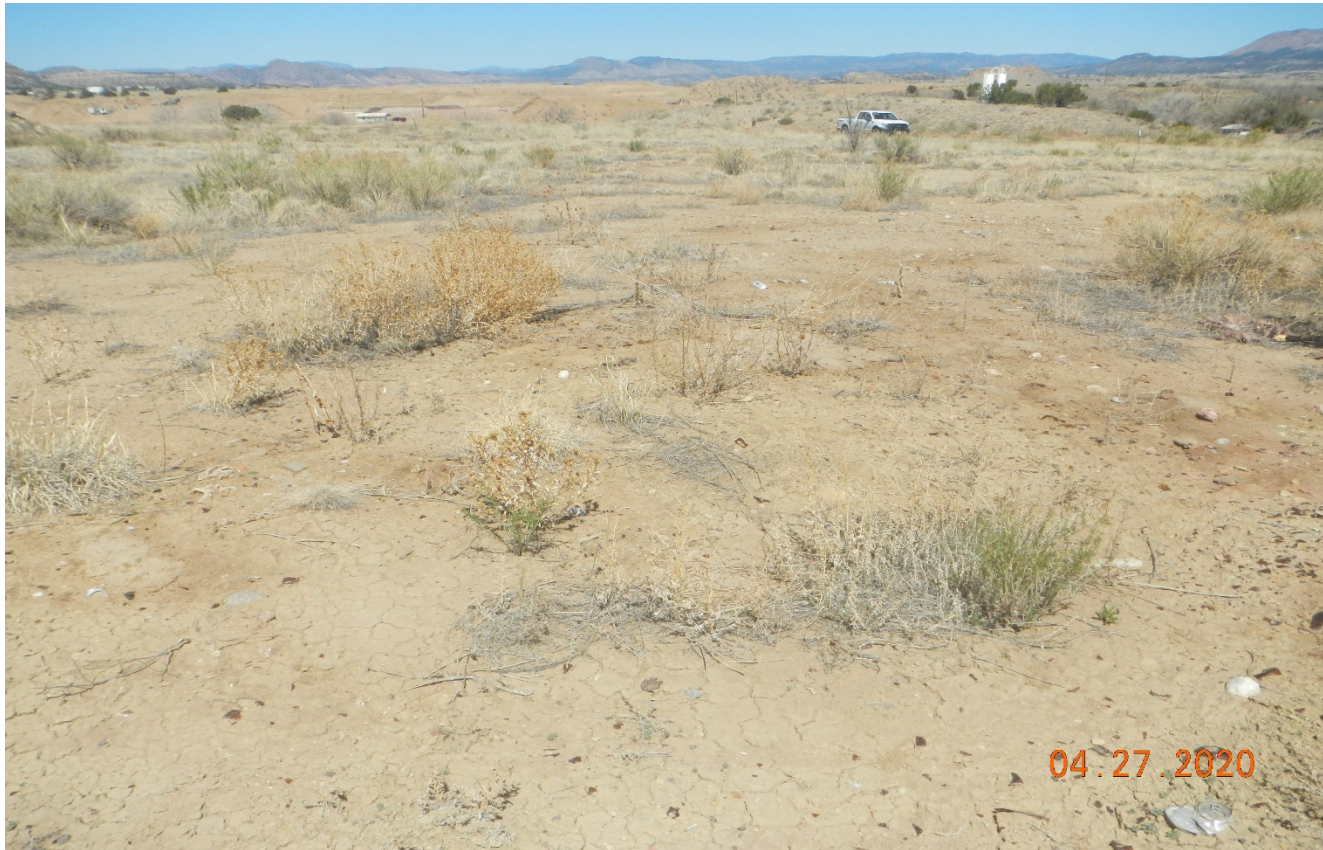
**Photo 5.** Facing northwest where well was located. This area is bare of vegetation and must be reclaimed.
