Inspection Photos
Location Name: UPRR 43 PAN AM I#29
Location ID: 318747

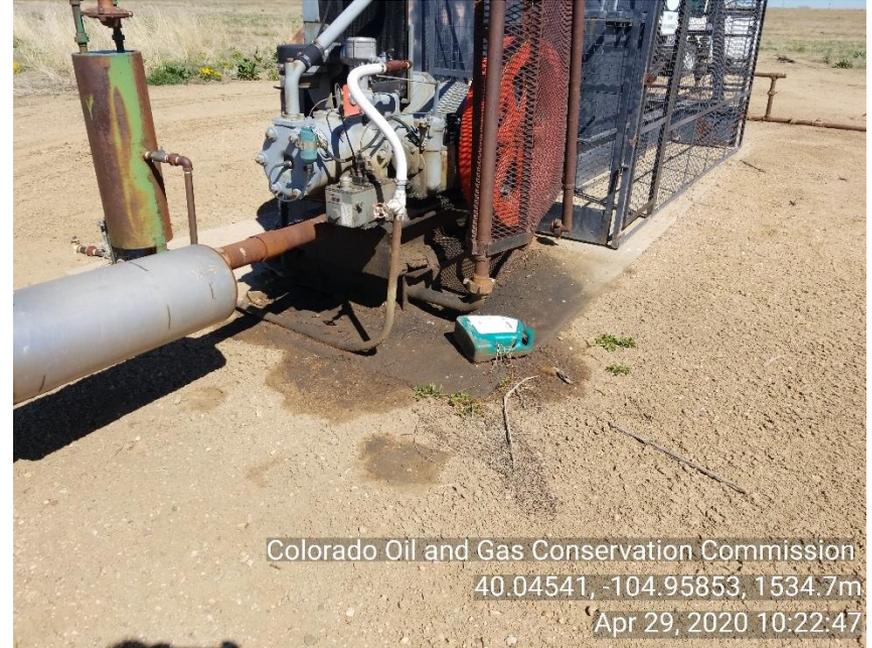
Photo 2 Stained soil around PU motor and Mechanical issue

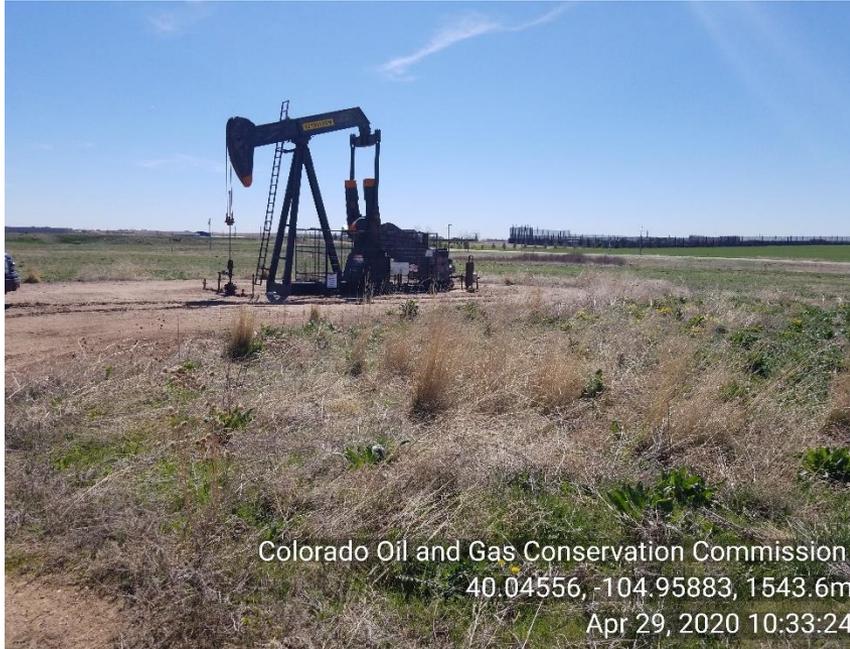
Photo 3 Debris: Dead weeds around location
