Inspection Photos

4/28/2020

Operator: CHEVRON USA INC - 16700

Location ID: 397164

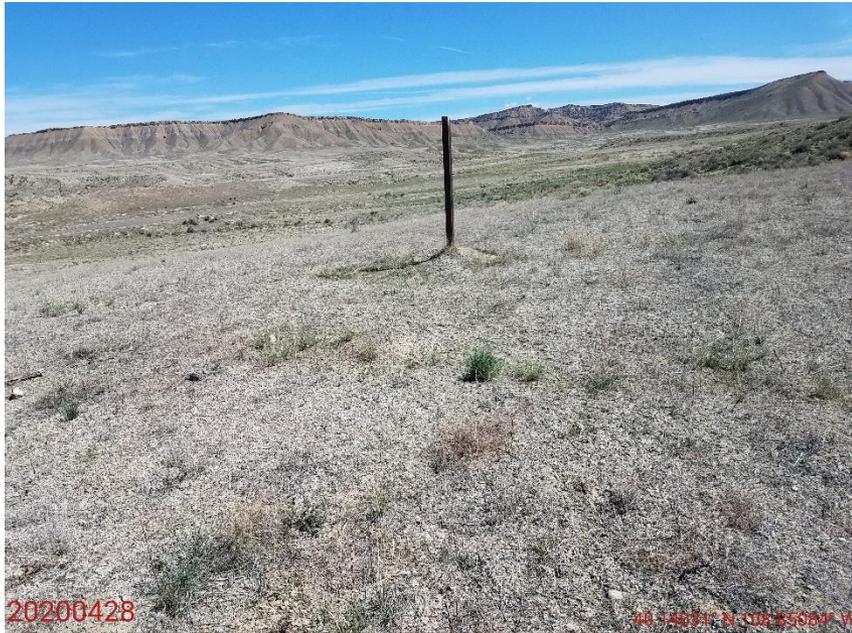
Photo 1: Photo taken from the well, facing northeast. Photo shows location is predominantly bare soil or vegetated by weedy debris.

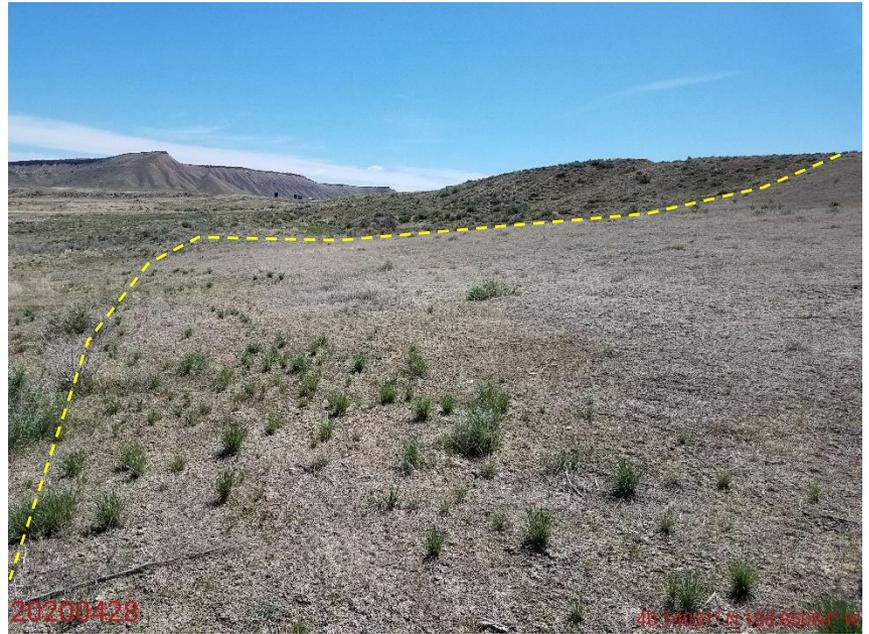
Photo 2: Photo taken from the north end of the Location, facing east. Photos 2-5 provide an overview of the Location from east, southeast, south, southwest to west. Yellow line shows approximate perimeter of the disturbance area and the adjacent reference. Photos show location is not reflective of the reference; location is predominantly bare soil or litter.

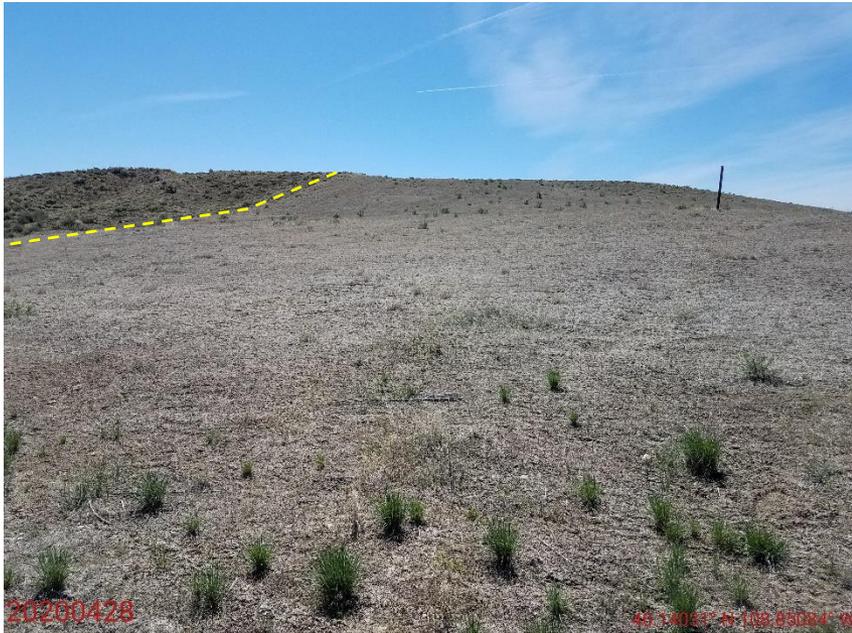
Photo 3: See comments under photo 2.

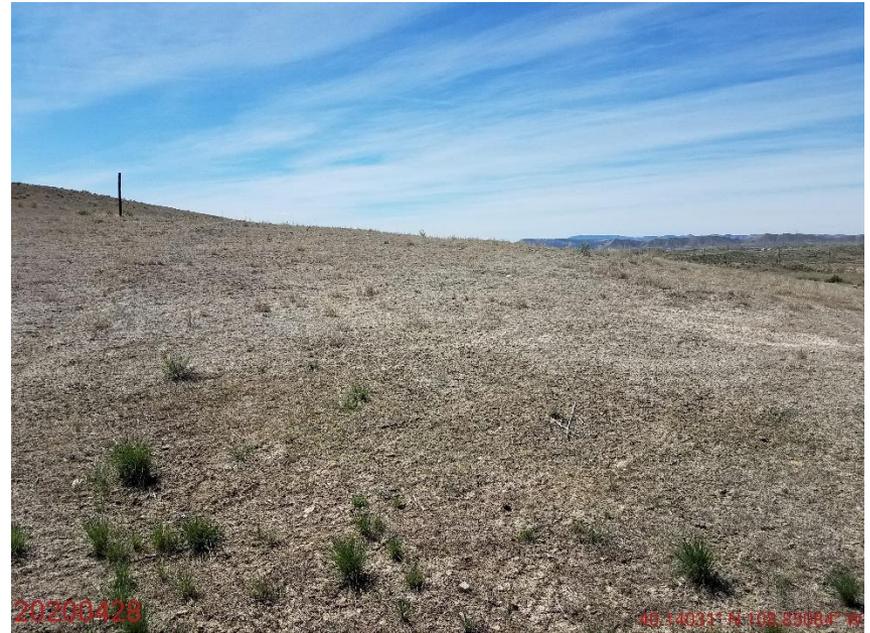
Photo 4: See comments under photo 2.

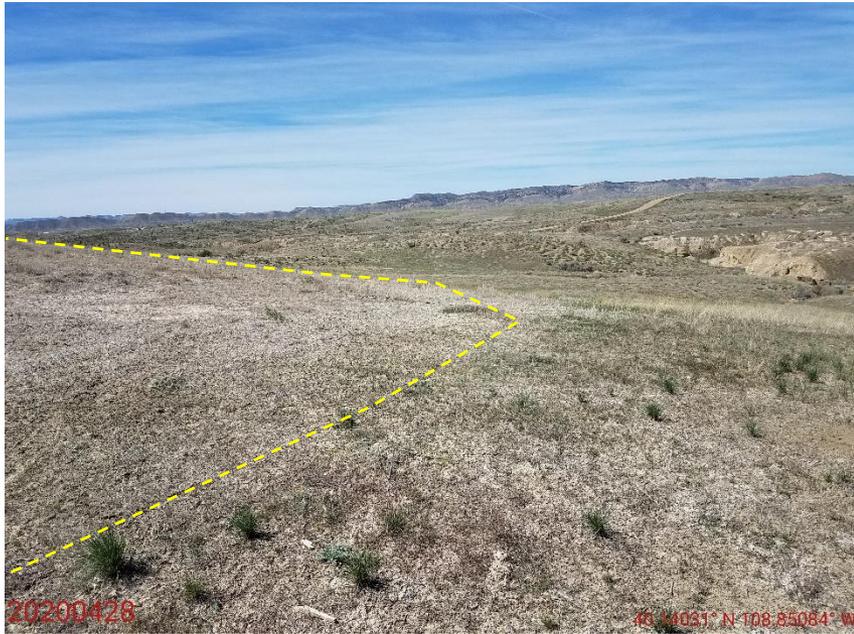
Photo 5: See comments under photo 2.

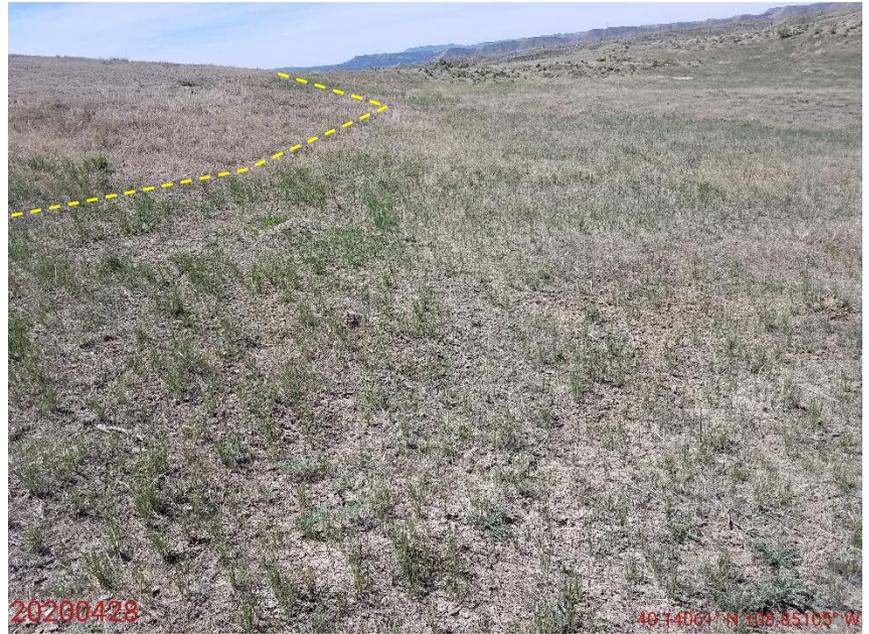
Photo 6: Photo taken from the western perimeter of the Location, facing north. Yellow line shows approximate perimeter of the disturbance area and the adjacent reference.

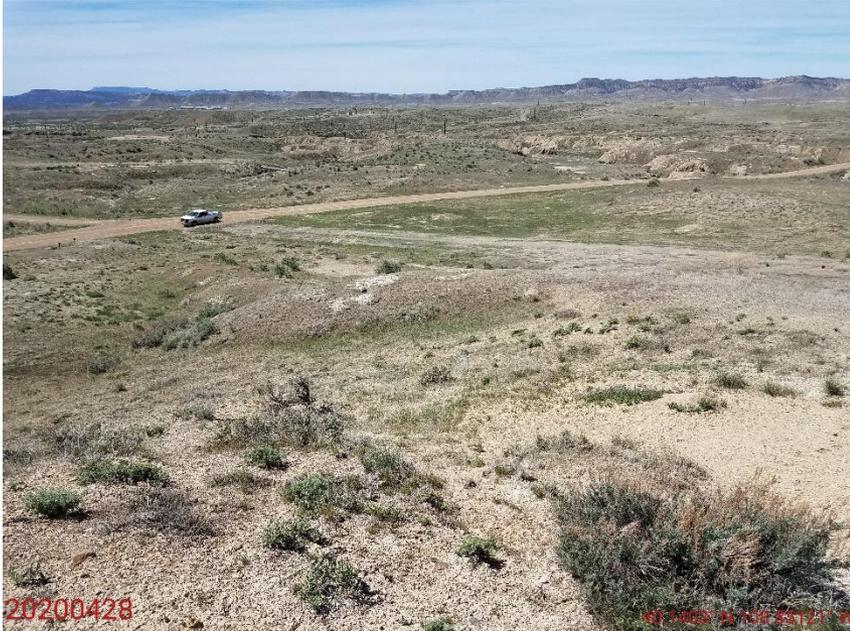
Photo 7: Photo taken from east end of the Location, facing southwest. Photos 7-10 provide an overview of the Location from southwest, west, north to northeast. Photos show location is not reflective of the reference; location is predominantly bare soil or litter

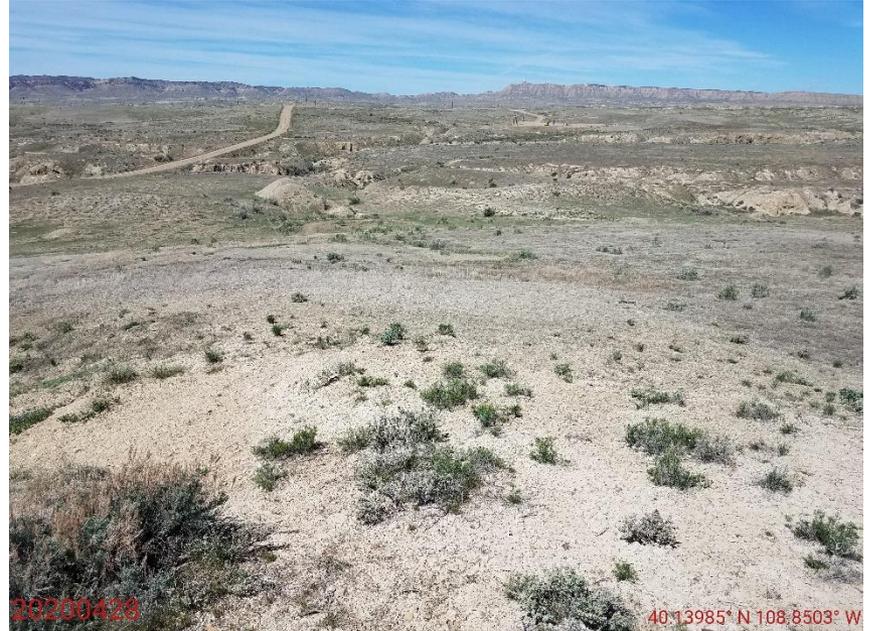
Photo 8: See comments under photo 7.

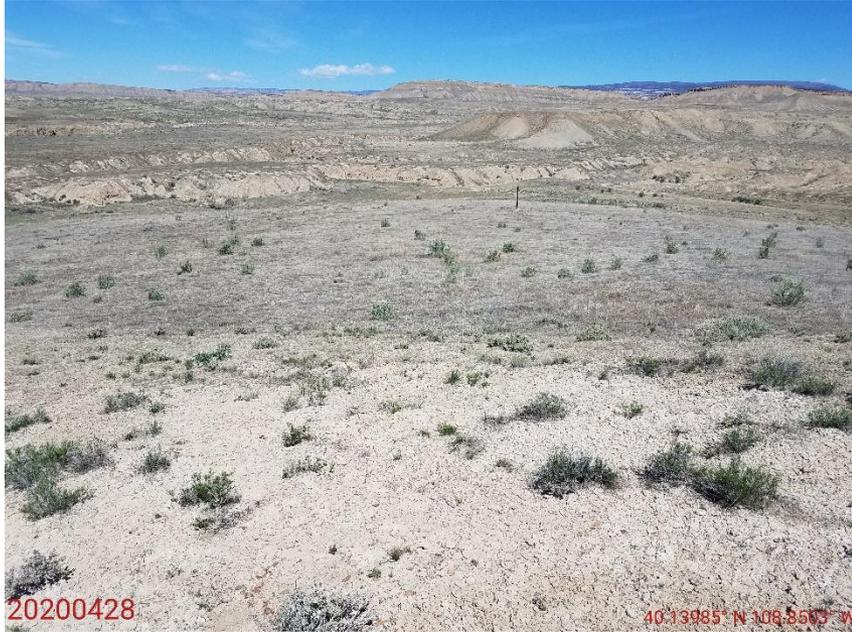
Photo 9: See comments under photo 7.

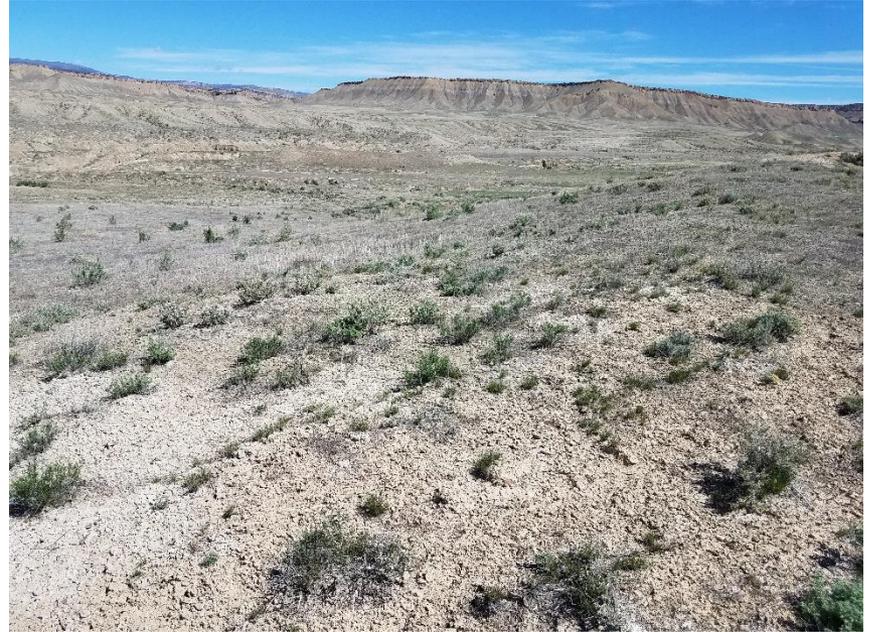
Photo 10: See comments under photo 7.

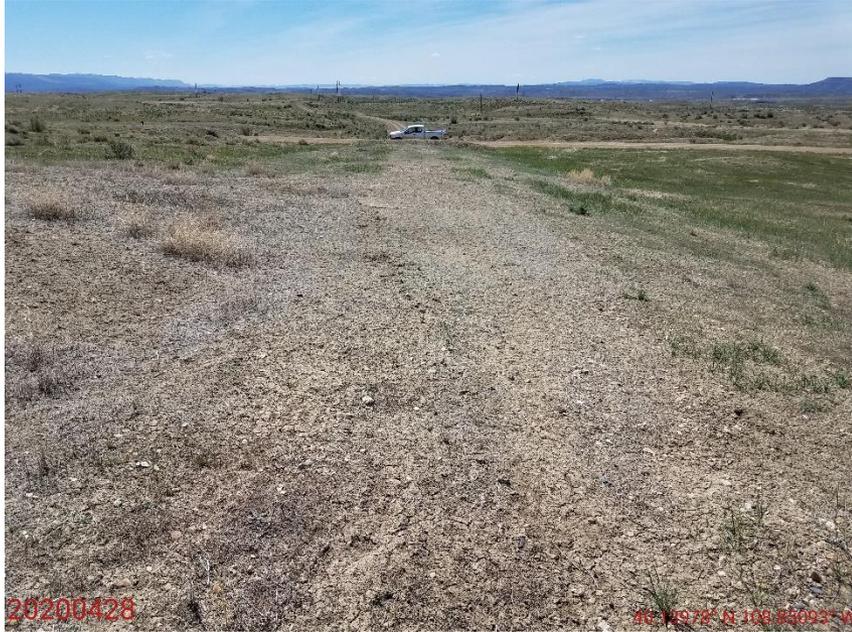
Photo 11: Photo taken from the access road, facing south. Photo shows access road remains predominantly bare and exposed soil.

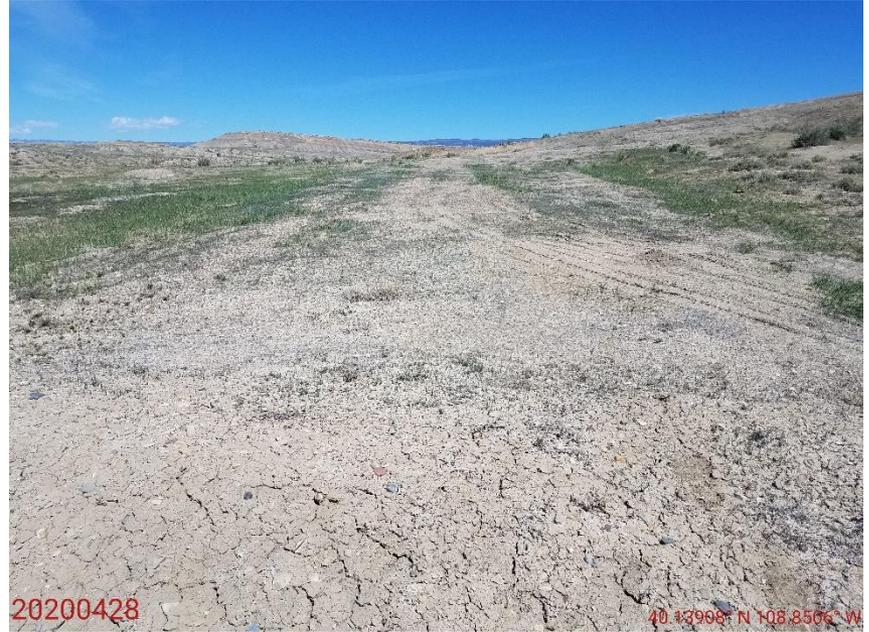
Photo 12: Photo taken from the access road, facing north. Photo shows access road remains predominantly bare and exposed soil.
