**Inspection Photos**  
**Location Name: 1415 Corp C unit #1**  
**Location ID: 318165**

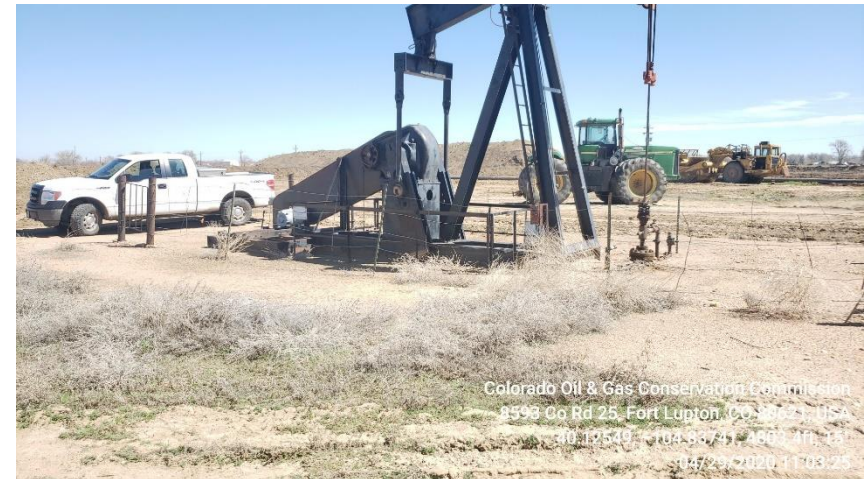
**Photo 2 PU and WH Dead weeds**

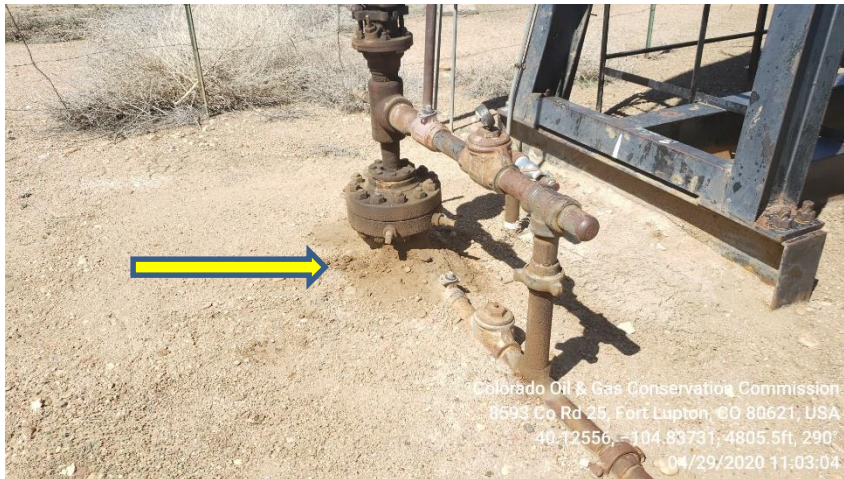
**Photo 3 Stained soil around WH**

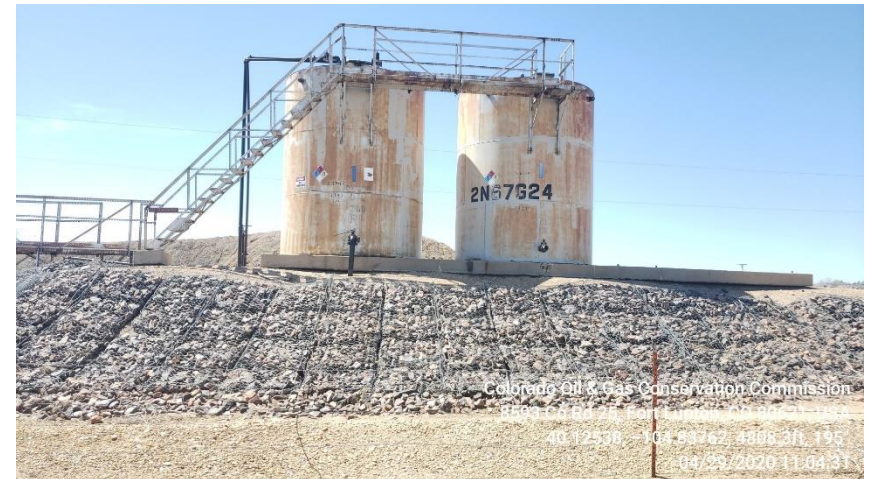
**Photo 6 TB Placards & labels faded, paint faded**

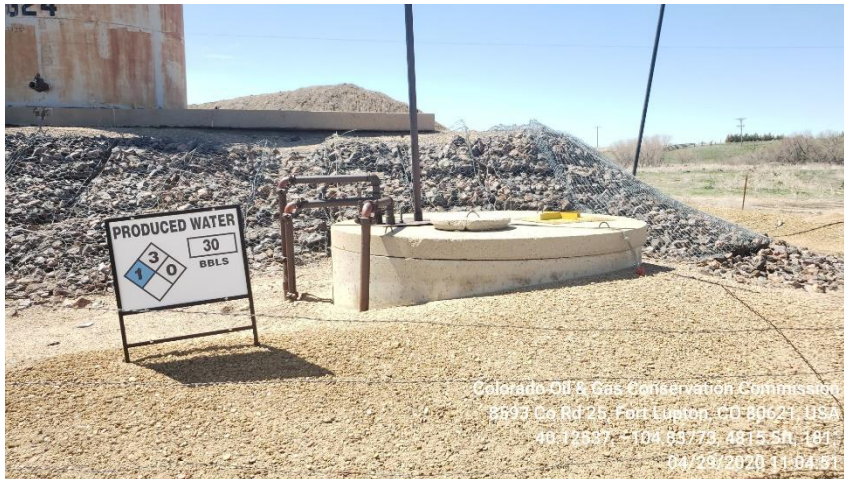
**Photo 7 PW vessel berm inadequate**

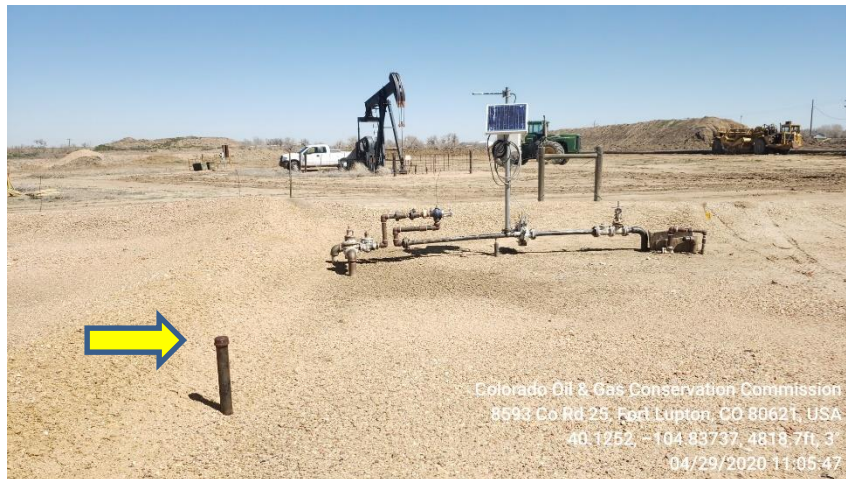
**Photo 9 Gas meter run, unused riser no LOTO**

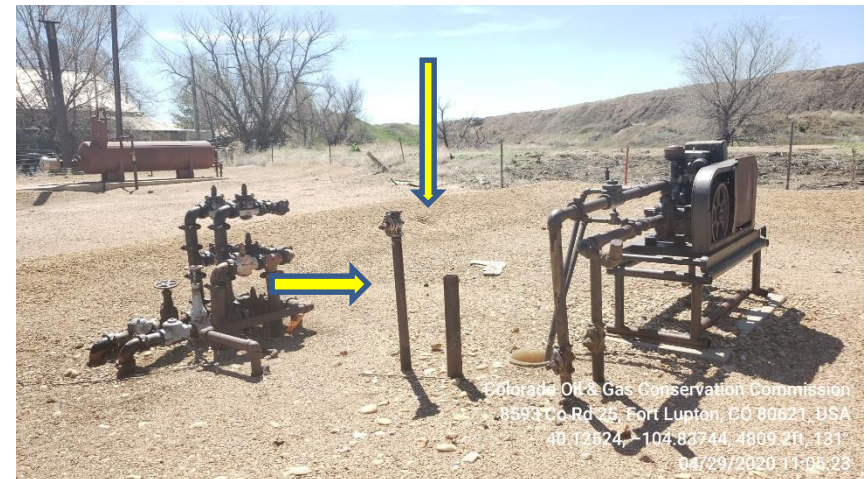
**Photo 10 unused risers, production equipment**

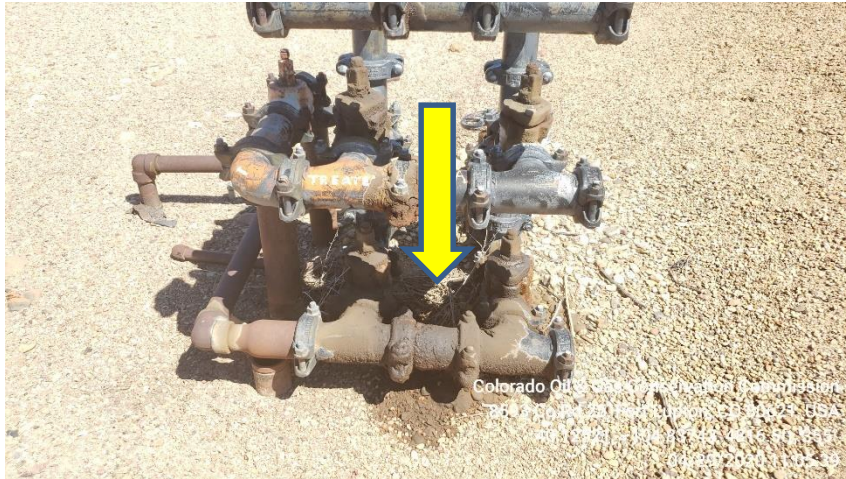
**Photo 11 stained soil by production manifold**

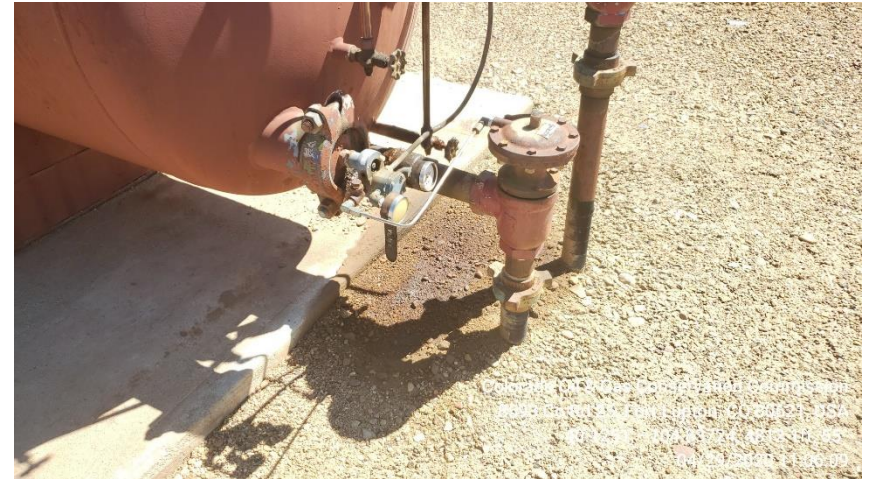
**Photo 12 Stained soil under separator valve**

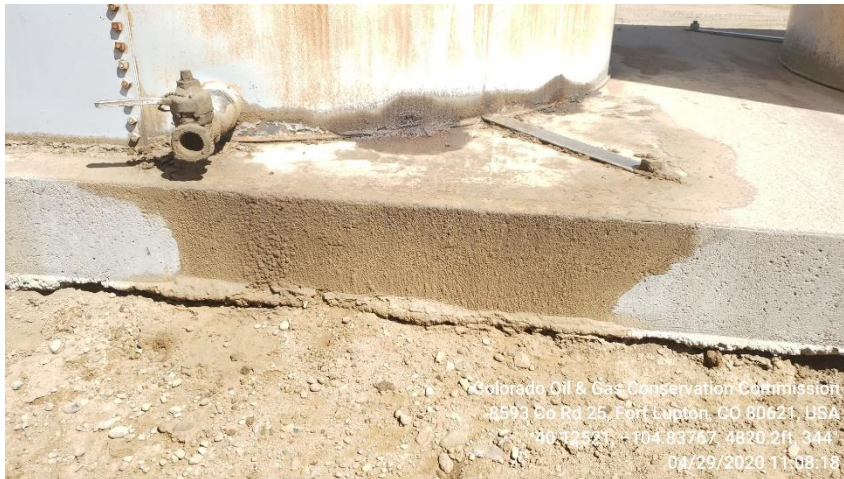
**Photo 13 stained cement/soil at base of crude tank**

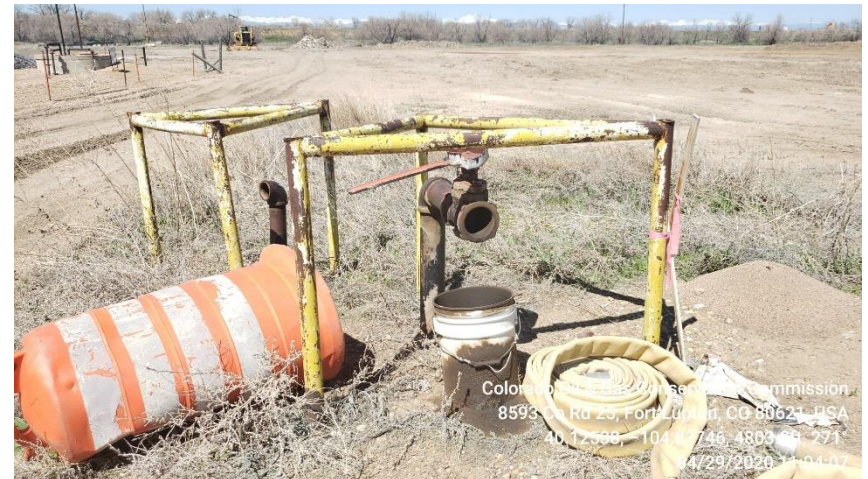
**Photo 14 Stained soil under valve trash**
