Stormwater Inspection Report

Operator:	Laramie Energy, LLC
Project:	Cascade Creek
Location:	C.C. 629-23-42
Date:	Wednesday, April 29, 2020
Weather:	Mostly Clear, Light Winds, High 78° Lo 48°

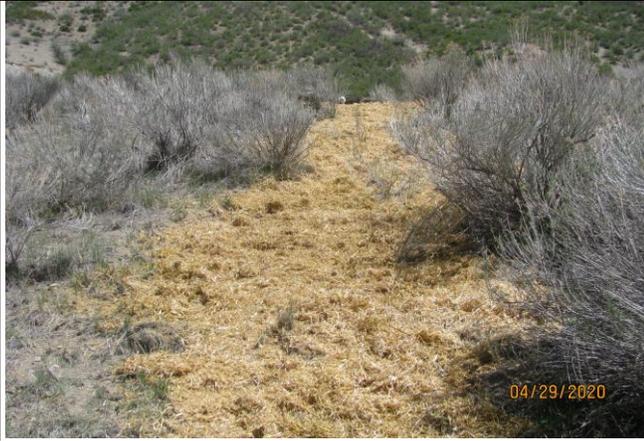
Photo 1

Disturbance Broadcast Seeded & Mulched on the C.C. 629-23-42 Fill Slope

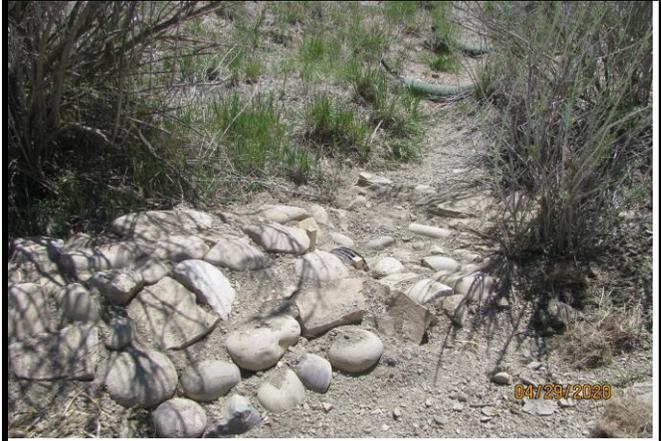
Photo 2

Flex Pipe Outlet & Downstream BMPs below the C.C. 629-23-42 Pad

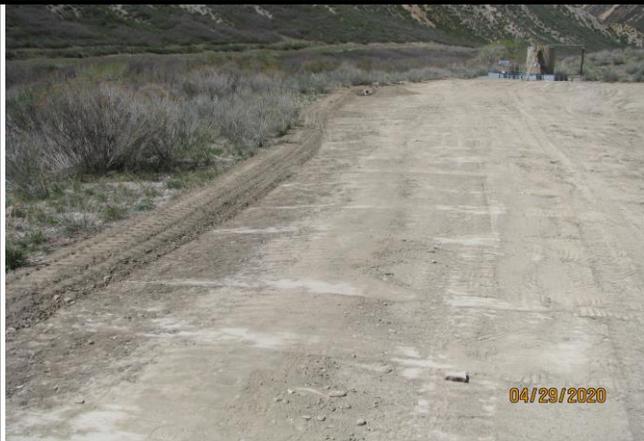
Photo 3

Grading and Berm Installation on the West Side of the C.C. 629-23-42 Pad

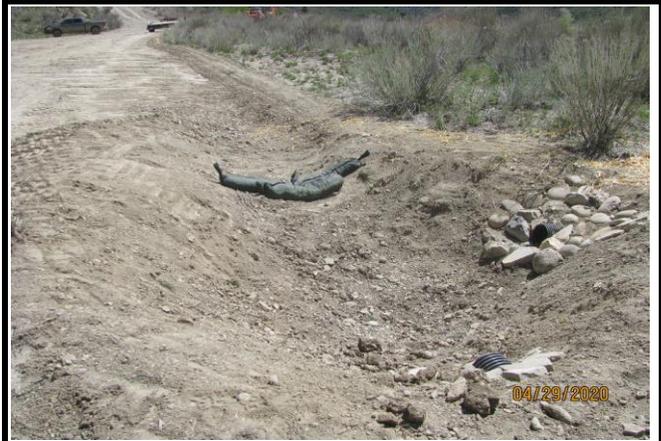
Photo 4

Sediment Trap & Flex Pipe Outlet on the West Side of the C.C. 629-23-42 Pad
