## Inspection Photos

Location Name: MARALEX RESOURCES INC DOME USA-610S98W /9SWNW

Location ID: 312561

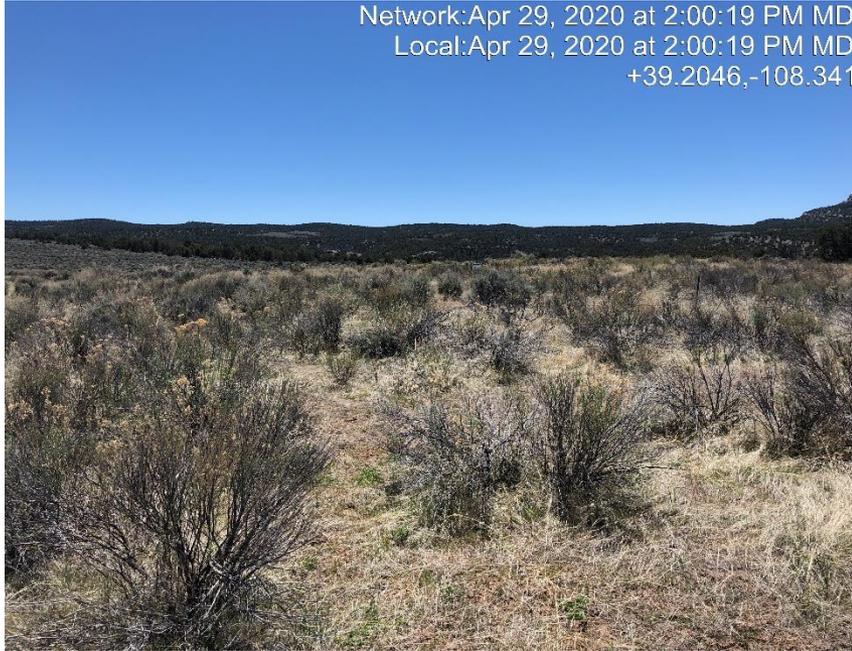
Photo #1092 from entrance to location

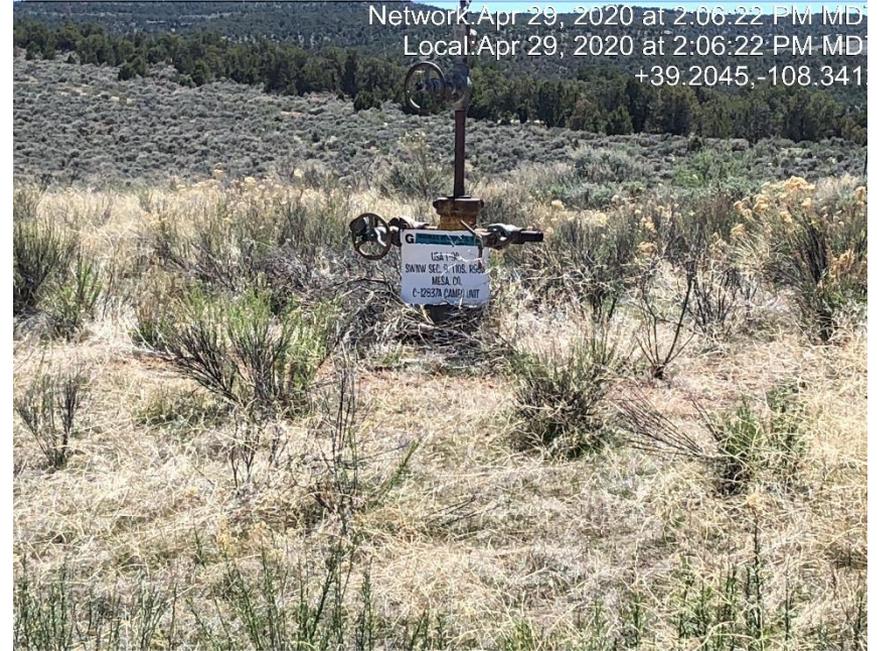
Photo #1094 Debris around wellhead.
