Inspection Photos
Location Name: State 16-2
Location ID: 312919

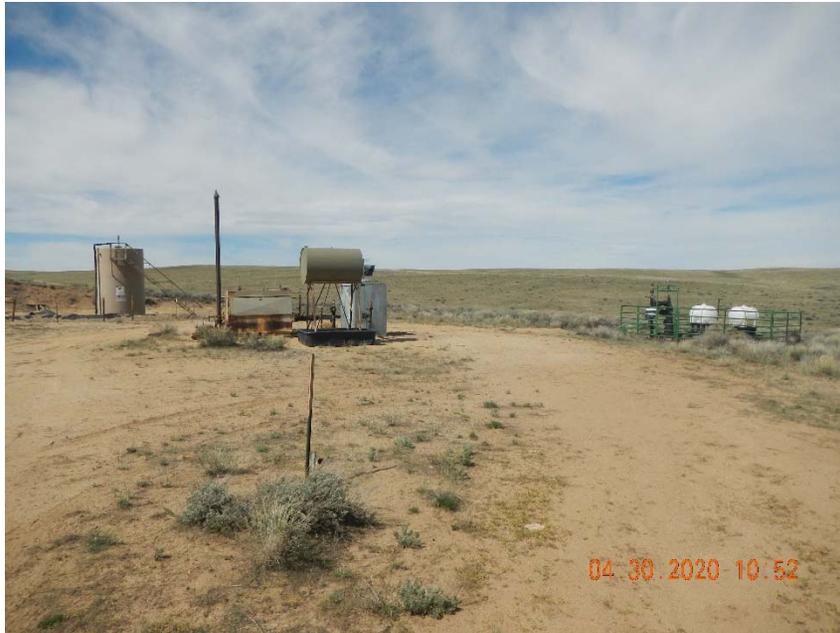
Photo 1. Overview of location taken facing southwest.

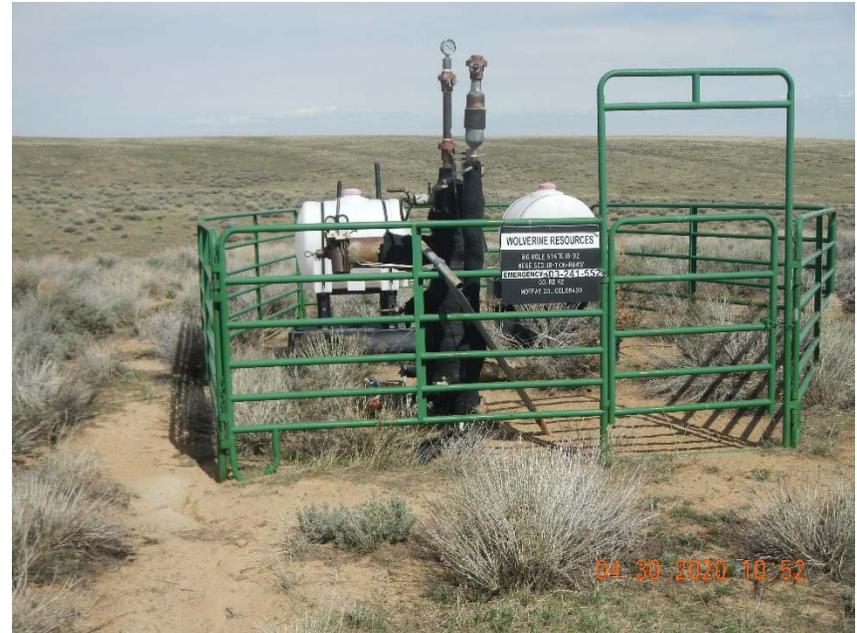
Photo 2. Wellhead with hissing sound coming from leak.

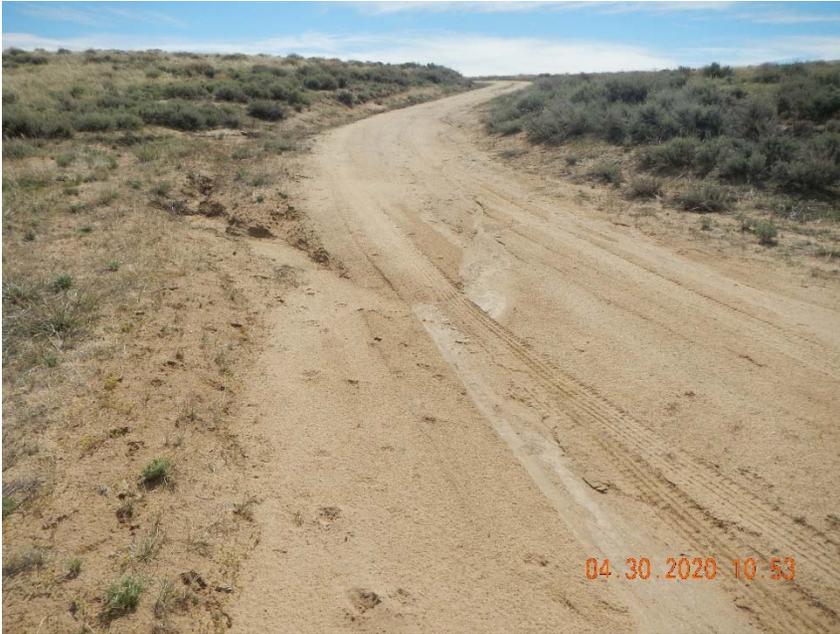
Photo 3. Sediment migration down access road.

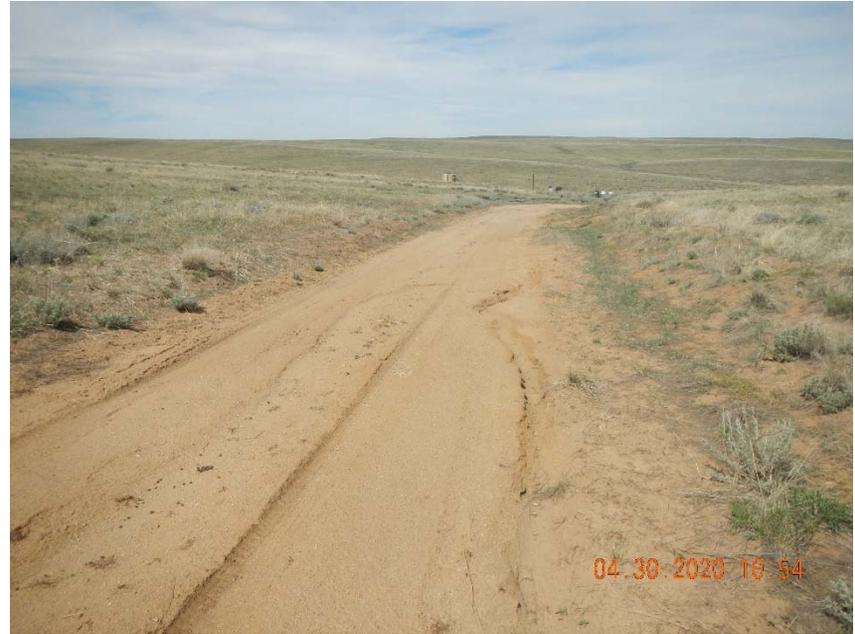
Photo 4. Sediment migration down access road.
