Inspection Photos
Operator: BP America
API#: 067-06547
Date: 4/28/2020

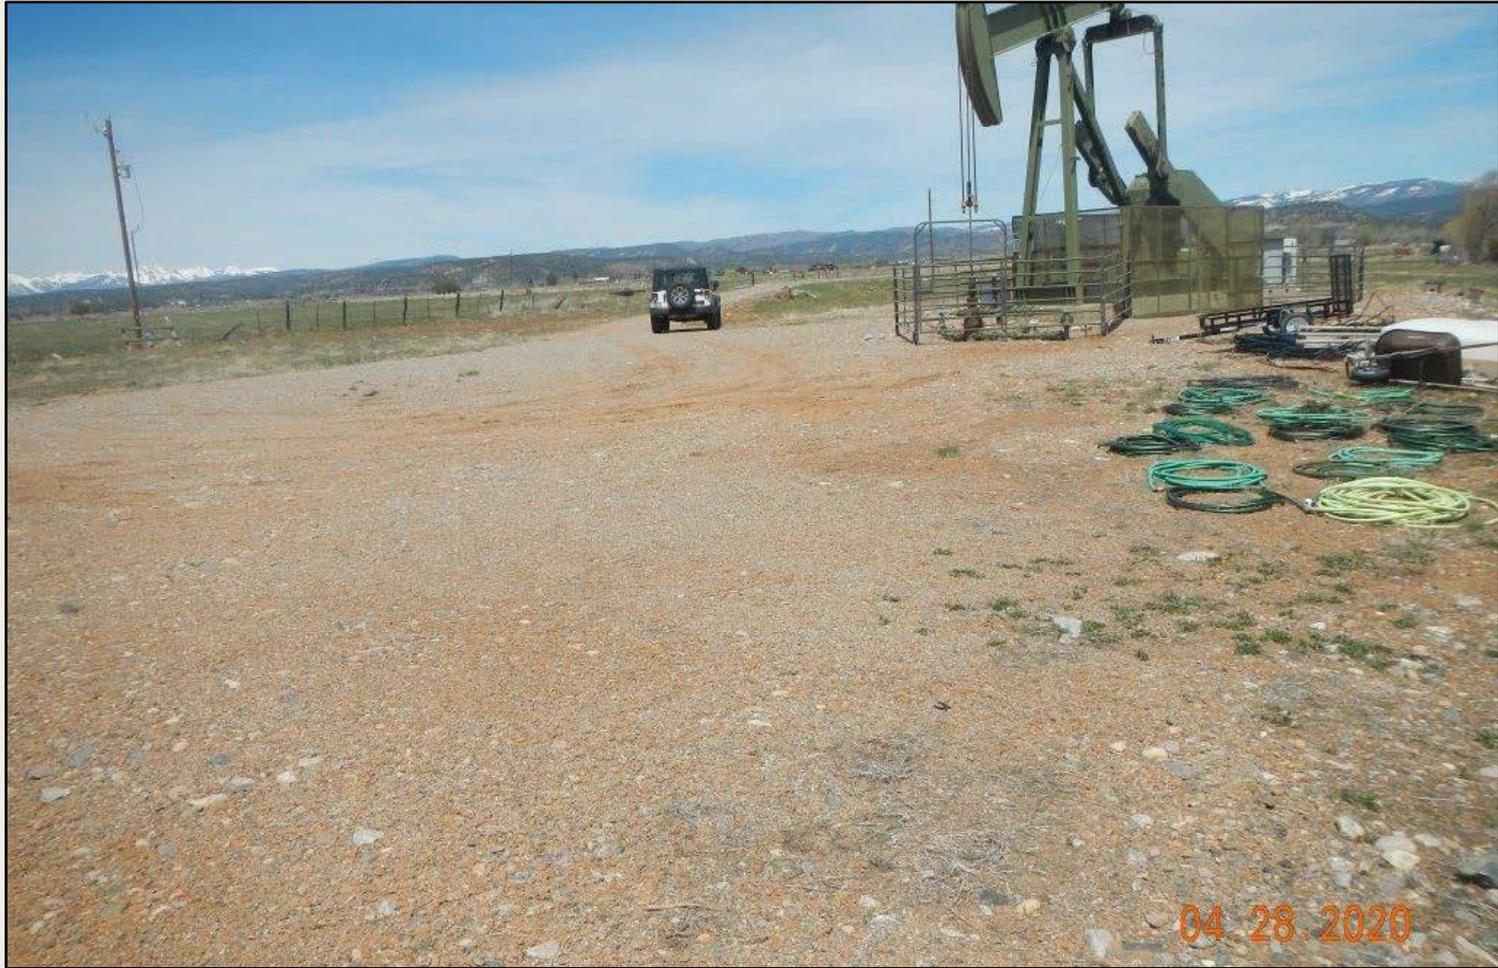
Photo 1. View of the project area from the southeastern corner facing center.

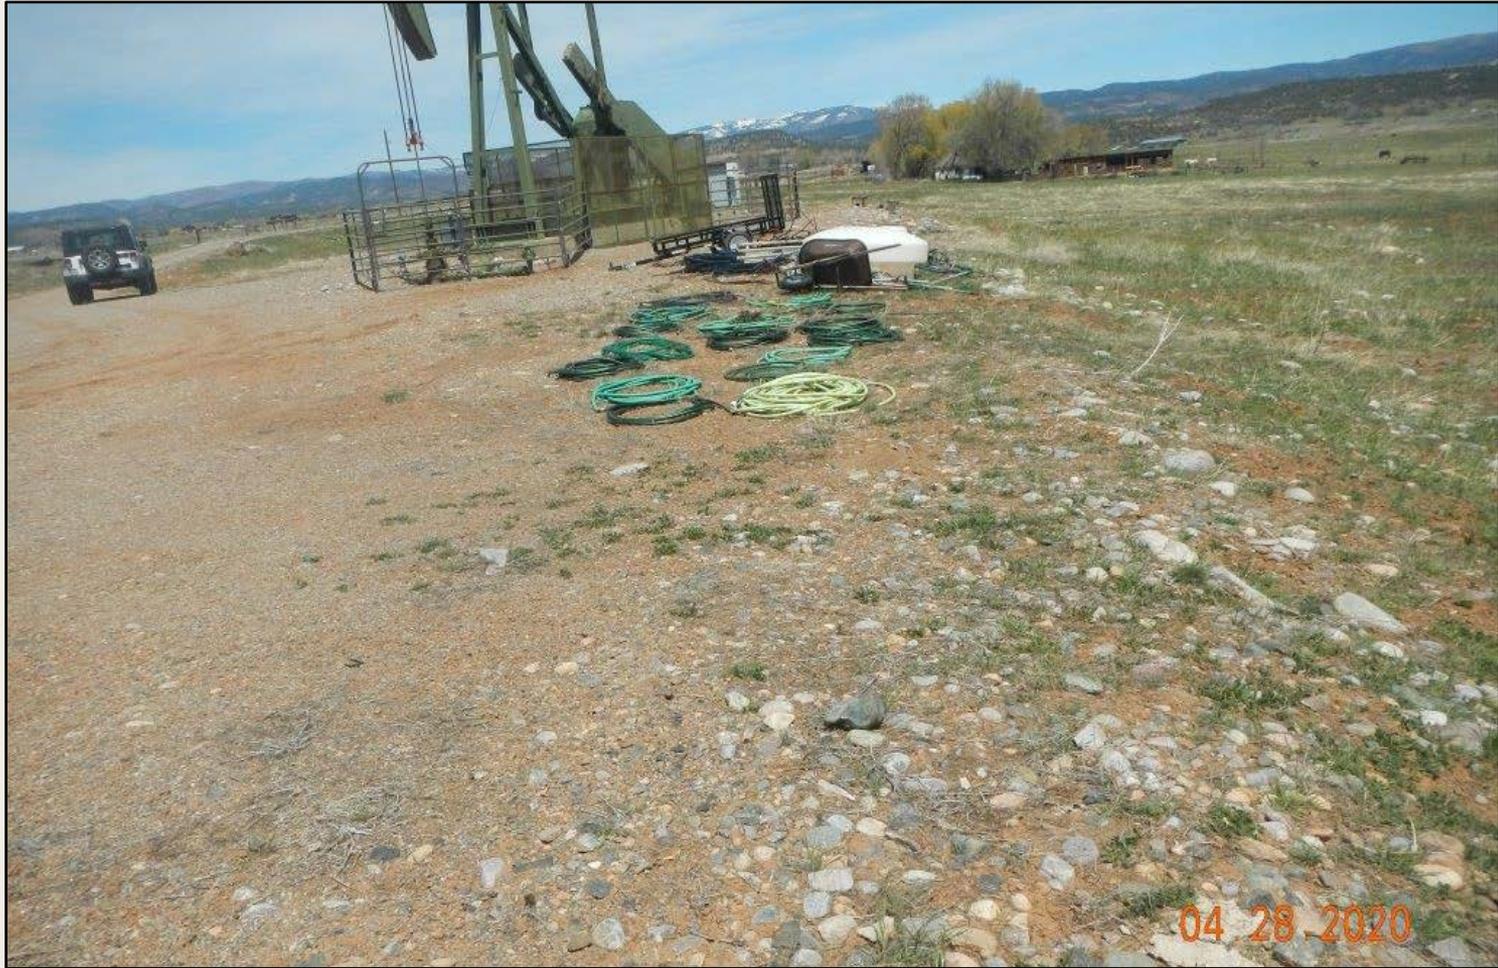
Photo 2. View of the eastern edge of the working area facing northward. Hoses and other unused equipment are stored here and need to be removed.

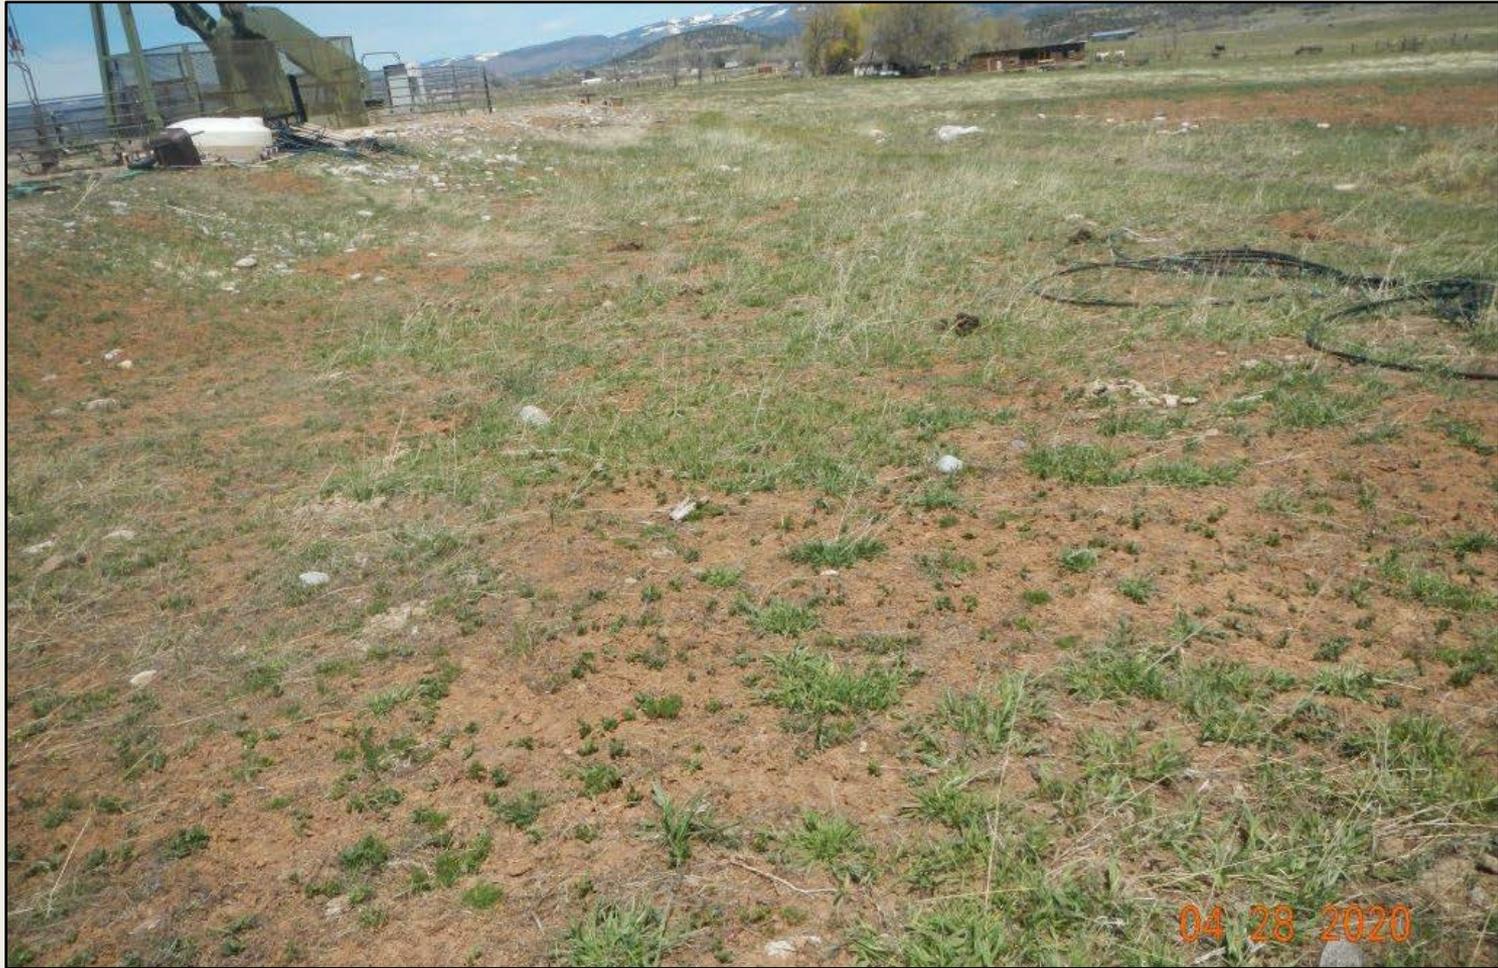
Photo 3. View of the eastern fill slope facing northward. Revegetation is progressing in a grazed condition with grasses such as smooth brome.

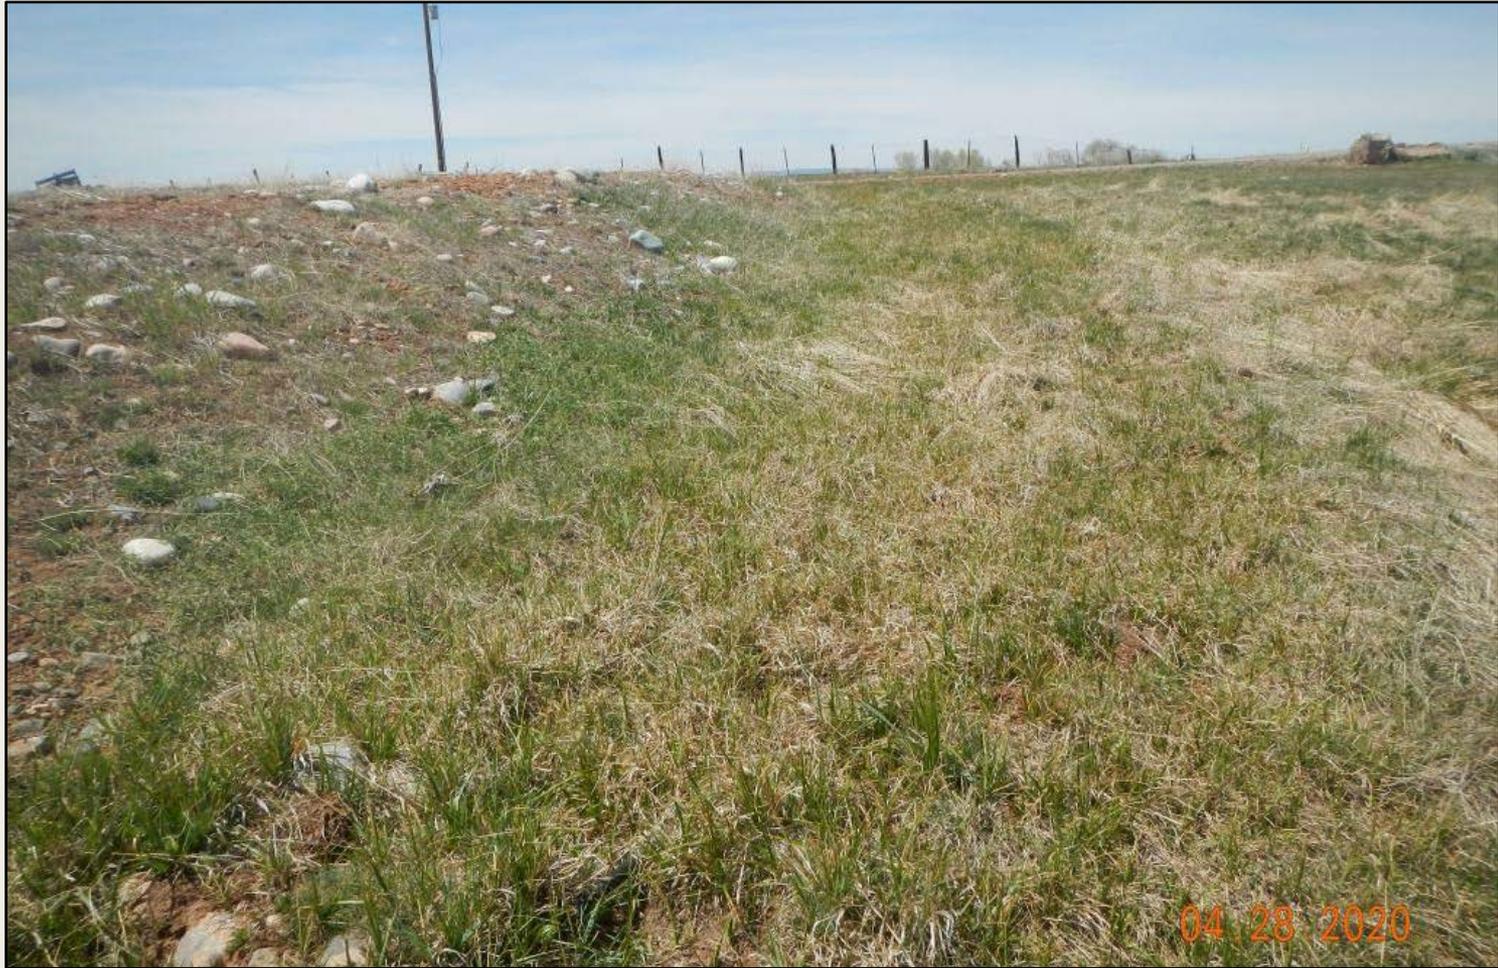
Photo 4. View of the northern project area facing westward.

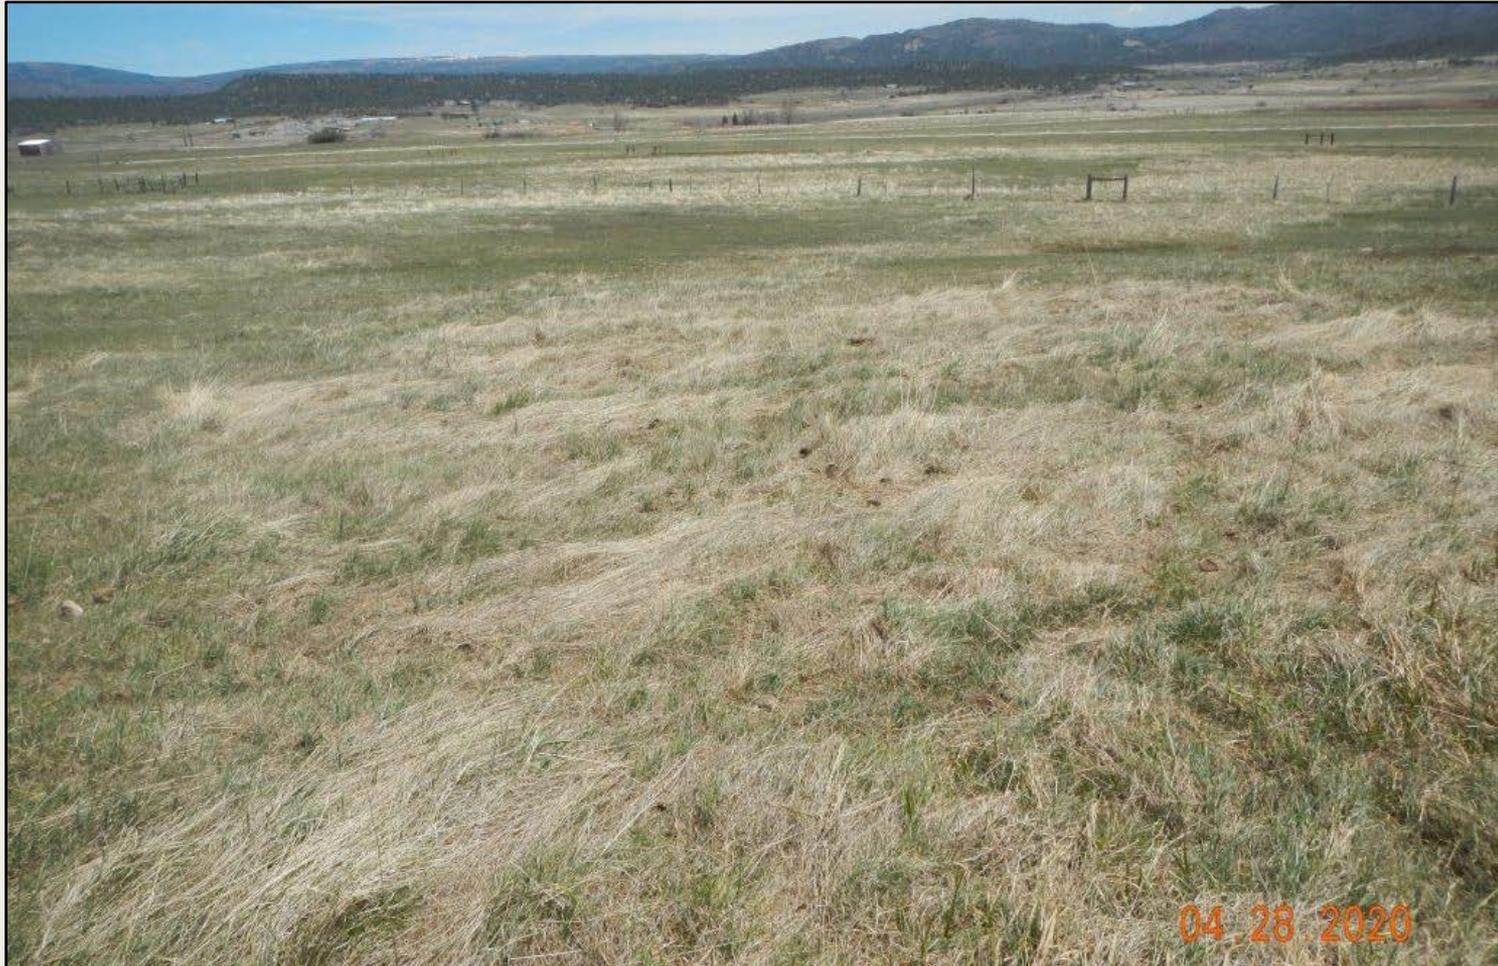
Photo 5. View of reference area vegetation comprised of open grass field with grasses such as smooth brome and western wheatgrass.
