Interim Reclamation and Stormwater Inspection

Operator: KERR MCGEE OIL & GAS ONSHORE LP #47120

Location ID: 327882

Inspection Document #: 697501430

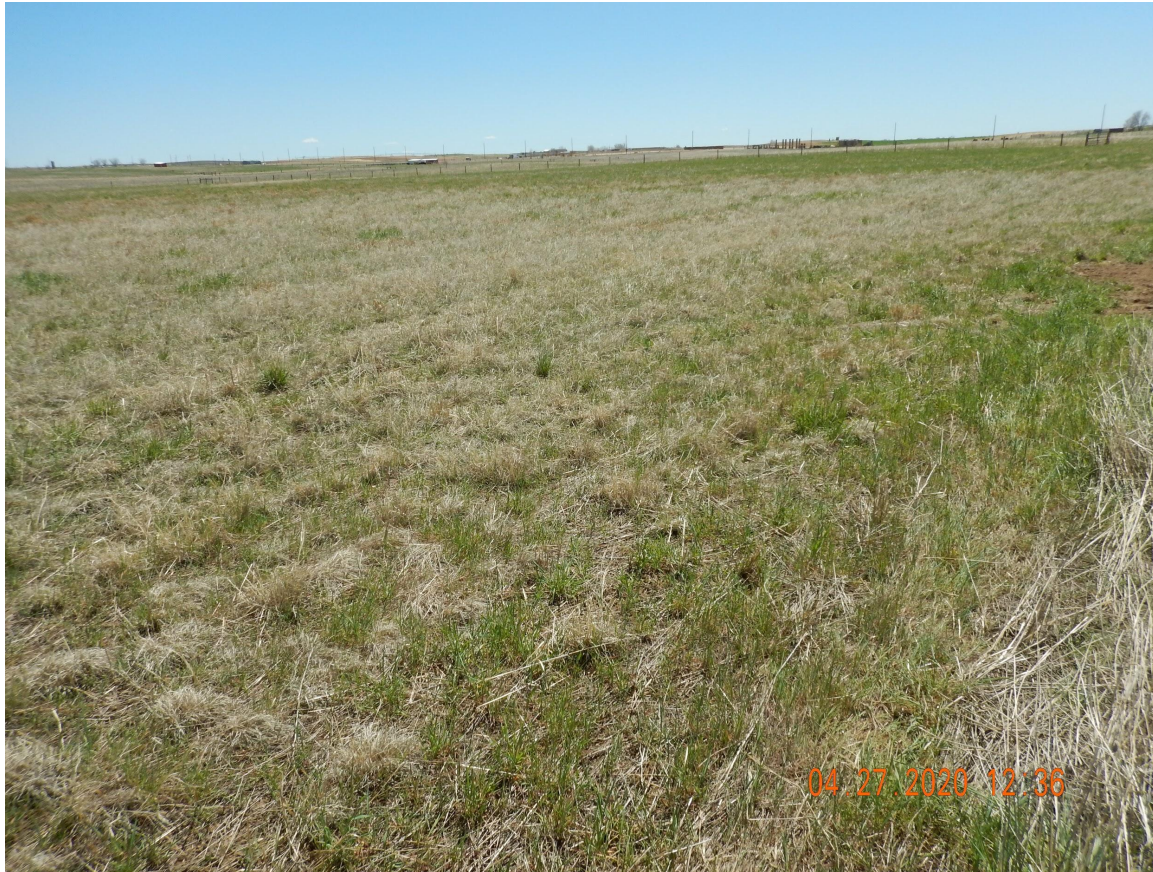
Photo 1. Photo taken from the western location, facing Southeast. Photo illustrates desirable, perennial plant species establishment is evident throughout the interim reclamation area. Some of the desirable species observed were: *Bouteloua gracilis*, *Panicum virgatum*, *Calamovilfa longifolia*, *Thinopyrum intermedia*, *Pascopyrum smithii*, and *Dactylis glomerata*.

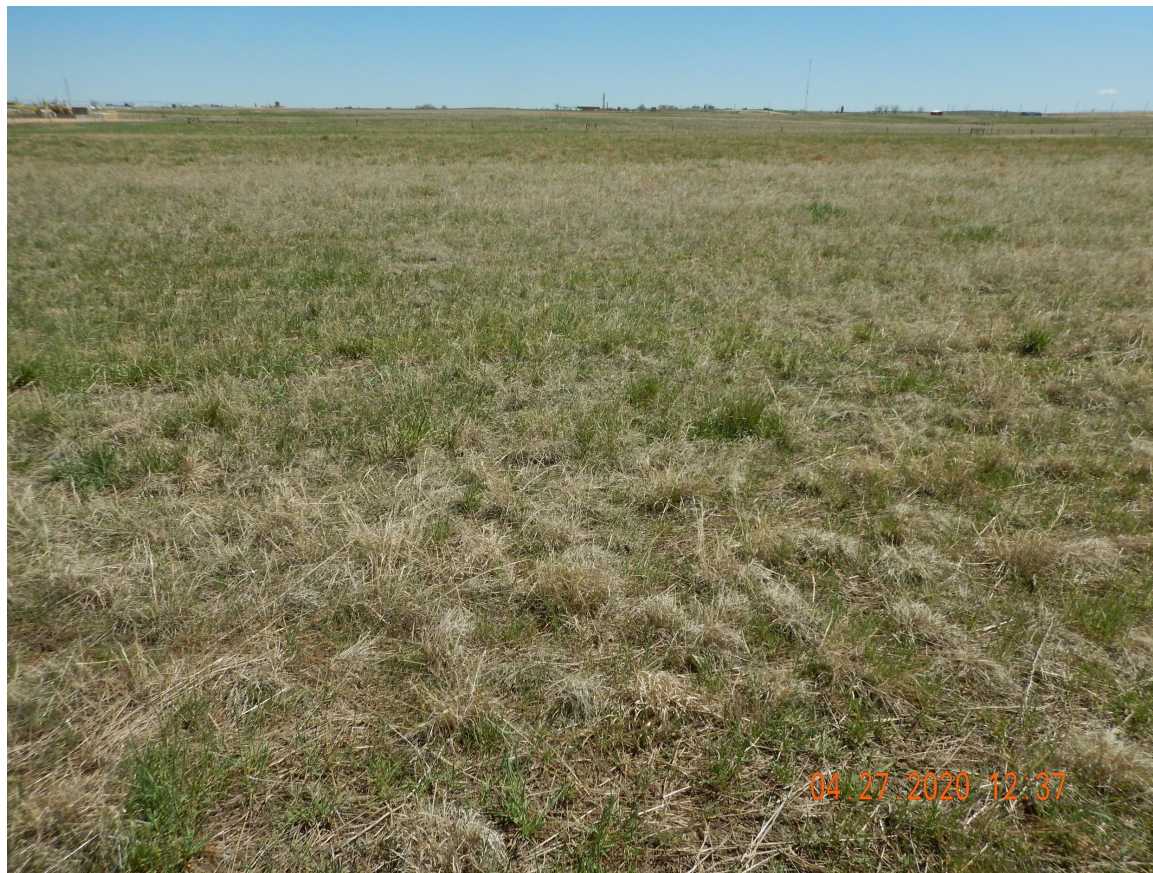
Photo 2. Photo taken from the western location, facing East. See comments under Photo 1.

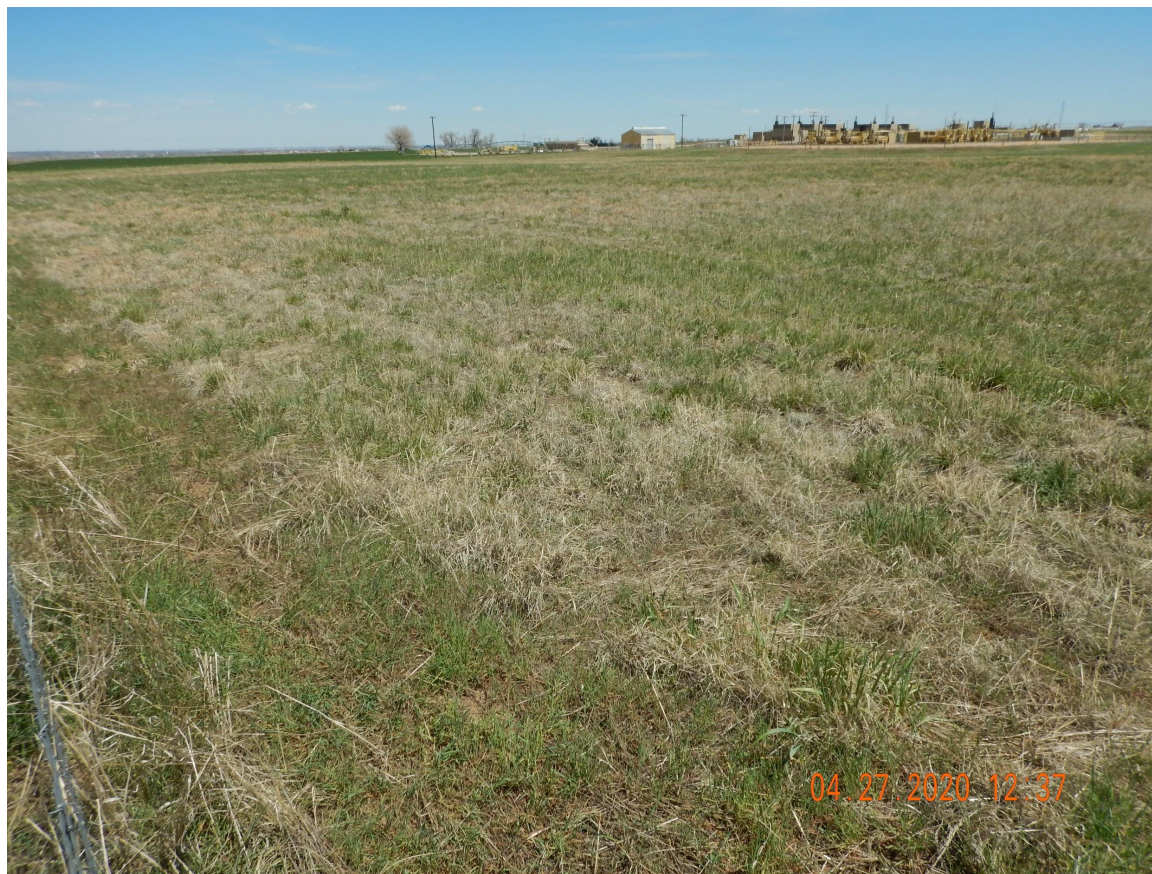
Photo 3. Photo taken from the western location, facing Northeast. See comments under Photo 1.

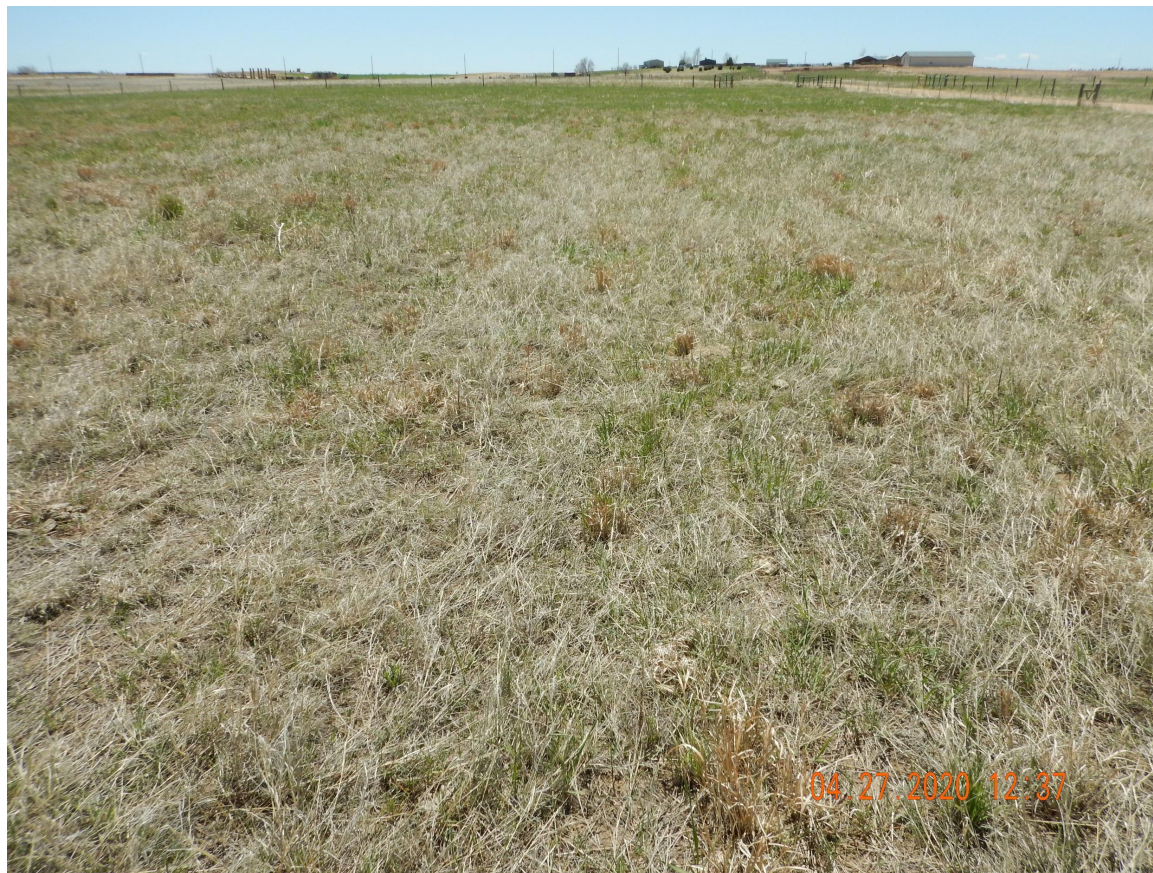
Photo 4. Photo taken from the eastern location, facing South. See comments under Photo 1.

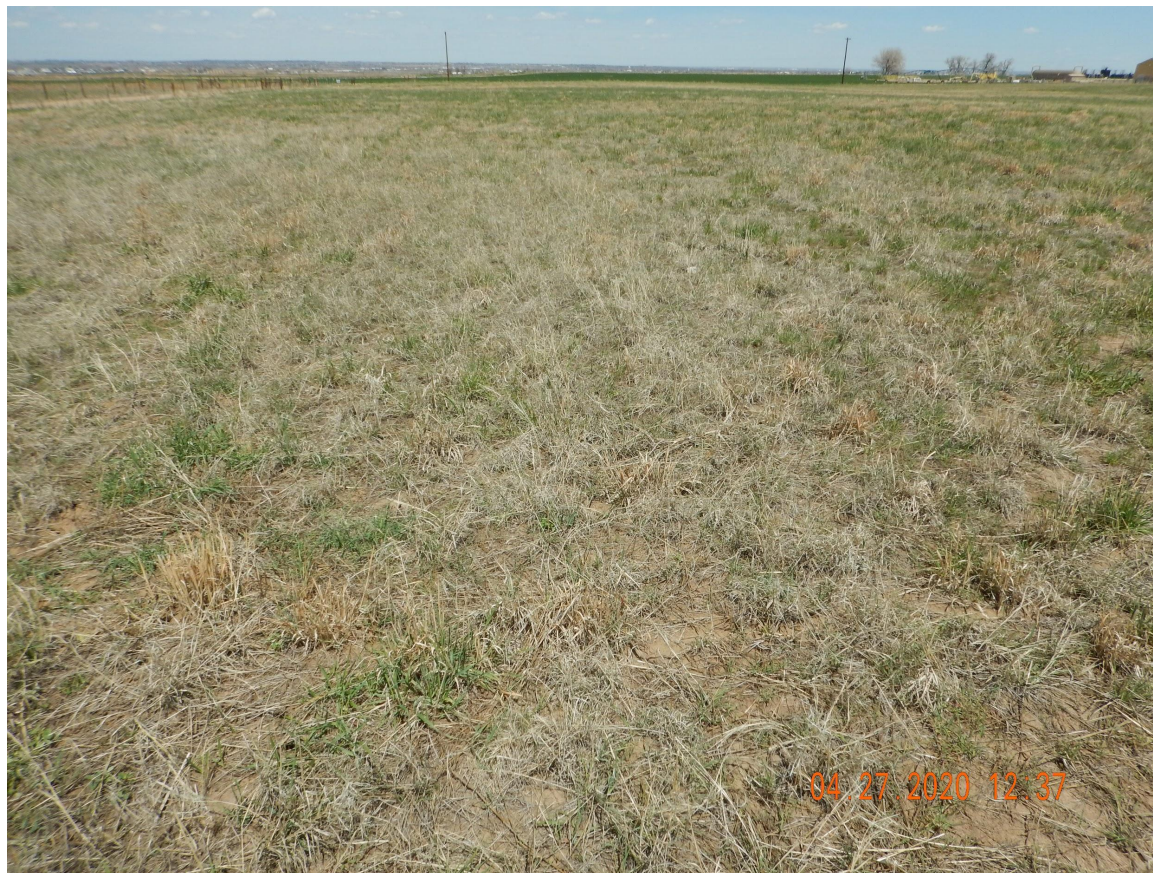
Photo 5. Photo taken from the eastern location, facing North. See comments under Photo 1.

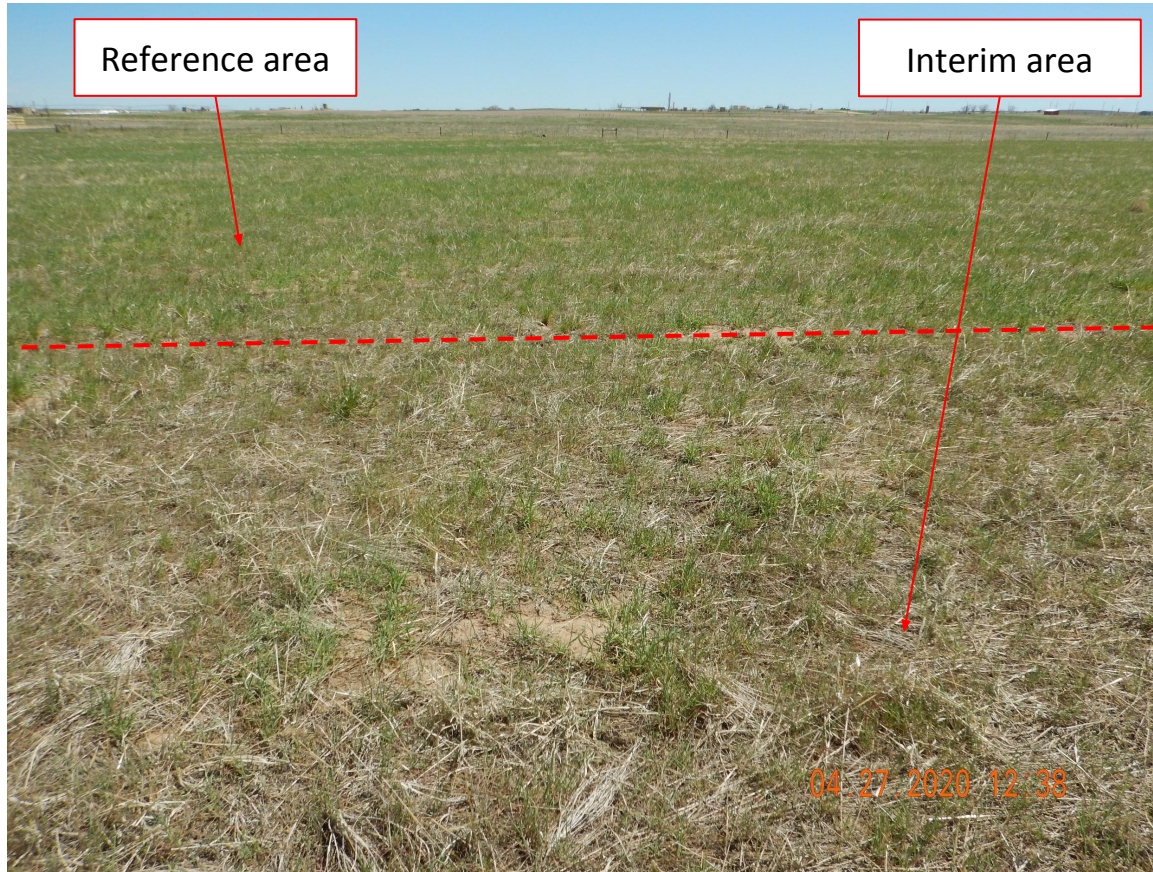
Photo 6. Photo taken from the eastern location, facing North. See comments under Photo 1.
