Inspection Photos  
Location Name: NEW ELK 25-06  
API#: 05-071-09536  
INSP. #: 695102767

Colorado Oil & Gas Conservation Commission  
37.14498, -104.94908, 2342.0m, 272°  
2020/04/30 11:32:10

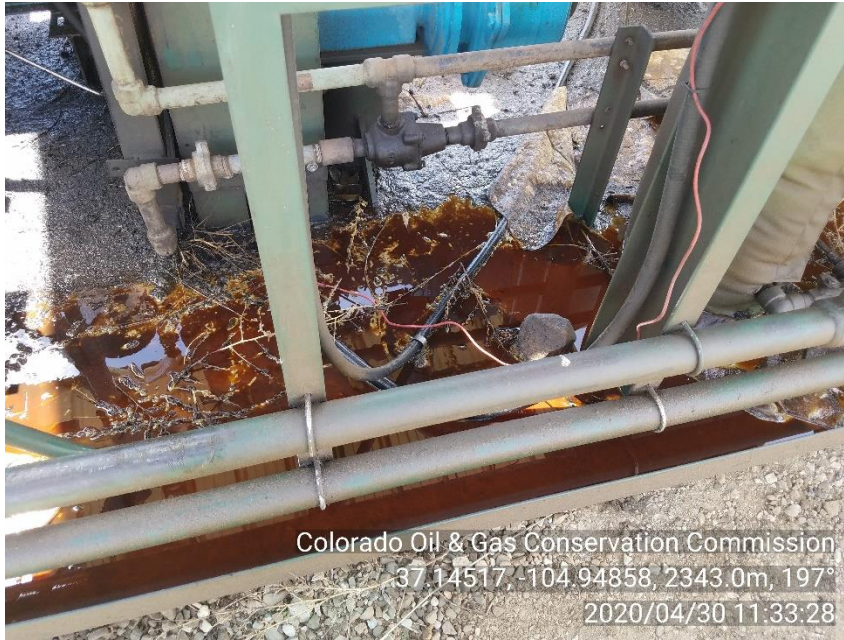
**PHOTO 3: STANDING OIL IN COMPRESSOR SKID.  
APPEARS THAT ENGINE OIL IS BEING DRAINED INTO  
SKID. Comply with general provisions of the oil and  
gas act for wildlife protection. CA DATE 5-7-20.**

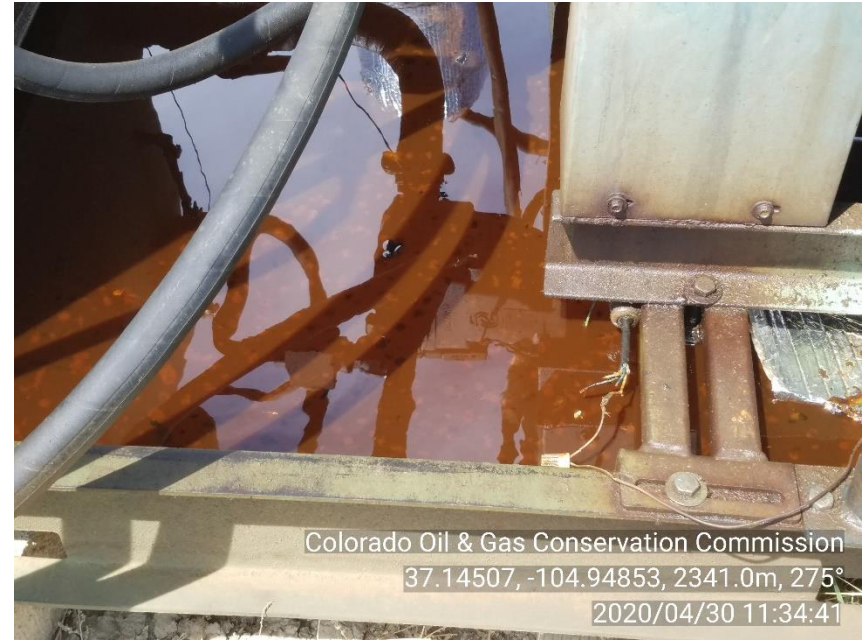
**PHOTO 4: STANDING OIL IN PRIME MOVER ENGINE SKID.  
APPEARS THAT ENGINE OIL IS BEING DRAINED INTO  
SKID. Comply with general provisions of the oil and gas act for  
wildlife protection. ENGINE SKID IS FULL OF FLUID AND  
ABOUT TO RUN OVER 24 OURS TO CORRECT CA DATE 5-1-20.**

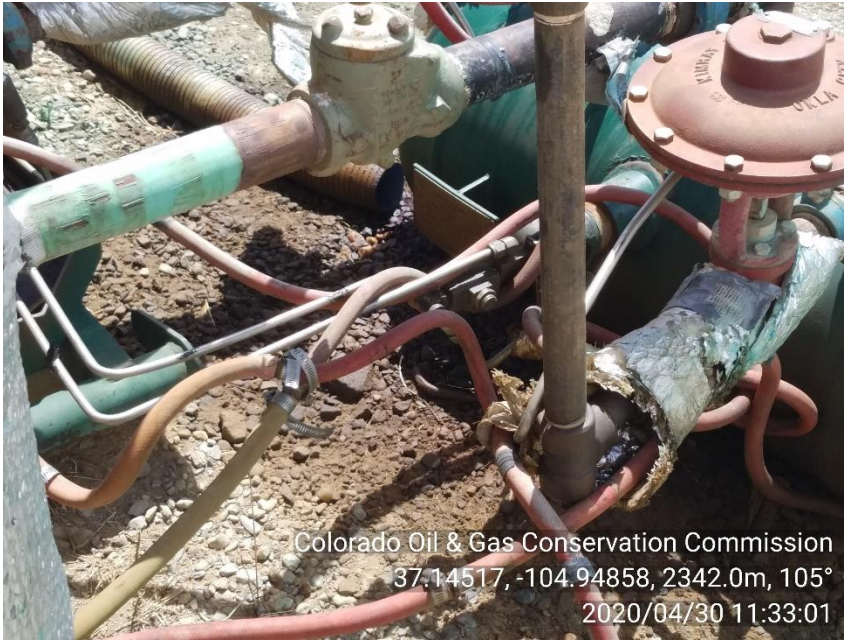
**PHOTO 5: IMPACTED SOIL NEAR AND AROUND COMPRESSOR SKID. Conduct maintenance on equipment, cleanup stained material and review self inspection processes. 5-7-20.**

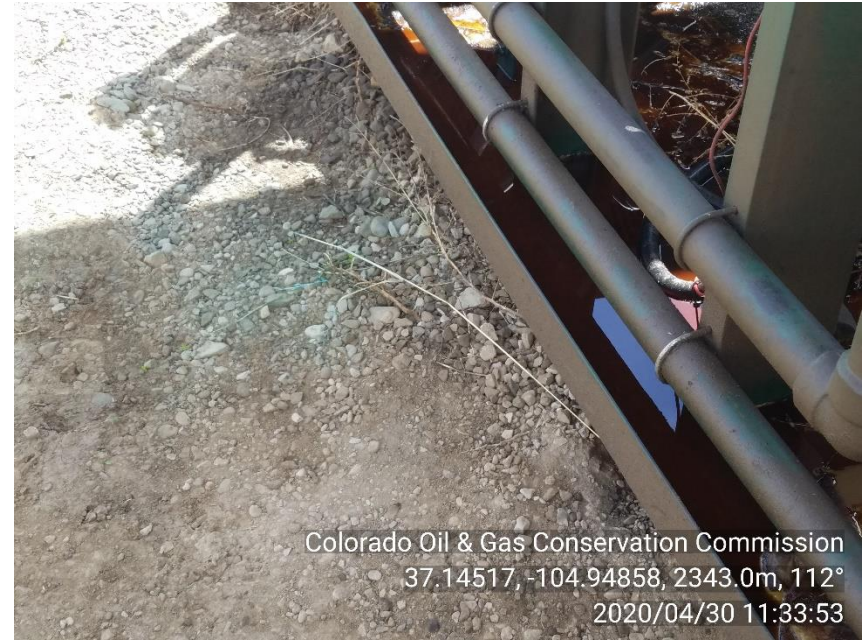
**PHOTO 6: ANOTHER IMAGE OF IMPACTED SOIL AROUND COMPRESSOR SKID.**

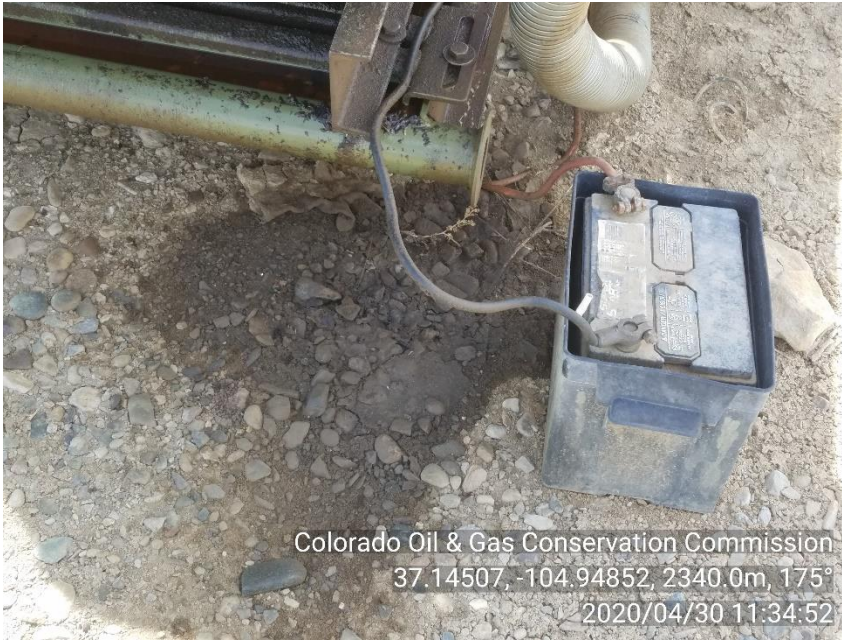
**PHOTO 7: IMPACTED SOIL NEAR AND AROUND  
PRIME MOVER ENGINE SKID. Conduct maintenance  
on equipment, cleanup stained material and review  
self inspection processes. 5-7-20.**
