Inspection Photos

Operator Name: FOUNDATION ENERGY MANAGEMENT LLC - 10112

Location ID: 327361

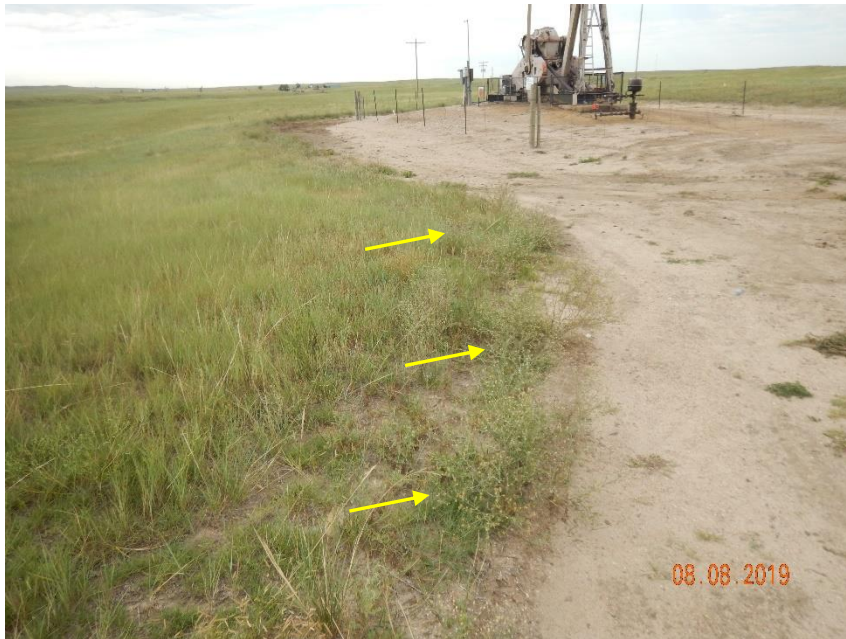
Photo 5: Photo taken from north end of the location, facing south. Photo shows Diffuse Knapweed (Plants with white flowers in photo) remains established on the location/access road.

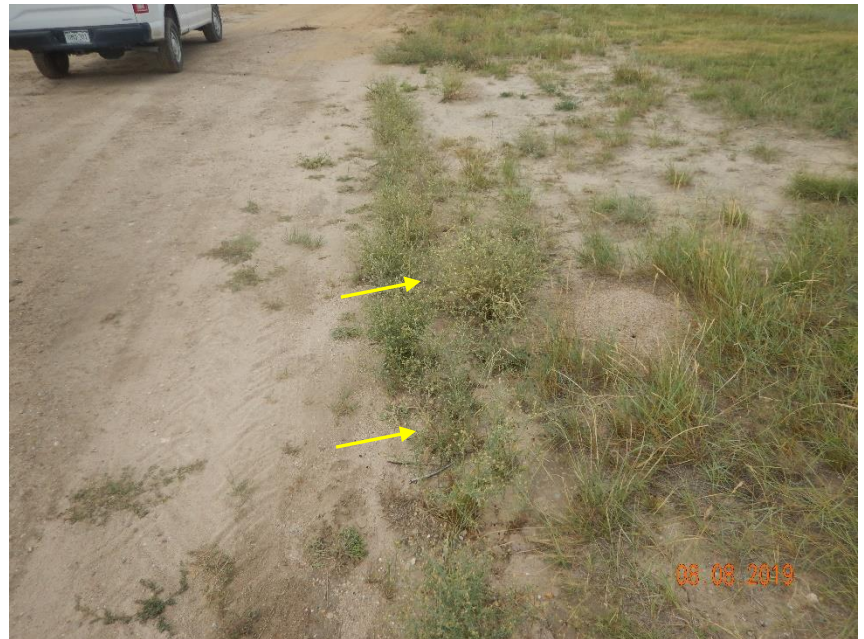
Photo 6: Photo taken from the northwest end of the location, facing south. See comments under photo 5.

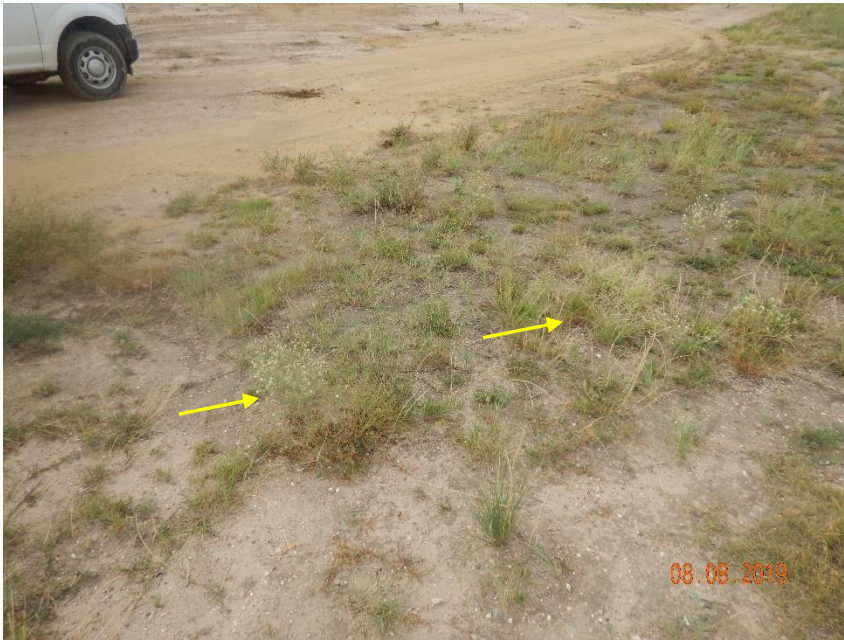
Photo 7: Continued from photo 6.

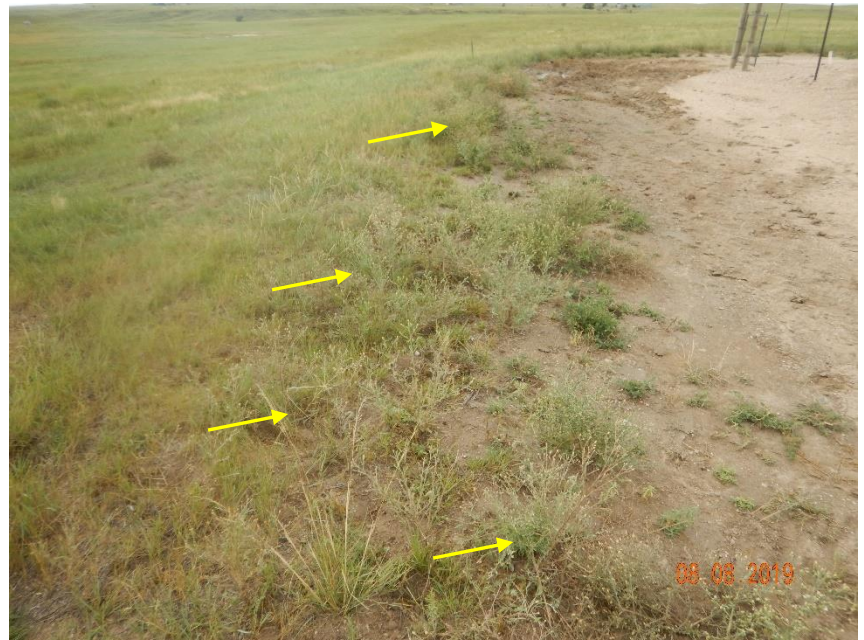
Photo 8: Photo taken from the east end of the location, facing south. See comments under photo 5.

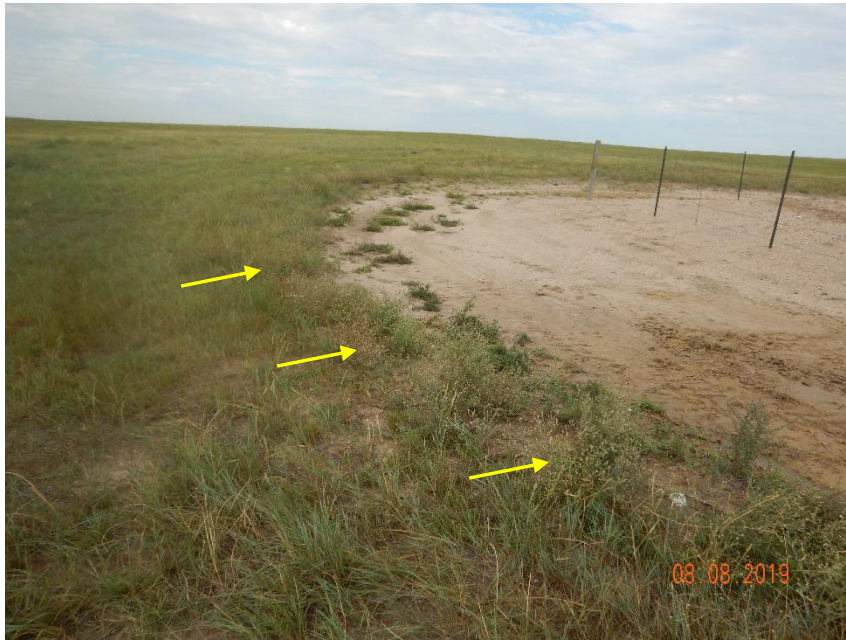
Photo 9: Photo taken from the south end of the location, facing west. See comments under photo 5.

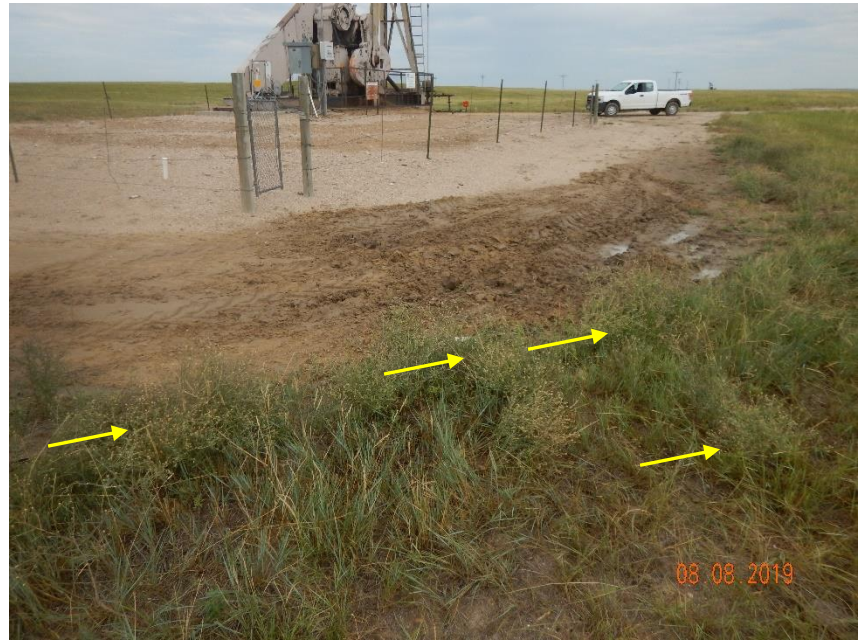
Photo 10: Photo taken from the south end of the location, facing northwest. See comments under photo 5.

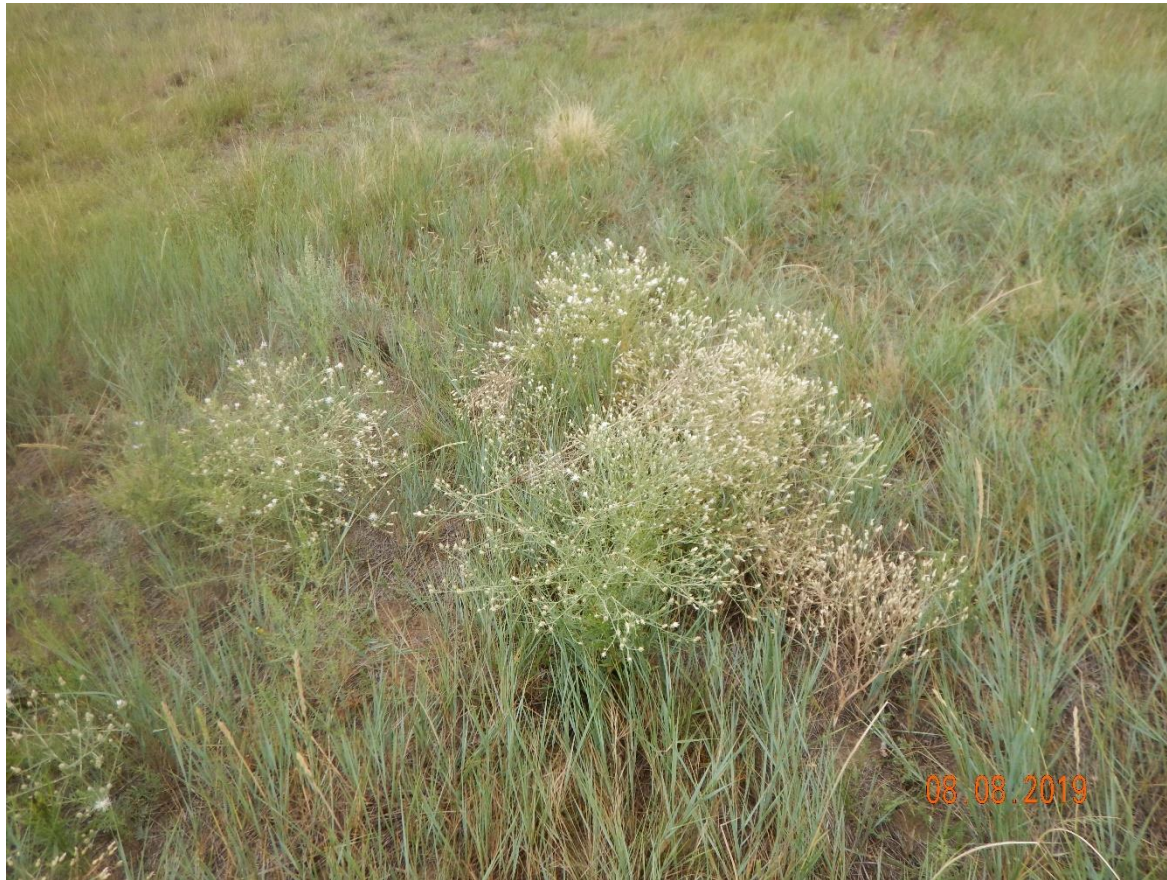
Photo 11: Photo taken from the interim areas of the location. Photo shows Diffuse Knapweed

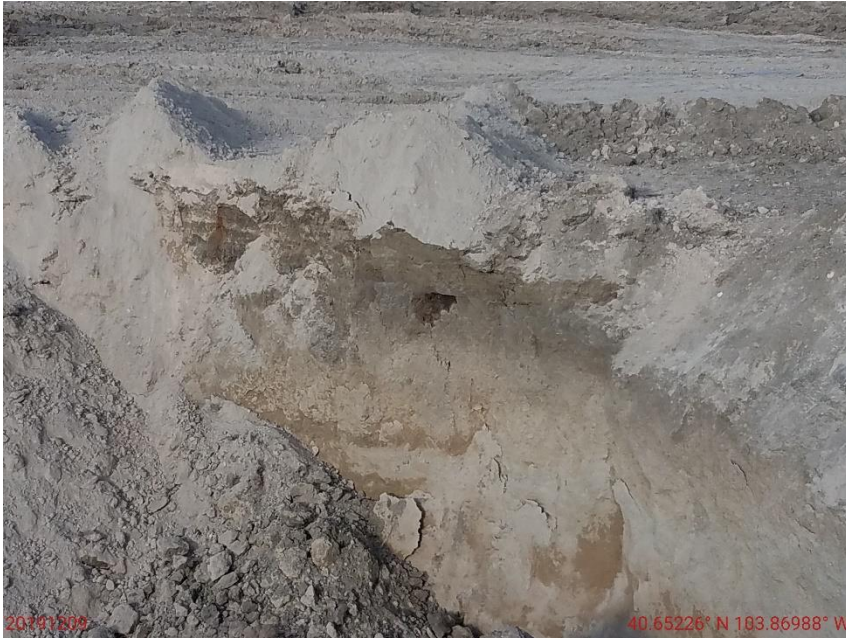
Photo 5: Photo of the excavated area on the east end of the location. Photo shows soils on location.

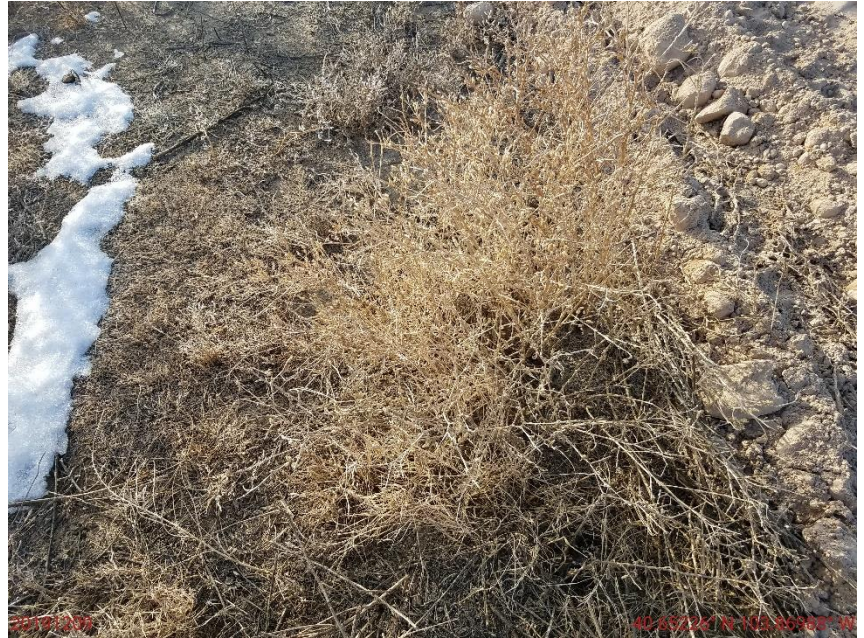
Photo 6: Photo taken from the east end of the location. Photo shows Diffuse Knapweed remains on the location.

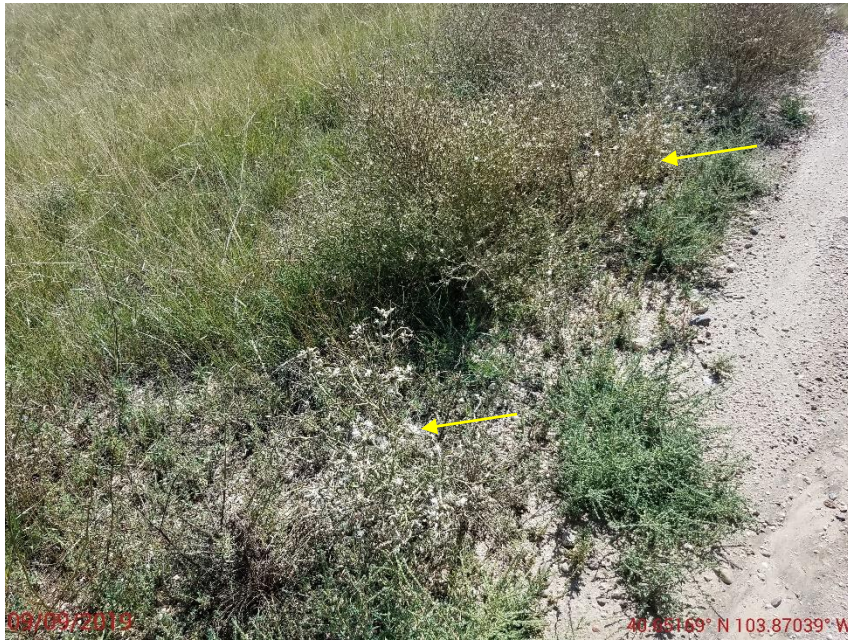
Photo 3: Photo shows noxious weeds (Diffuse Knapweed) remaining on location.

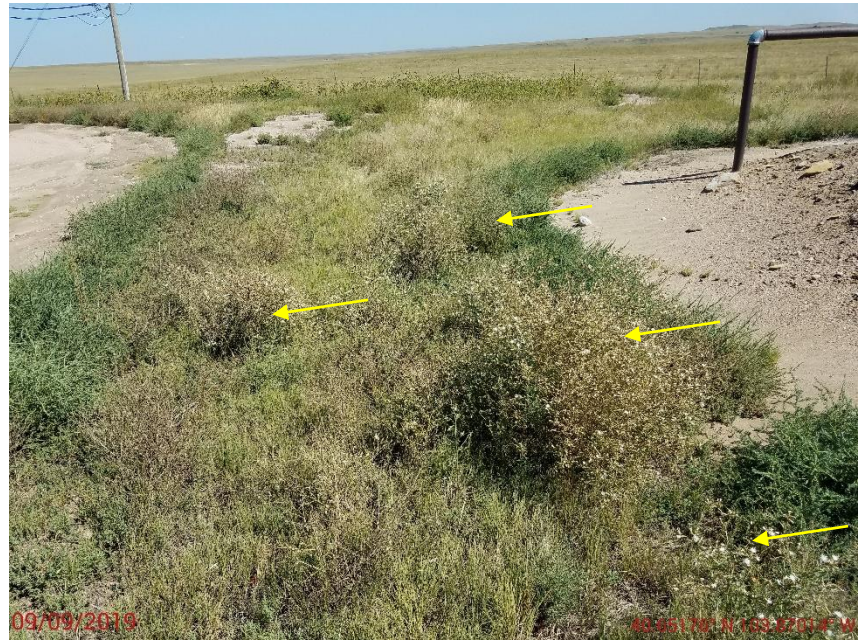
Photo 4: See comments under photo 3

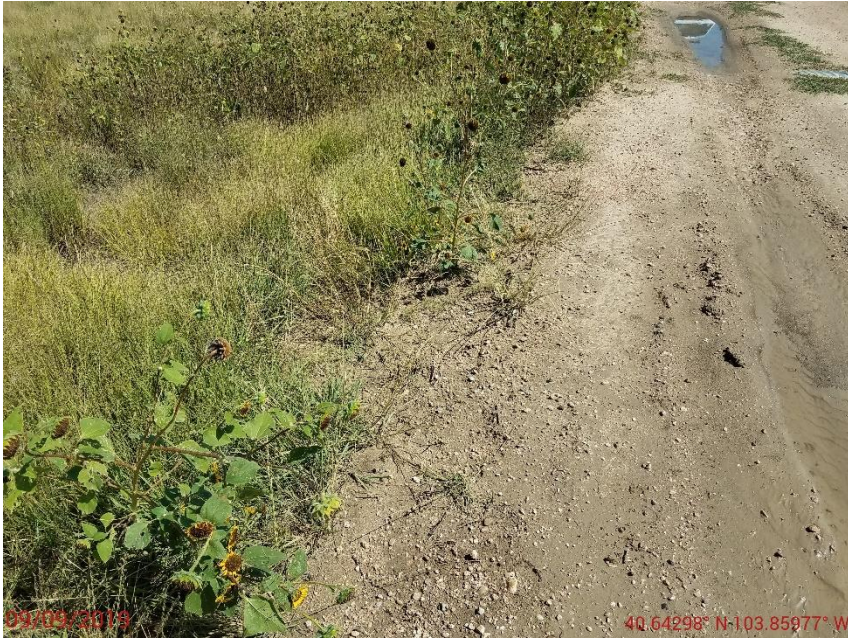
Photo 3: Photo shows areas where stormwater from the access road is discharging onto the adjacent lands. Sediment deposition evident.

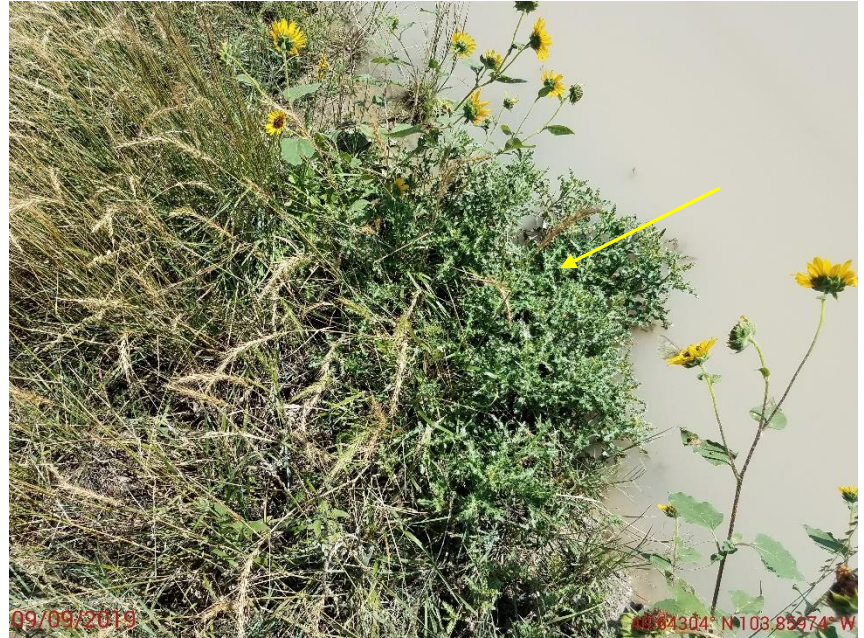
Photo 4: Photo taken from the access road. Photo shows what appear to be Canada thistle is establishing on location.

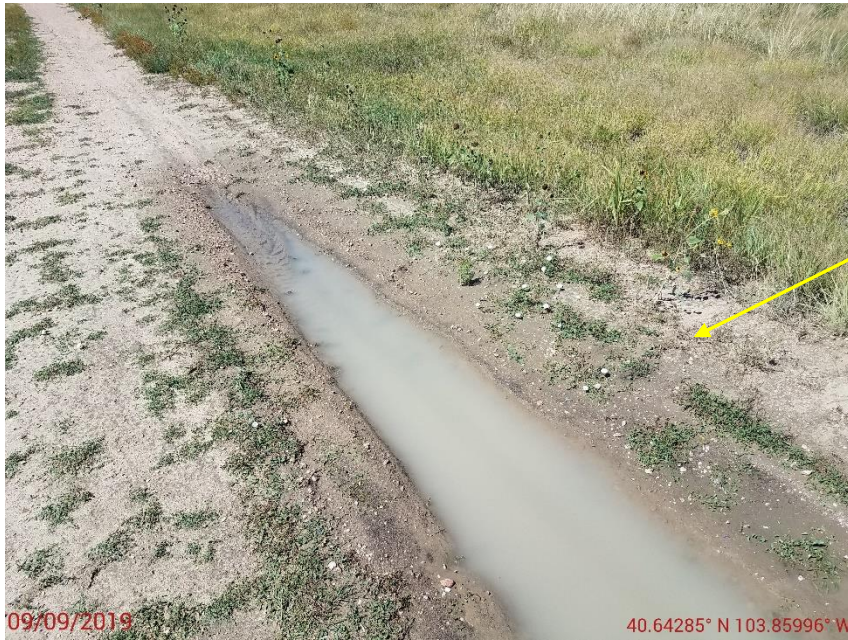
Photo 5: Photo shows bindweed on access road.

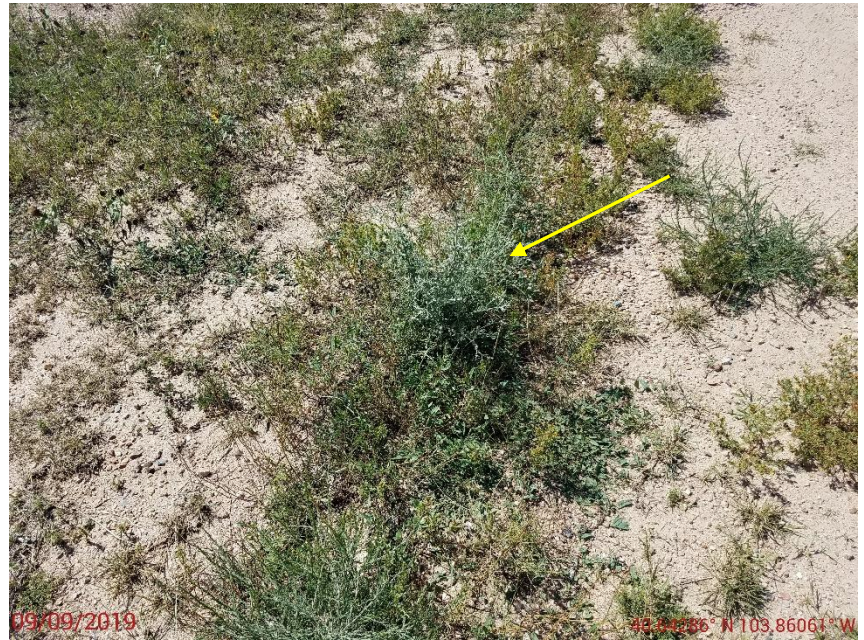
Photo 6: Photo taken from the southwest end of the location. Photo shows Diffuse Knapweed (Plants with white flowers in photo) remains established on the location.

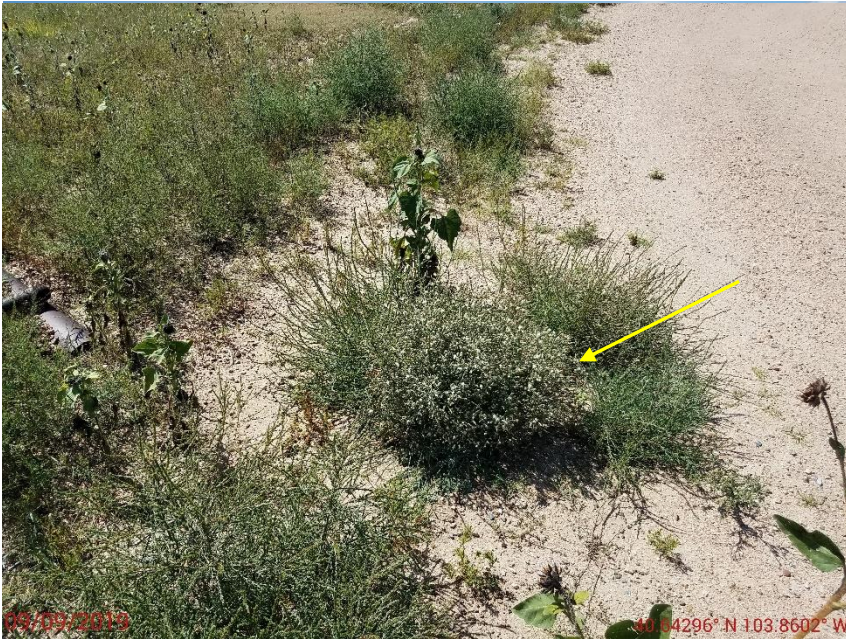
Photo 7: Photo taken from the southwest end of the location. Photo shows Diffuse Knapweed (Plants with white flowers in photo) remains established on the location.

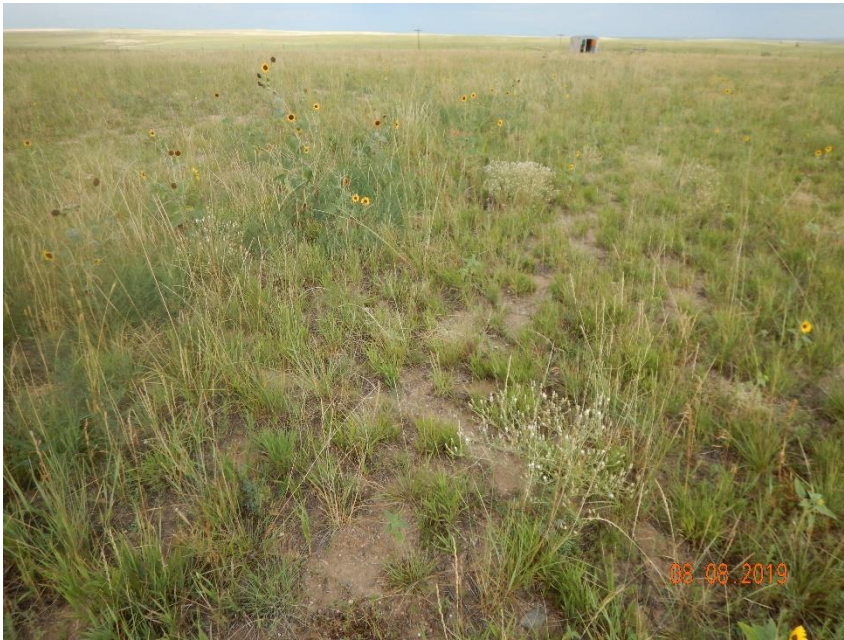
Photo 3: Photo taken from the location, facing northwest. Photo shows Diffuse Knapweed (Plants with white flowers in photo) remains established on the location. Sufficient and on-going weed management does not appear to be occurring.

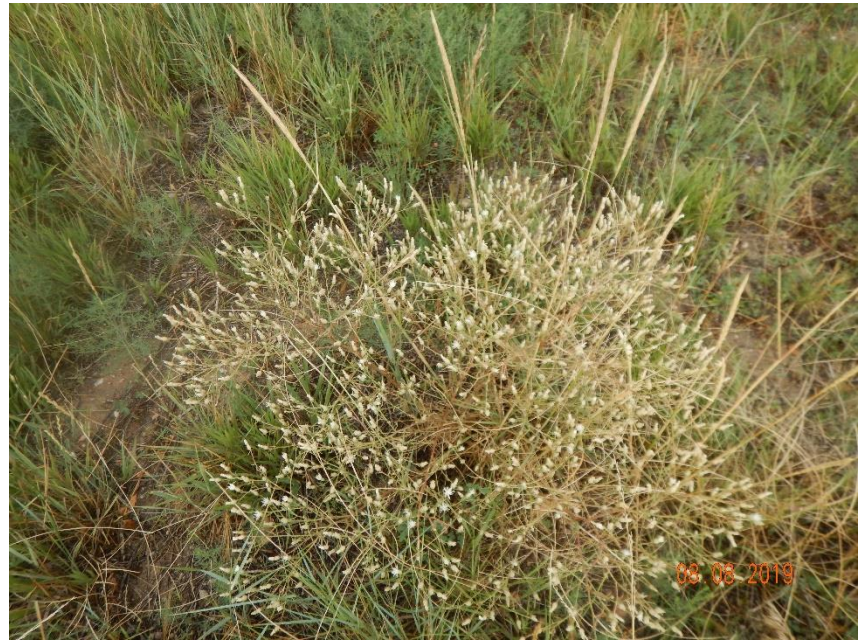
Photo 4: Photo shows Diffuse Knapweed on location.

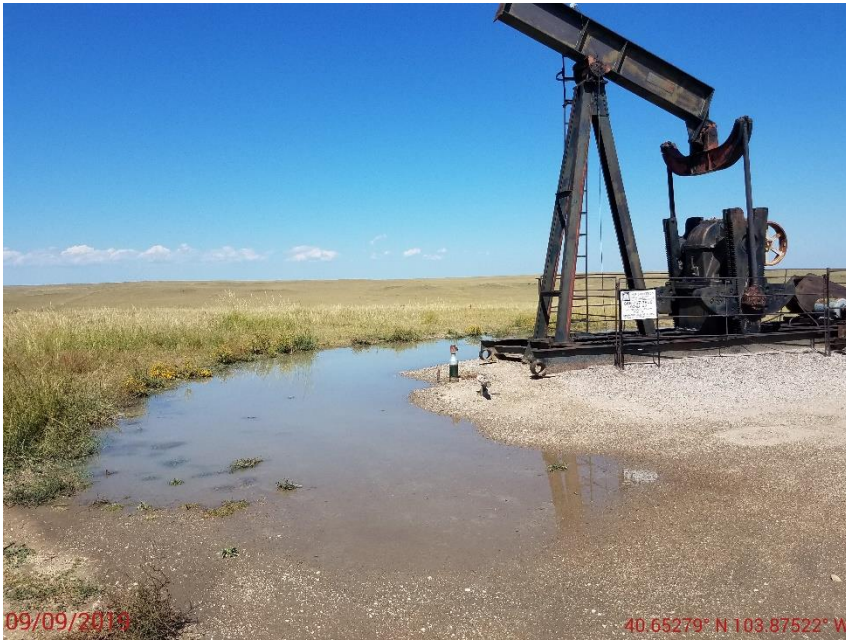
Photo 1: Photo taken from the north end of the location, facing south. Photo shows stormwater ponding around well and location.

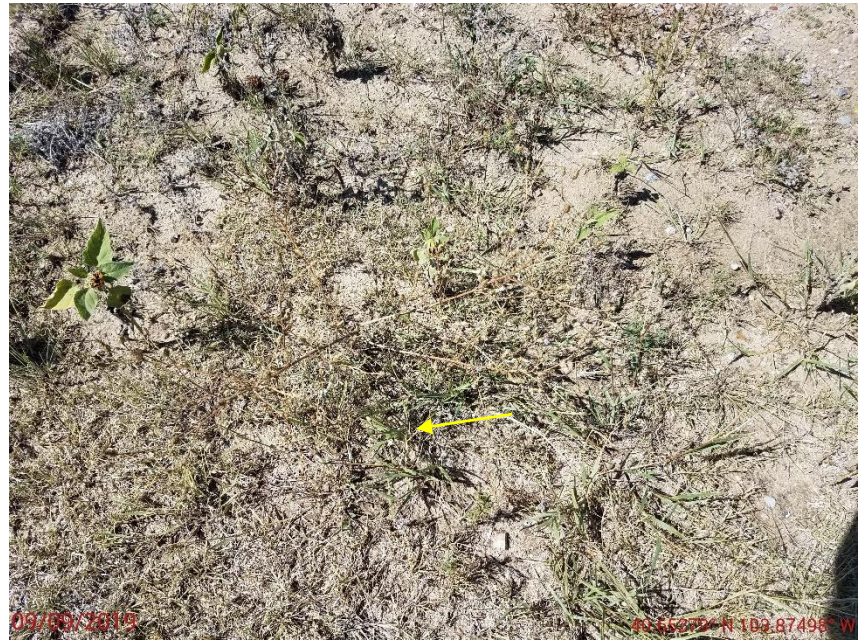
Photo 2: Photo shows noxious weeds (Diffuse Knapweed) remaining on location.

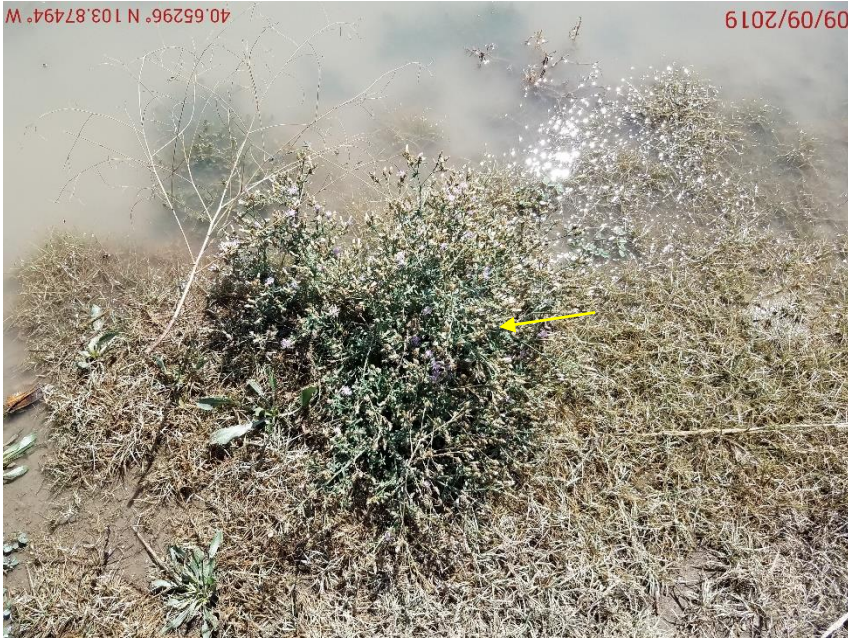
Photo 3: Photo shows noxious weeds (Diffuse Knapweed) remaining on location.

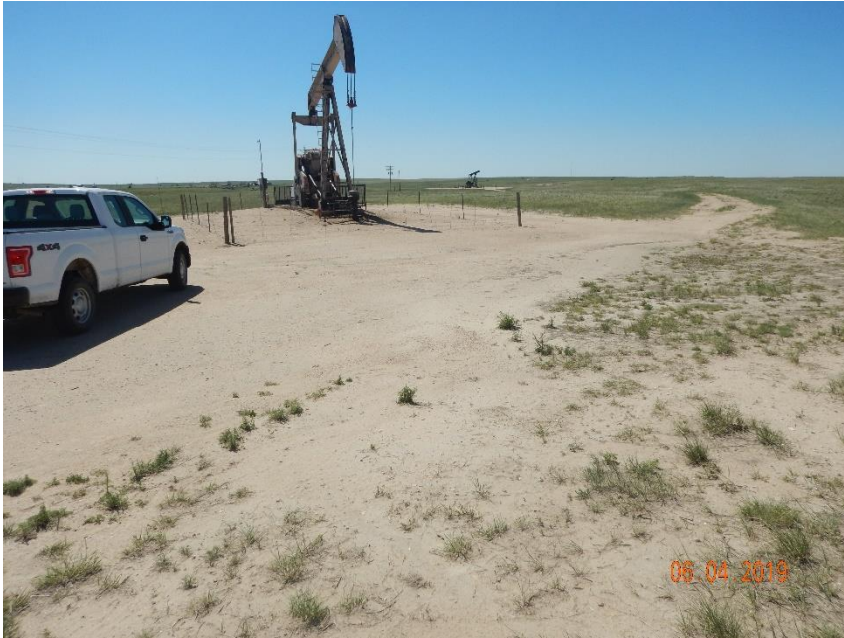
Photo 1: Photo taken from north end of the location, facing south. Photo shows well and location.

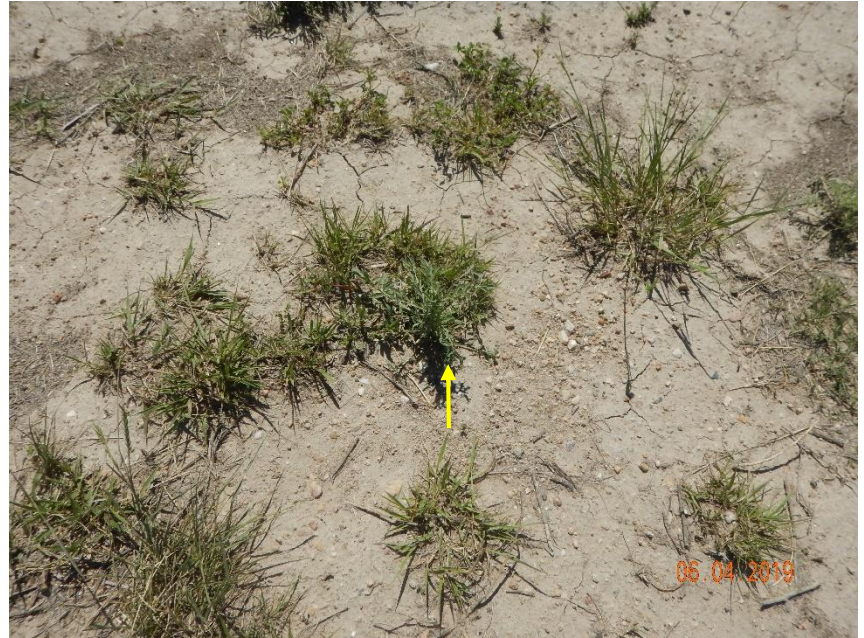
Photo 2: Photo taken from the west end of the location. Photo shows Diffuse Knapweed maturing on location.

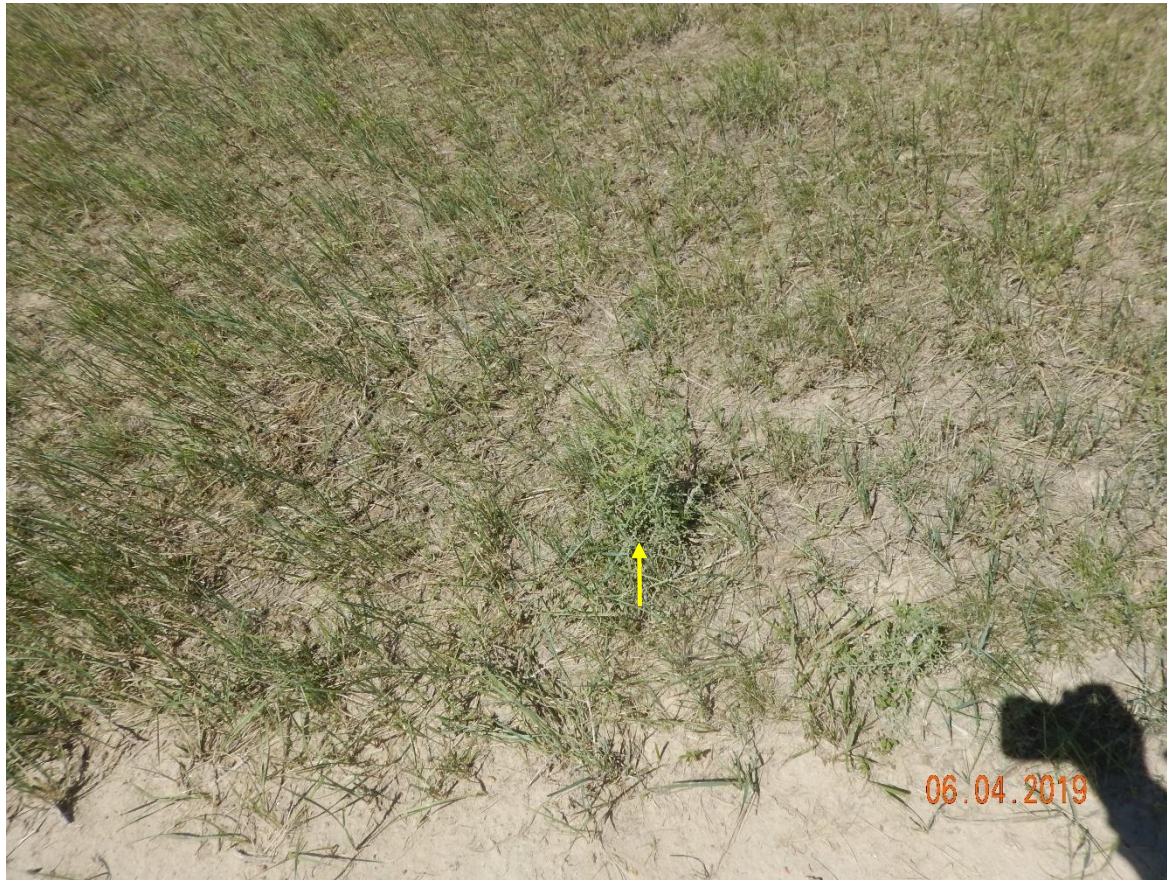
Photo 3: Photo taken from the location. Photo shows Diffuse Knapweed maturing on location.

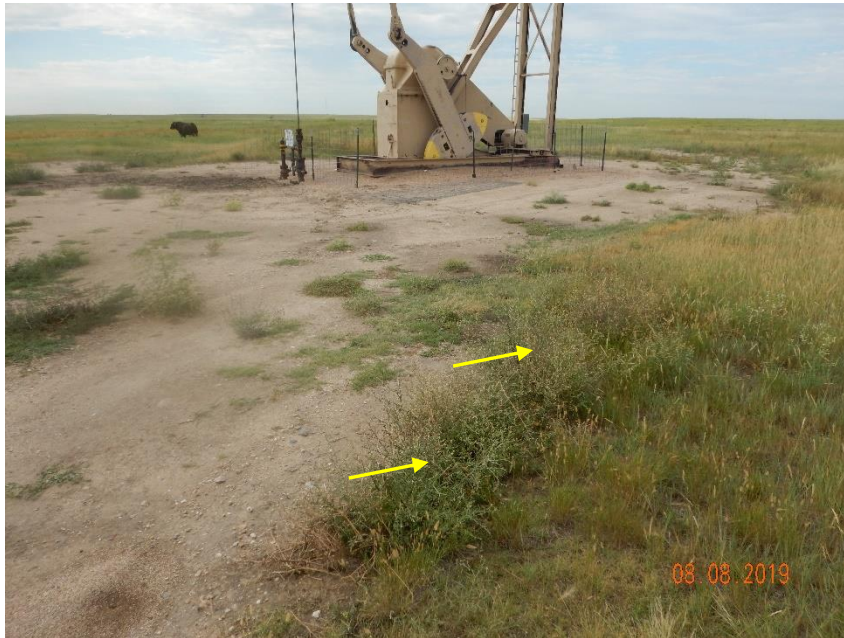
Photo 1: Photo taken from north end of the location, facing south. Photo provides an overview of the location. Photo shows Diffuse Knapweed (Plants with white flowers in photo) remains established on the location/access road. Operator has failed to conduct sufficient ongoing noxious weed management on the location.

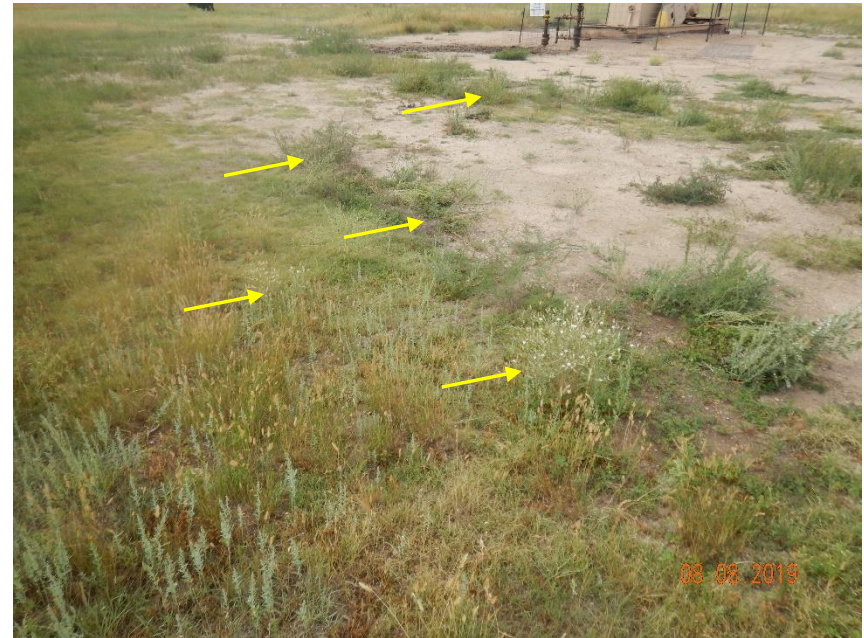
Photo 2: Photo taken from east end of the location, facing southwest. See comments under photo 1.

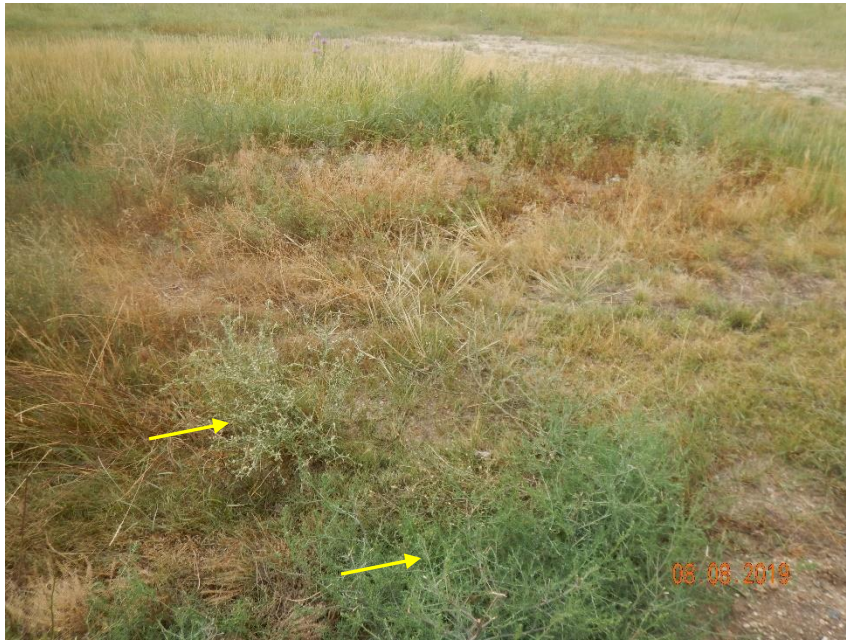
Photo 3: Photo taken from south end of the location, facing southwest. See comments under photo 1.

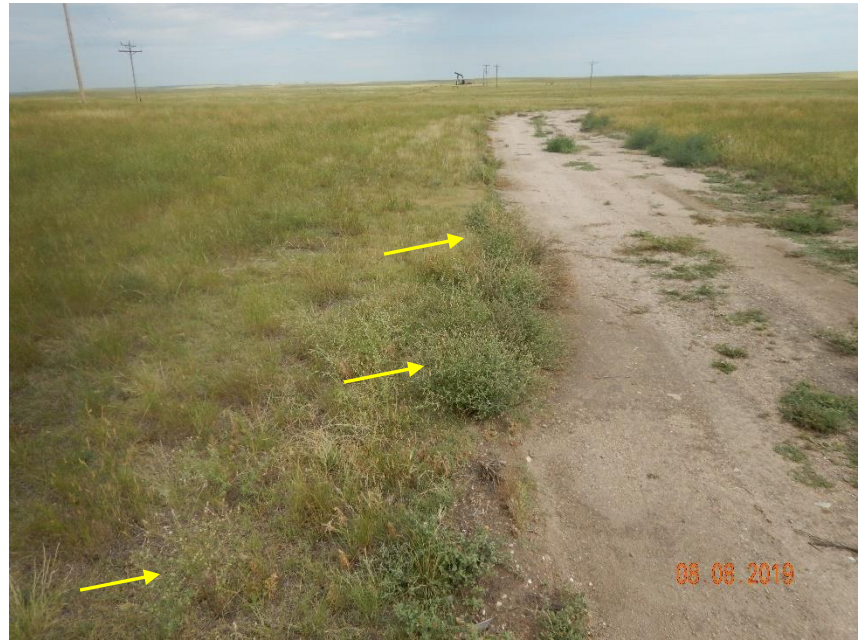
Photo 4: Photo taken from the access road, facing north. See comments under photo 1
