# Inspection Photos

Operator: Western Gas Resources  
API#: 067-08004  
Date: 5/1/2020

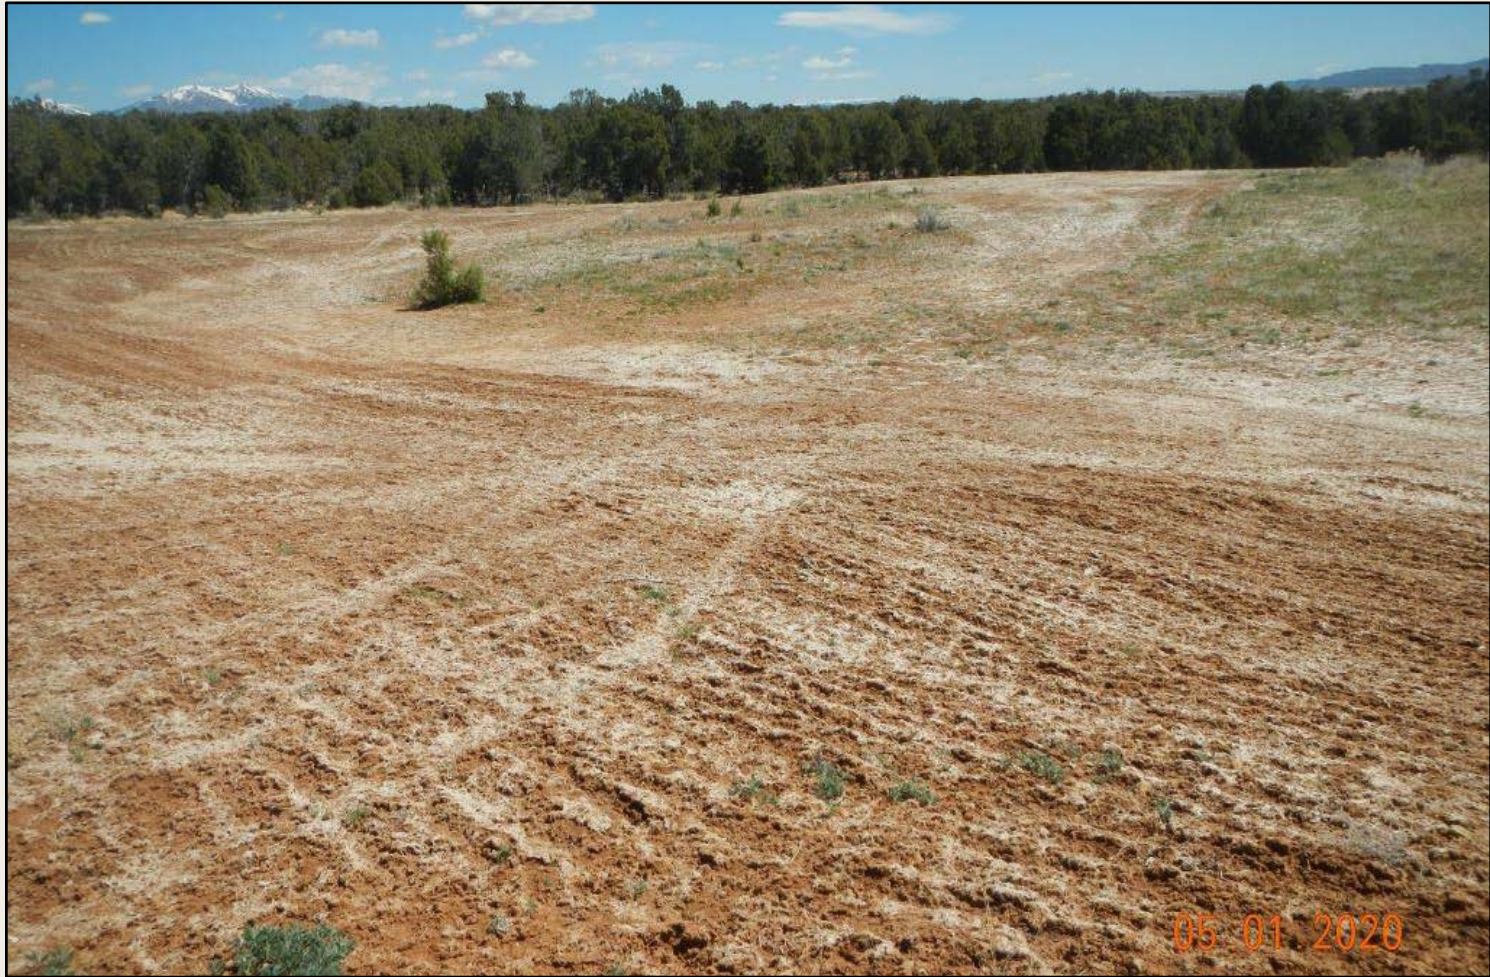
Photo 1. View of the project area from the southwestern corner facing center. The well pad cut and fill slopes are recontoured. A flat portion in the center of the well pad remains flat, as described in the proposed reclamation variance at this location.

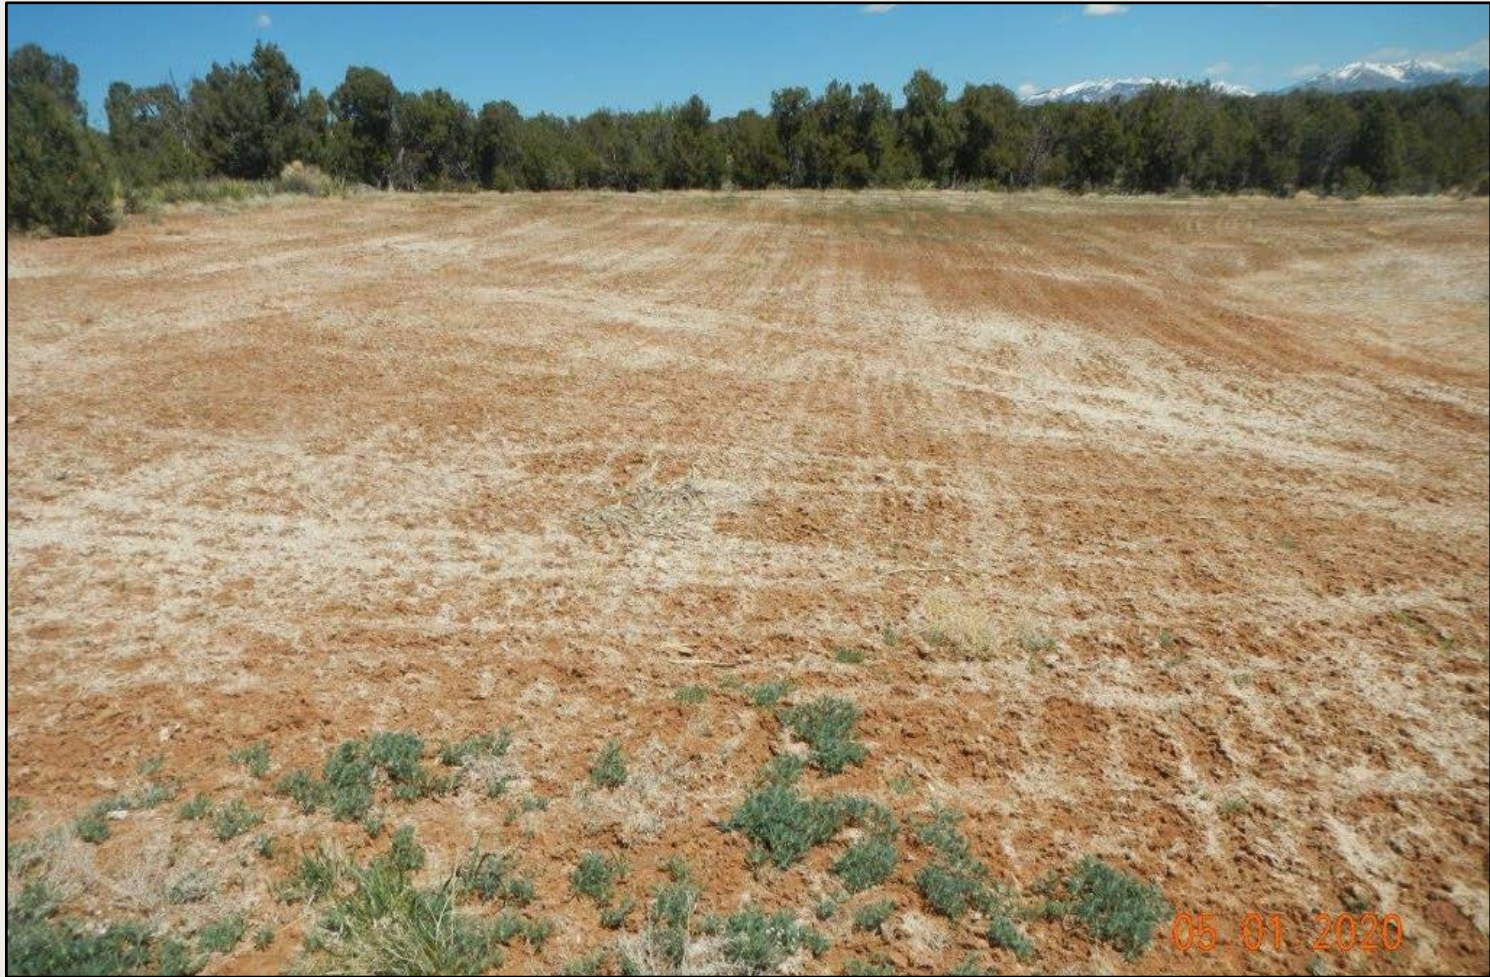
Photo 2. View of the western project area from the southwestern corner facing northward. Cut-slope is recontoured, hydromulched, seeded, and tracked.

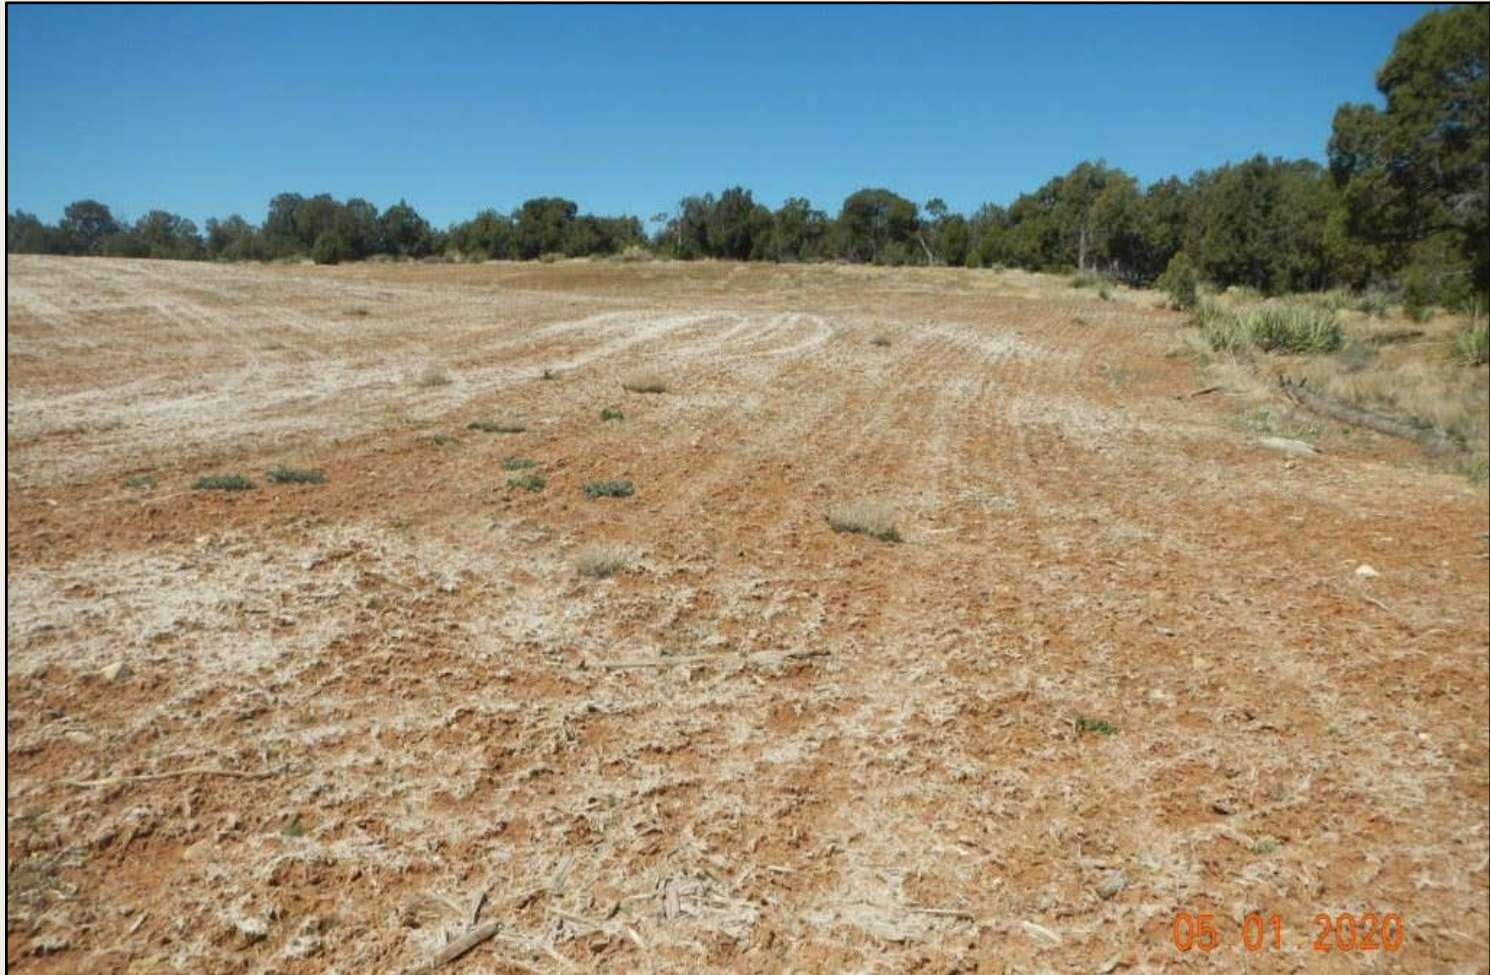
Photo 3. View of the northern project area from the southeastern corner facing northward.

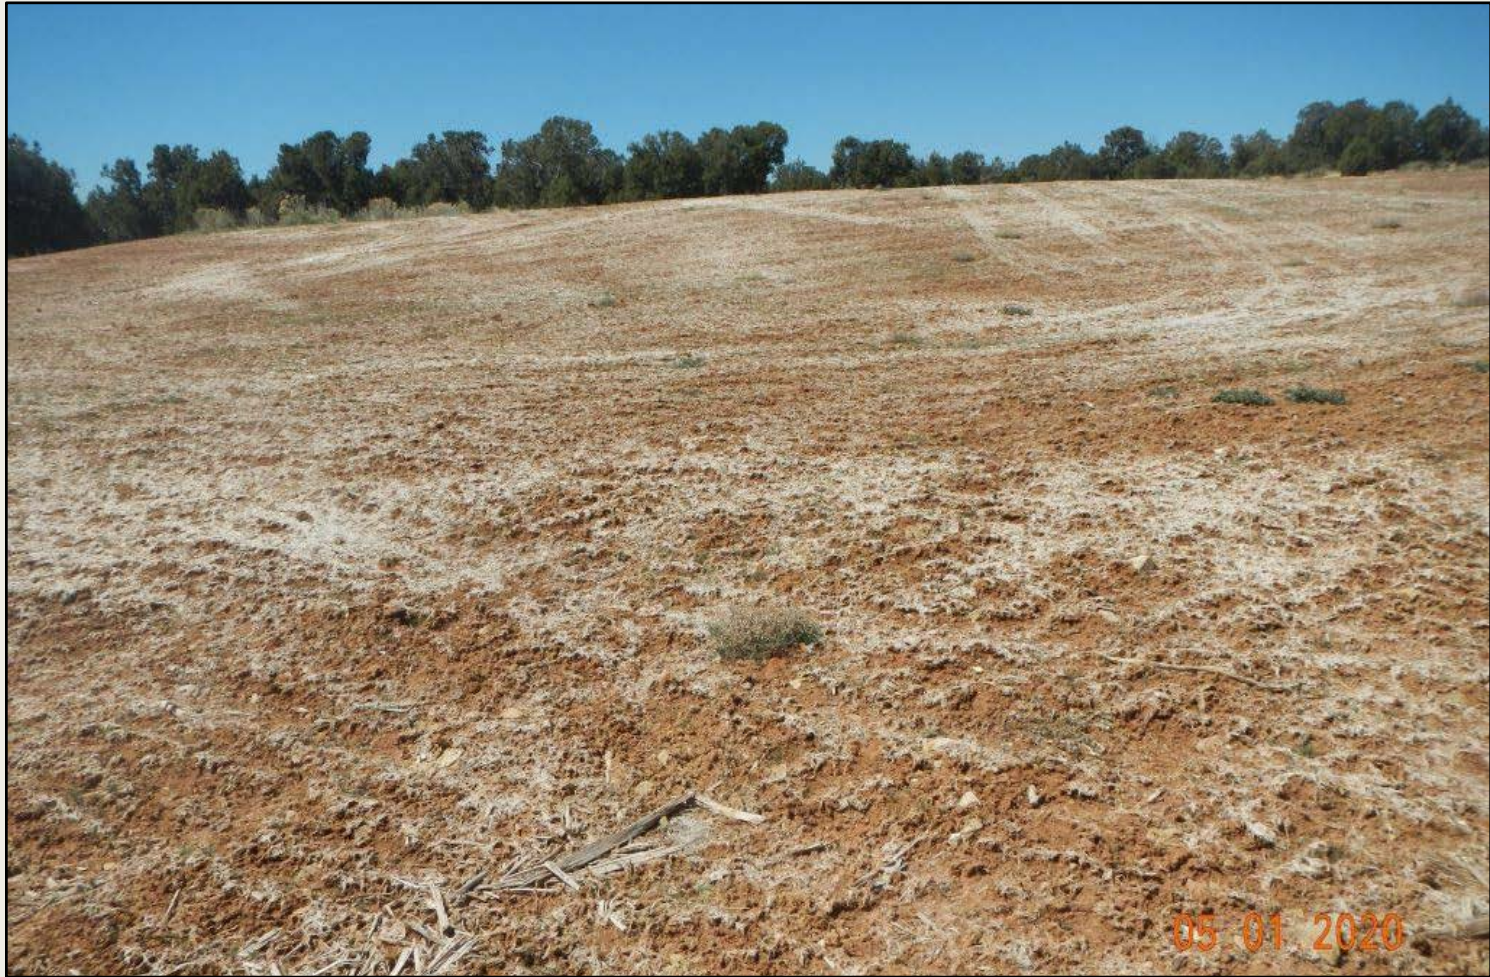
Photo 4. View of the project area from the southeastern corner facing center.

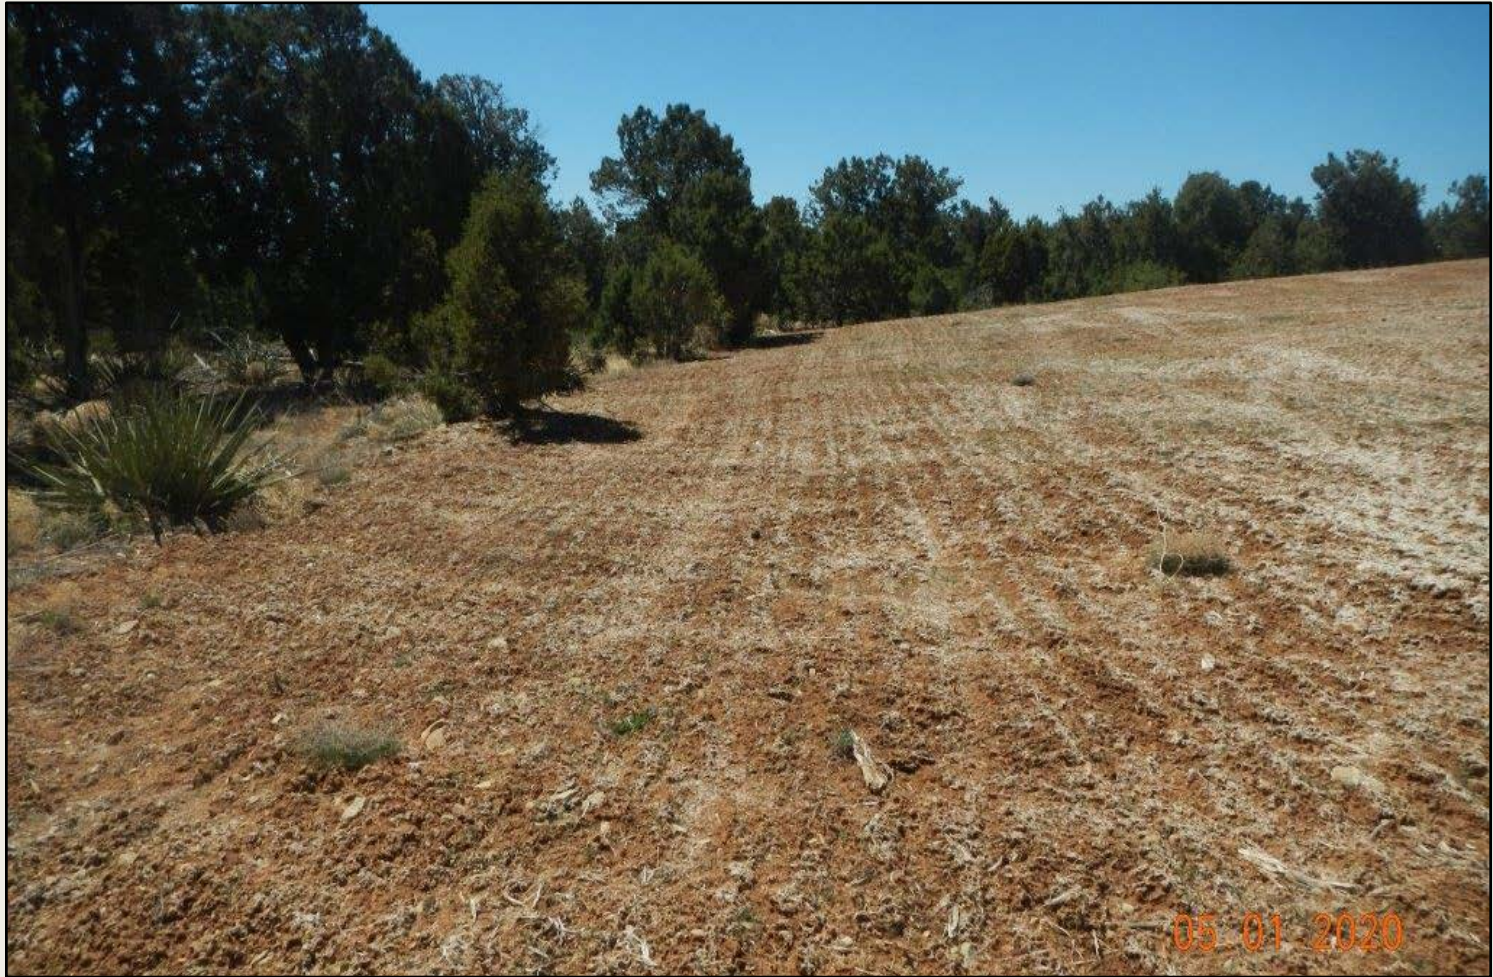
Photo 5. View of the eastern project area from the northeastern corner facing southward.

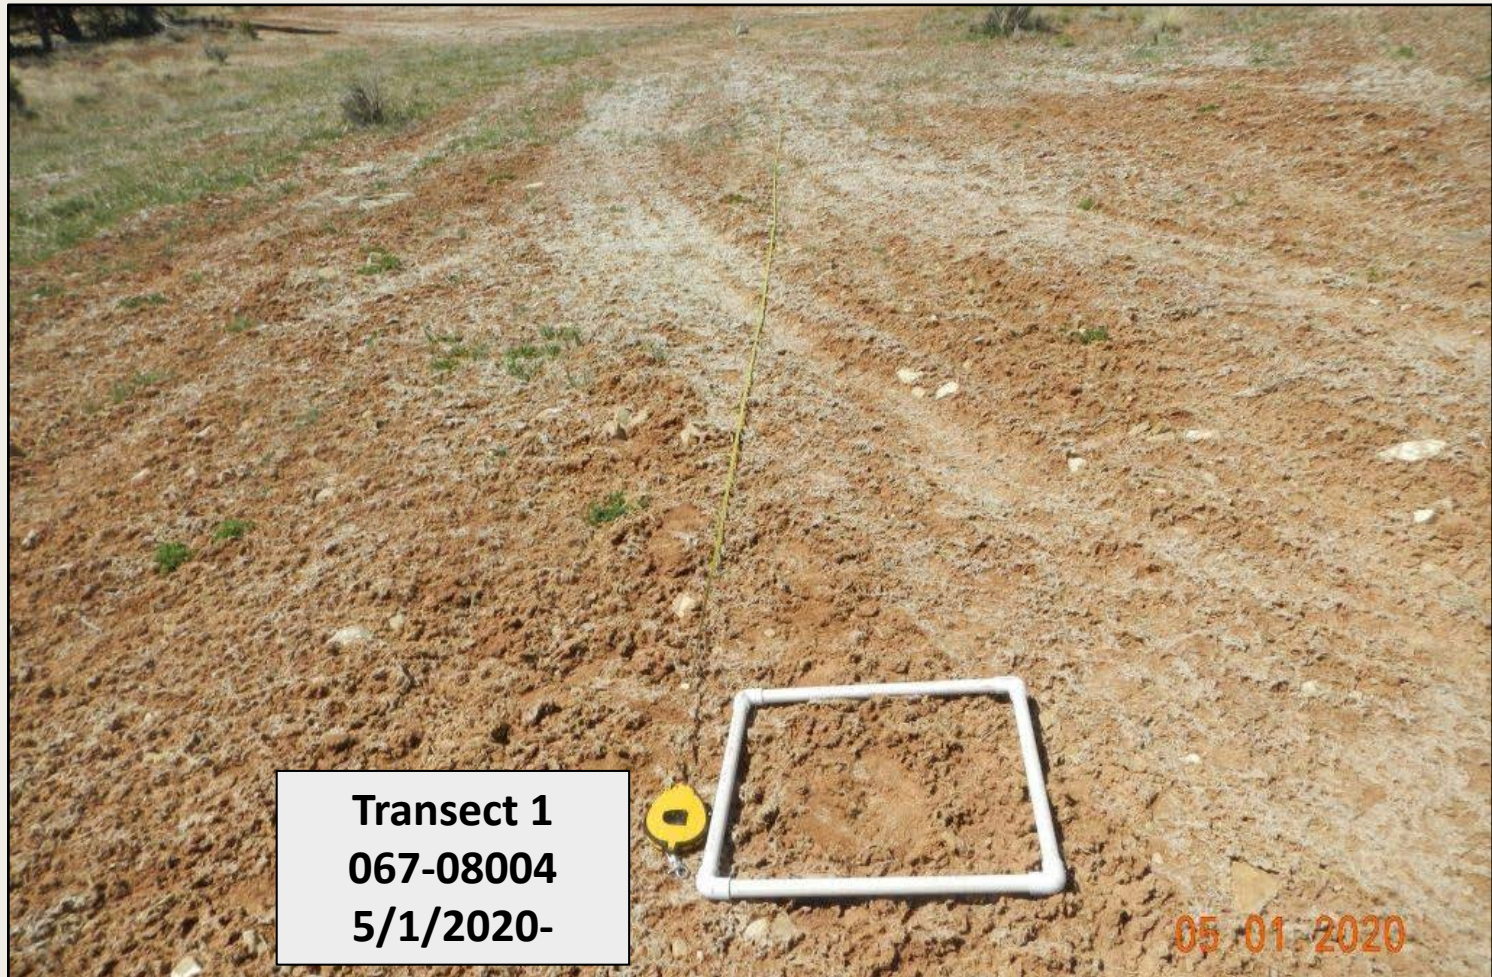
Photo 6. View of the beginning of germination Transect 1, facing eastward.

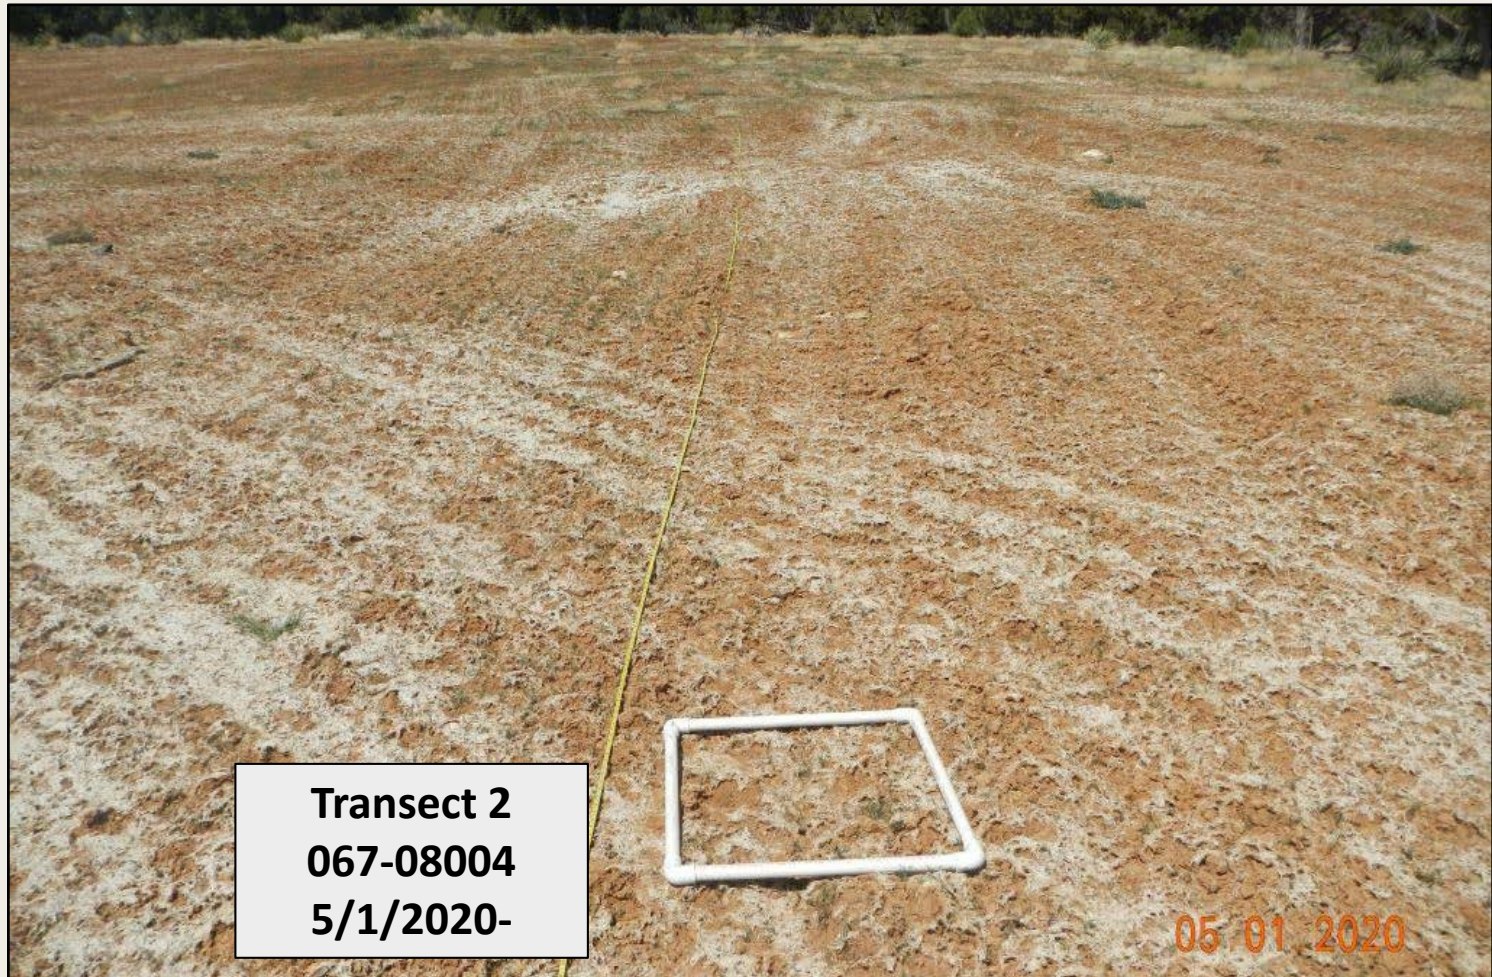
Photo 7. View of the beginning of germination Transect 2, facing westward.

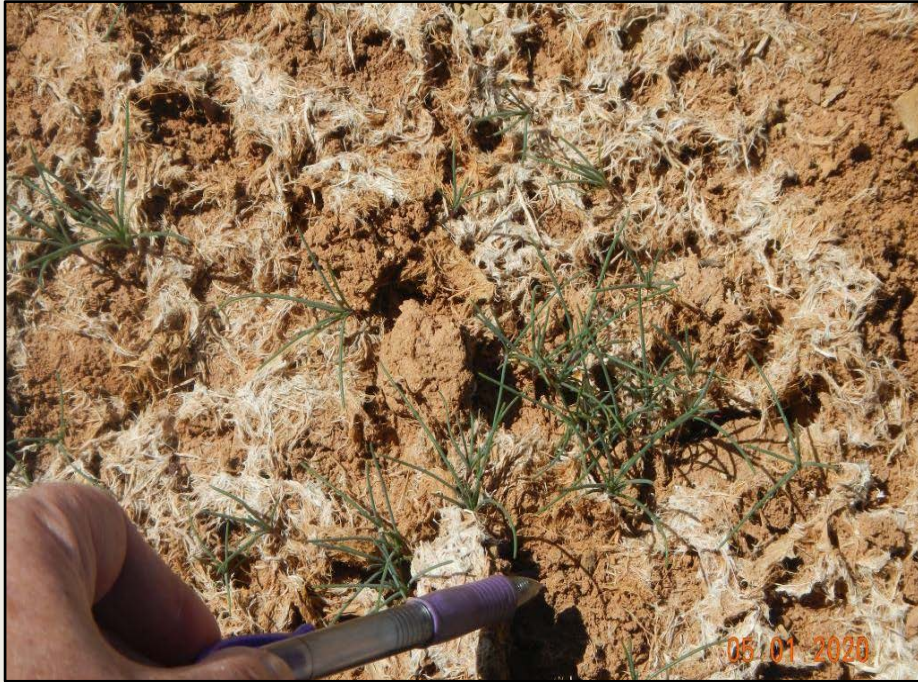
Photos 8/9. Closeup view of vegetation within germination transects. Dense Russian thistle seedlings observable in Photo 8. Grass seedlings remain small (~1 inch) as observed within the germination transects (Photo 9).

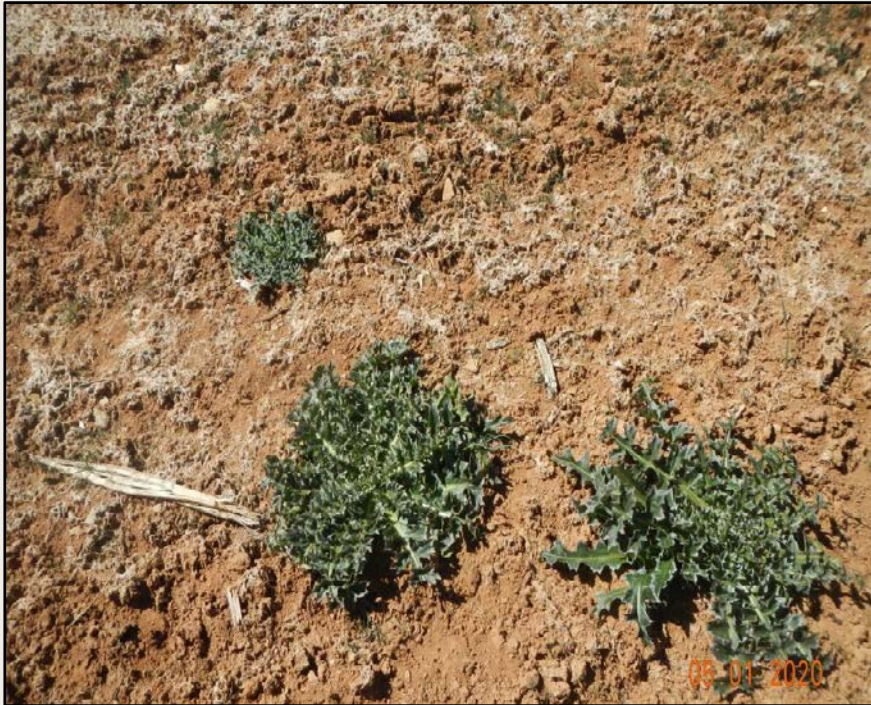
10.

Photos 10/11. View of musk thistles observed within the project area. Approximately 150 individuals observed.

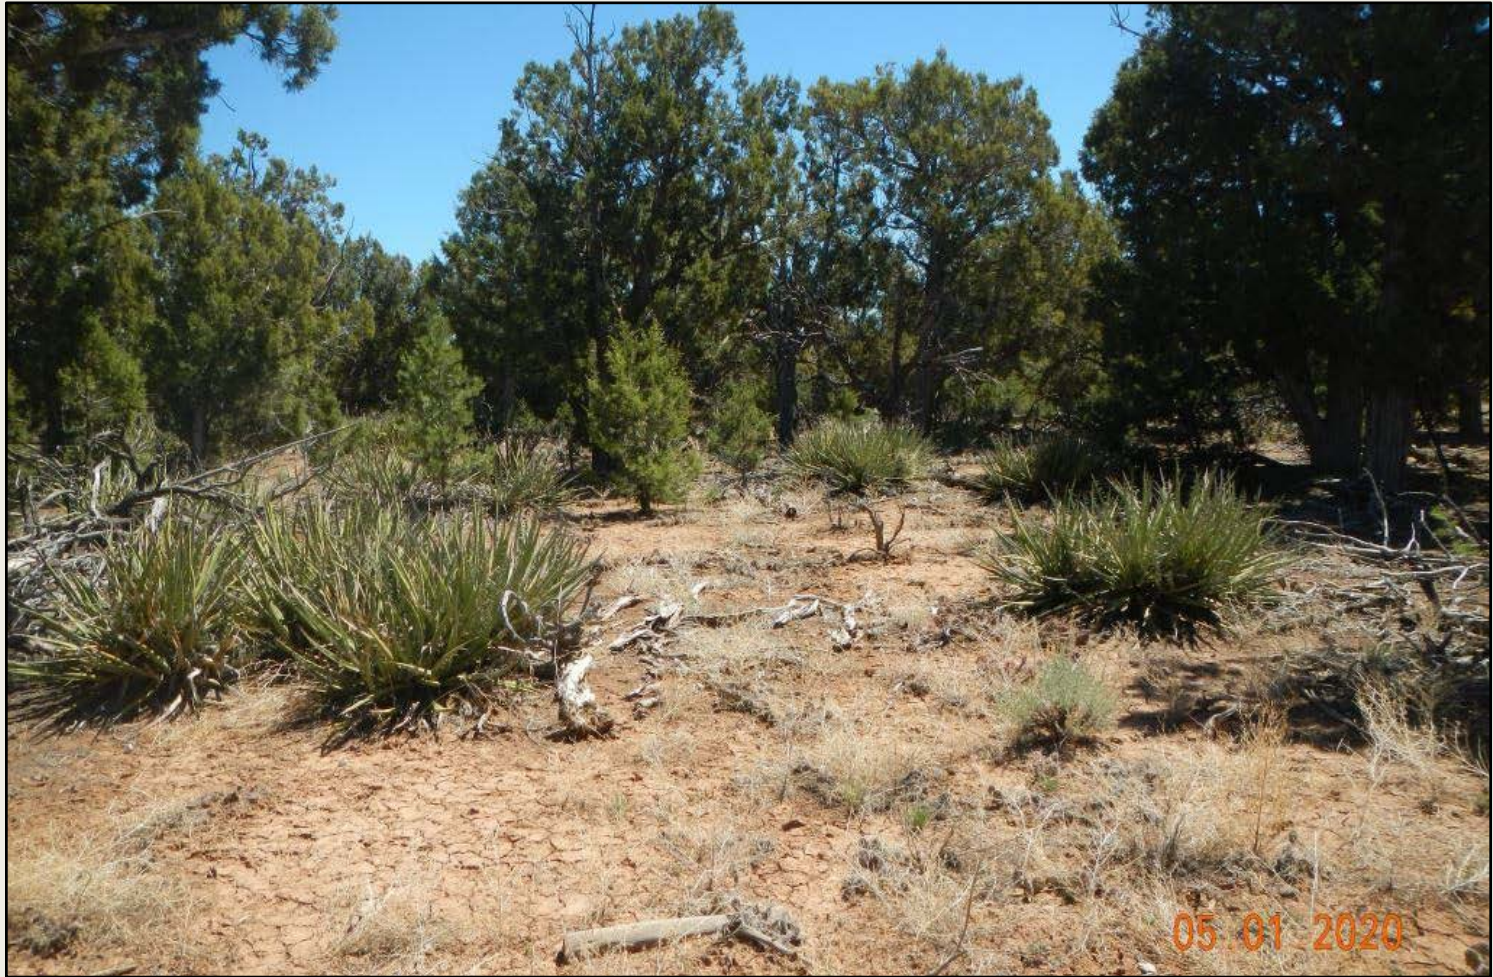
Photo 12. View of reference area comprised of pinyon and juniper woodland with shrubs such as sagebrush, snakeweed, and yucca, as well as grasses such as blue grama, James galleta, and forbs such as penstemon and *Tetraneuris* sp.
