Inspection Photos
Location Name: Tom L. Russell #2
Location ID: 318279

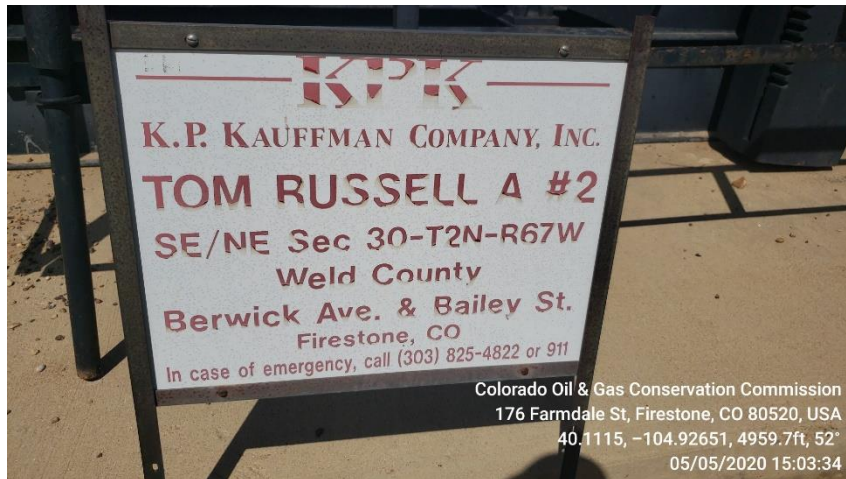
Photo 1 WH sign

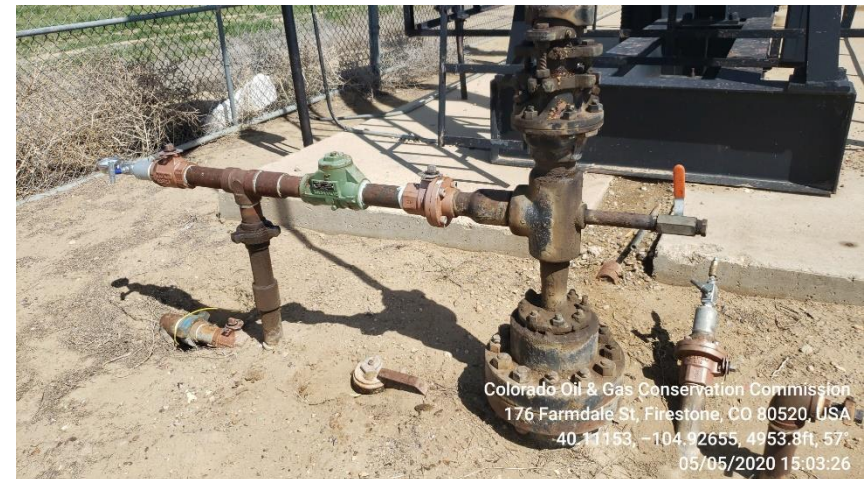
Photo 2 WH

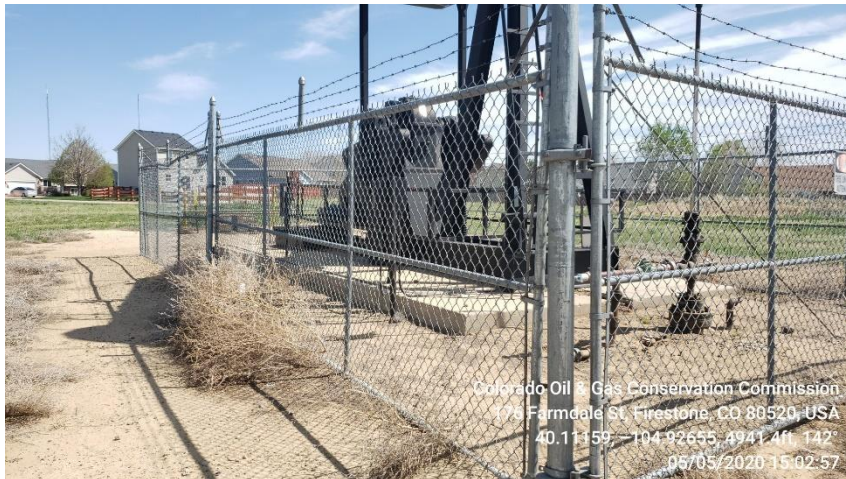
Photo 3 dead weeds around WH/PU fencing

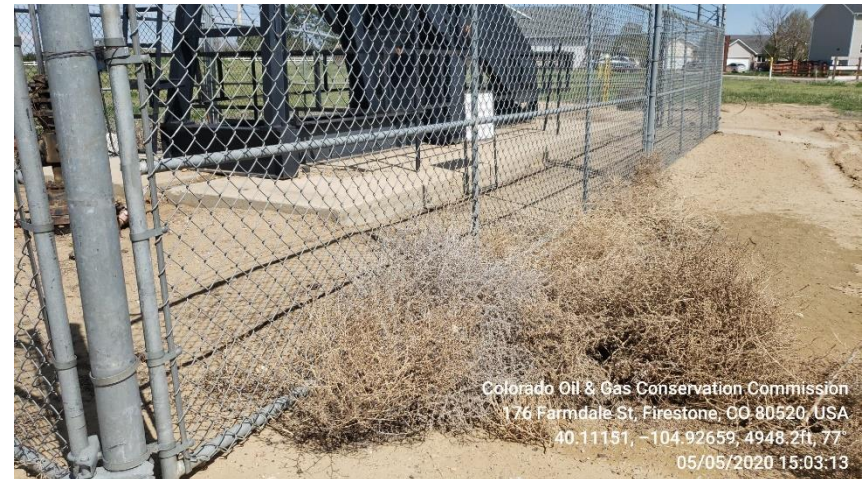
Photo 4 dead weeds around WH/PU fencing

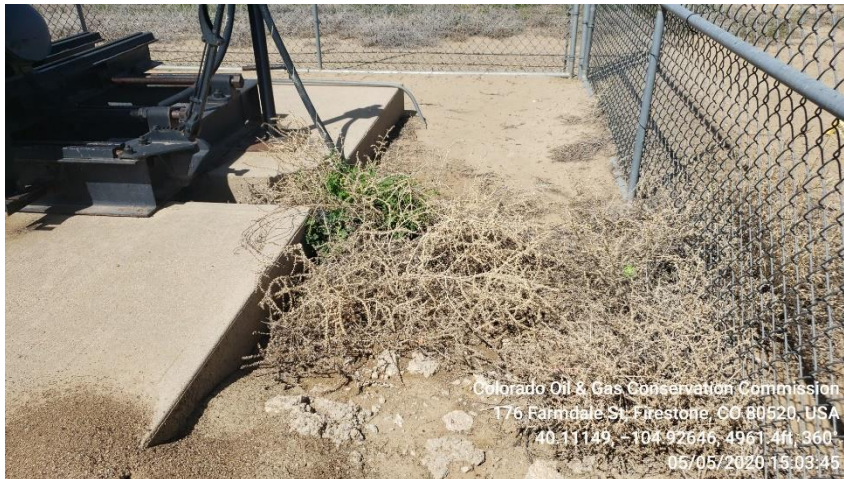
Photo 5 dead weeds inside WH/PU fencing

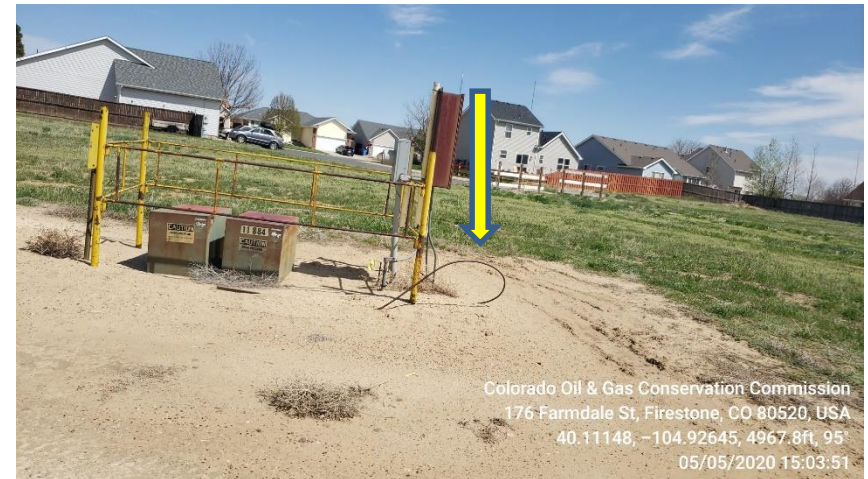
Photo 6 transformers, meter box and electric panel, Trash (bent rebar)

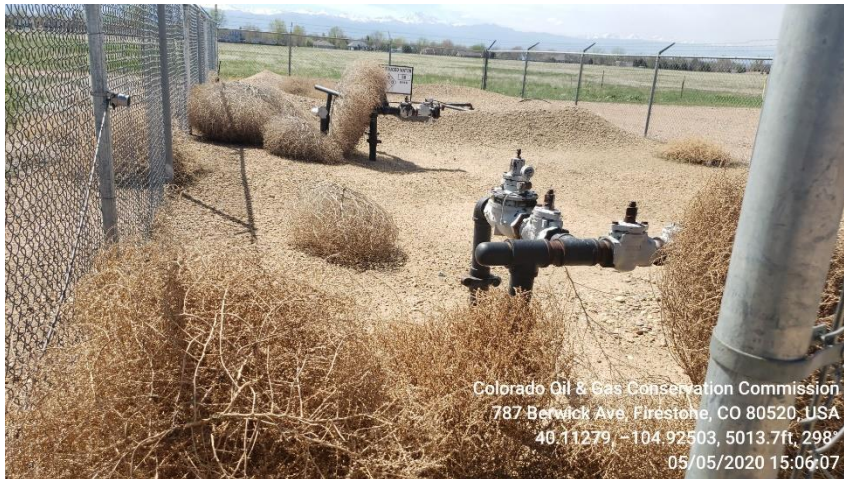
Photo 7 dead weeds inside PW tank fencing

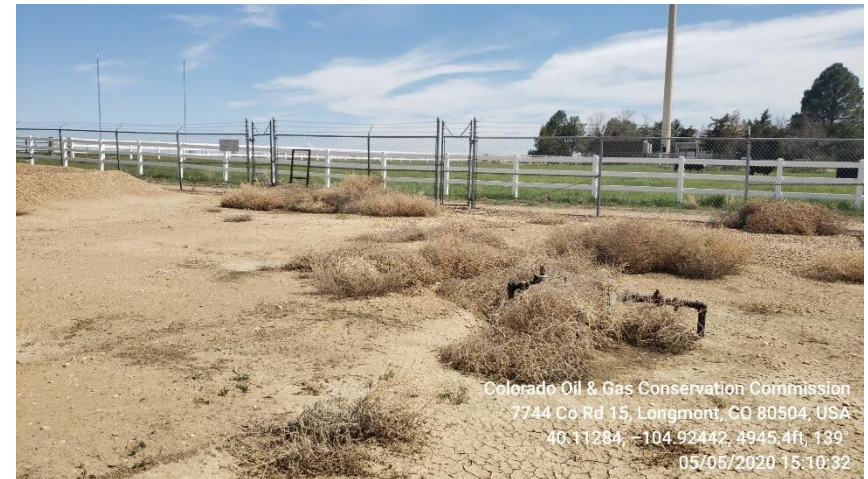
Photo 8 dead weeds inside tank battery fencing

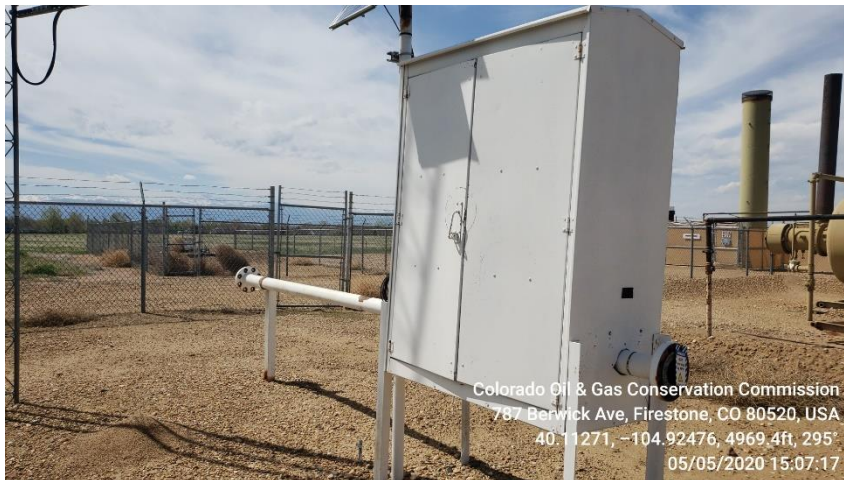
Photo 9 unused gas meter run

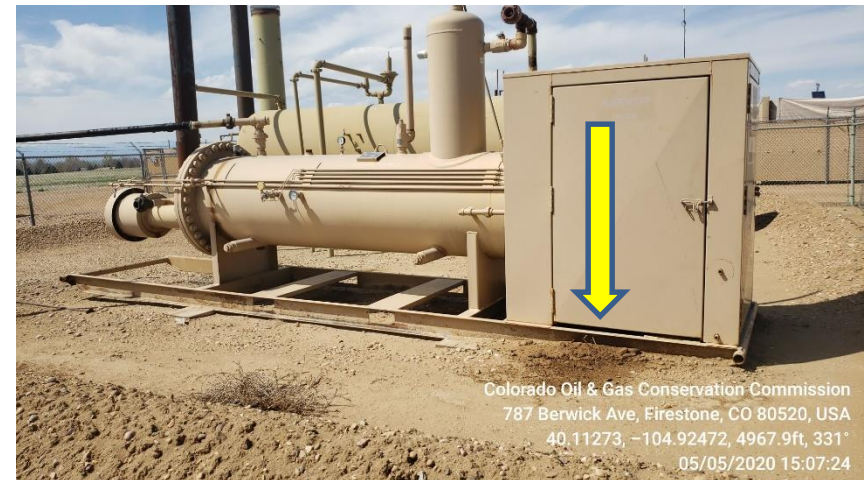
Photo 10 stained soil by horiz.heated sep. door

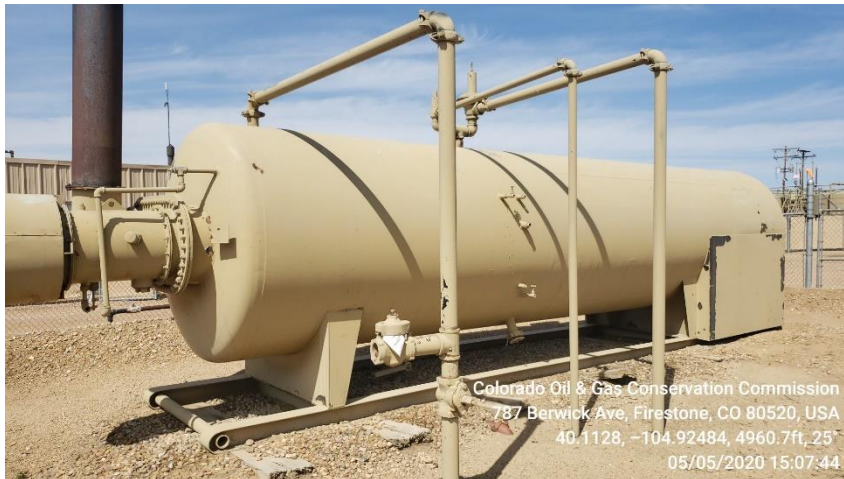
Photo 11 Horizontal Heated separator

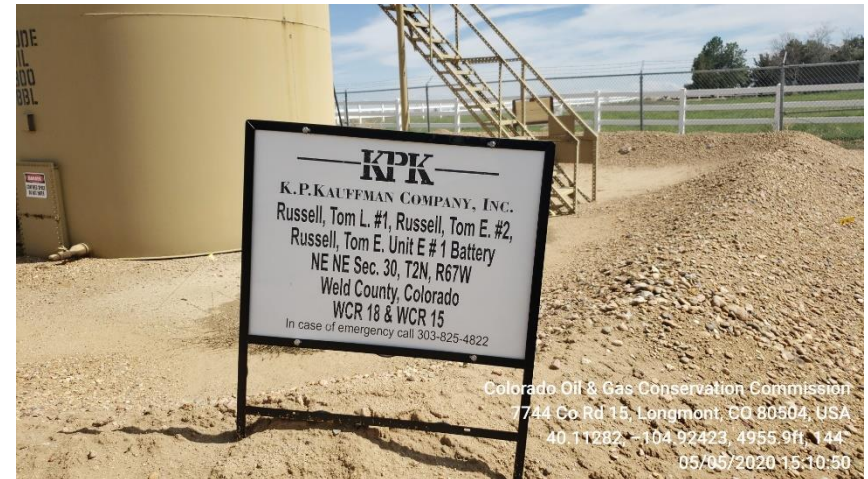
Photo 12 TB sign

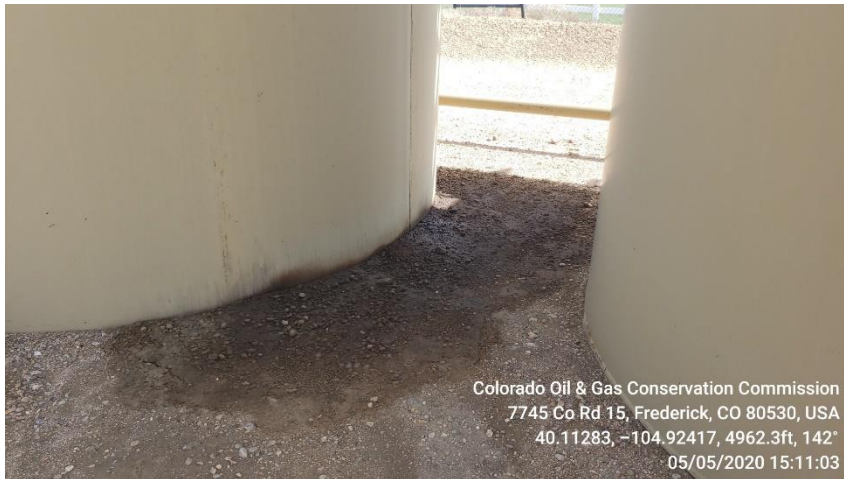
Photo 13 Stained soil between crude oil tanks

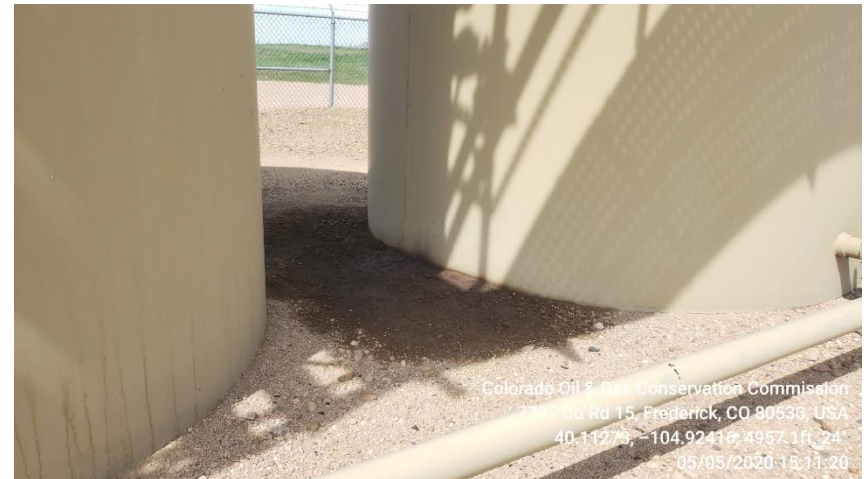
Photo 14 Stained soil between crude oil tanks

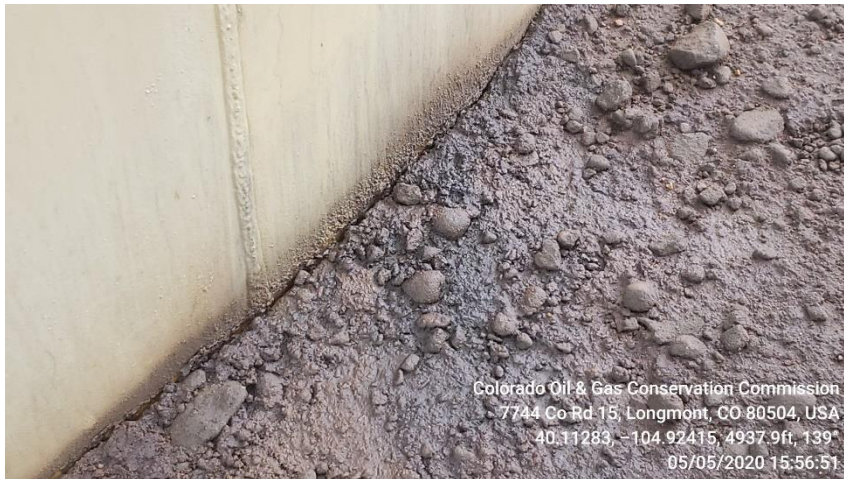
Photo 15 East crude oil tank appears to be leaking

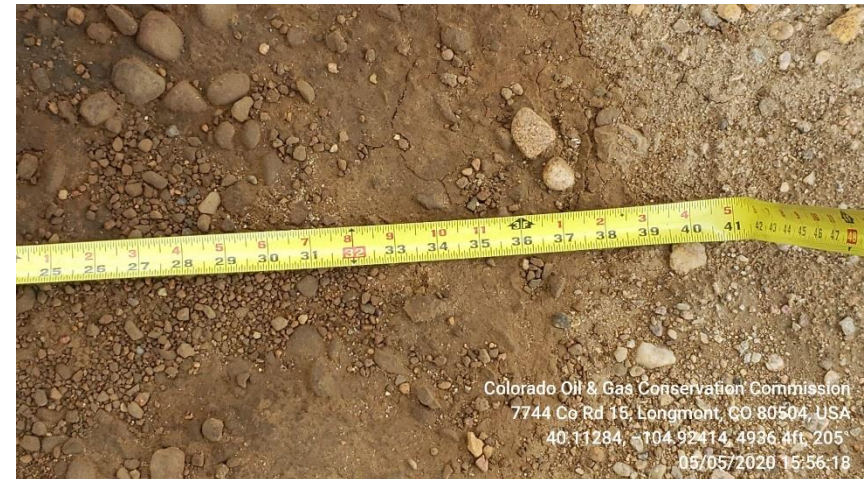
Photo 16 Stained soil approximately 3' wide

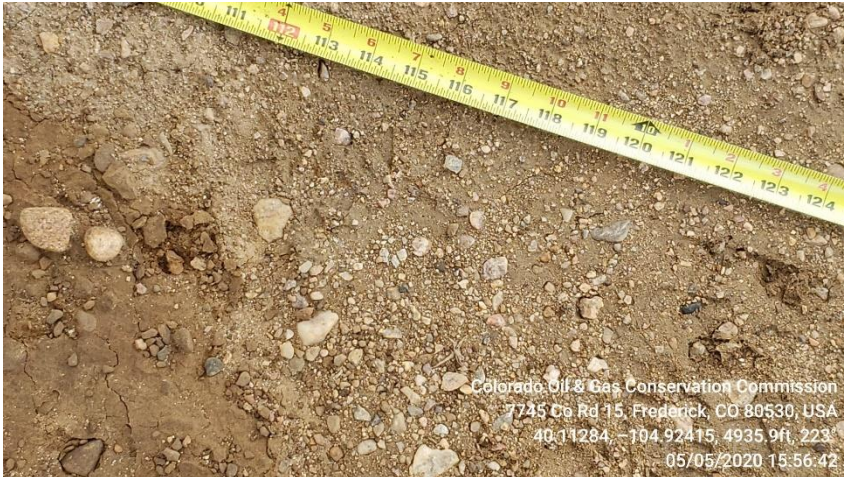
Photo 17 Stained soil approximately 10' long
