Churchill Energy, Inc - COGCC Inspection Photos

Location: Kinsman Unit 1-18

API # 123-07545 Date 5/04/2020

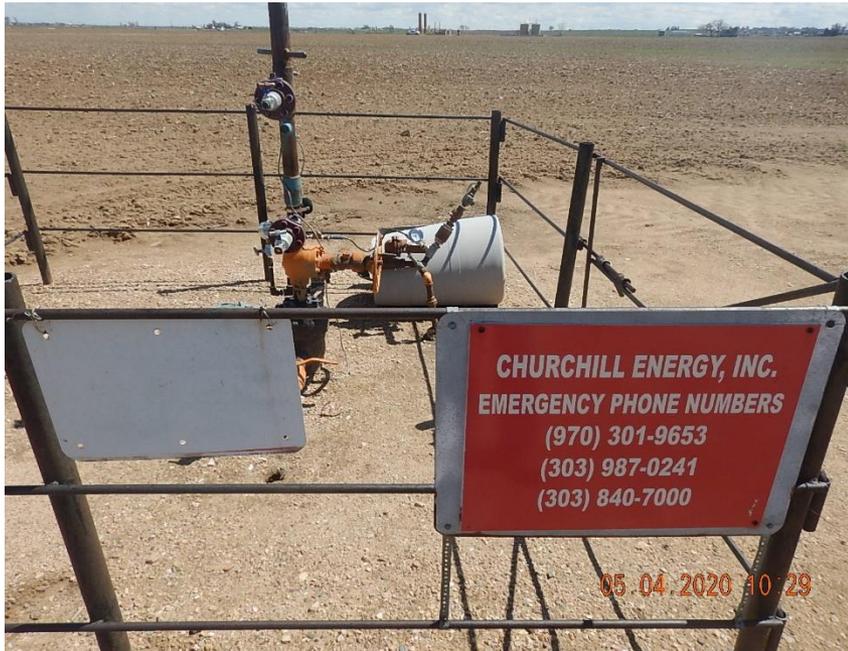
Incomplete signage at wellhead; view North

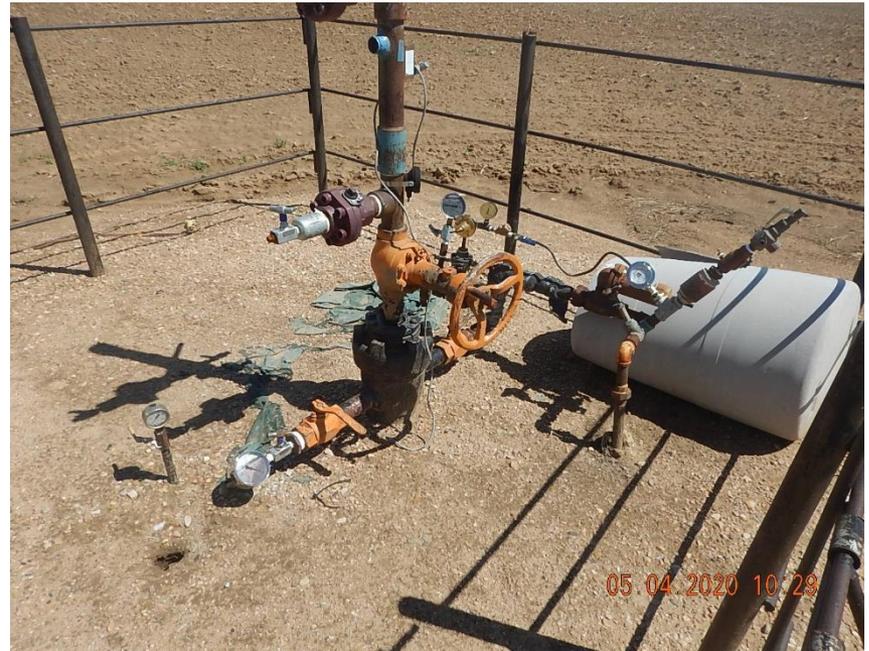
View of (TA) wellhead; Flowline riser removed (hole)
Domestic tap/ pressured with casing gas.

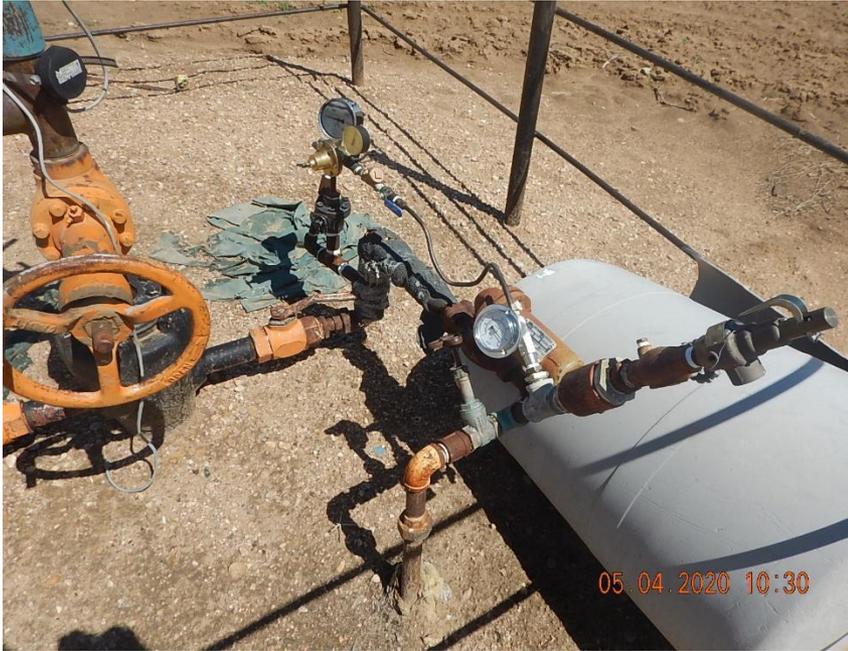
Close up view of domestic tap; Tied into casing, appears to be active (in service).

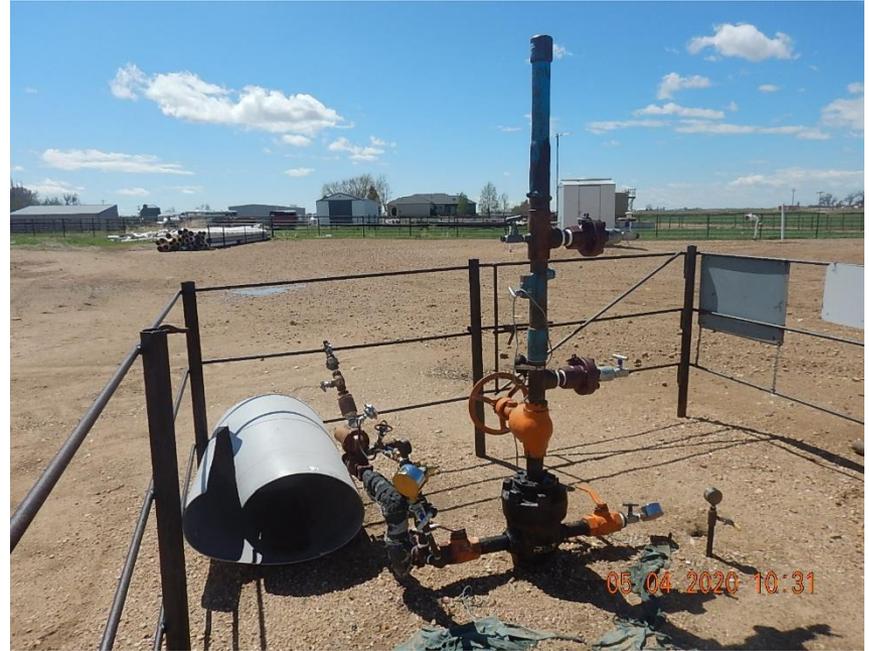
View south from wellhead to gas gathering meter run; area where surface equipment and tank battery has been removed by operator.

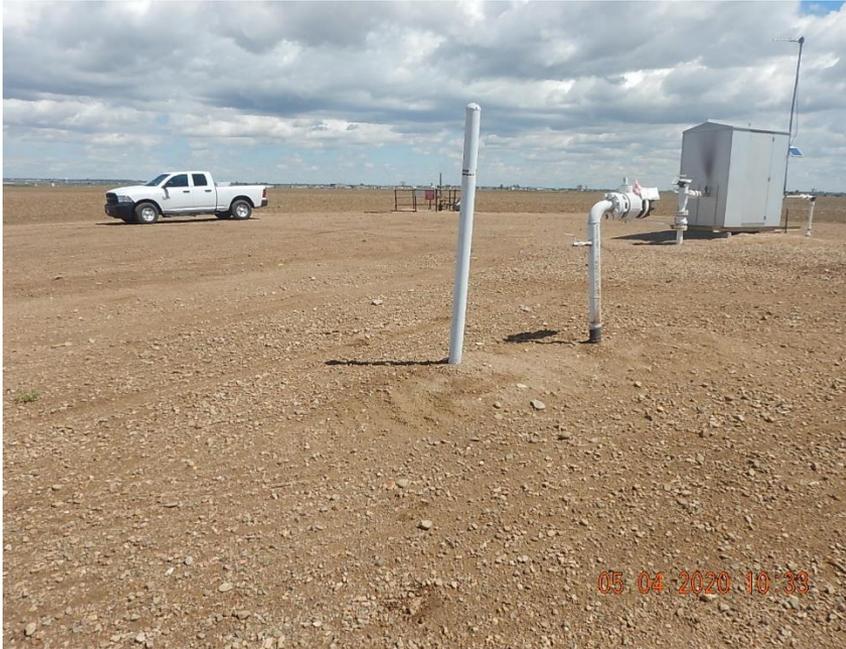
Out of service gas gathering risers in area where production equipment (meter run) has been removed (View NE).

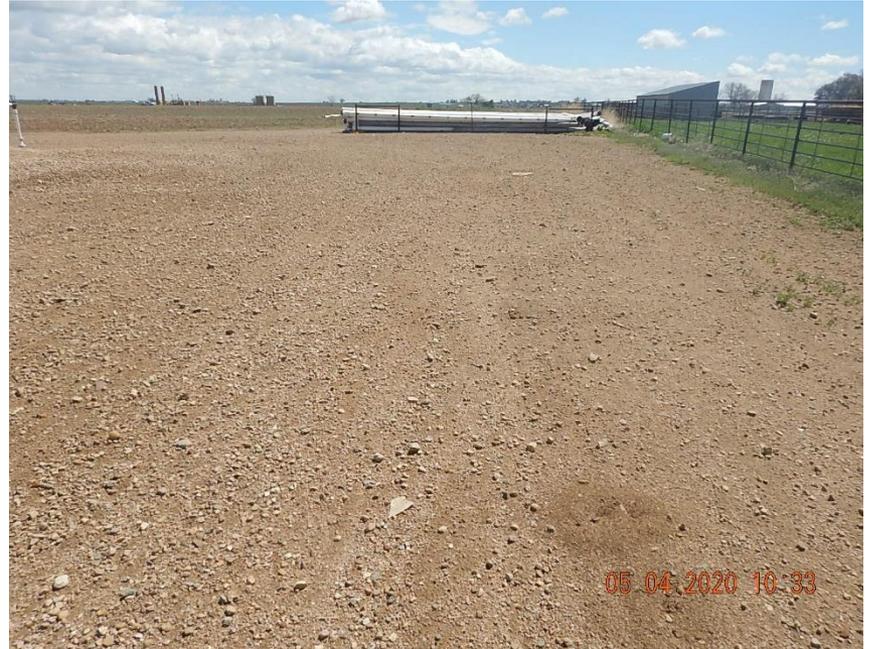
Production equipment and battery removed; view east from SE corner location.
