Churchill Energy, Inc - COGCC Inspection Photos
Well: Stromberger Unit 2-12
API # 123-09299 Date 5/04/2020

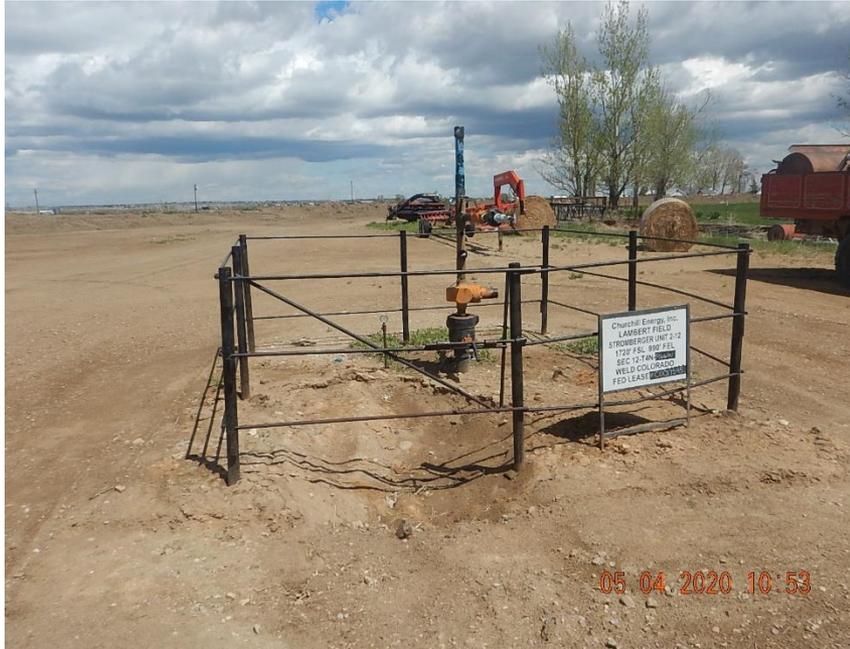
Incomplete signage at wellhead; view North

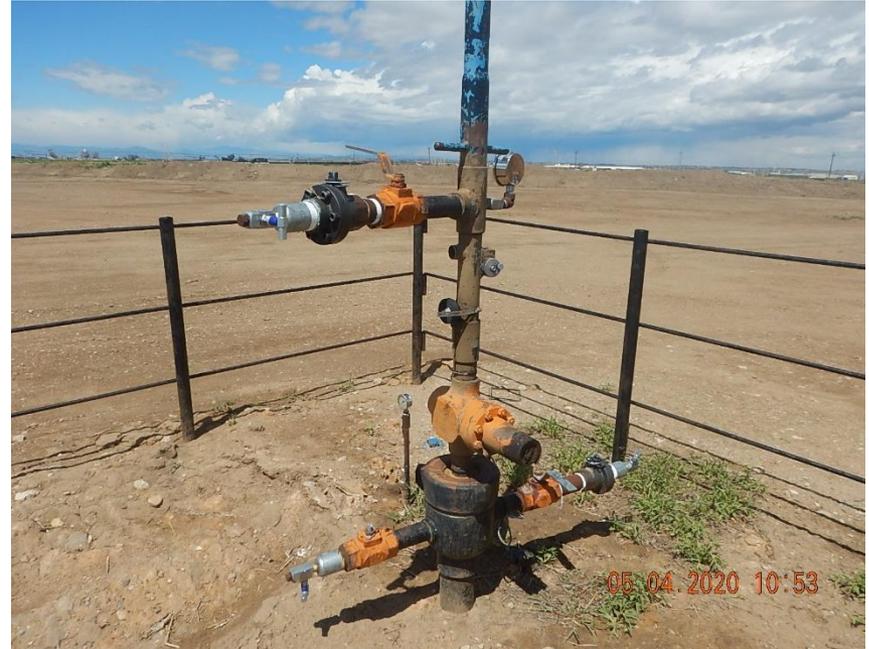
View of (TA) wellhead; Flowline riser removed. Valves closed; bull plugged. View NW

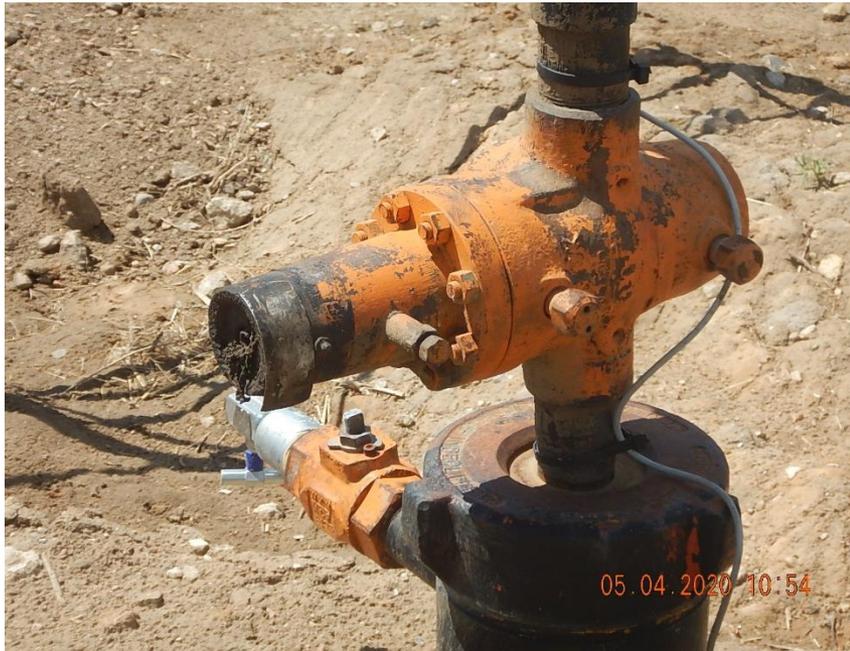
Broken master valve at wellhead.

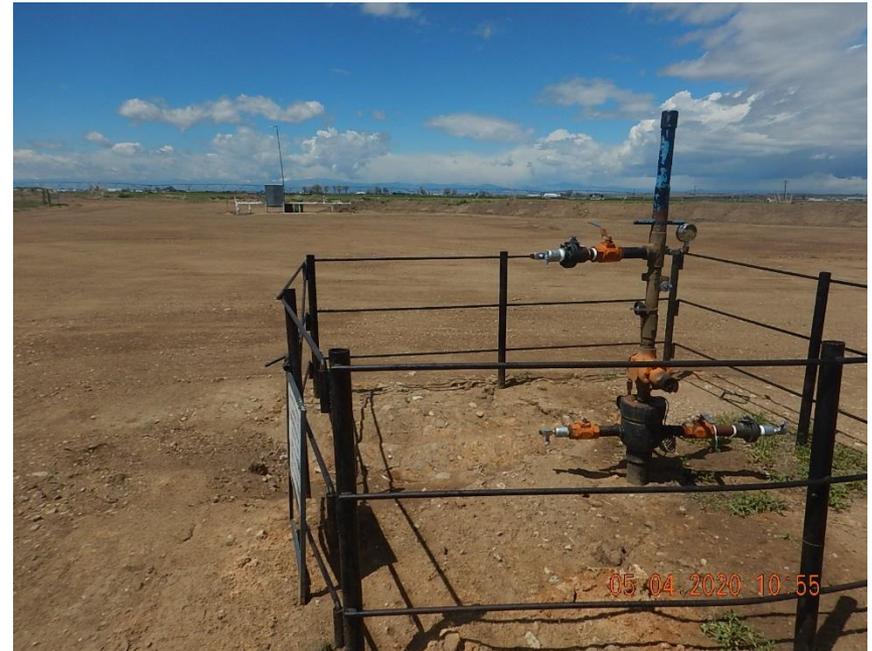
View of (TA) wellhead; View west of location toward area where production equipment/ battery has been removed.

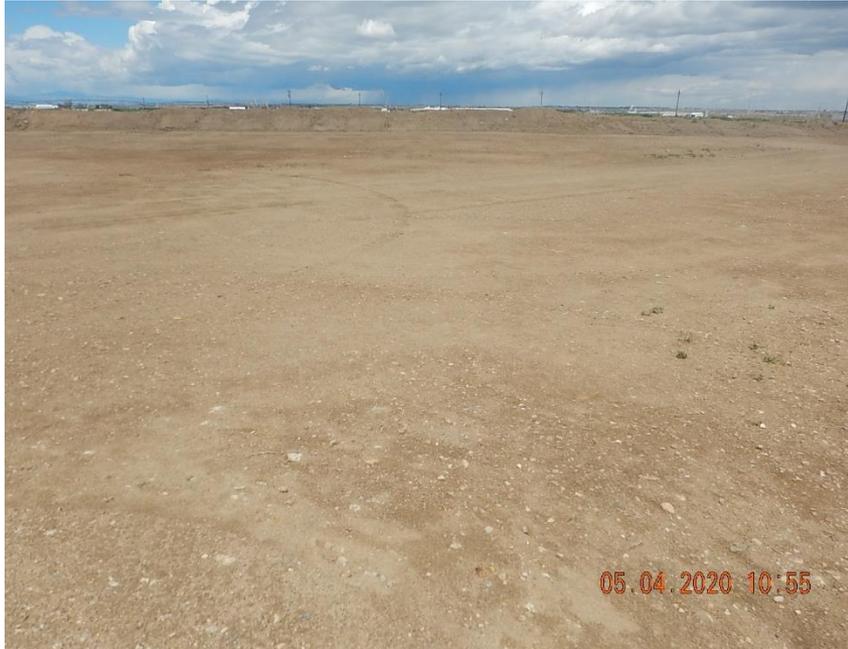
View of location from wellhead; looking North

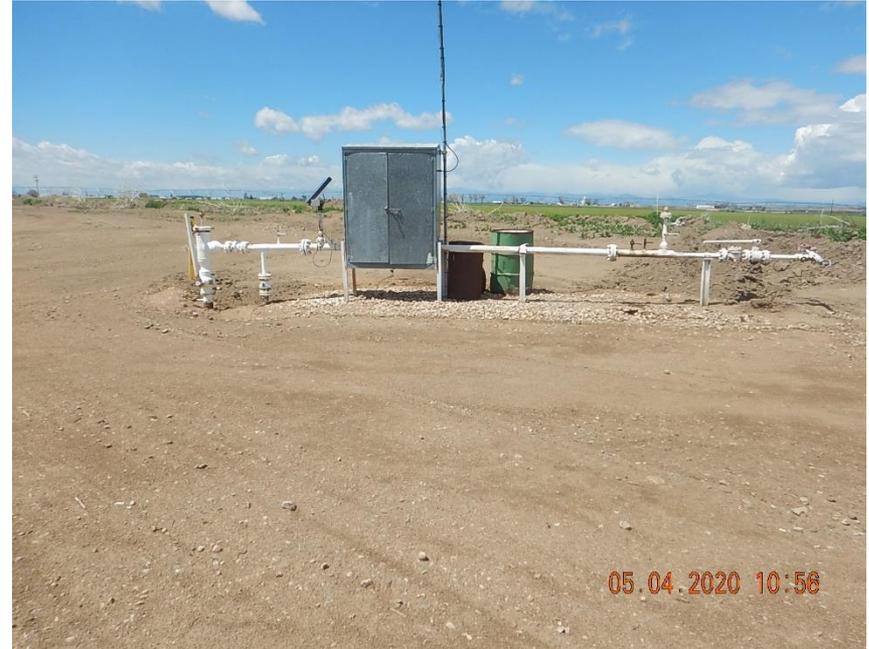
Out of service gas meter run
