Inspection Photos
Operator: BP America
API#: 067-07741
Date: 5/5/2020

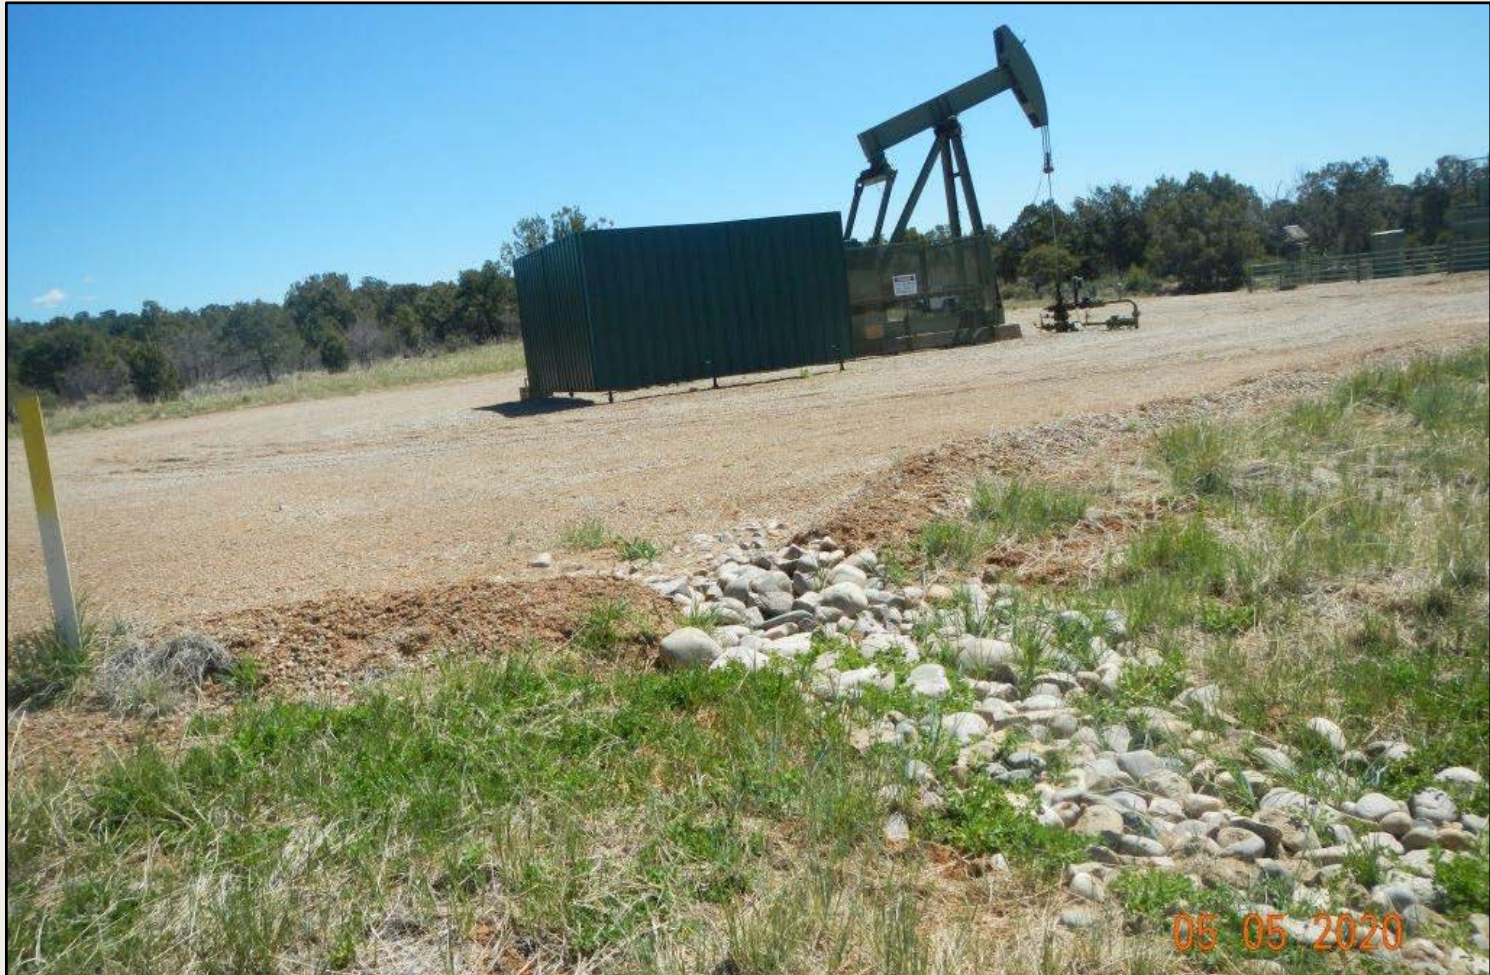
Photo 1. View of the project area from the southwestern corner facing center.

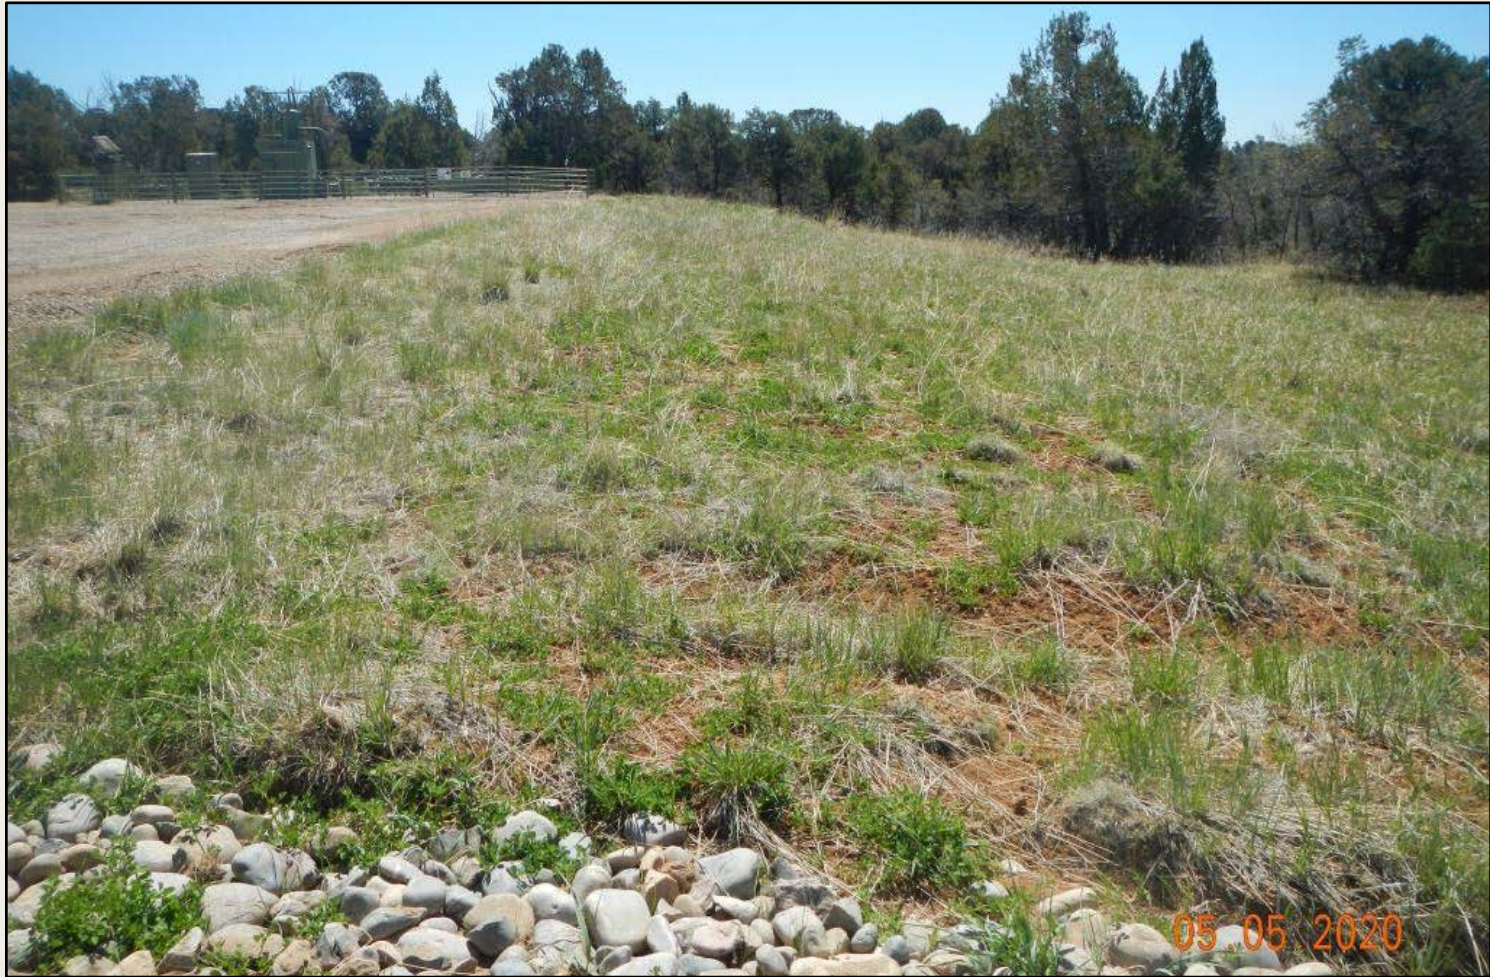
Photo 2. View of the southern project area from the southwestern corner facing eastward. Revegetation is progressing with western wheatgrass and various wheatgrasses.

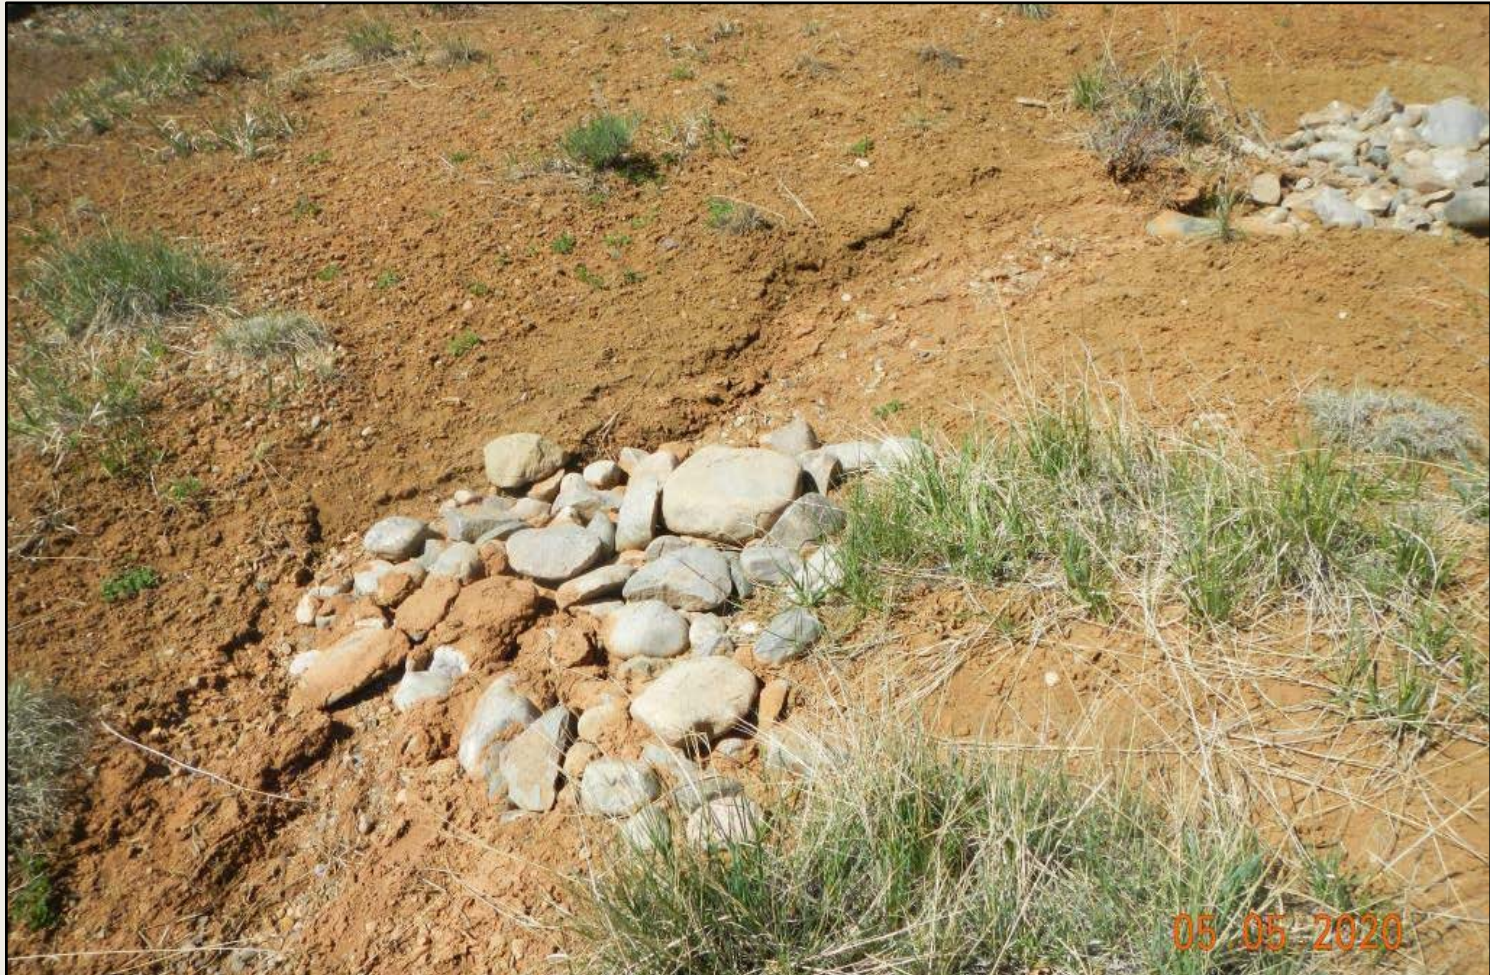
Photo 3. View of cobble placed in southwestern erosional channel. Erosion is continuing around cobble and between cobble bars, as it is not an adequate BMP in this area. Additional BMPs are needed.

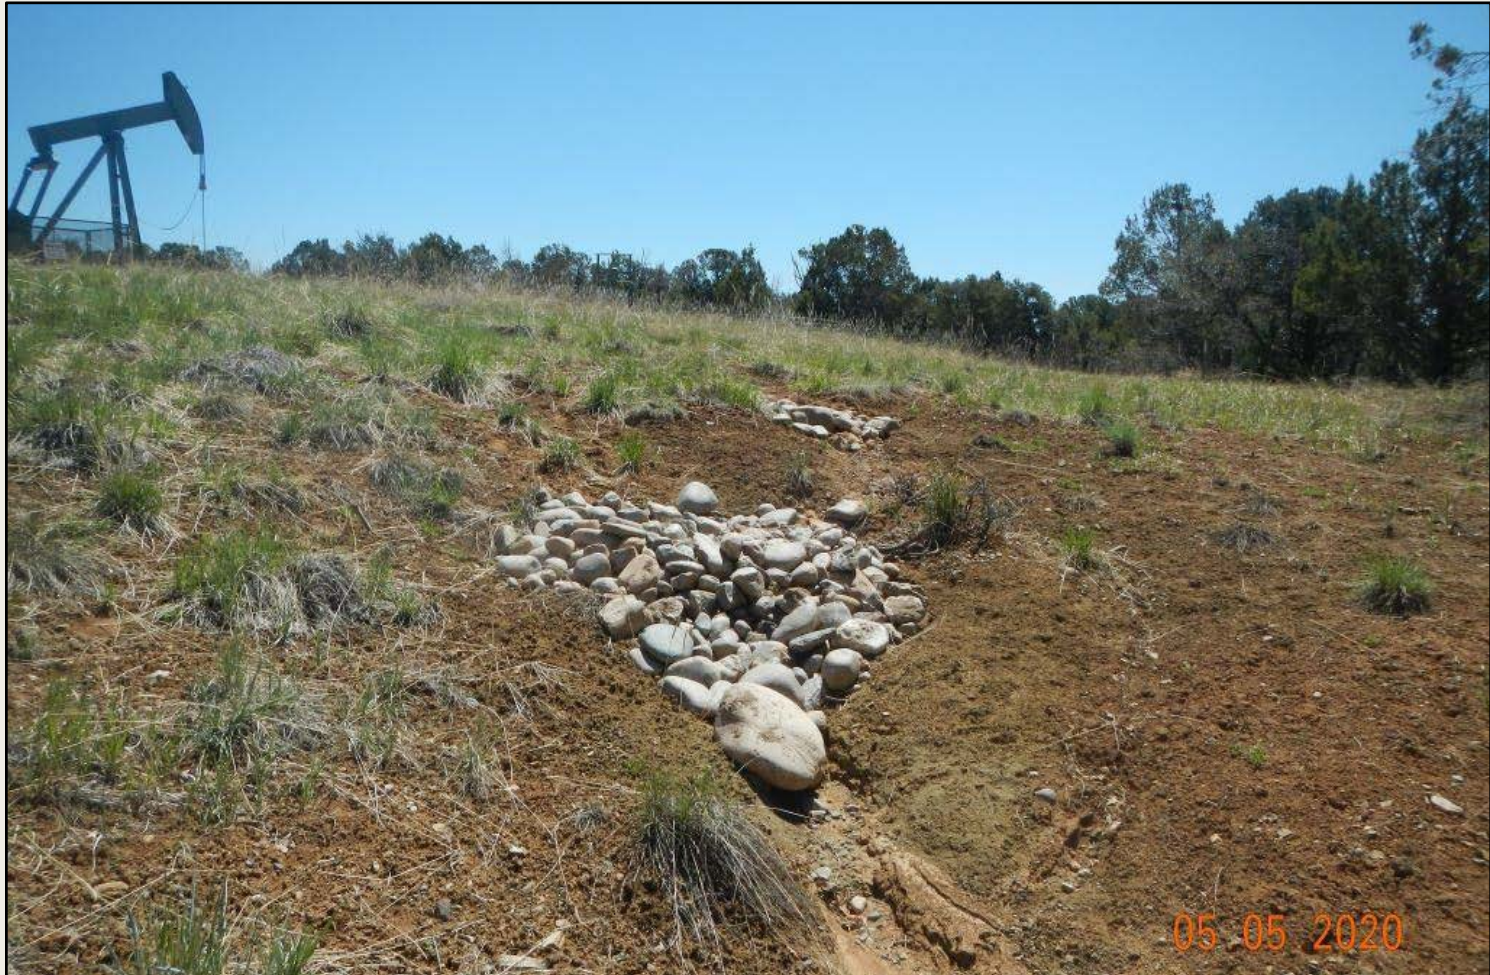
Photo 4. View of cobble bare in the southwestern project area. Erosional scouring and sediment transport continuing between BMPs.

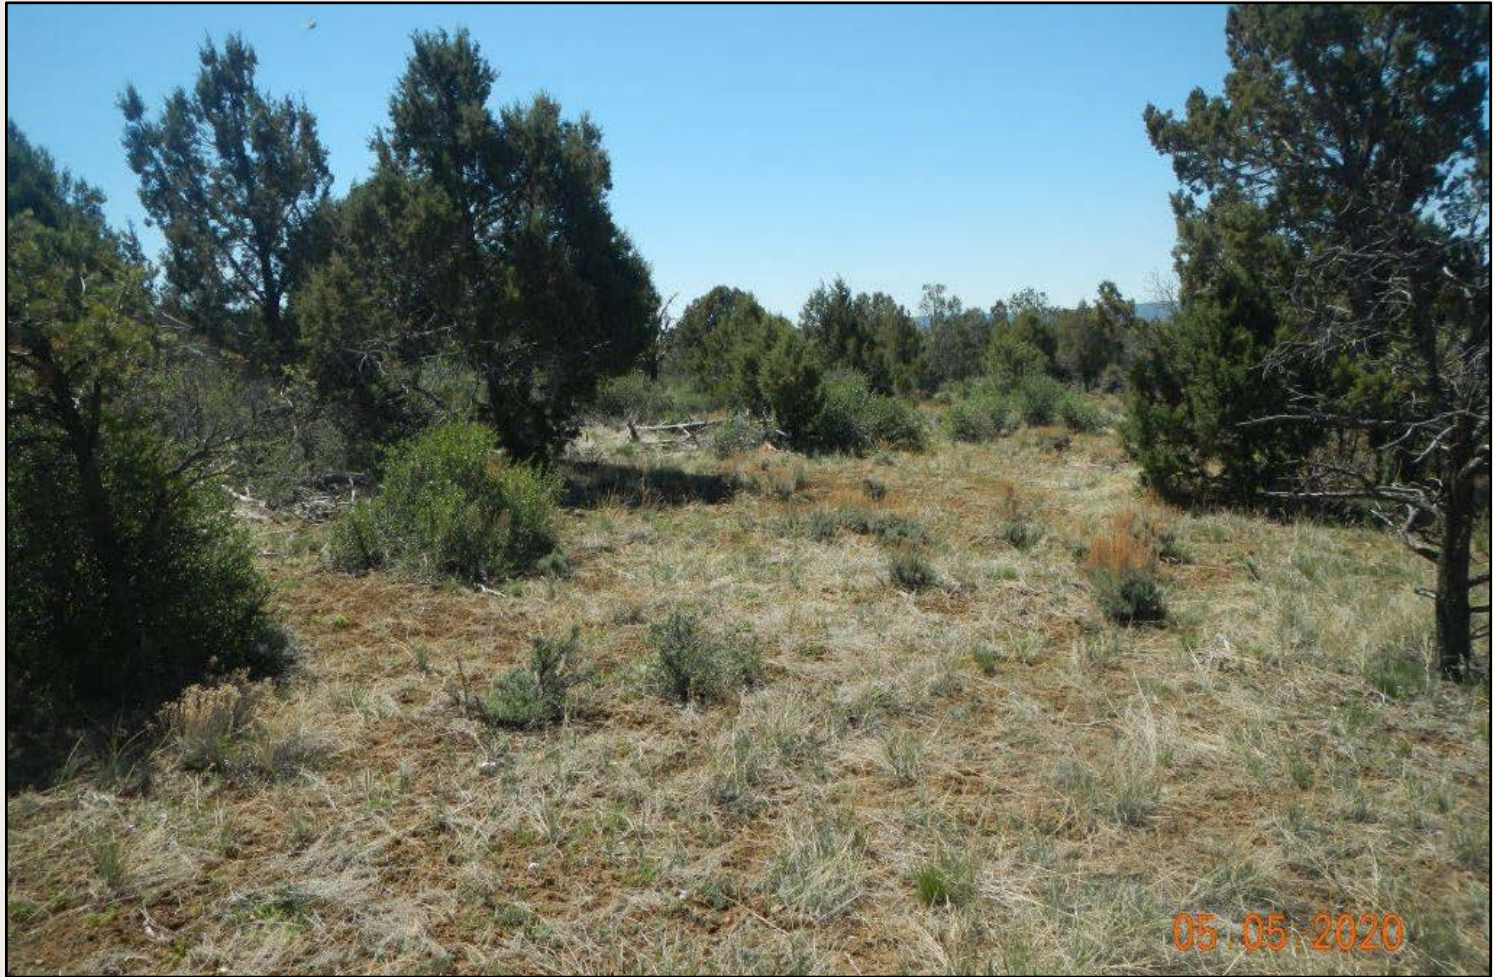
Photo 5. View of reference area comprised of pinyon-juniper woodland with sagebrush, squaw apple, western wheatgrass, and James galleta.
