Inspection Photos

API: 071-08351

Operator: TIMBER CREEK OPERATING

Inspection Date: 5/8/2020

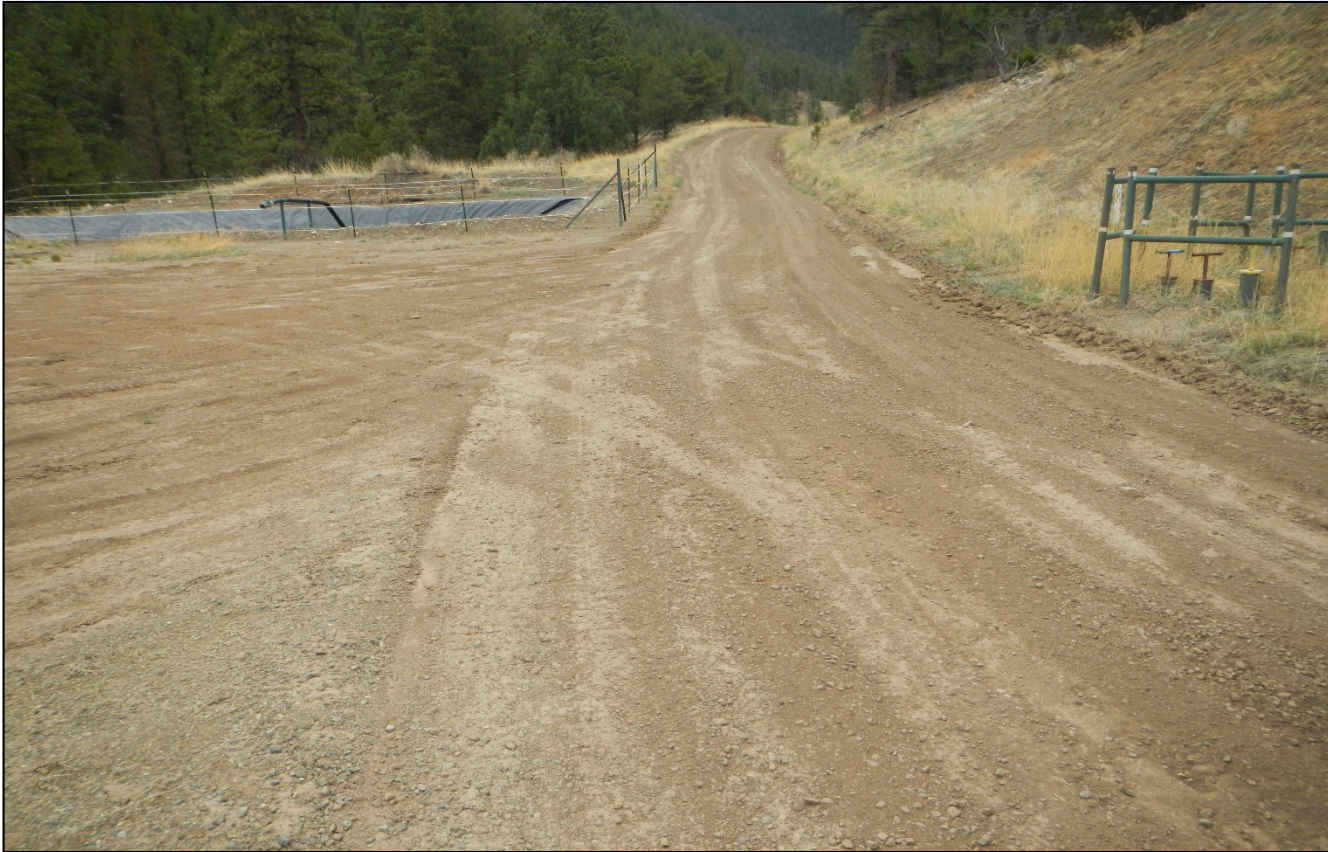
Photo 1. Facing southwest along the access road near the GE 31-04 site. The road has been graded and maintained.

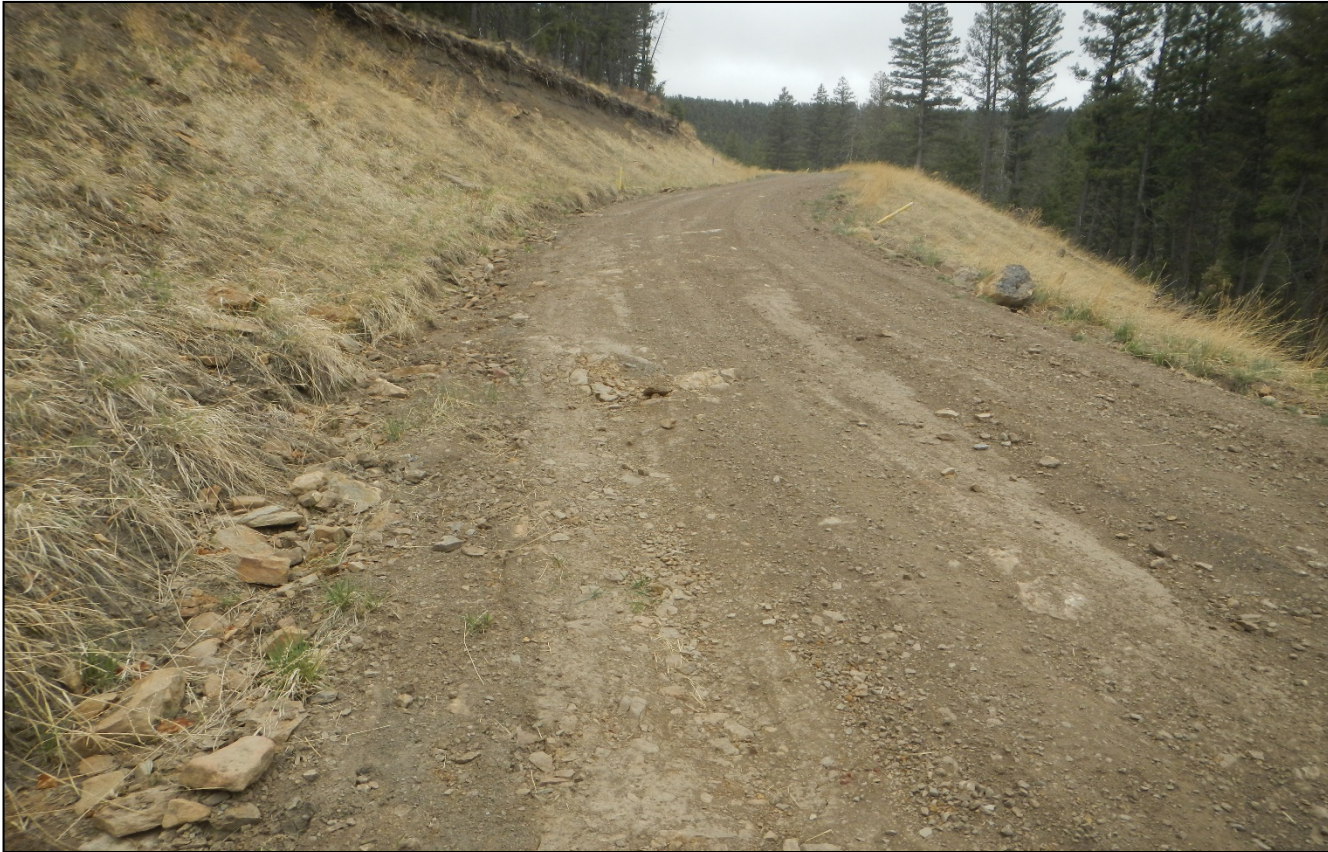
Photo 2. Facing west along the access road. The road has been graded and large rock moved off the road.

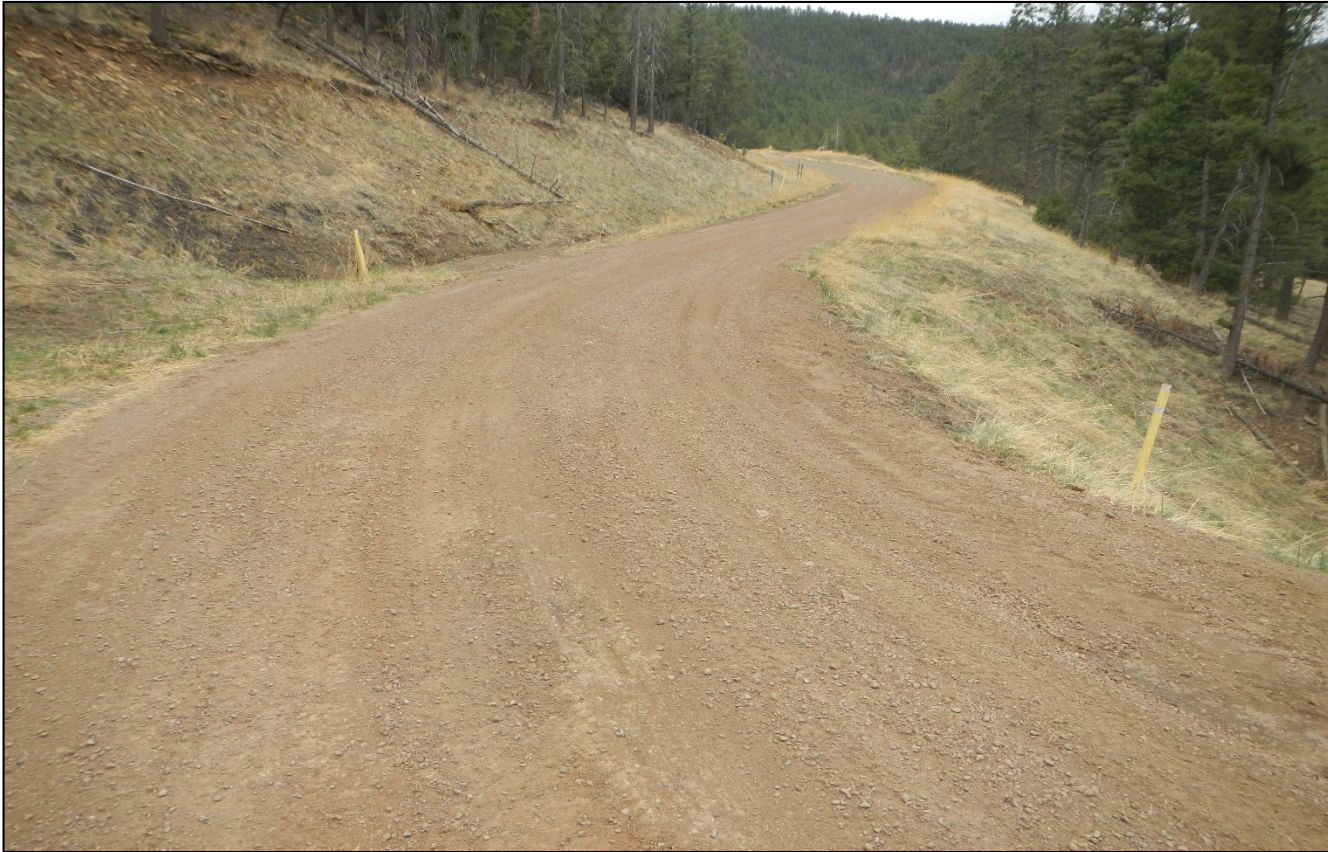
Photo 3. The culvert inlet has been maintained and erosion repaired along the road.

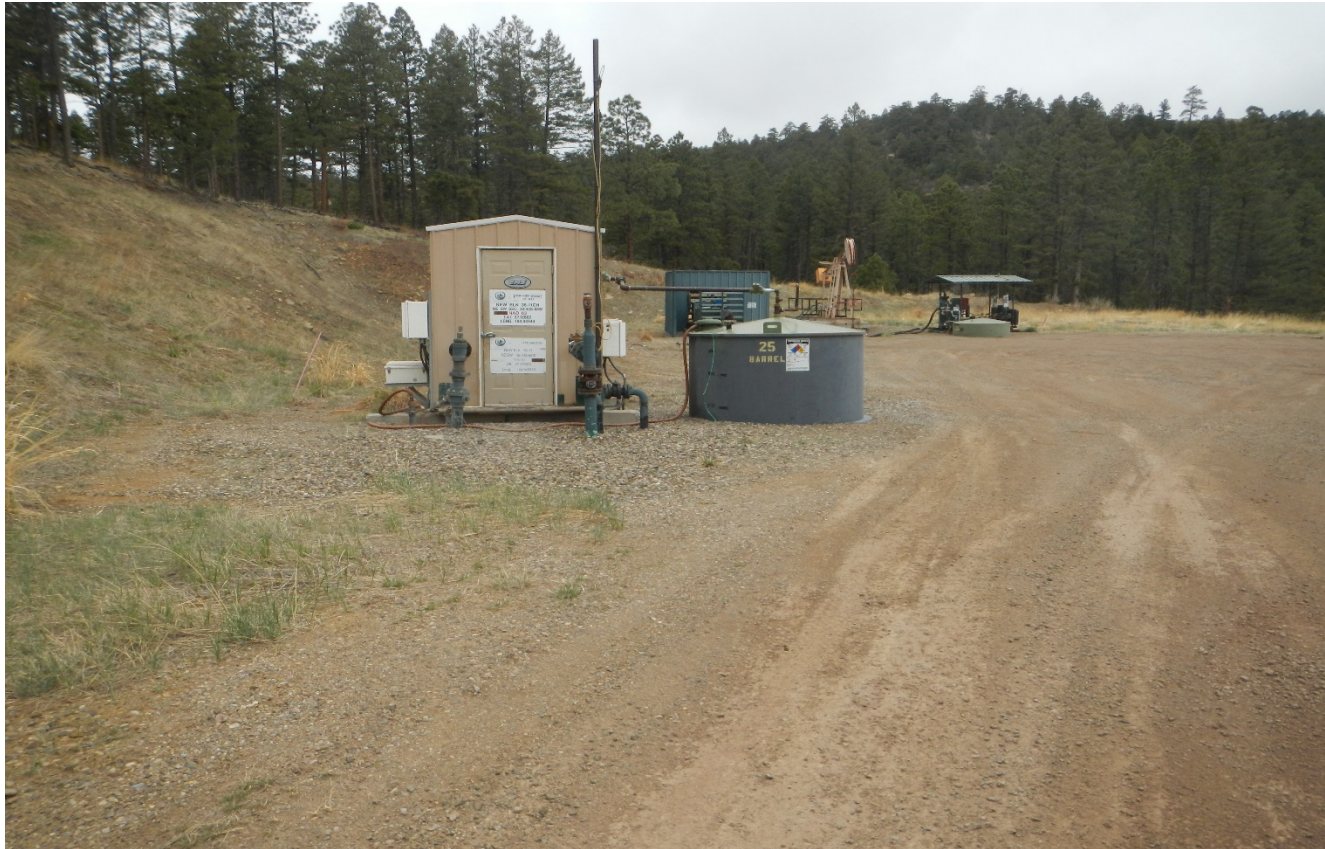
Photo 4. Facing toward the location.

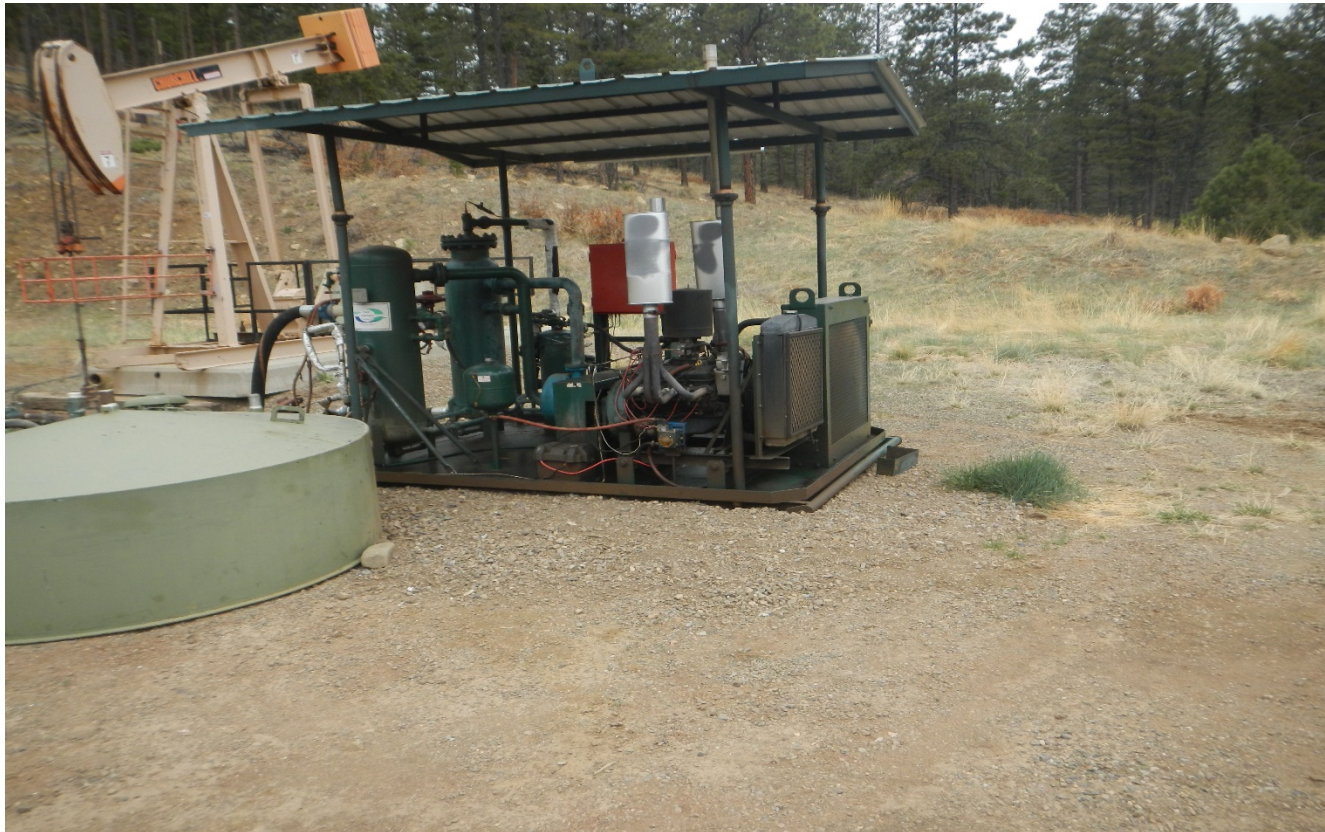
Photo 5. The oil in the engine skid has been cleaned up.

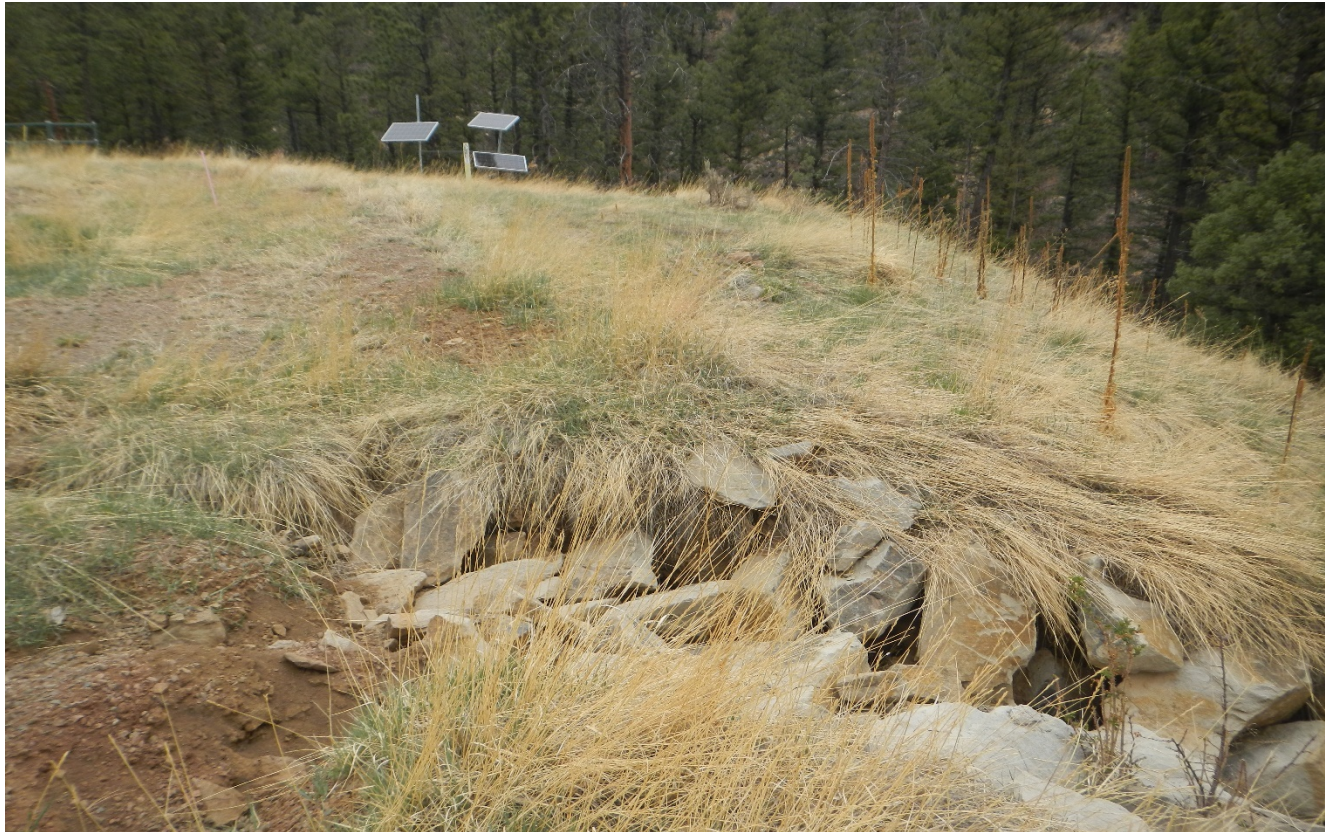
Photo 6. The vegetation is well established in the interim area fill slope.

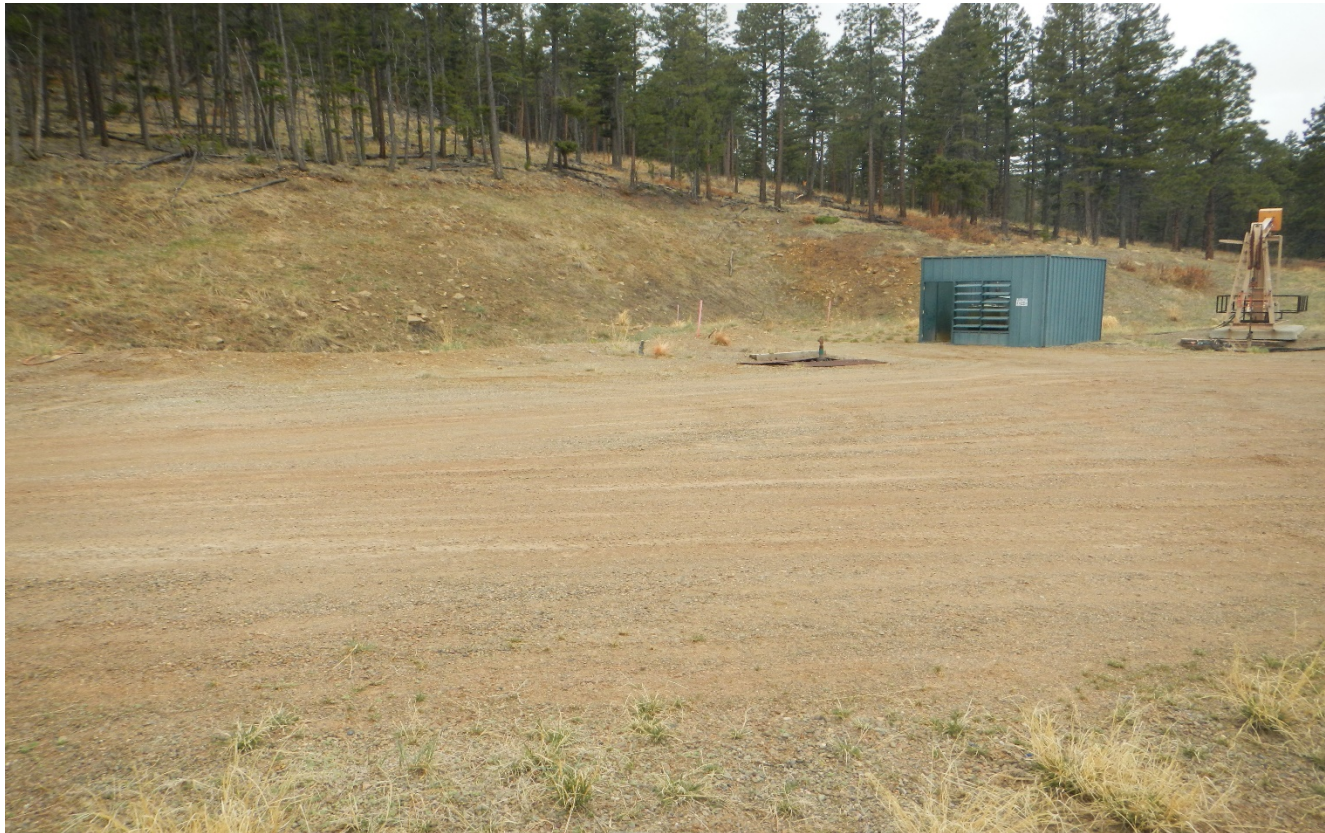
Photo 7. Facing toward the location.
