Investment Equipment LLC, Colorado State 1  
121-05320

Inspection #688307801

5/4/2020

Reinspection of pit spill

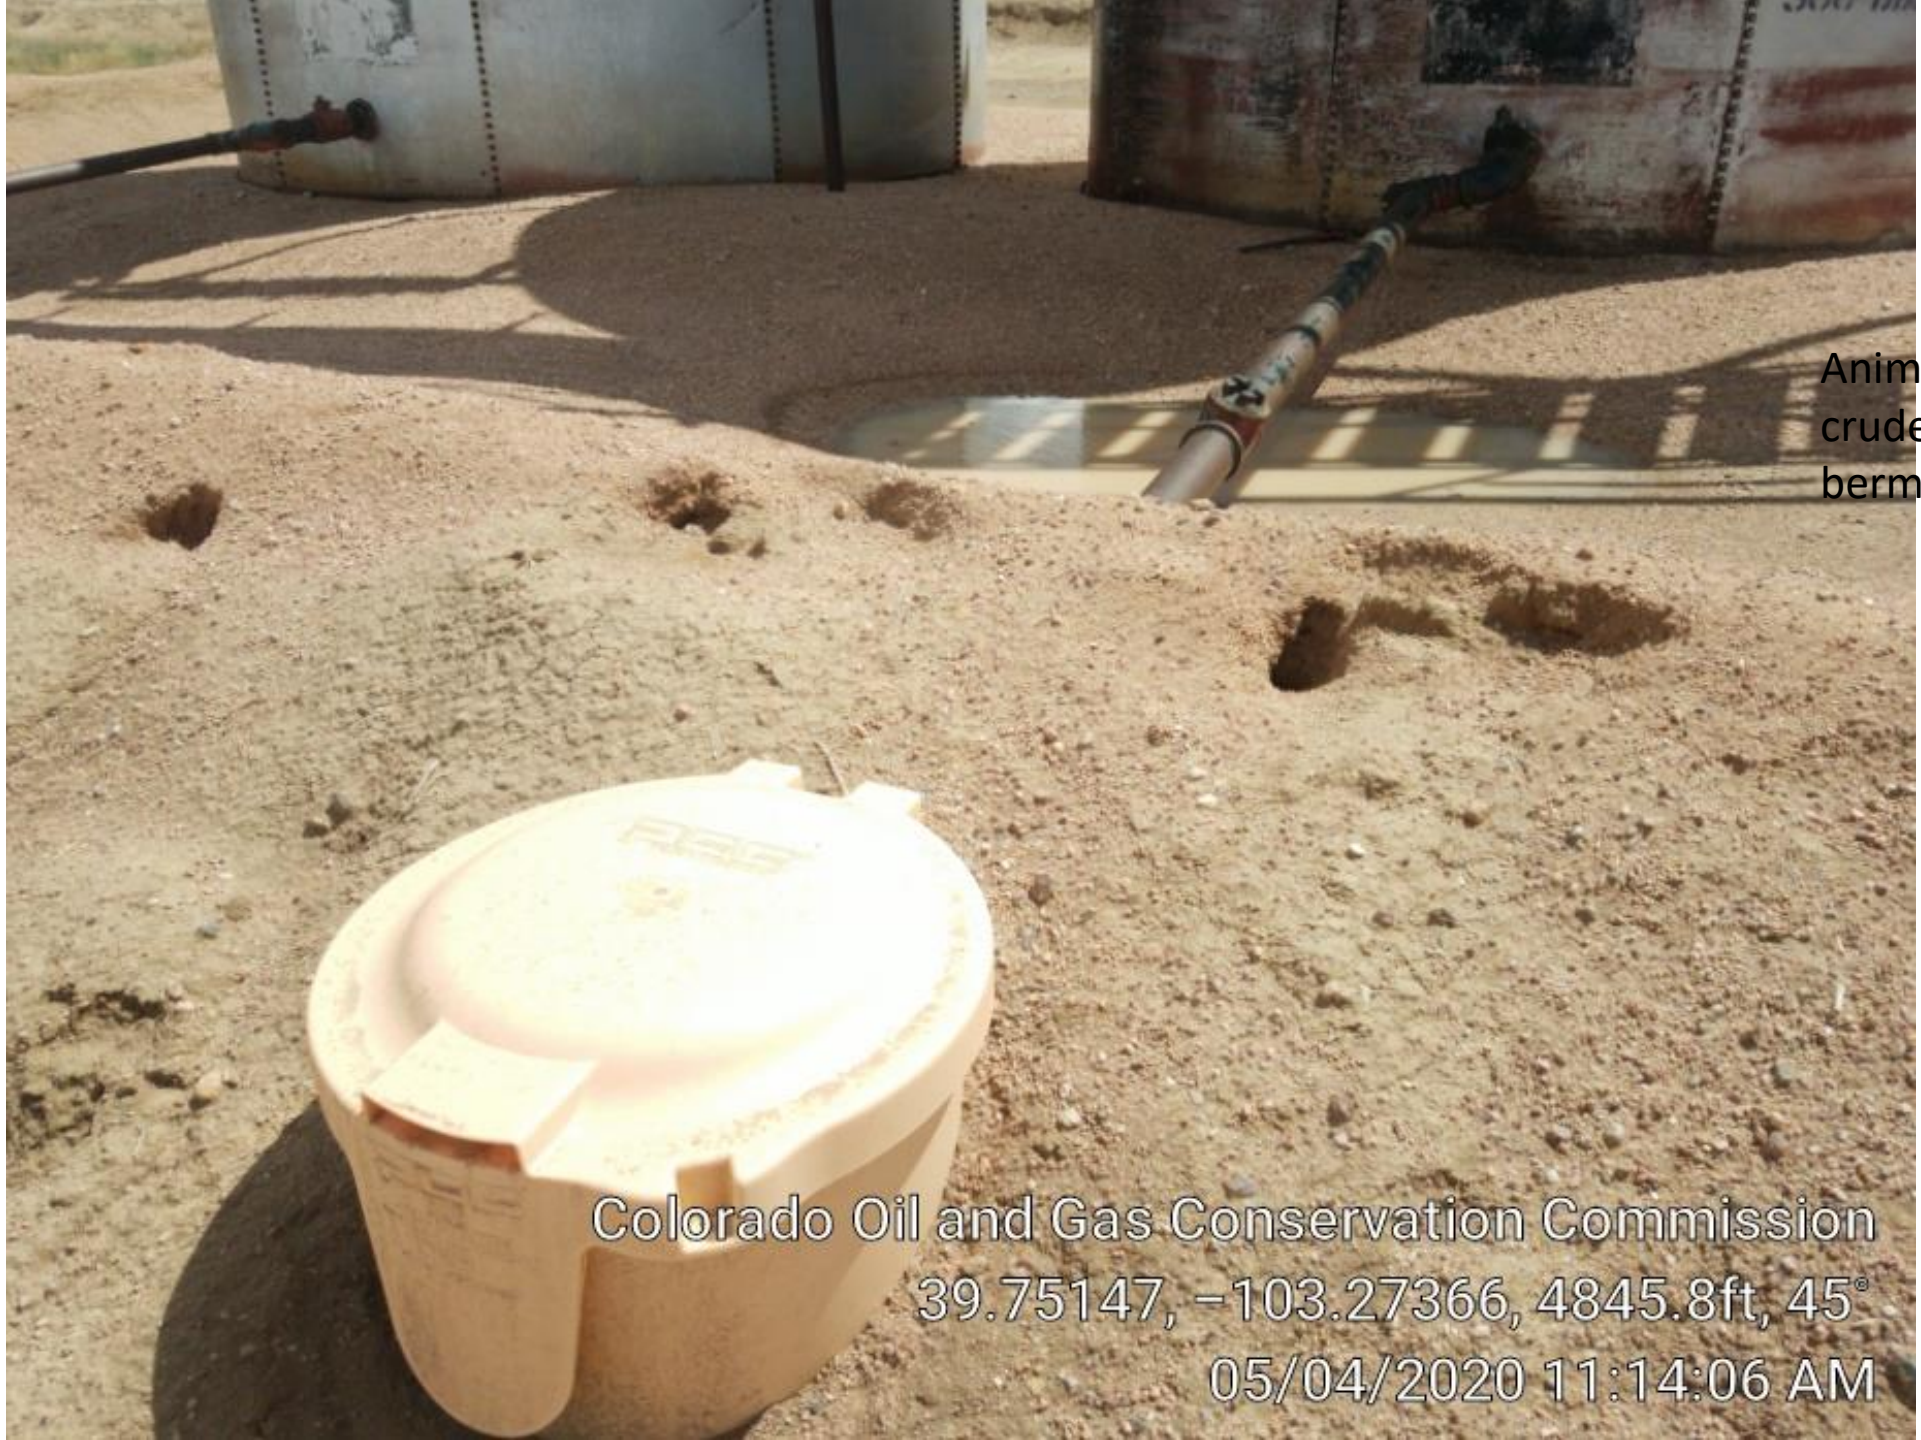
Animal holes in  
crude oil tank  
berms/maintain.

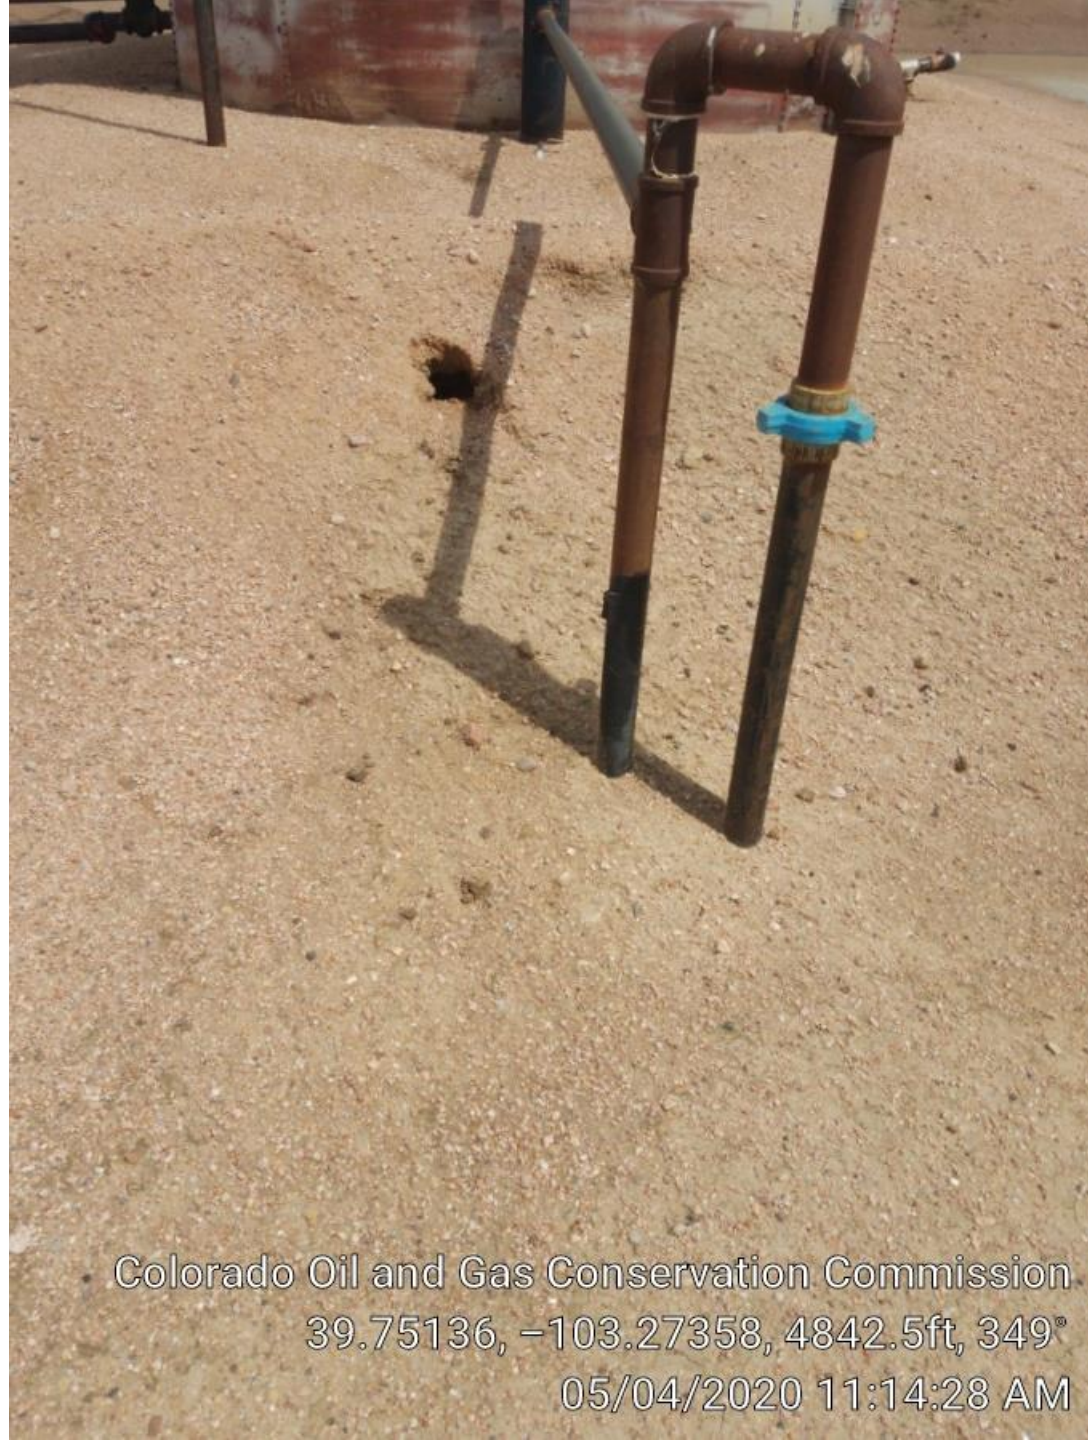
Animal hole in  
produced water  
tank  
berms/maintain.

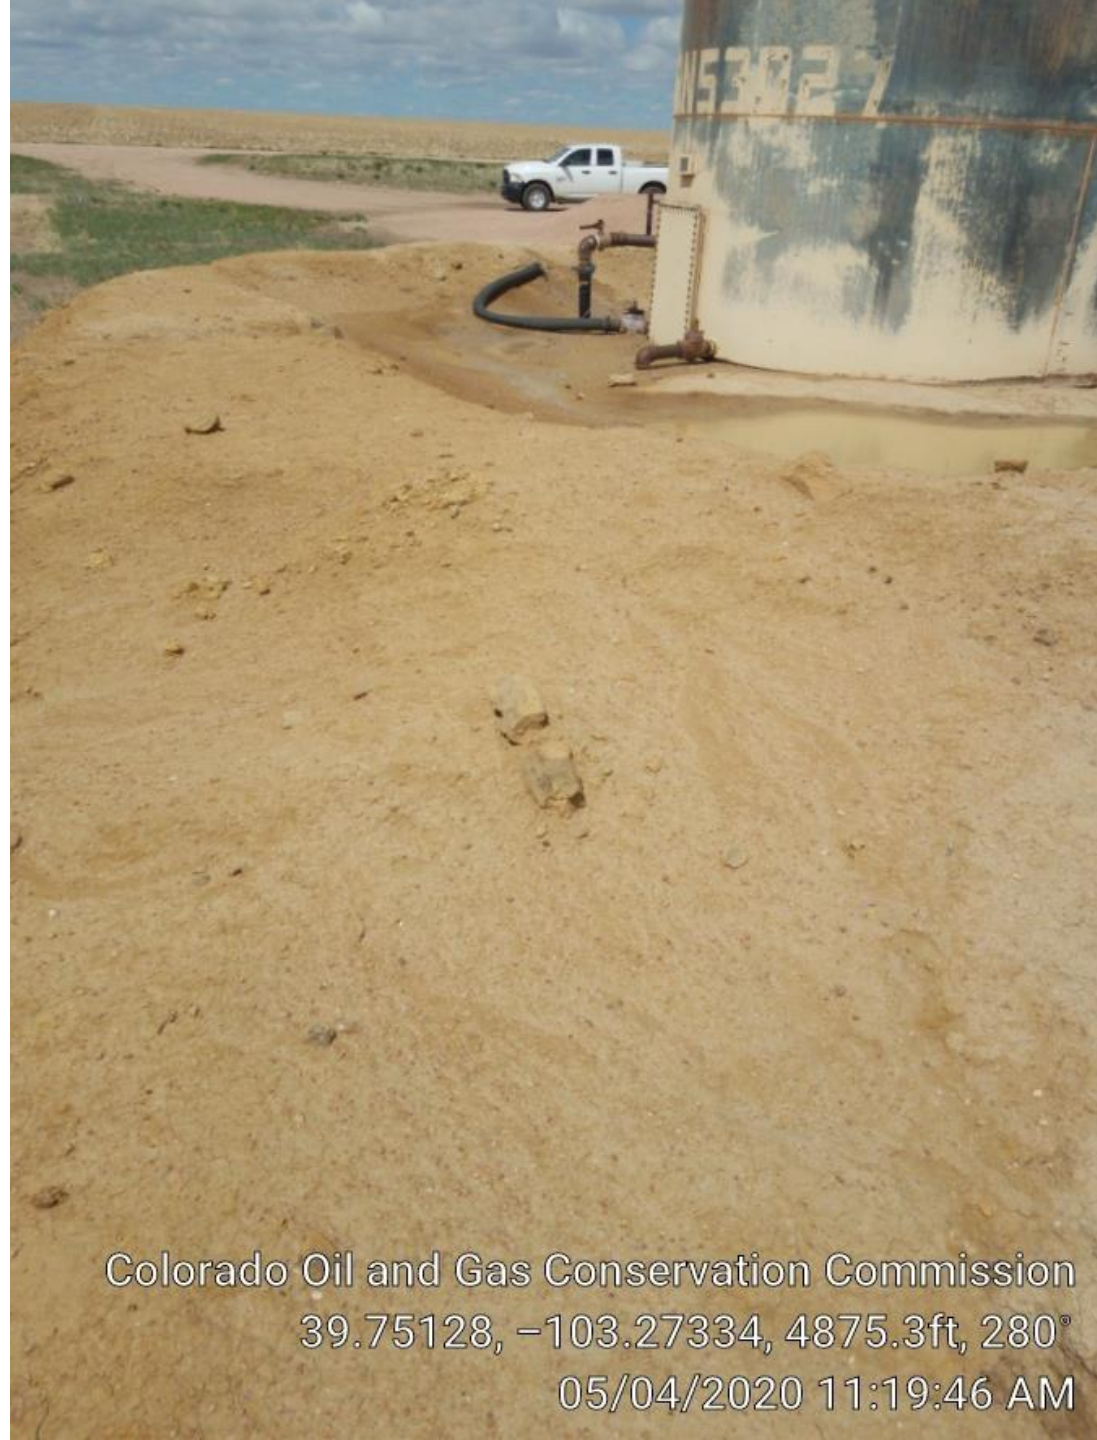
Low spot in  
produced  
water tank  
berms on  
south side.

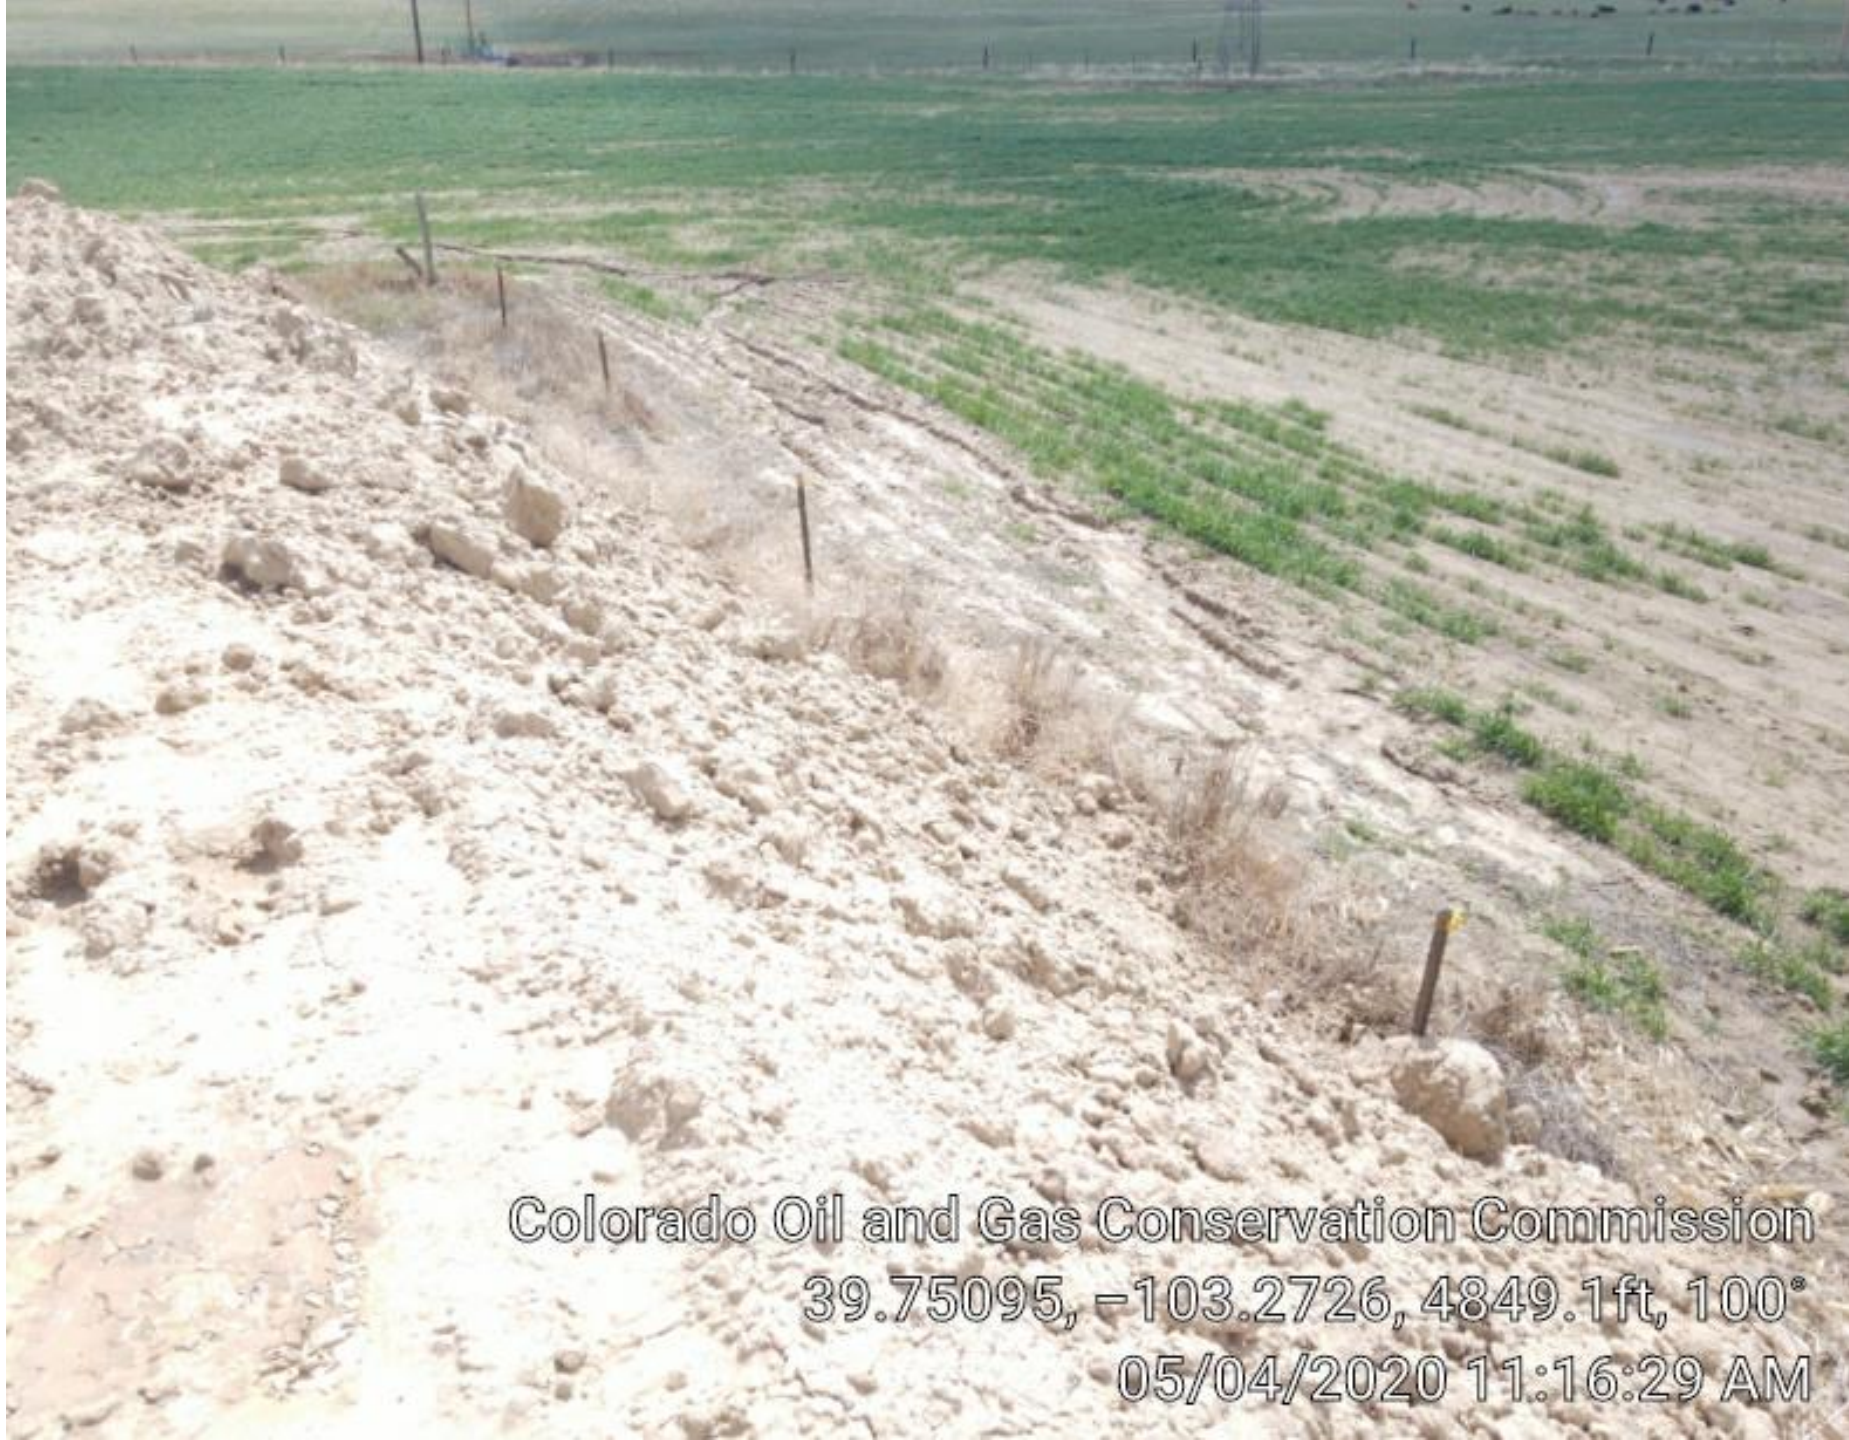
Area on south side of produced water pit berms where berm breached and spilled into field.

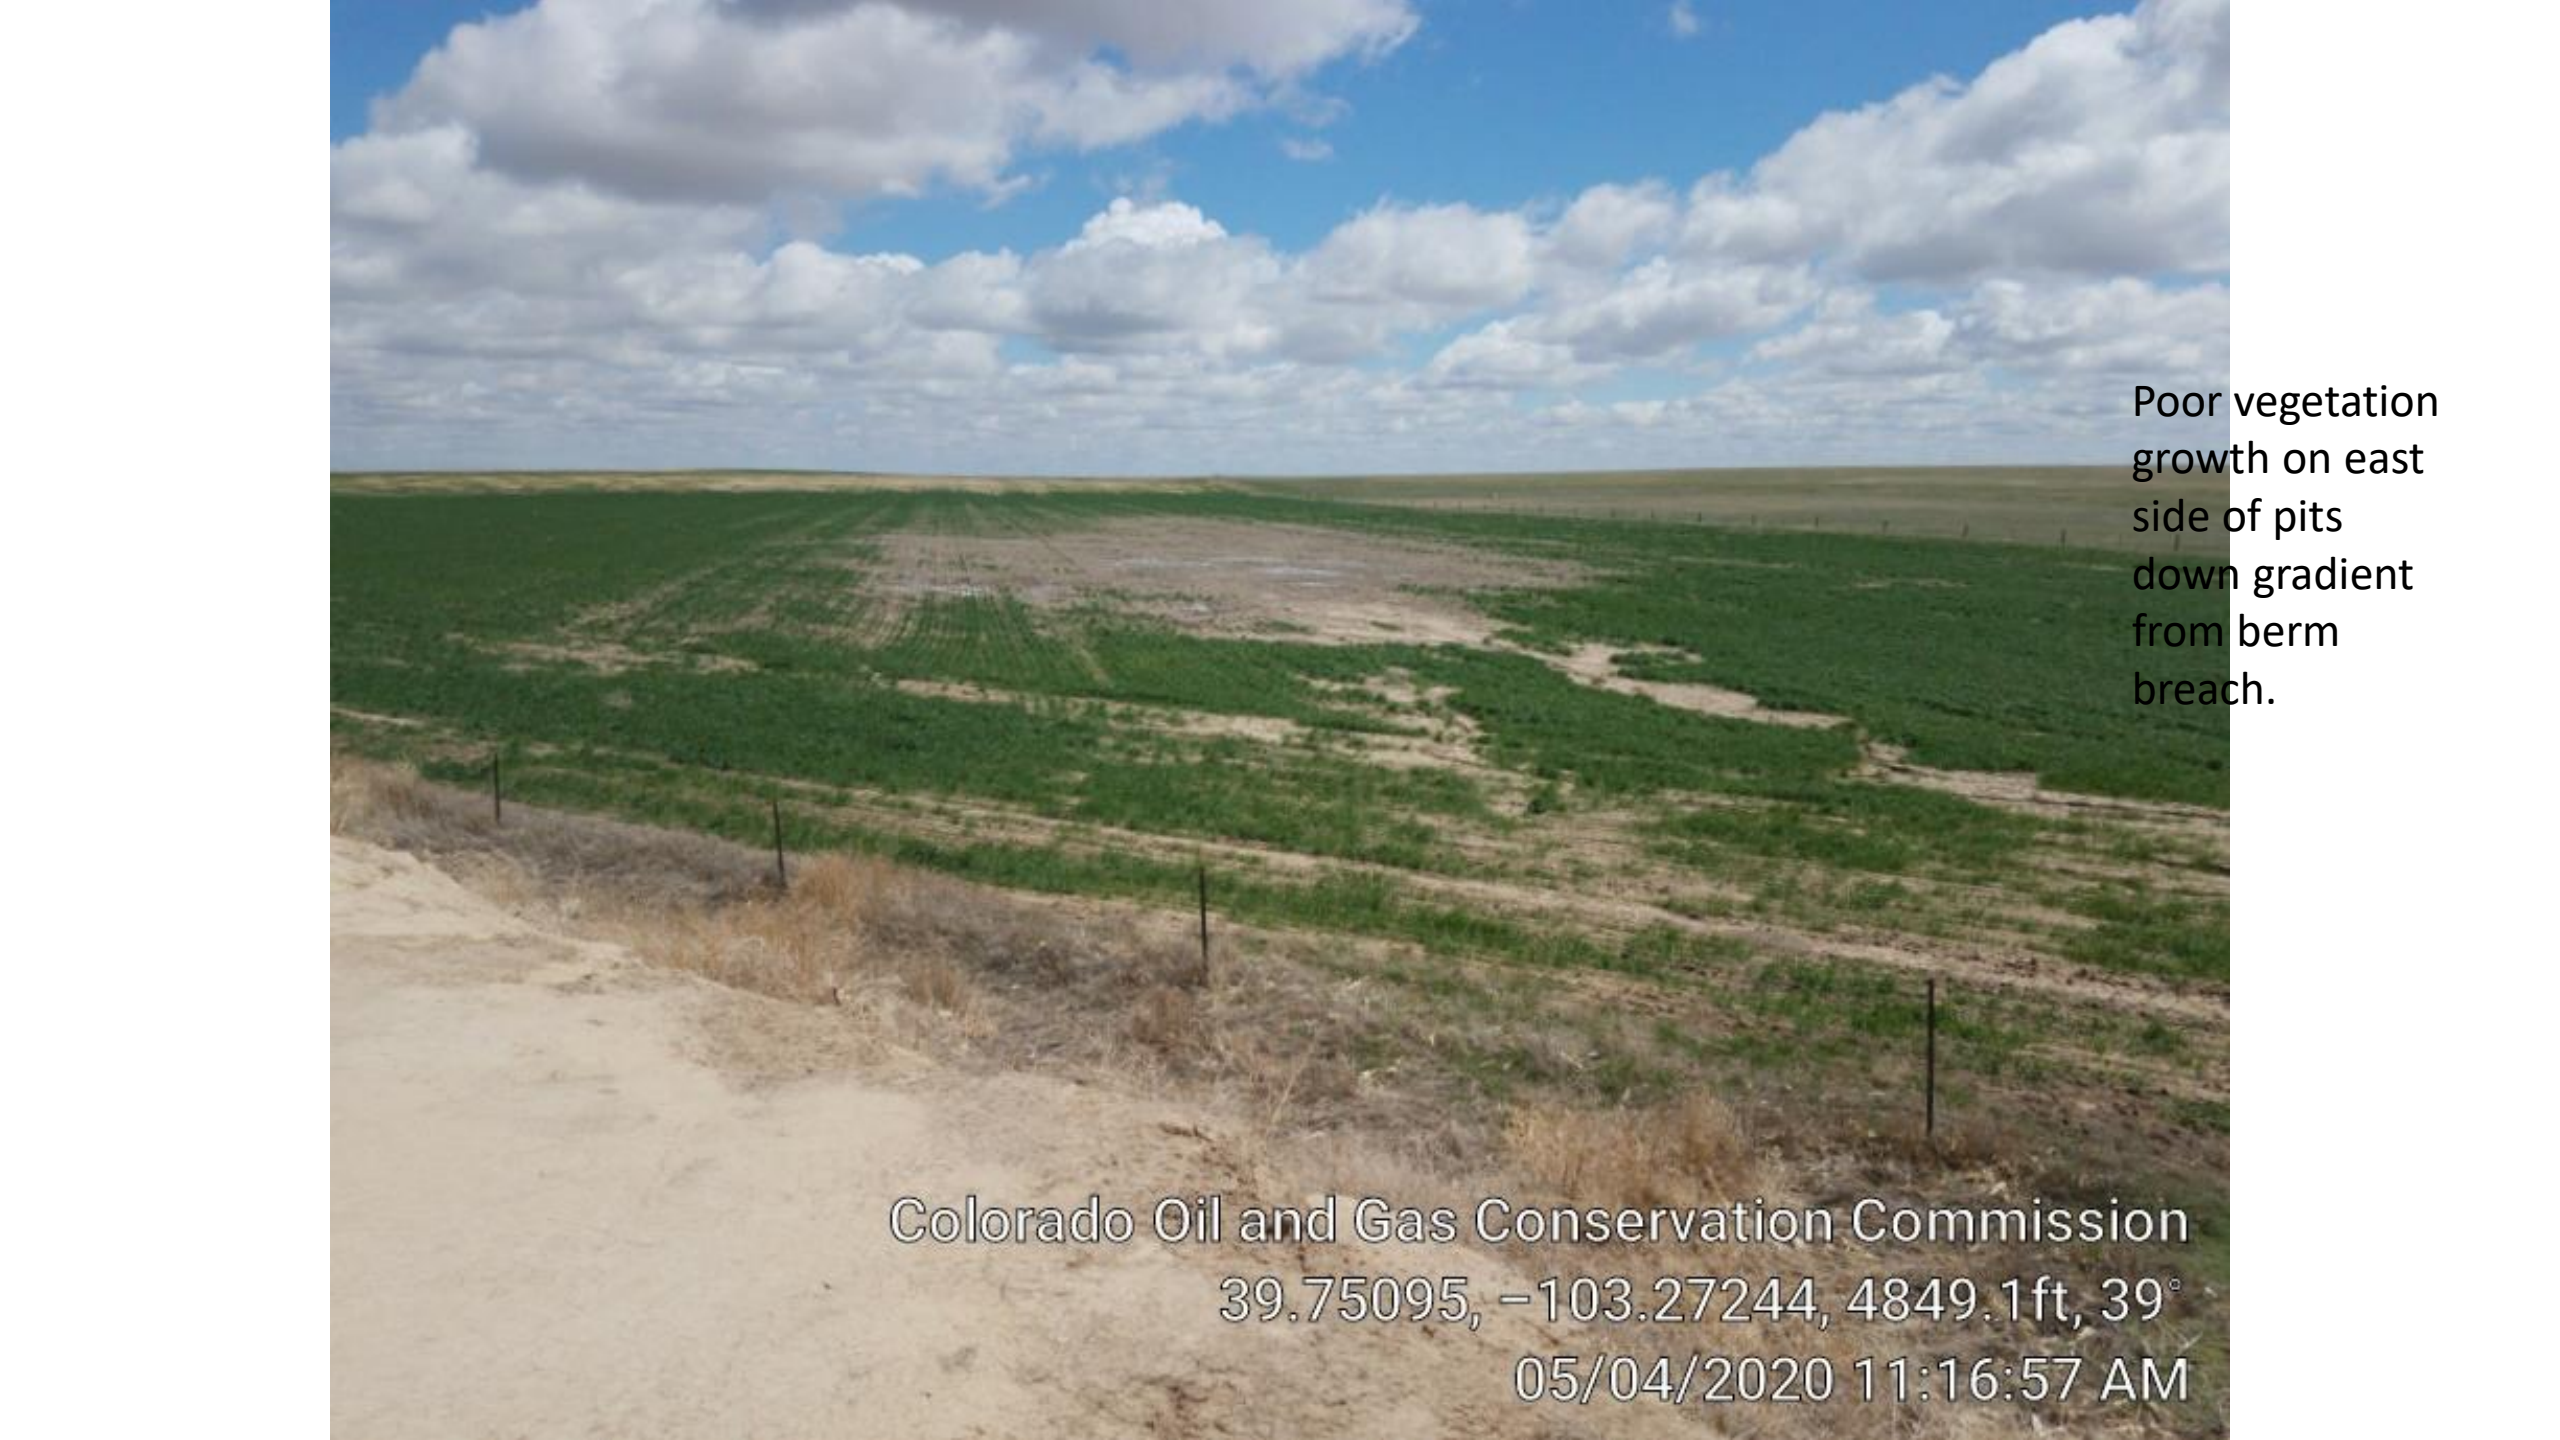
Poor vegetation  
growth on east  
side of pits  
down gradient  
from berm  
breach.
