Inspection Photos
Location Name: YOUNBERG 32-12
Location ID: 324061
Inspection Date: May 5, 2020

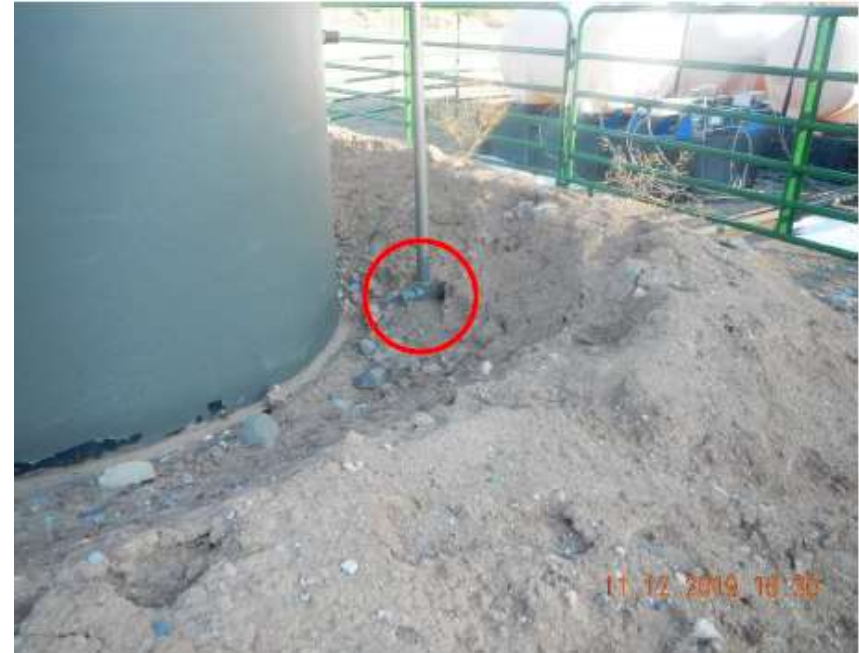
11/12/2019 2-inch flowline penetrating the earthen secondary containment

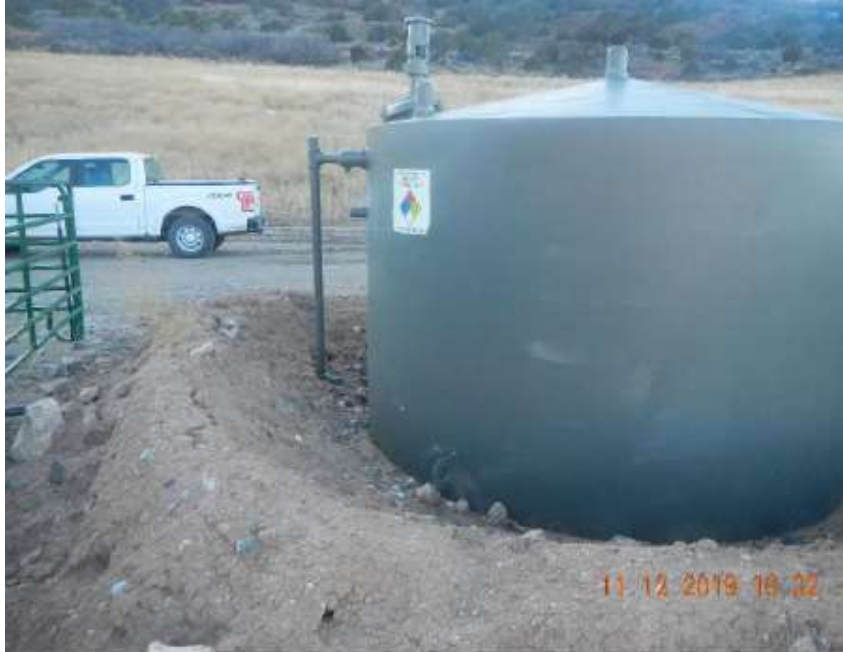
11/12/2019 80 bbl produced water steel AST with earthen secondary containment

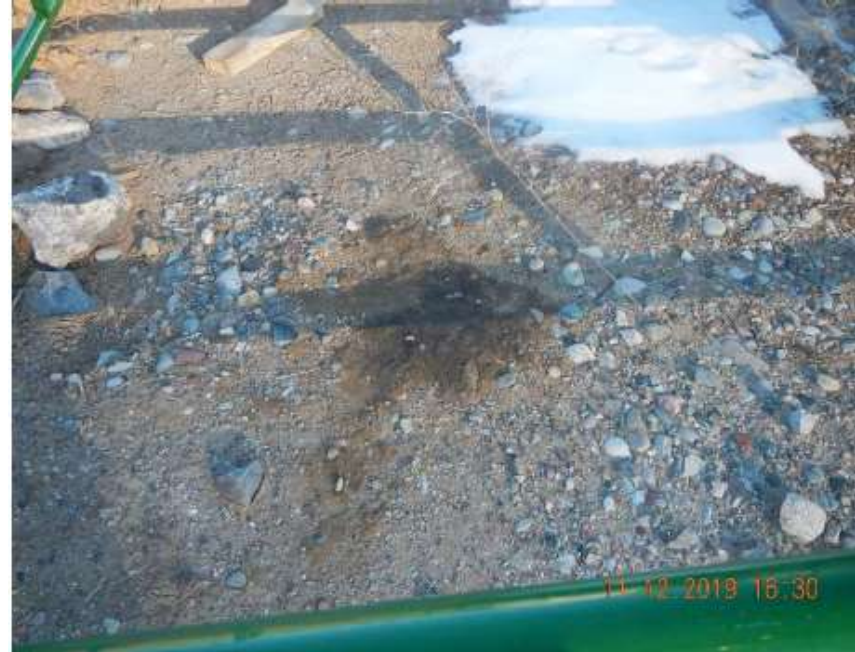
11/12/2019 Stained soil located south of the wellheads

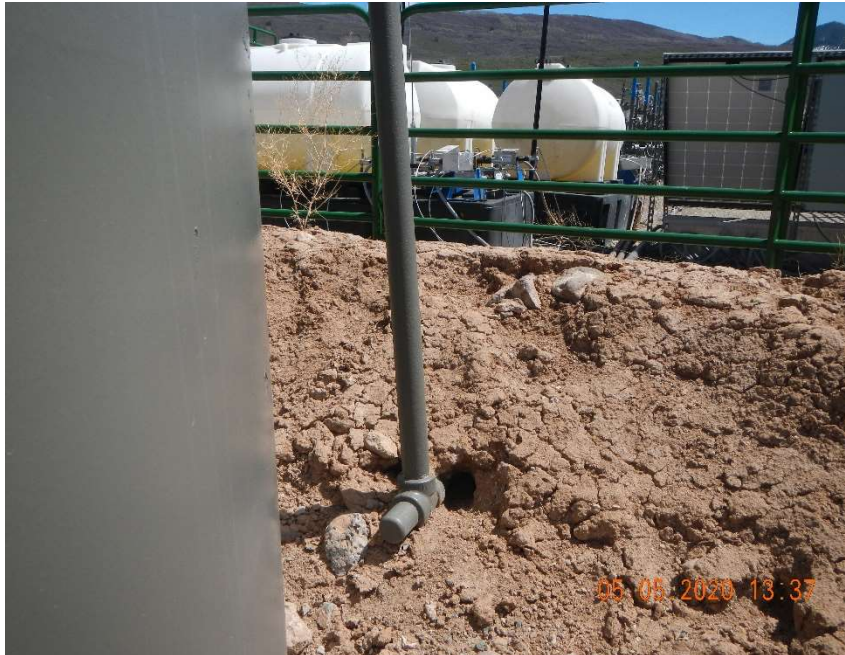
5/5/2020 2-inch flowline penetrating the earthen secondary containment

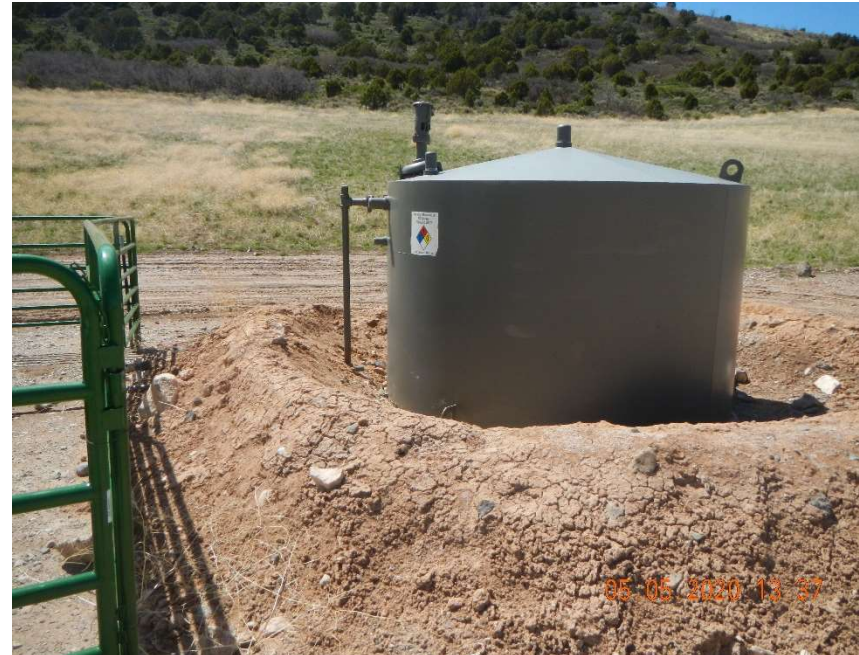
5/5/2020 80 bbl produced water steel AST with earthen secondary containment

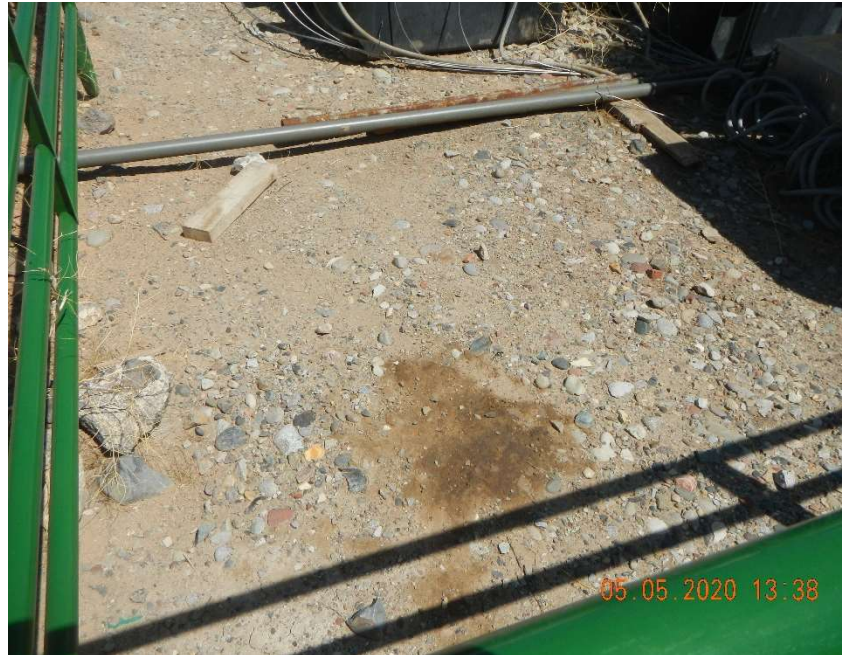
5/5/2020 Stained soil located south of the wellheads
