Inspection Photos  
Operator: BP America  
API#: 067-07842  
Date: 5/8/2020

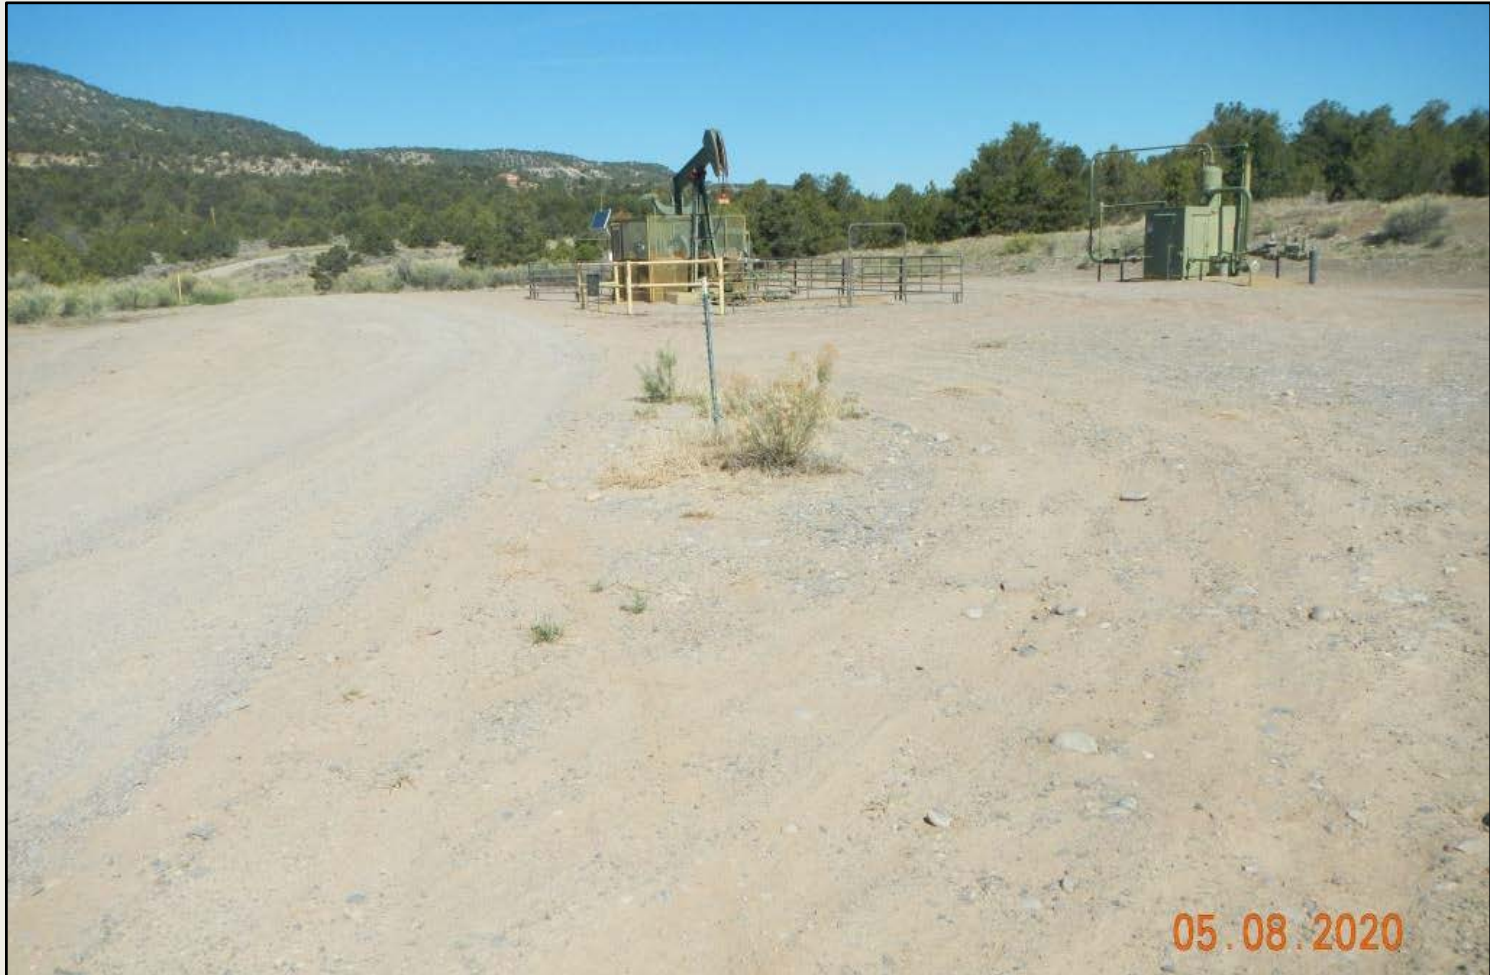
Photo 1. View of the northern well pad from the southeastern access facing center.

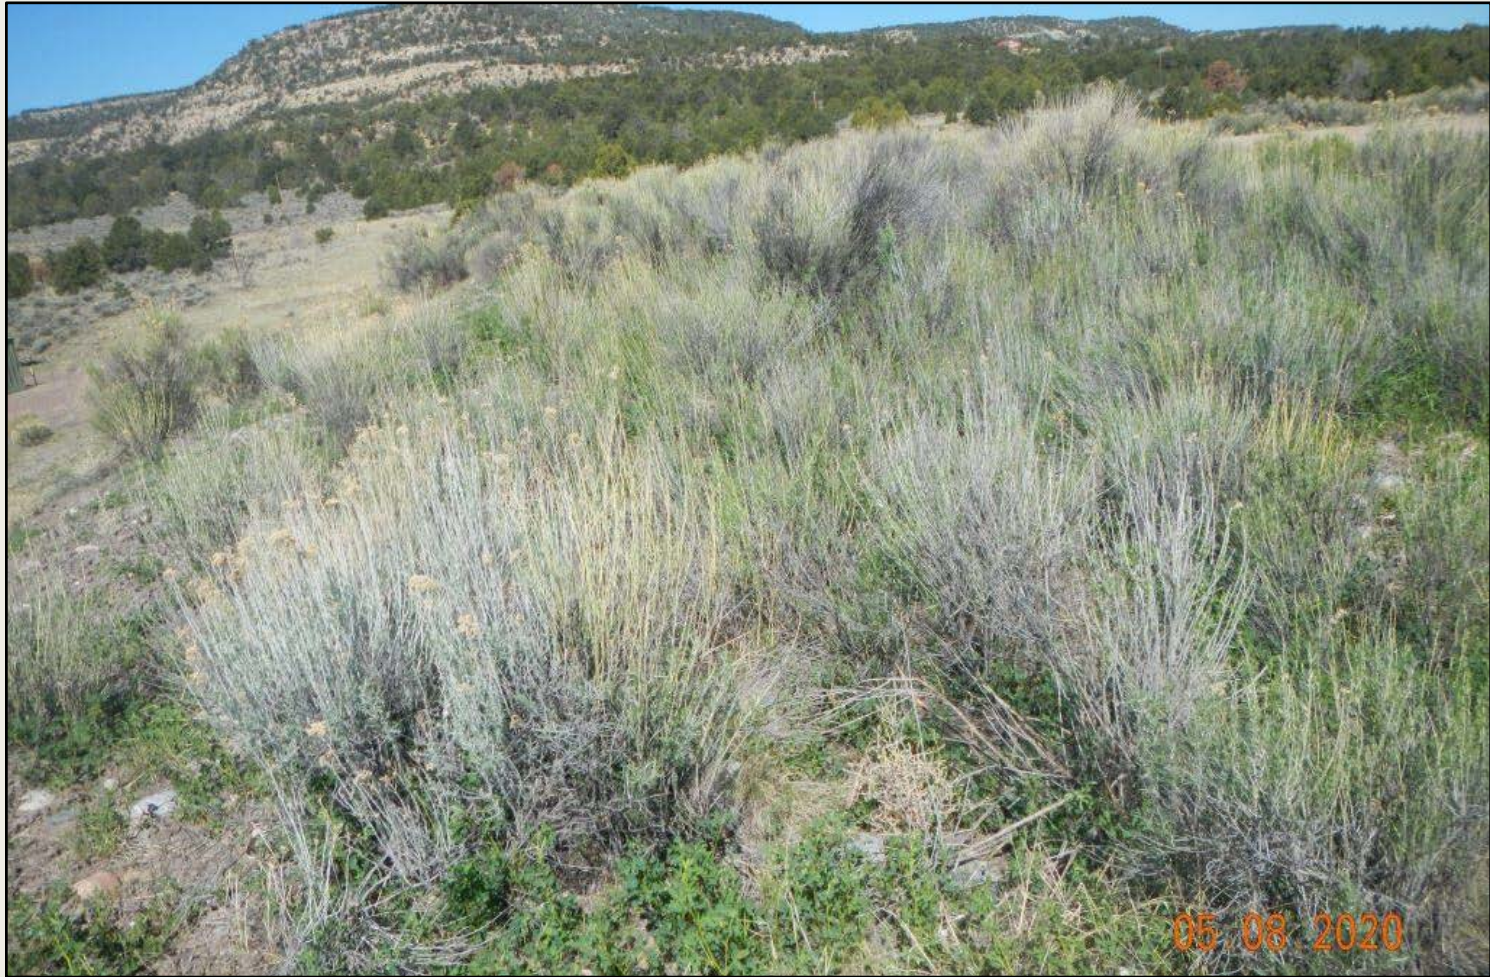
Photo 2. View of vegetation south of the northern well pad from the southeastern corner facing westward. Revegetation is progressing here, largely with rubber rabbitbrush, Indian ricegrass, and purple threeawn.

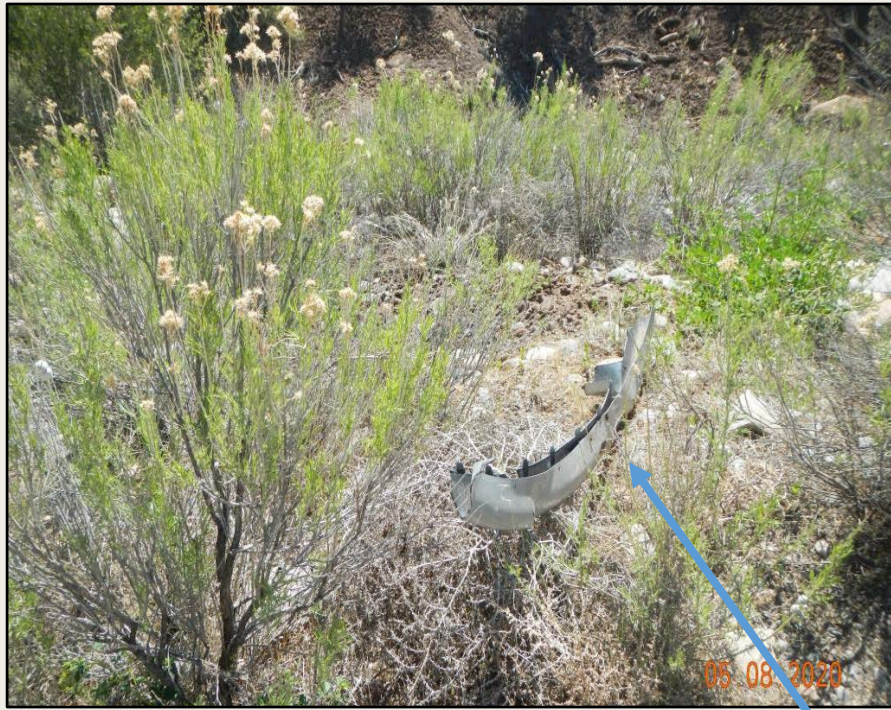
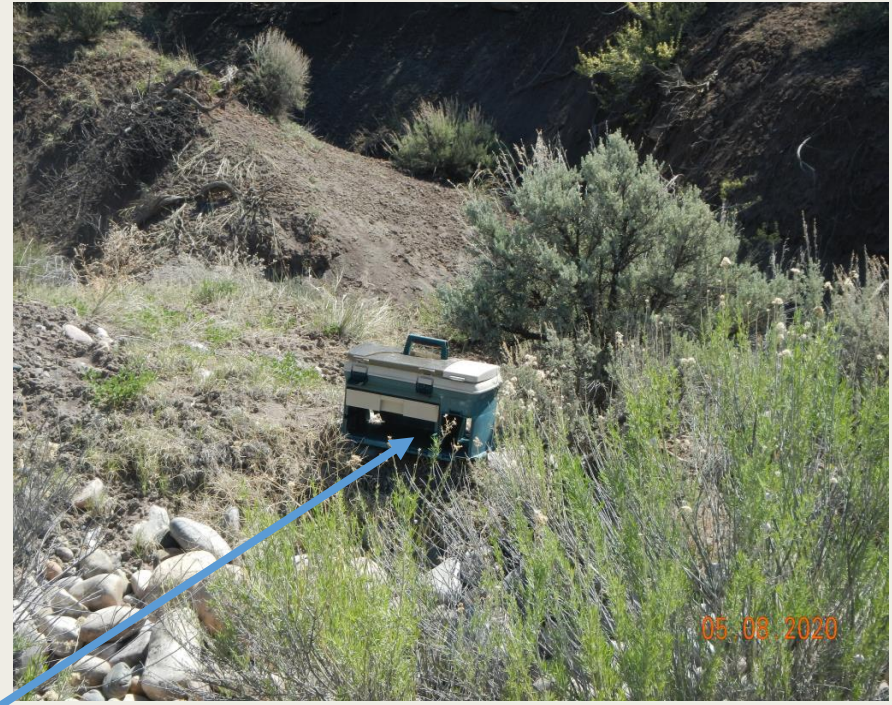
**Waste and debris in the northern project area.**

Photos 3/4. View of examples of waste and debris observed within the northern project area.

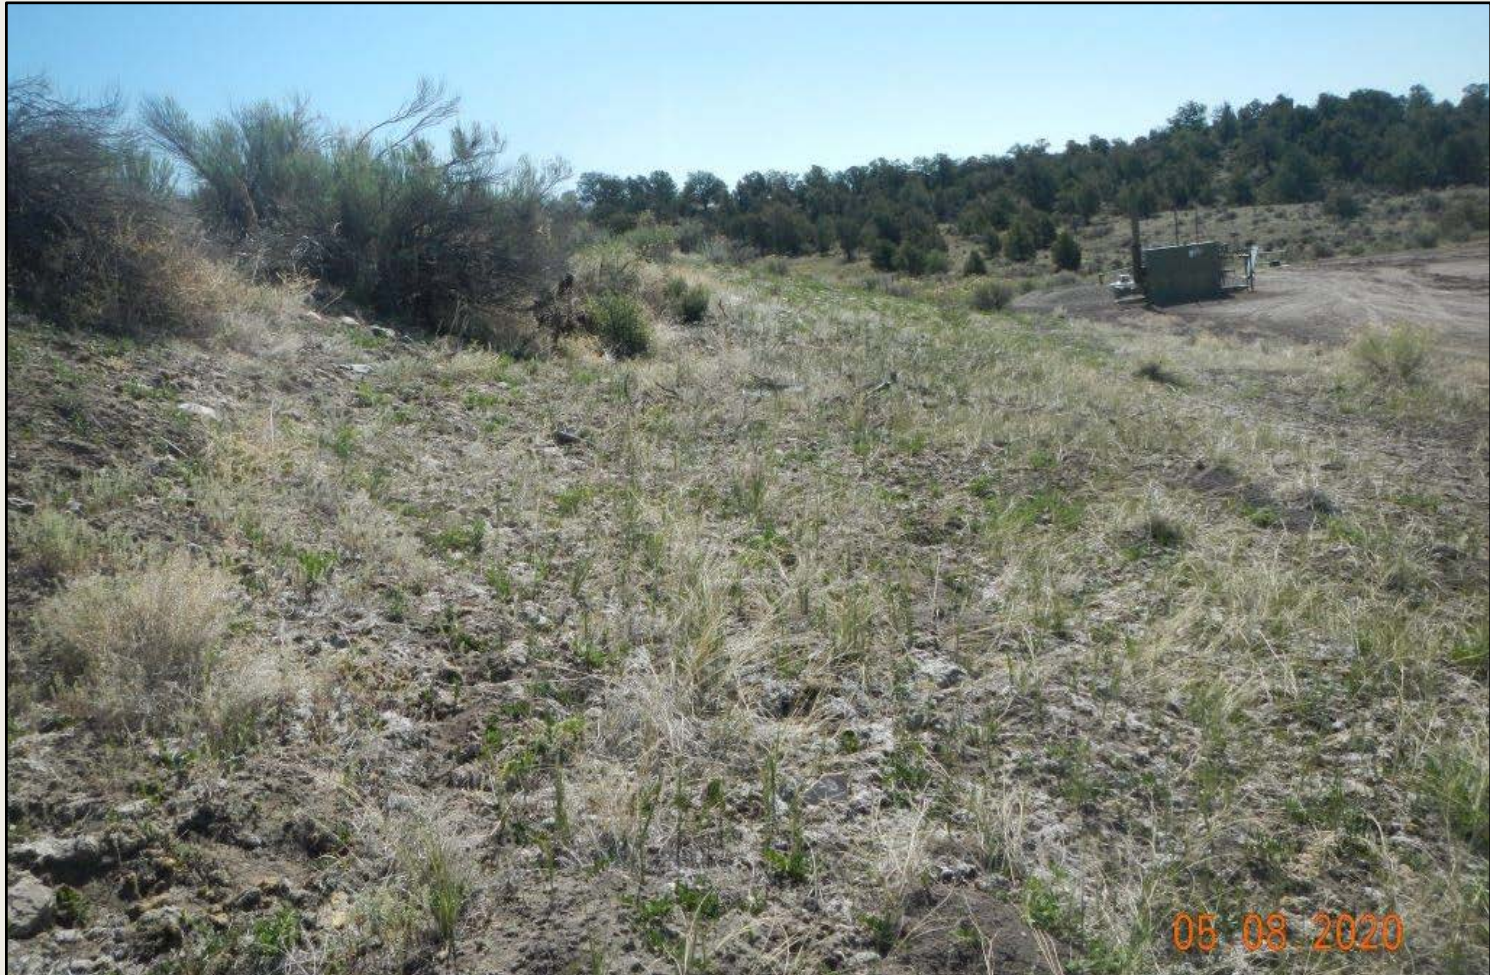
Photo 5. View of the central fill slope between two well pads from the southwestern corner facing eastward. Fill slope was seeded in 2018, some grasses such as smooth brome becoming established here. Hydromulch still visible. Poor germination observed on portions of the slope.

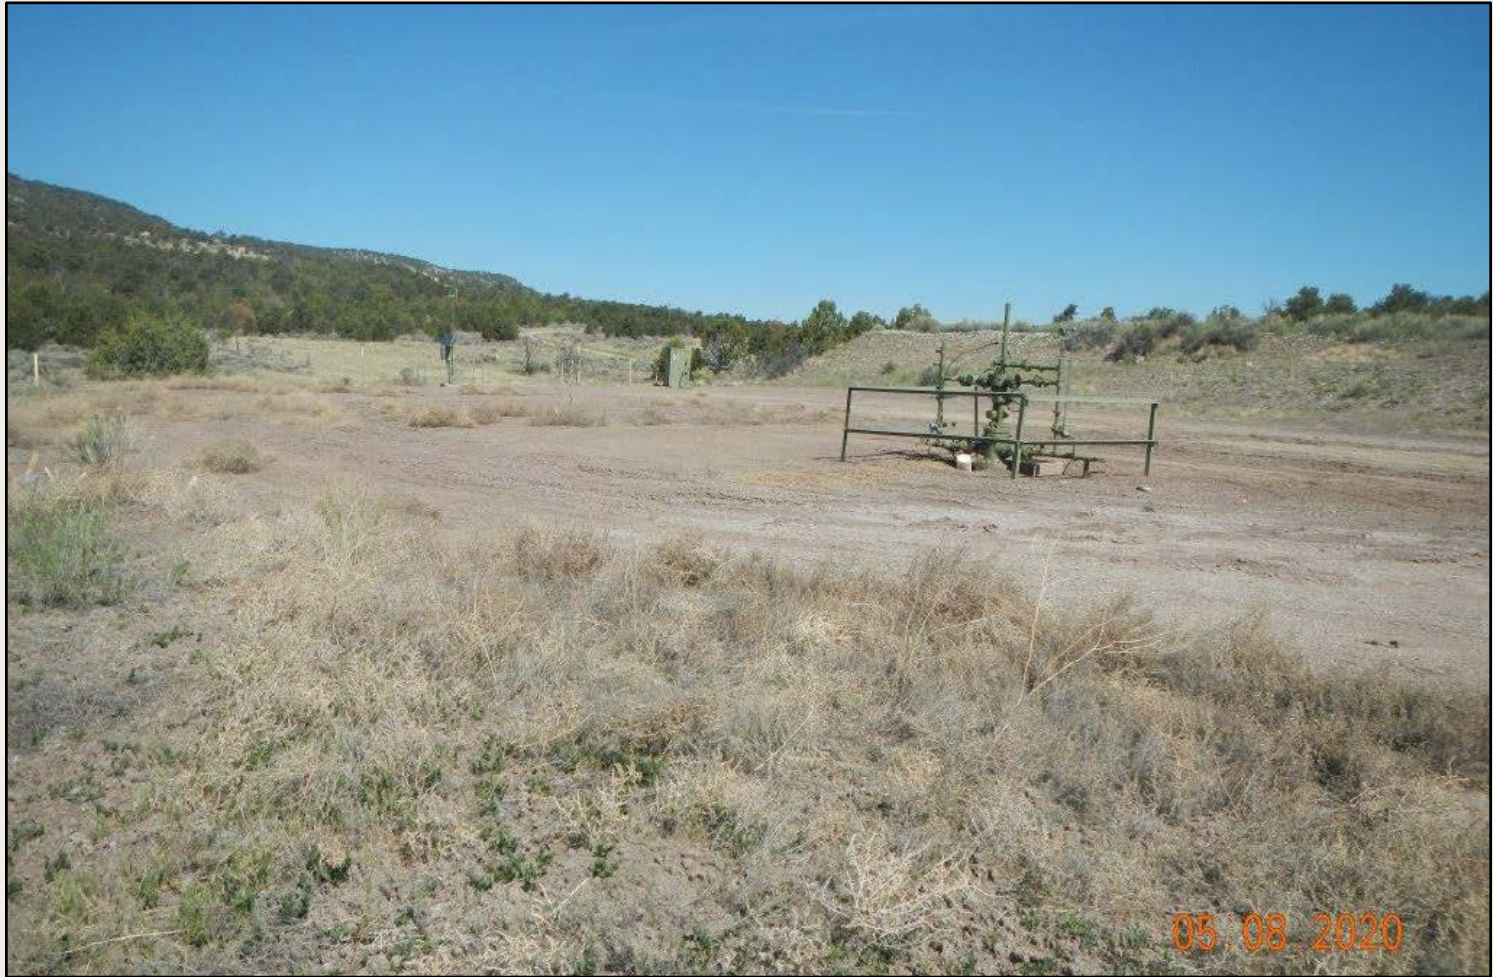
Photo 6. View of the southern well pad from the southeastern corner facing center.

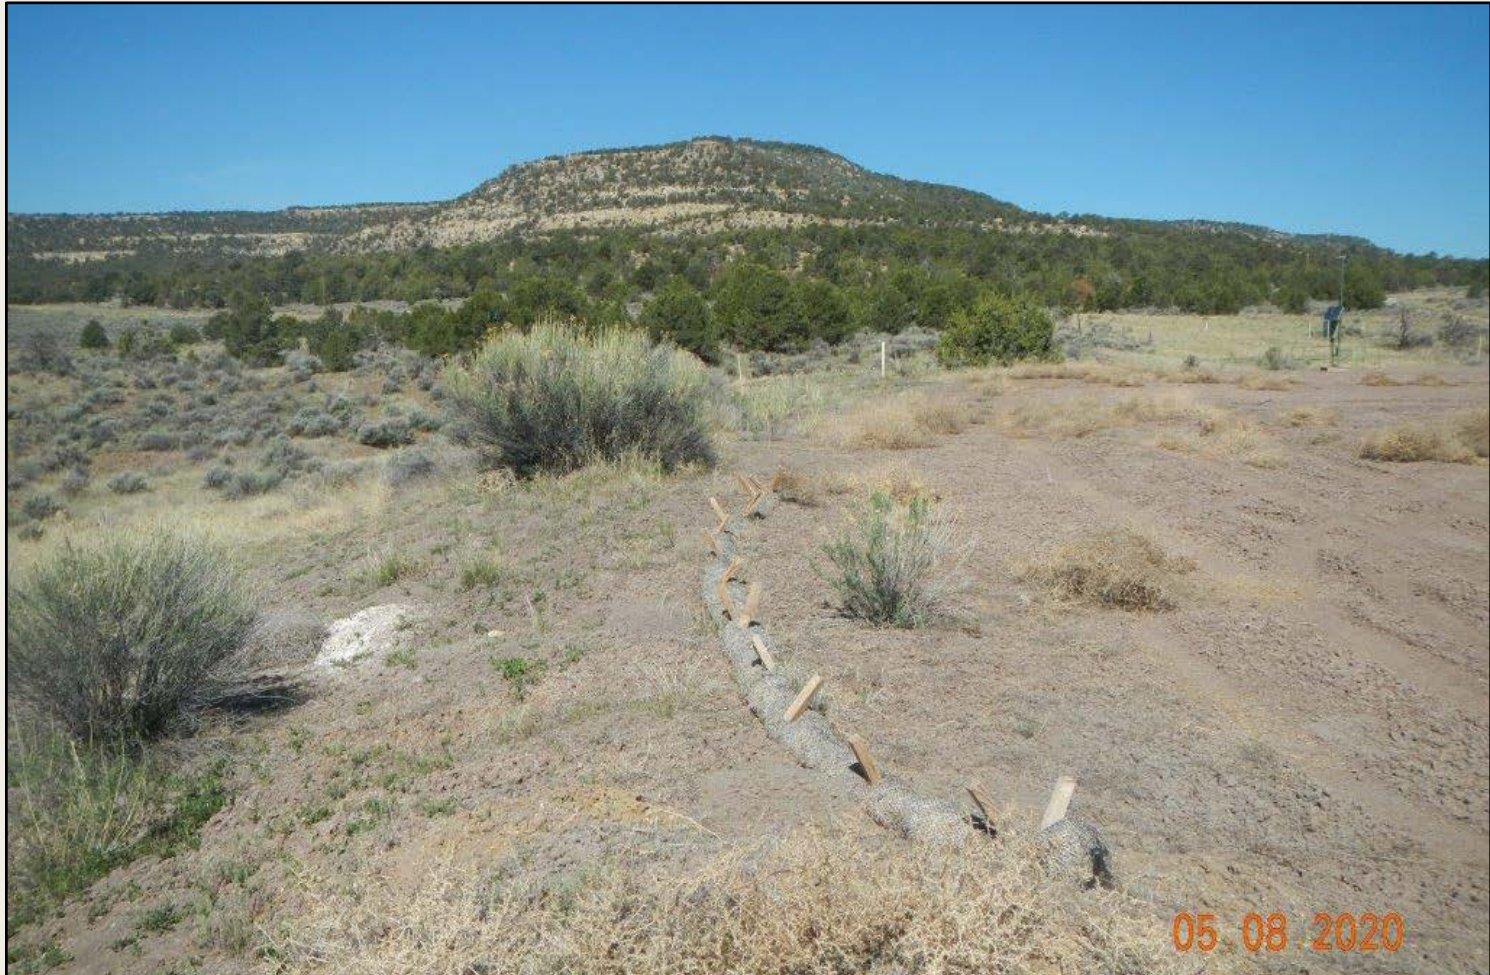
Photo 7. View of the southern fill slope facing westward. Wattle is full of sediment and needs maintenance.

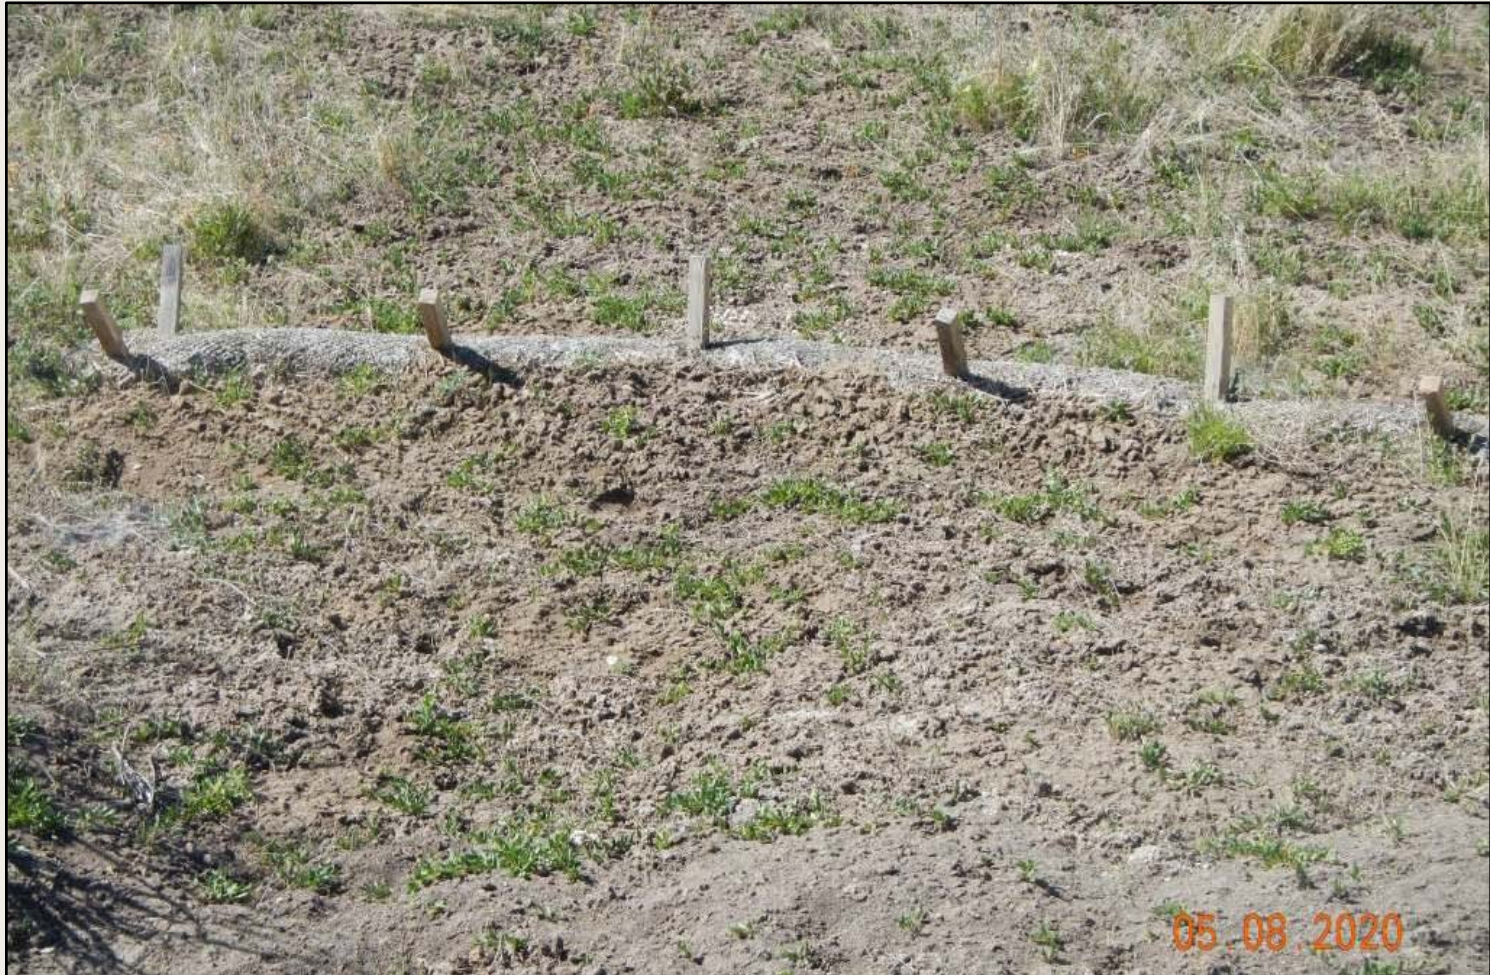
Photo 8. View of another wattle in the southern fill slope that is full of sediment.

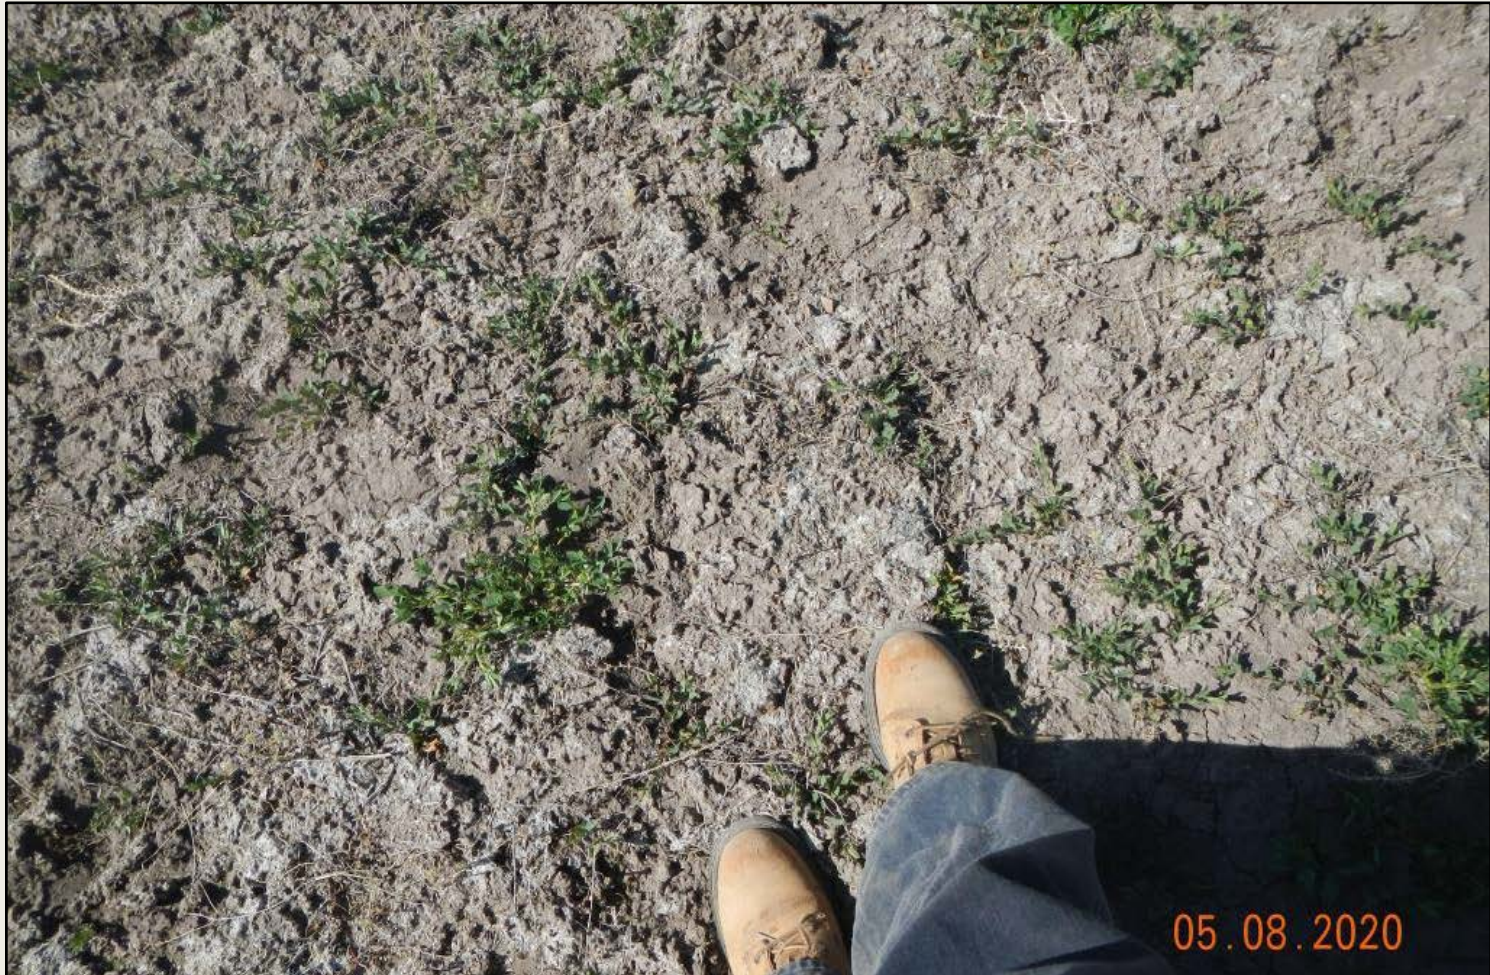
Photo 9. Birdseye view of revegetation within the southern project area. Broadleaf weeds are field bindweed. Young grasses are becoming established, although significant bare areas remain. Hydromulch remains in place.

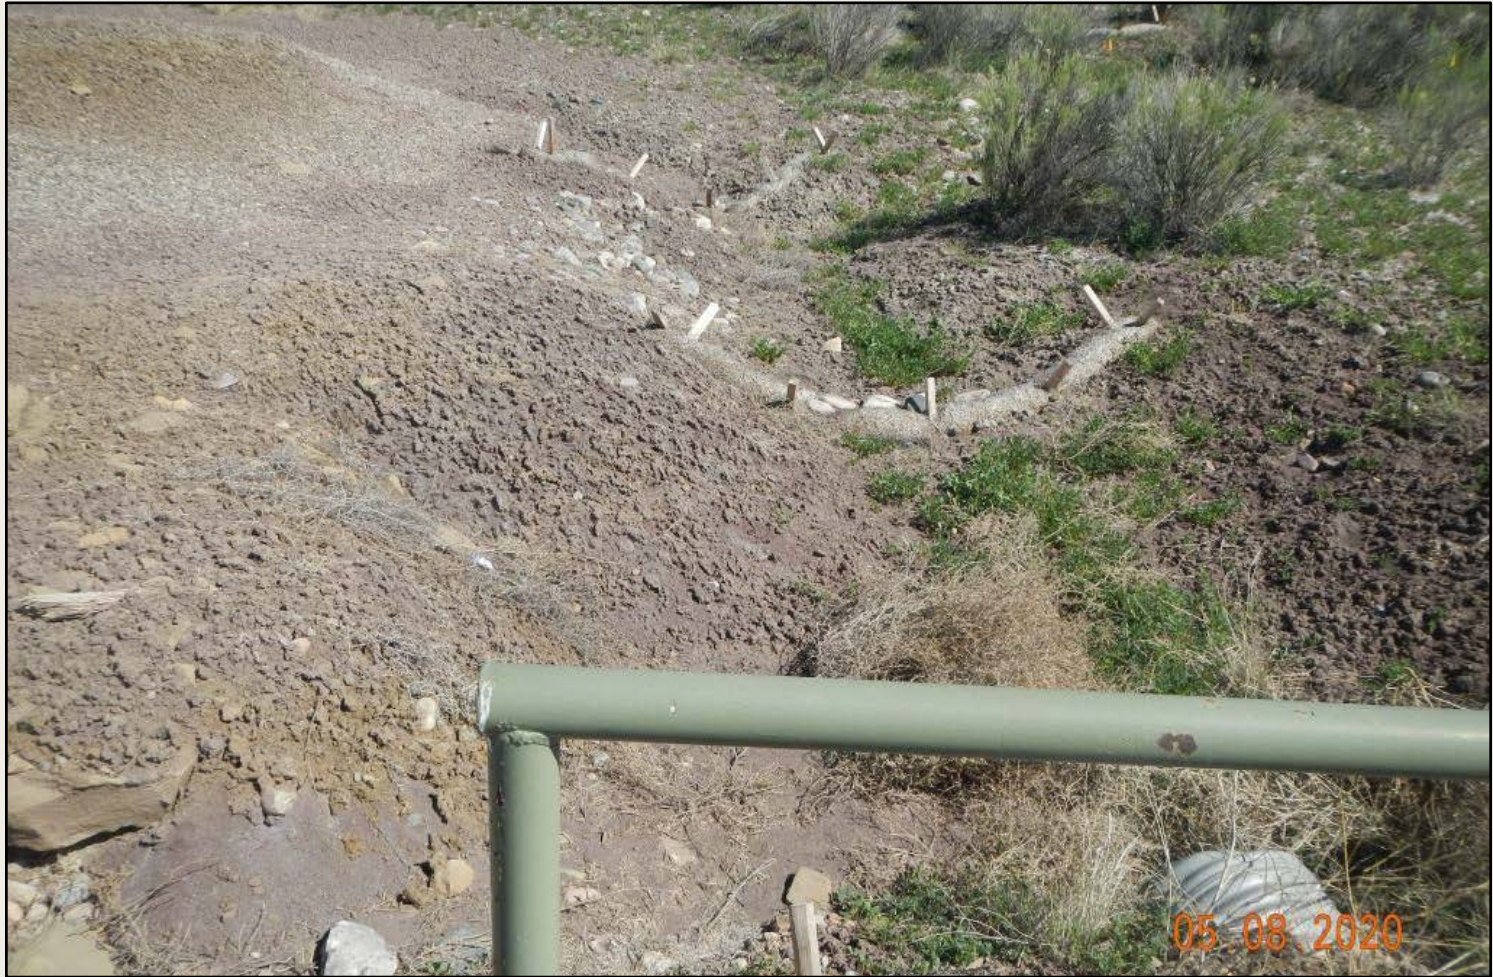
Photo 10. View of culvert inlet at the entrance to the southern well pad. Bare soils are not stabilized, wattles and cobble are full of sediment.

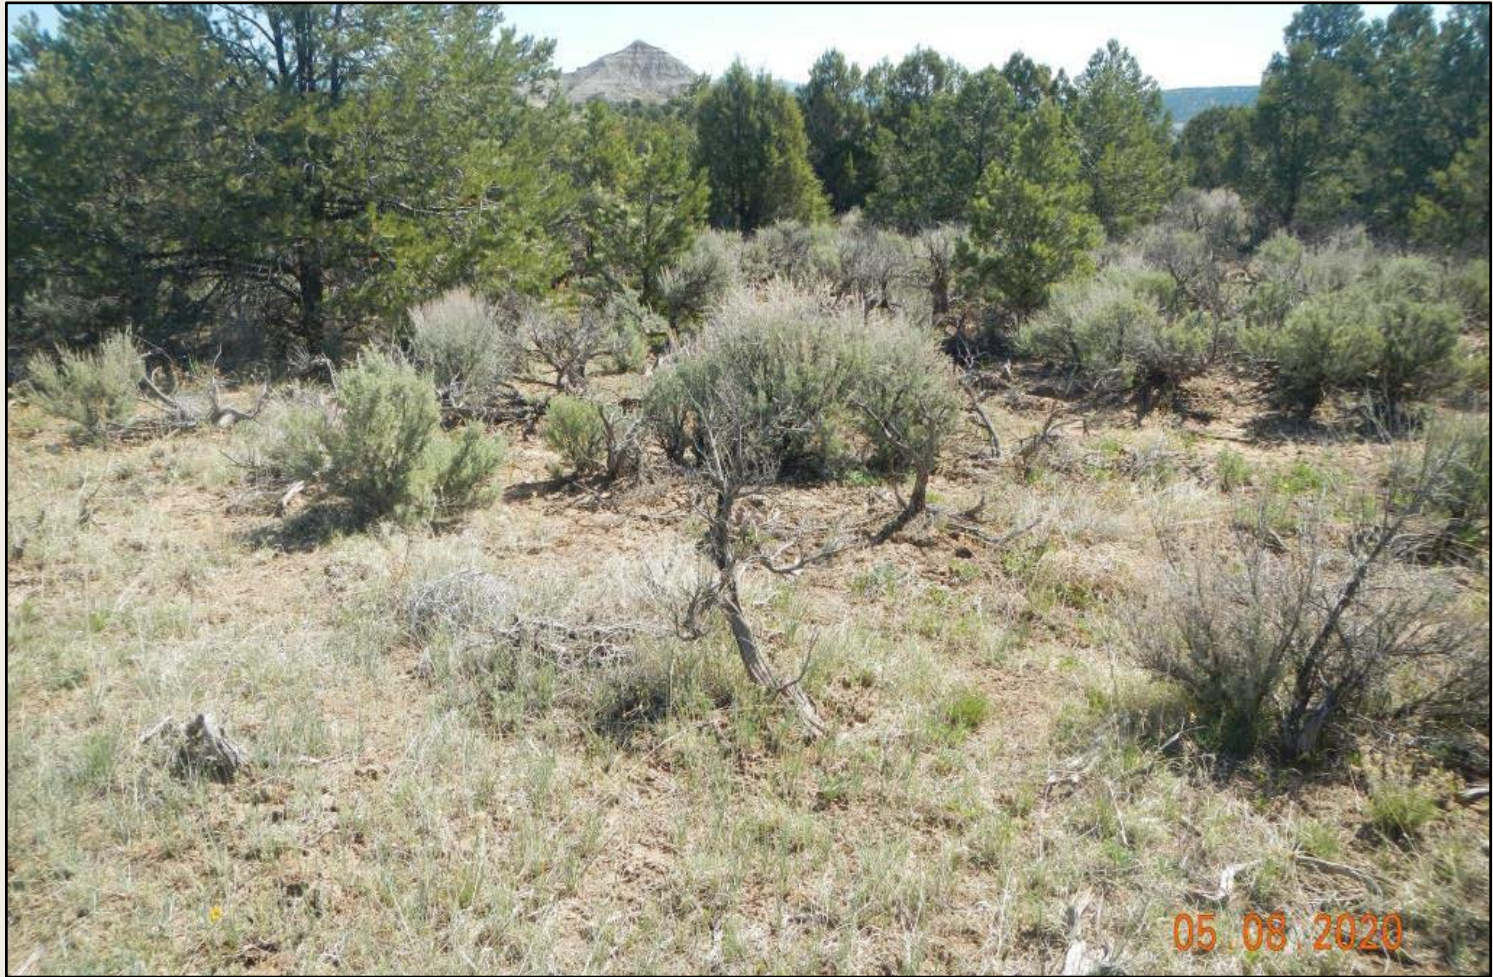
Photo 11. View of reference area comprised of mixed pinyon and juniper woodland, with sagebrush and mixed herbaceous understory (ie: blue grama, Navajo tea)
