Inspection Photos
Operator: Enervest Operating
API#: 067-06026
Date: 5/8/2020

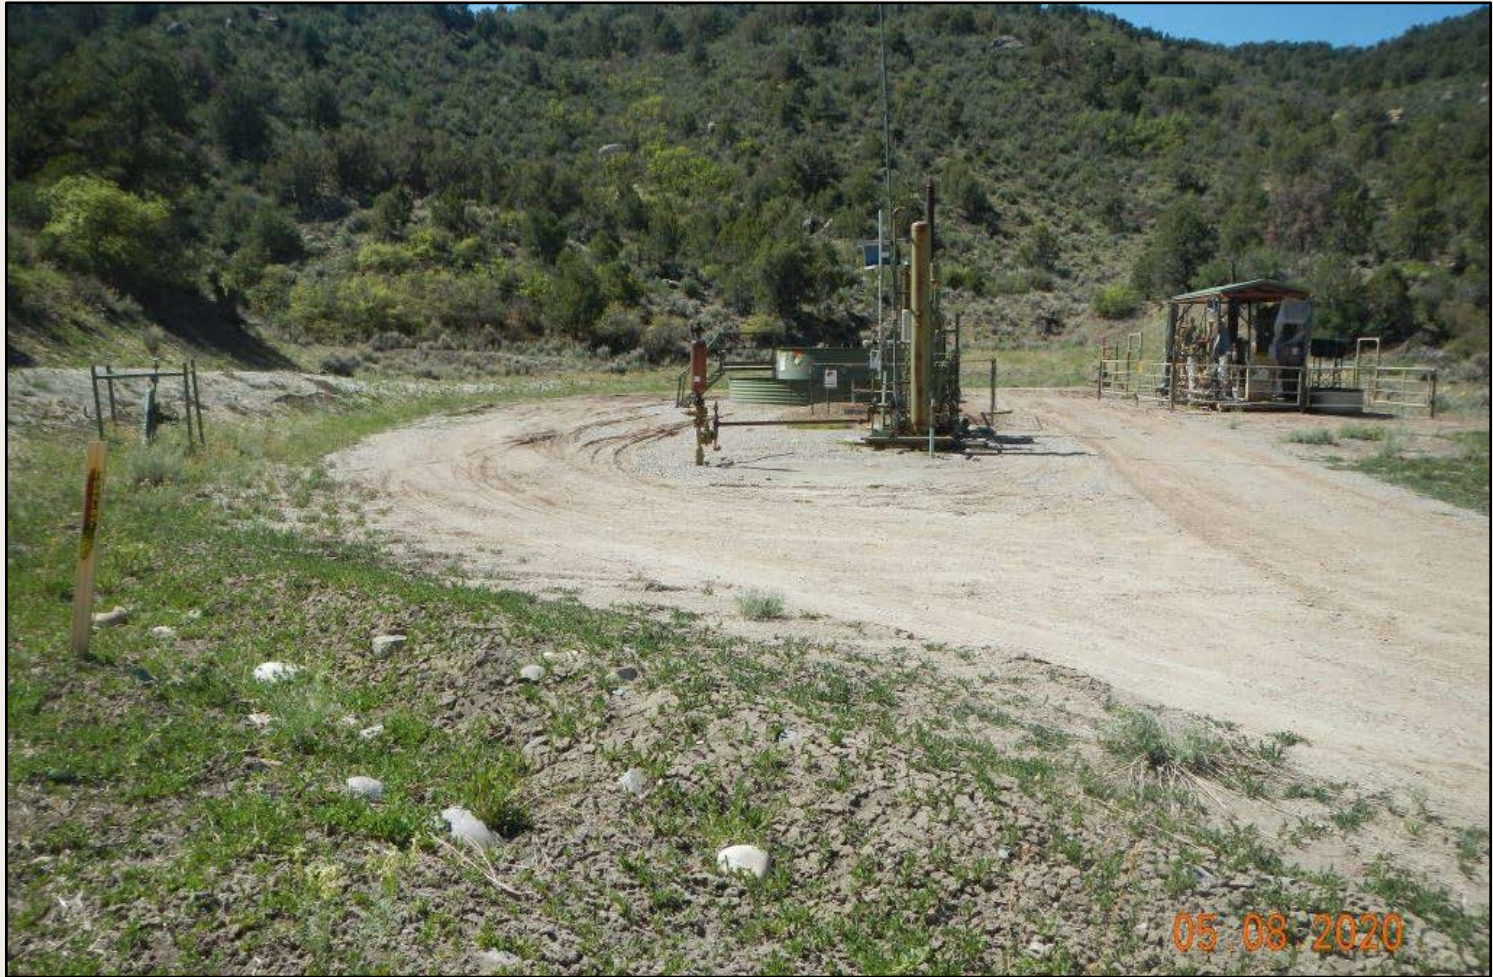
Photo 1. View of the project area from the northern edge facing center.

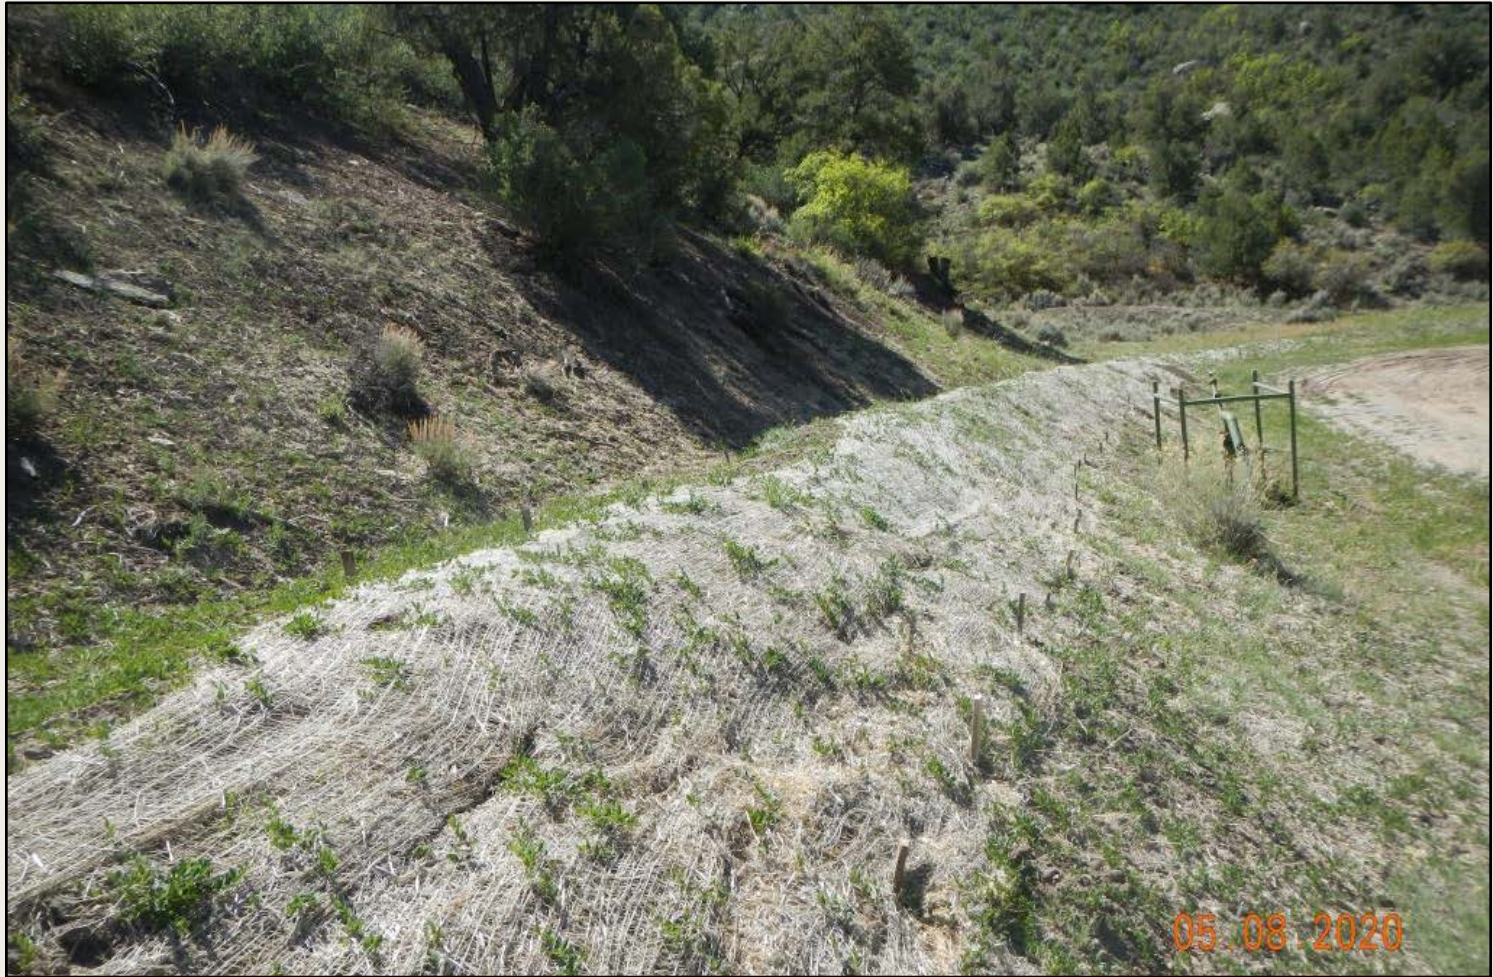
Photo 2. View of the eastern project area from the northeastern corner facing southward. Erosion control blanket appears to be functioning. Cut-slopes are seeded/straw-mulched in response to 2018 reclamation inspection.

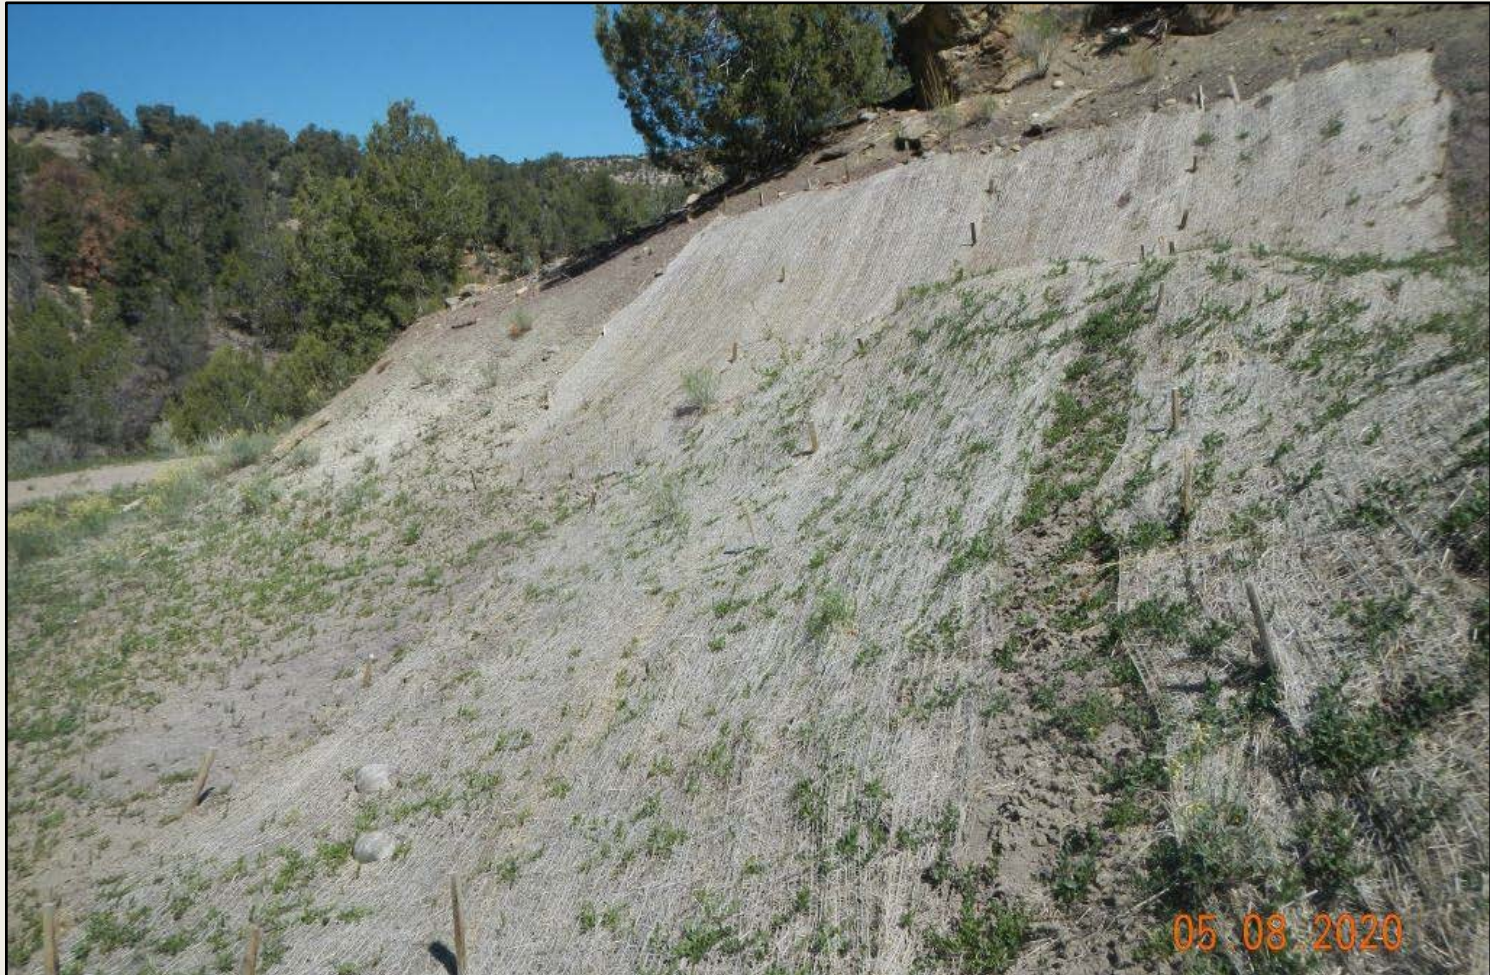
Photo 3. View of erosion control blanket placed on northeastern cut-slope.

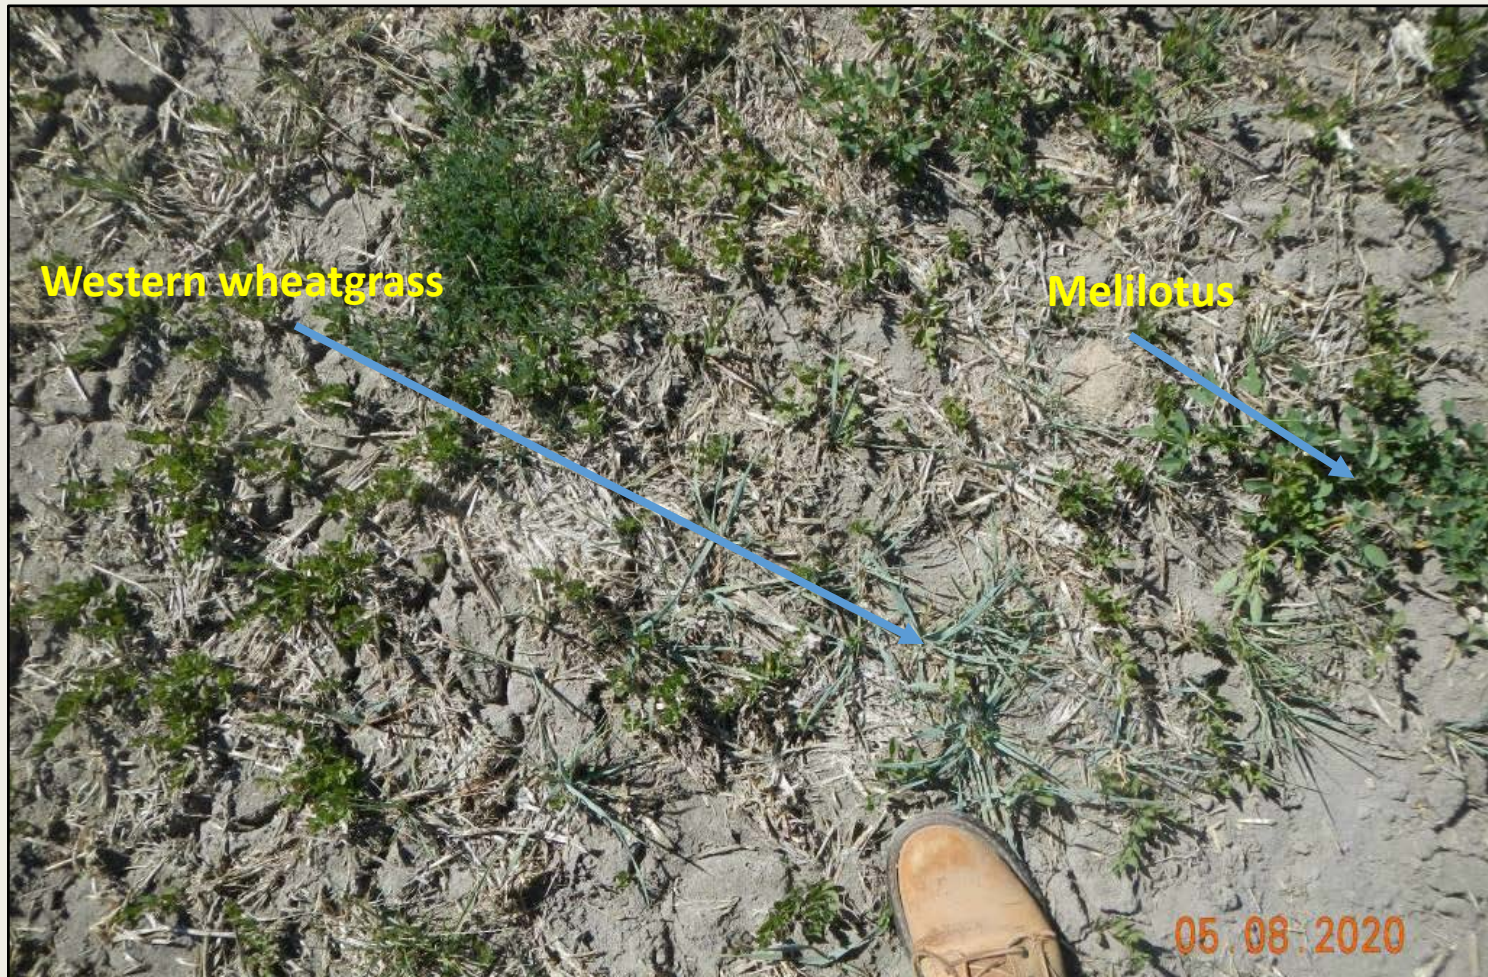
Photo 4. Birdseye view of vegetation growing within the 2018 reclaimed areas. Desirable western wheatgrass observed, as well as weedier species such as field bindweed and melilotus.

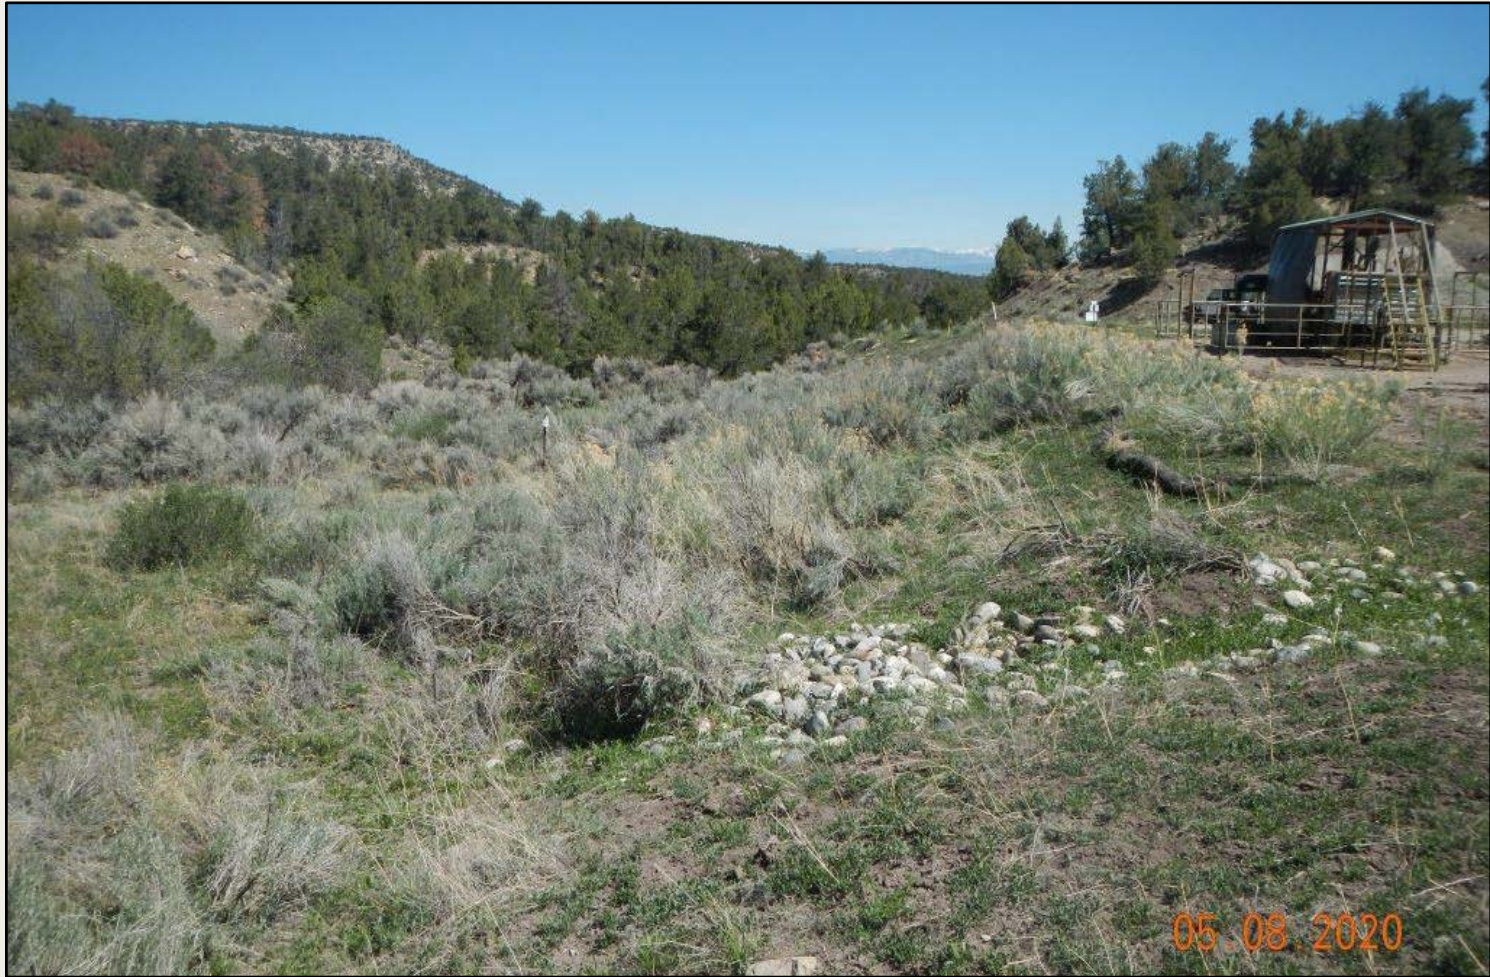
Photo 5. View of the western fill slope. Revegetation is progressing here, largely with rubber rabbitbrush, Indian ricegrass, and mixed wheatgrasses.

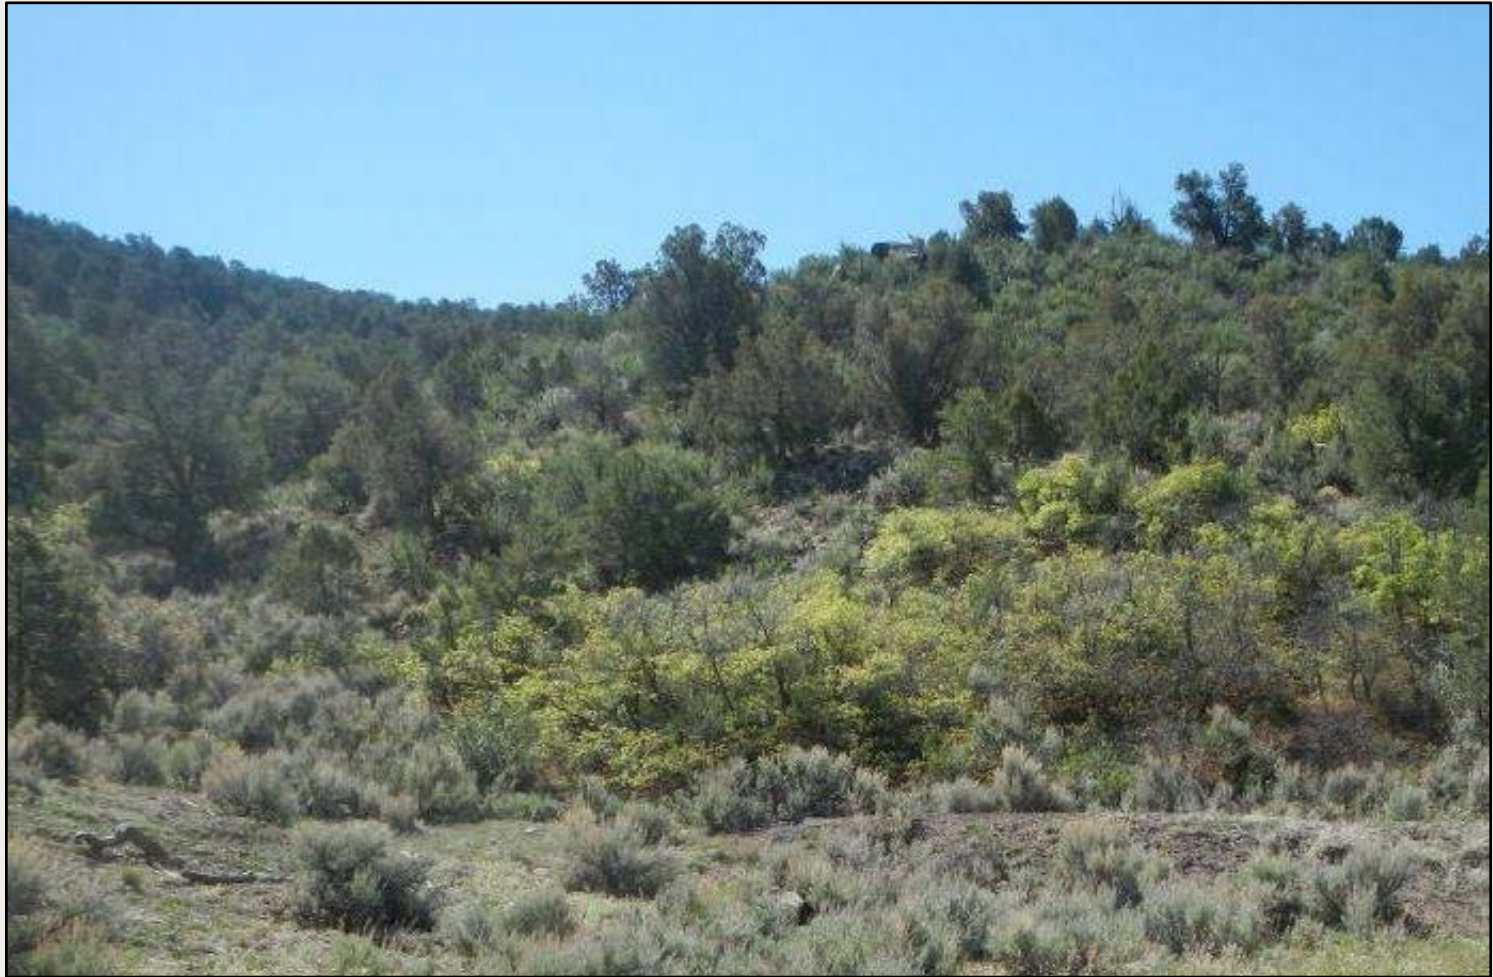
Photo 6. View of reference area comprised of mixed pinyon and juniper woodland, with gambel oak, mountain mahogany, sagebrush, and mixed herbaceous understory (ie: Arizona fescue, firecracker penstemon)
