Inspection Photos

Operator: LARAMIE ENERGY LLC # 10433

Location ID: 424970

Garfield County, CO

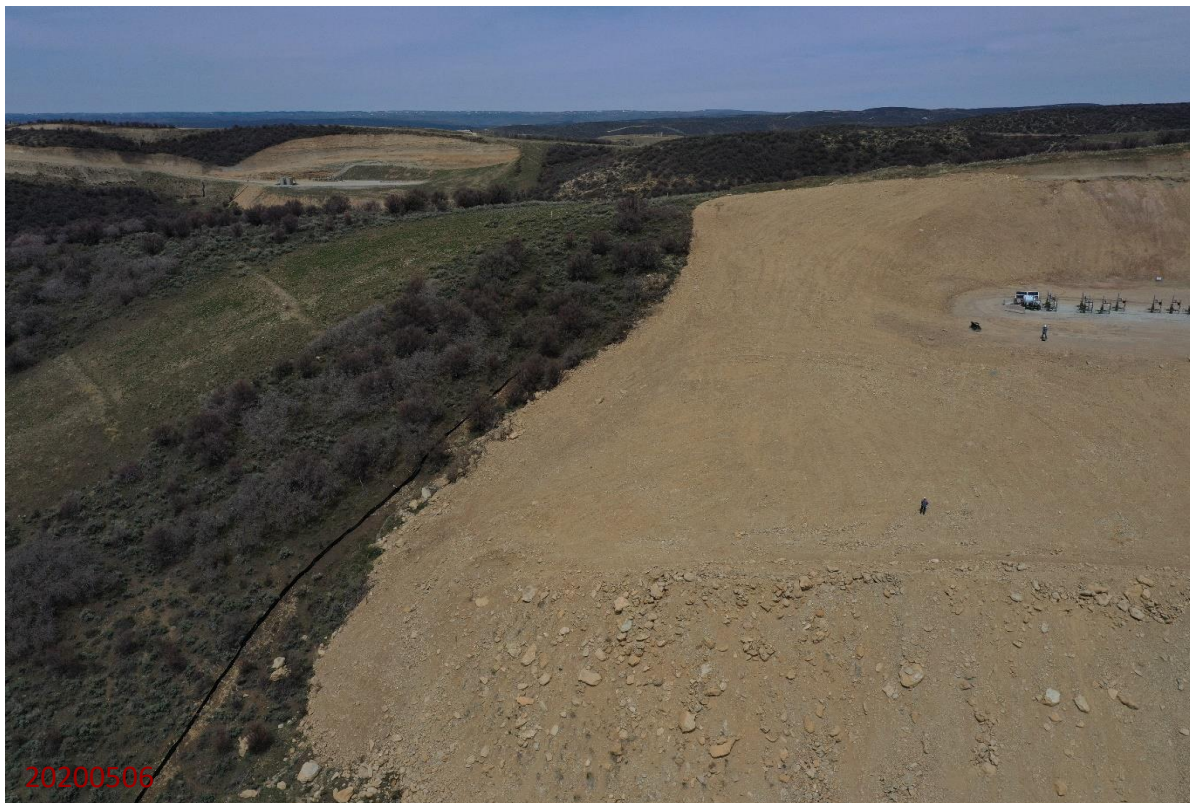
Photo 1: On 5/6/2020, with use of a SUA, Reclamation specialist Trujillo utilized a SUA to capture aerial imagery of the Location. Photos 1-3 were taken from the Southeast of the Location facing northwest, north and northeast. Photos provide a current overview of the Location.

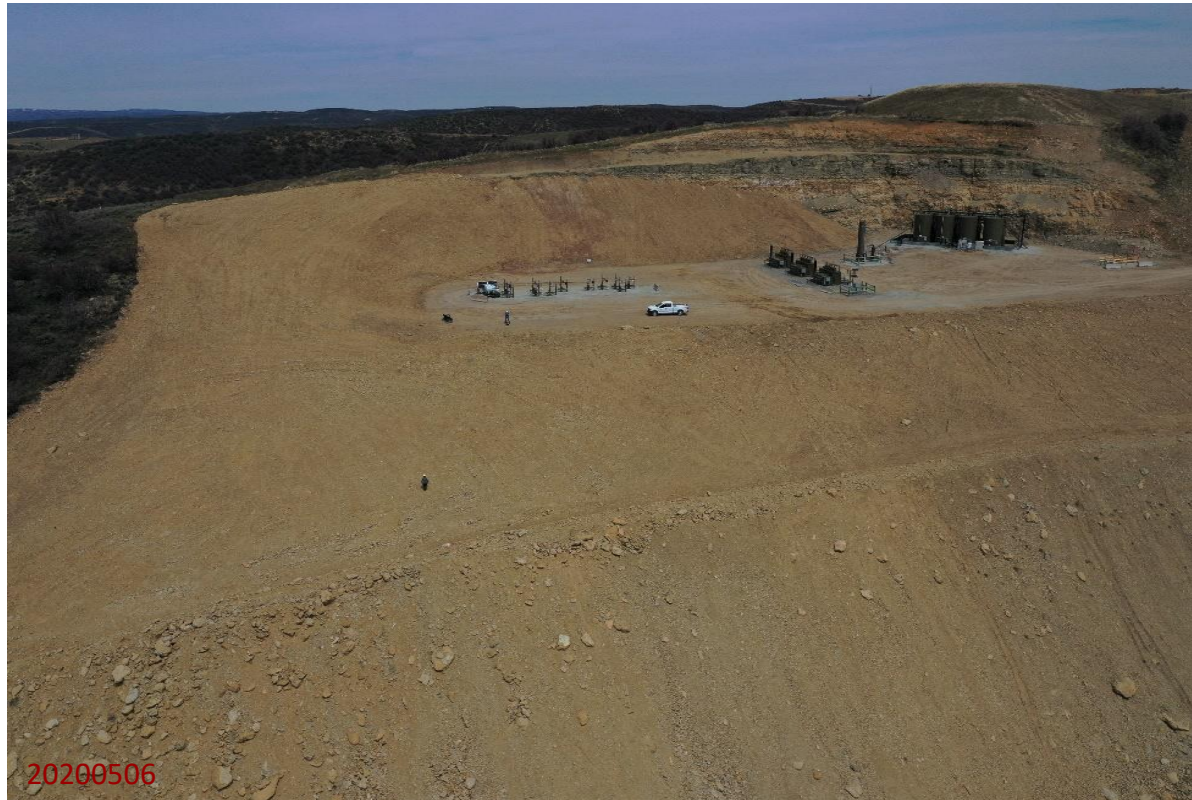
Photo 2: See comments under photo 1.

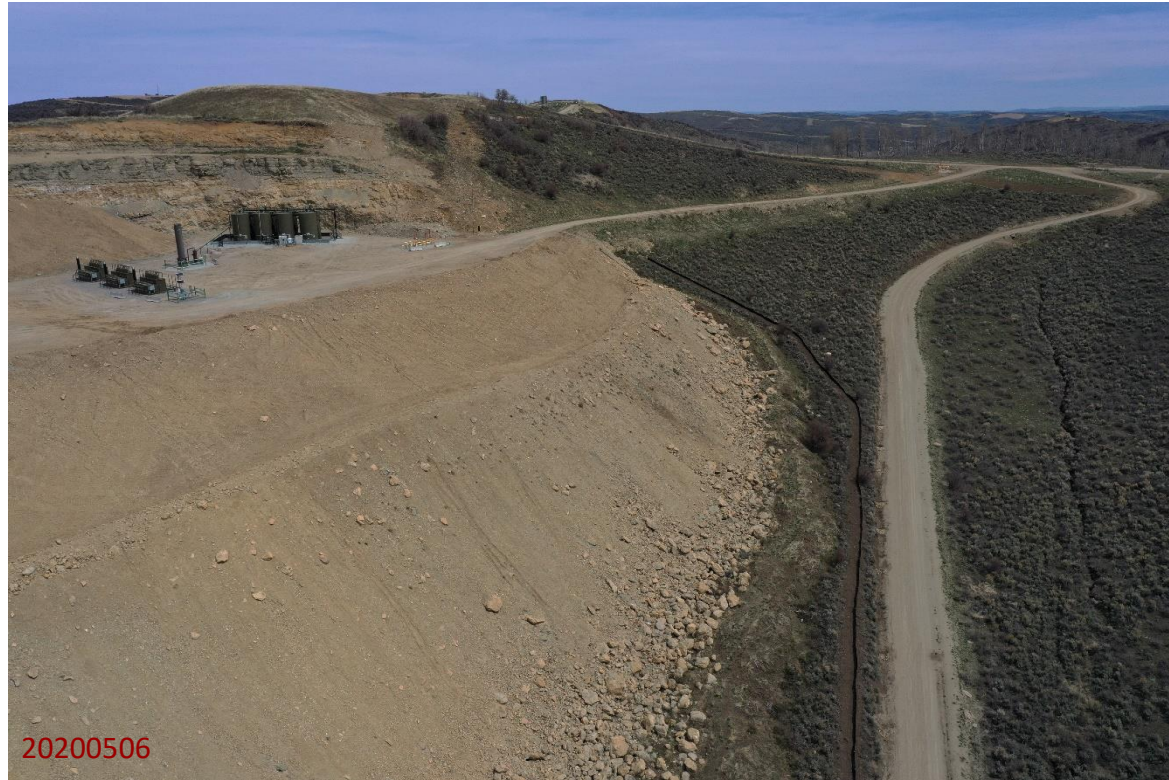
Photo 3: See comments under photo 1.

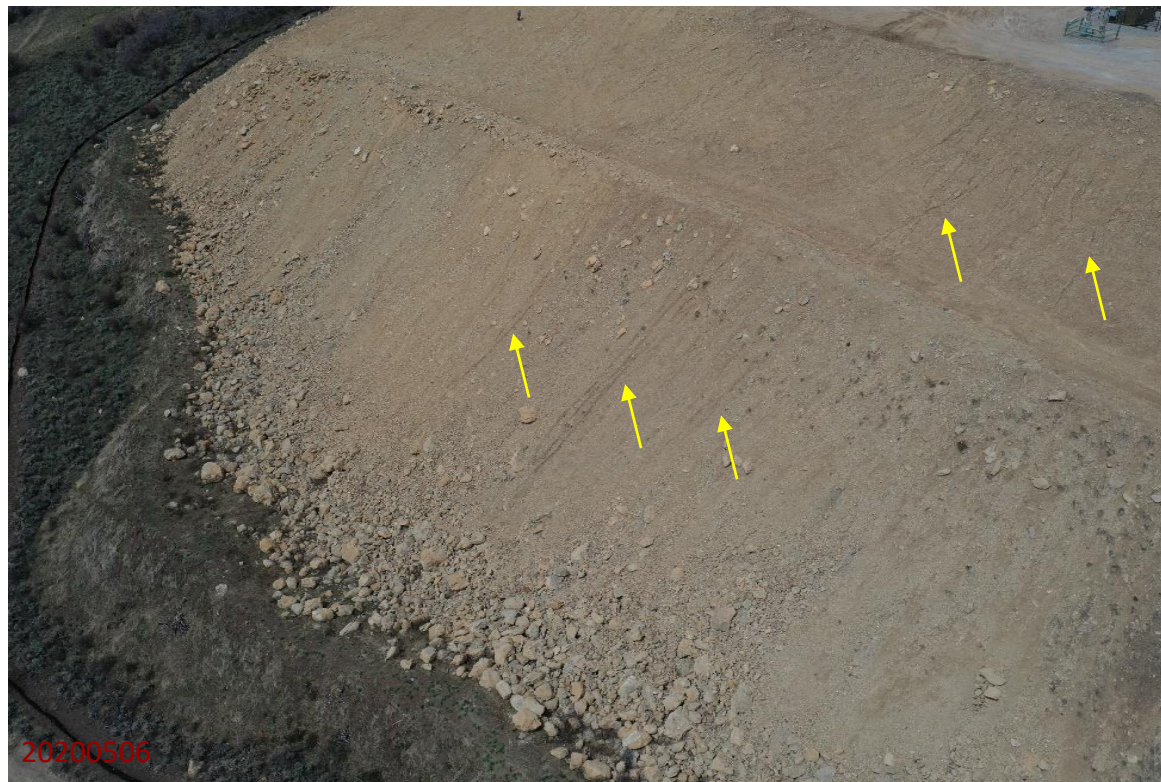
Photo 4: On 5/6/2020, Reclamation specialist Trujillo utilized a SUA to capture aerial imagery of the Location. Photo shows areas where rill erosion/erosion degradation on the southeastern slopes of the Location is evident; BMPs remain missing or insufficient. Photo also shows interim reclamation (revegetation activities) has not been completed.

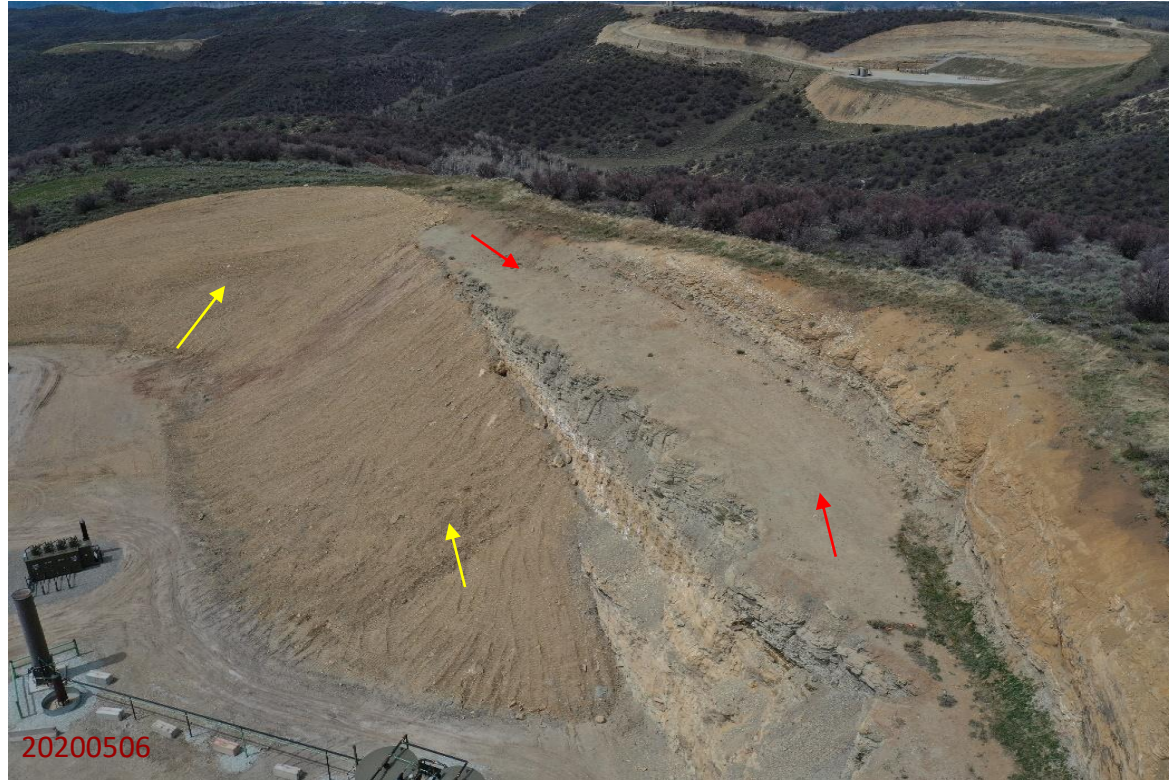
Photo 5: On 5/6/2020, Reclamation specialist Trujillo utilized a SUA to capture aerial imagery of the Location. Photo shows areas on the northern end of the Location where soil replacement/contouring has been conducted (yellow). Photo also shows areas on the northern end of the Location that have not been contoured (red). Photo also shows interim reclamation (revegetation activities) has not been completed.

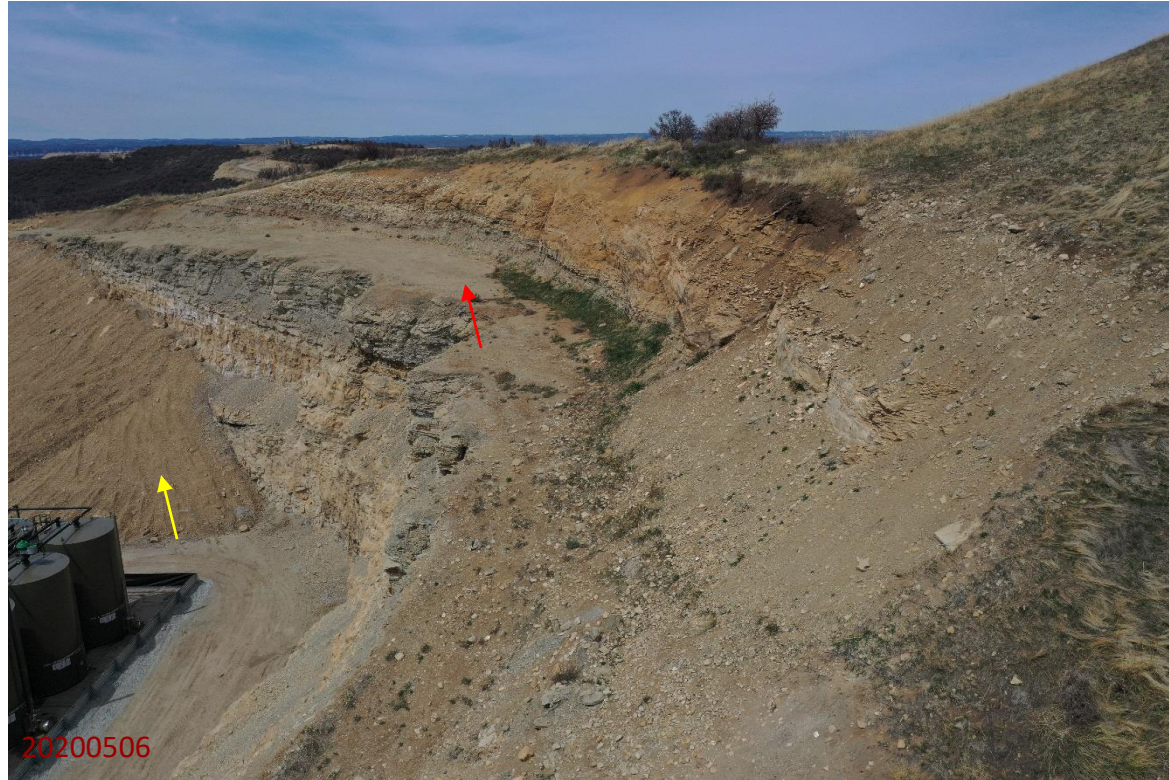
Photo 6: Continued from photo 5. Photo shows areas on the northern end of the Location where soil replacement/contouring has been conducted (yellow). Photo also shows areas on the northern end of the Location that have not been contoured (red). Photo also shows interim areas where BMPs appear to be missing, or insufficient, and where interim reclamation (revegetation activities) has not been completed.

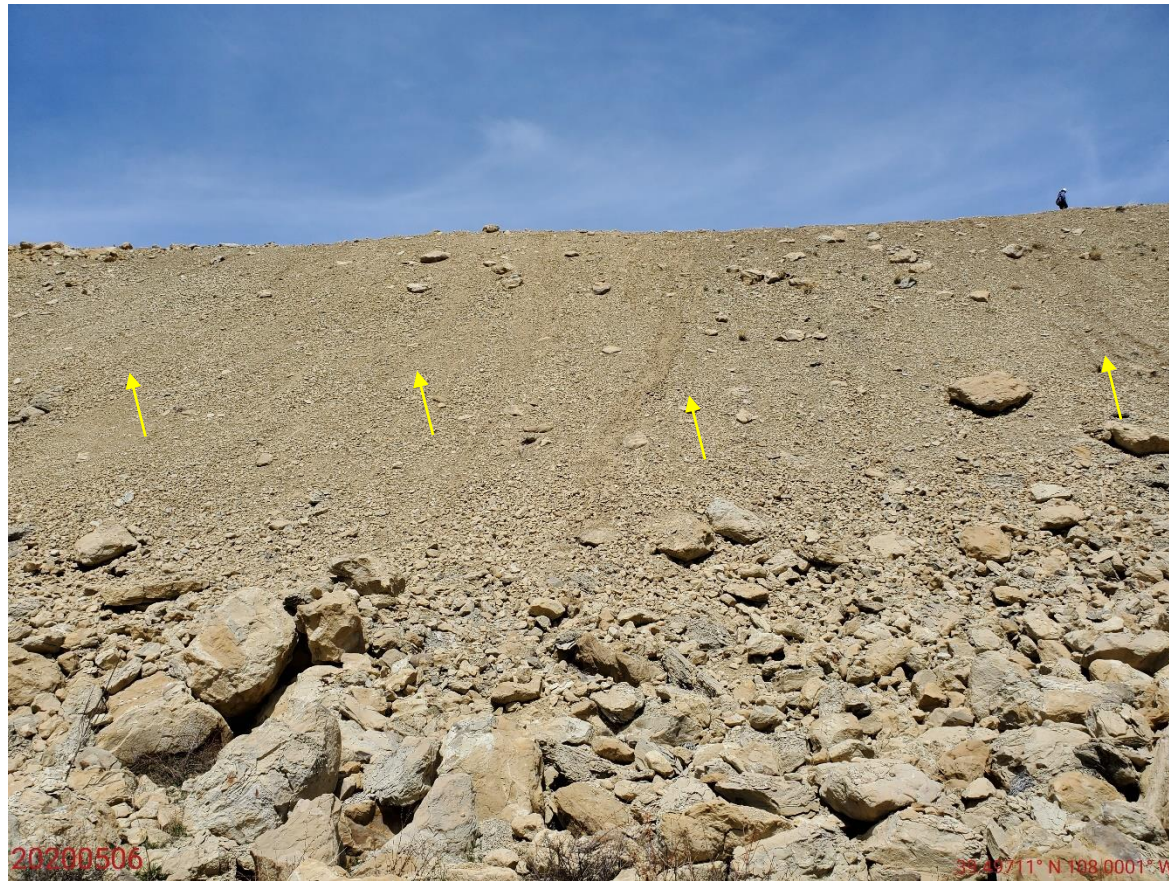
Photo 7: Photo taken from the southeast end of the Location, facing northwest. Photo shows areas where rill erosion/erosion degradation on the southeastern slopes of the Location is evident; BMPs remain missing or insufficient. Photo also shows interim reclamation (revegetation activities) has not been completed. Inspector at top right of photo for reference.

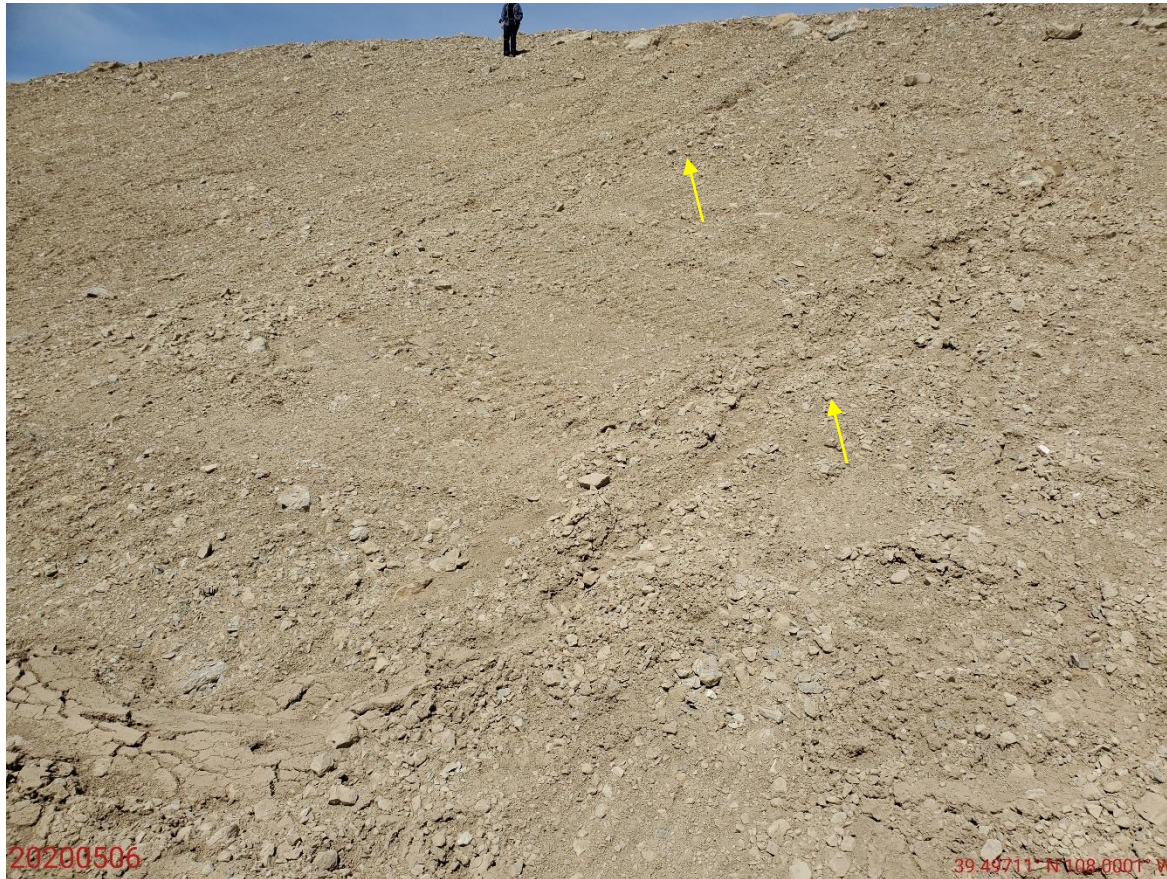
Photo 8: Continued from photo 7. Photo shows areas where rill erosion/erosion degradation on the slopes of the Location is evident; BMPs remain missing or insufficient. Photo also shows interim reclamation (revegetation activities) has not been completed. Inspector at top of photo for reference.

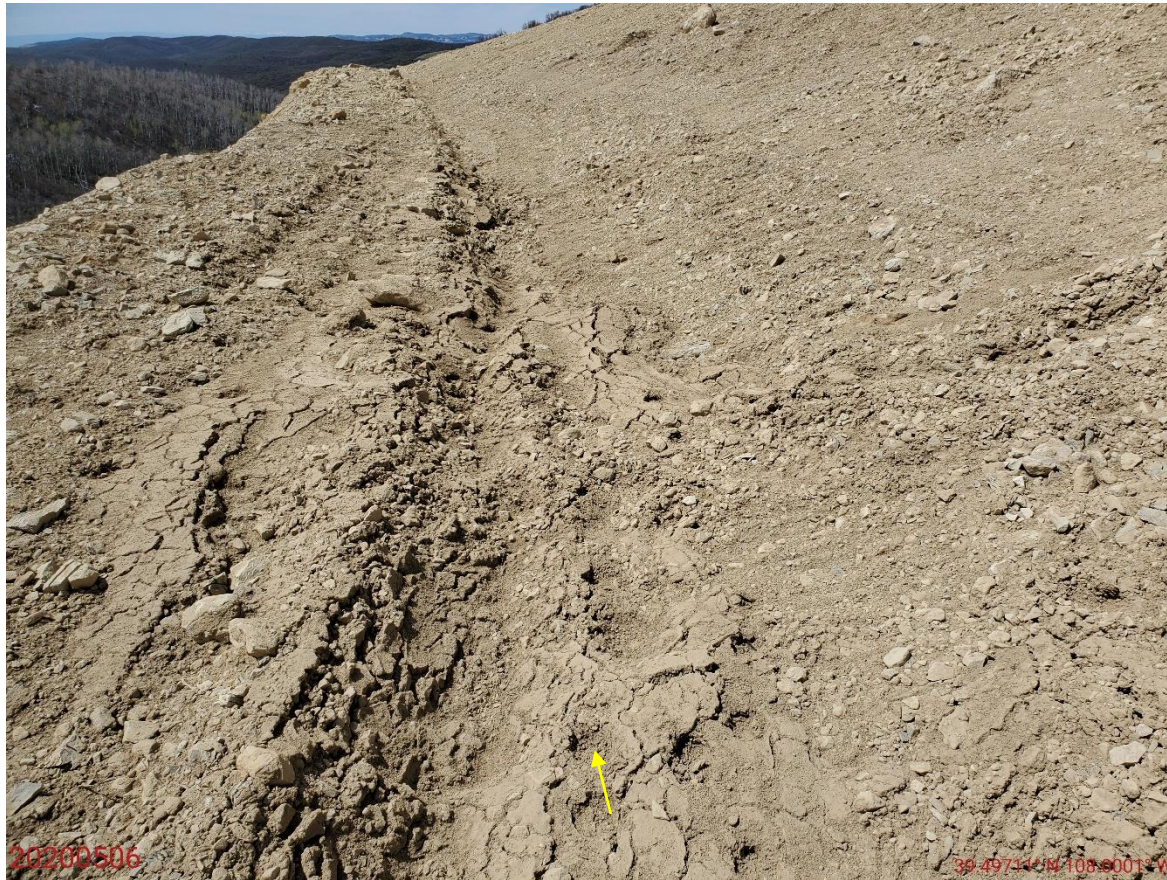
Photo 9: Continued from photo 8. Photo shows sediment deposition due to erosion from the slopes.

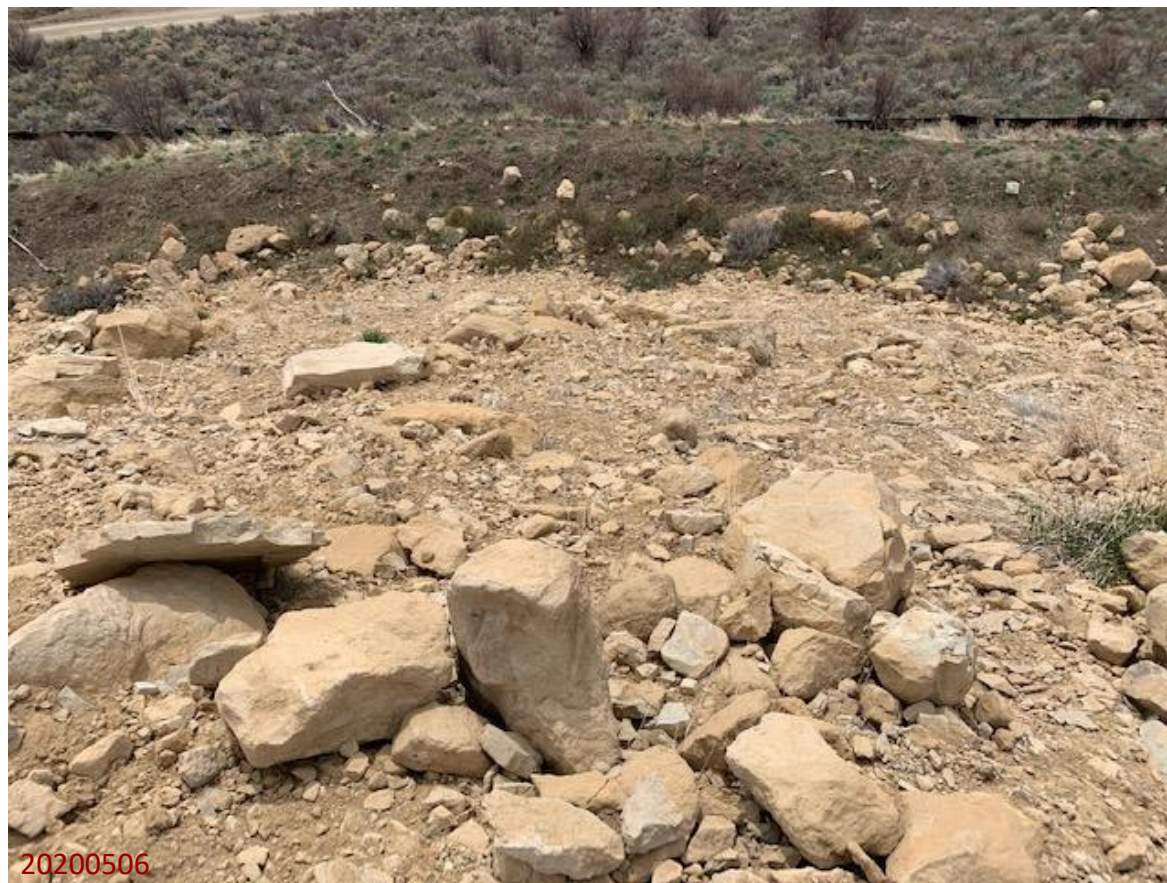
Photo 10: Photo taken from the slopes on the southeast end of the Location. Photo shows slopes have not been sufficiently stabilized, and/or BMPs missing or insufficient. Photo shows rocks that appear to have fallen from the slopes onto areas below the Location; Risk of rocks falling.

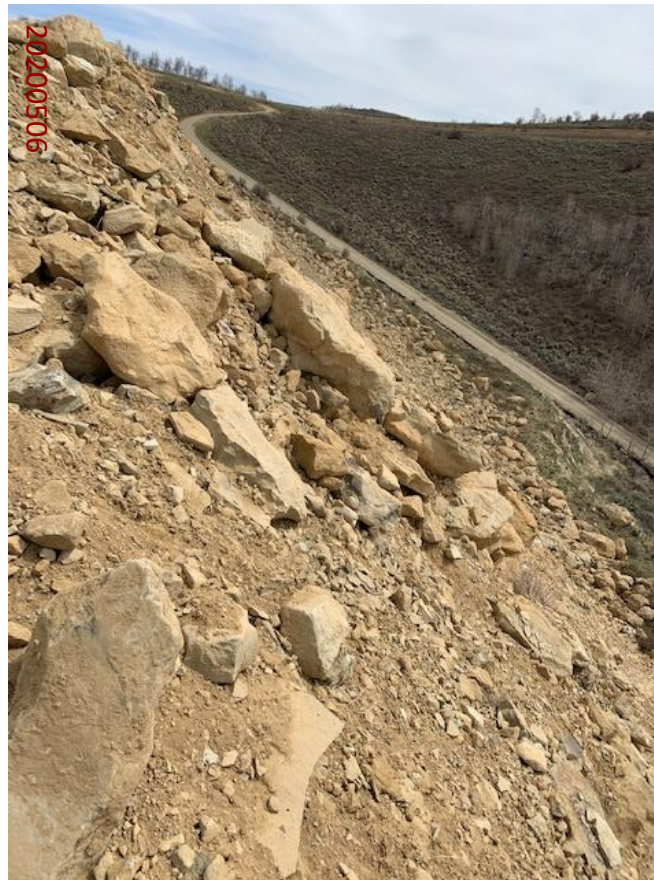
Photo 11: See comments under photo 10

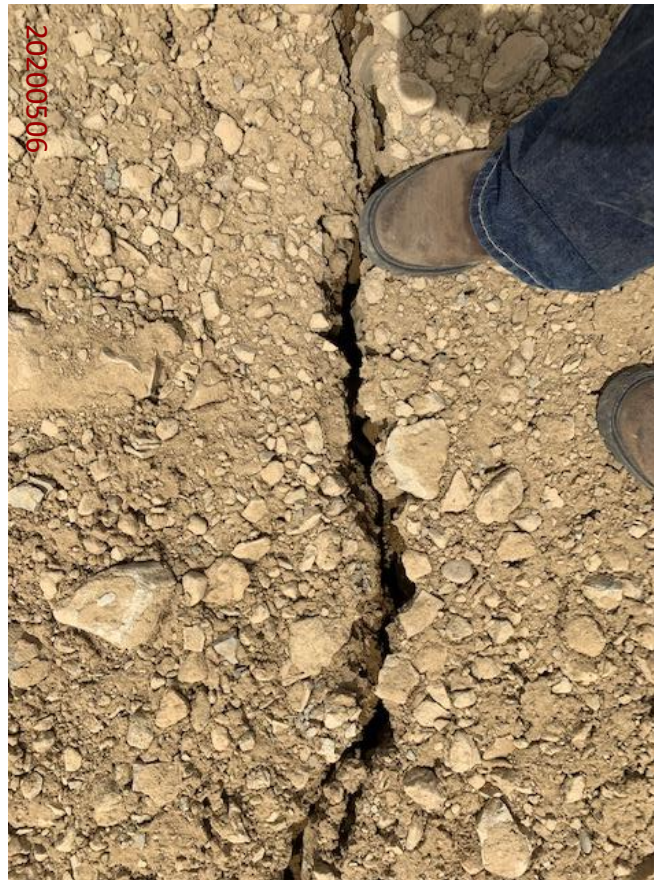
Photo 12: Photo taken from the slopes on the north end of the Location. Photo shows a crack forming along the interim areas indicating soils are unstabilized and are beginning to shift/slough.

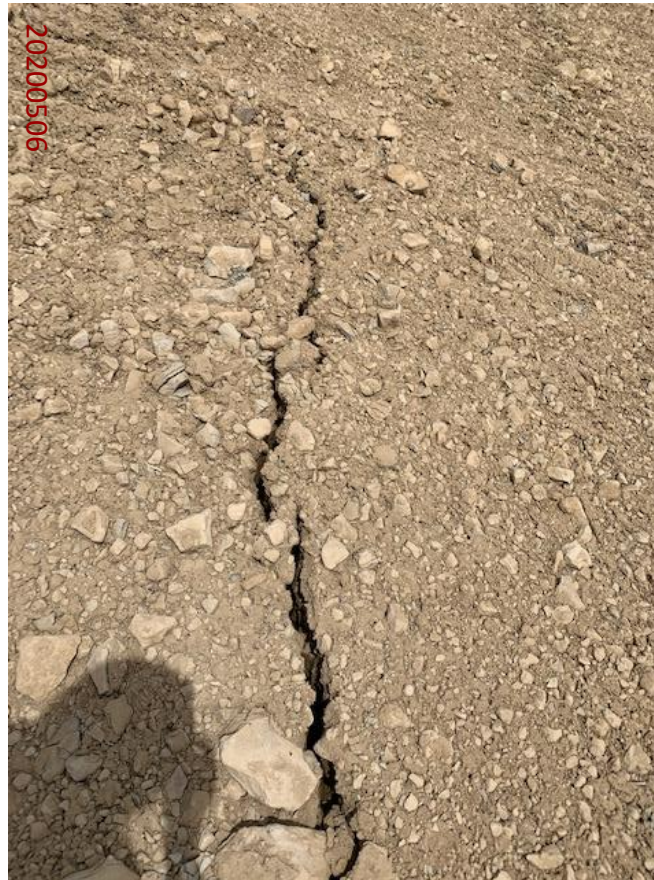
Photo 13: See comments under photo 12.

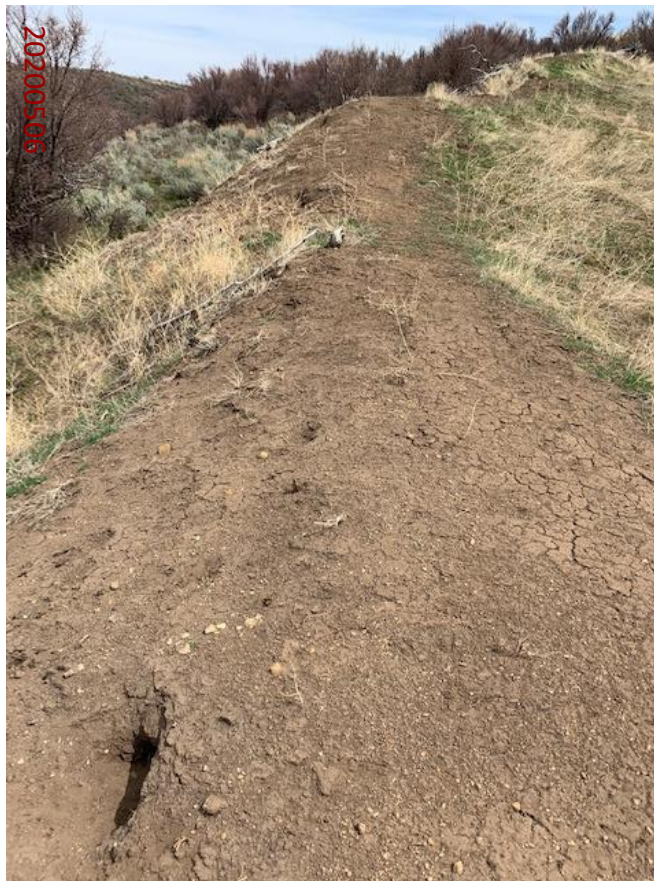
Photo 14: Photo taken from the topsoil stockpile on the northwest end of the Location. Photo shows soil stockpile is predominantly exposed soil, or vegetated by undesirable weedy plant species.
