# Inspection Photos

API: 071-08793

Operator: TIMBER CREEK OPERATING

Inspection Date: 5/11/2020

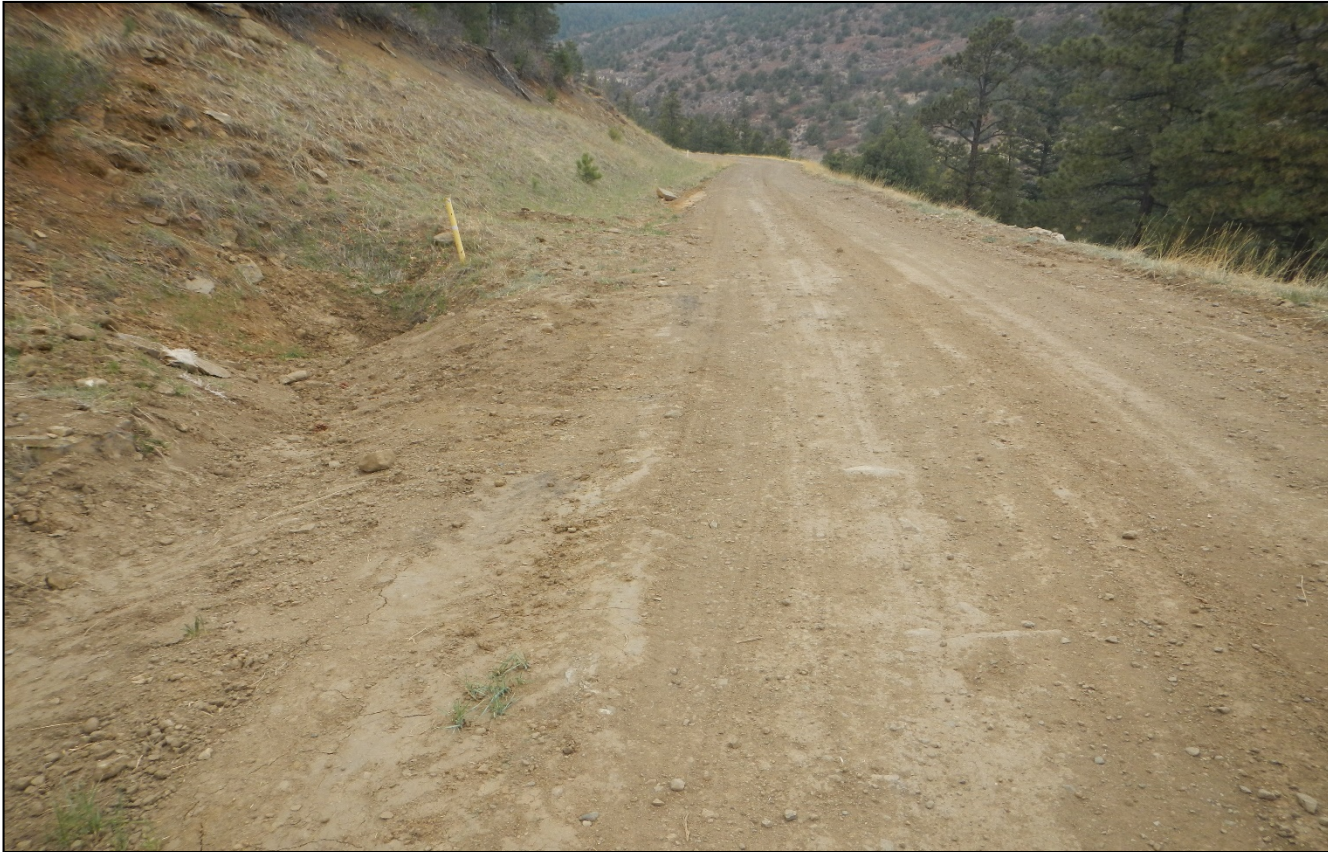
**Photo 1.** There erosion near culvert inlet has been repaired.

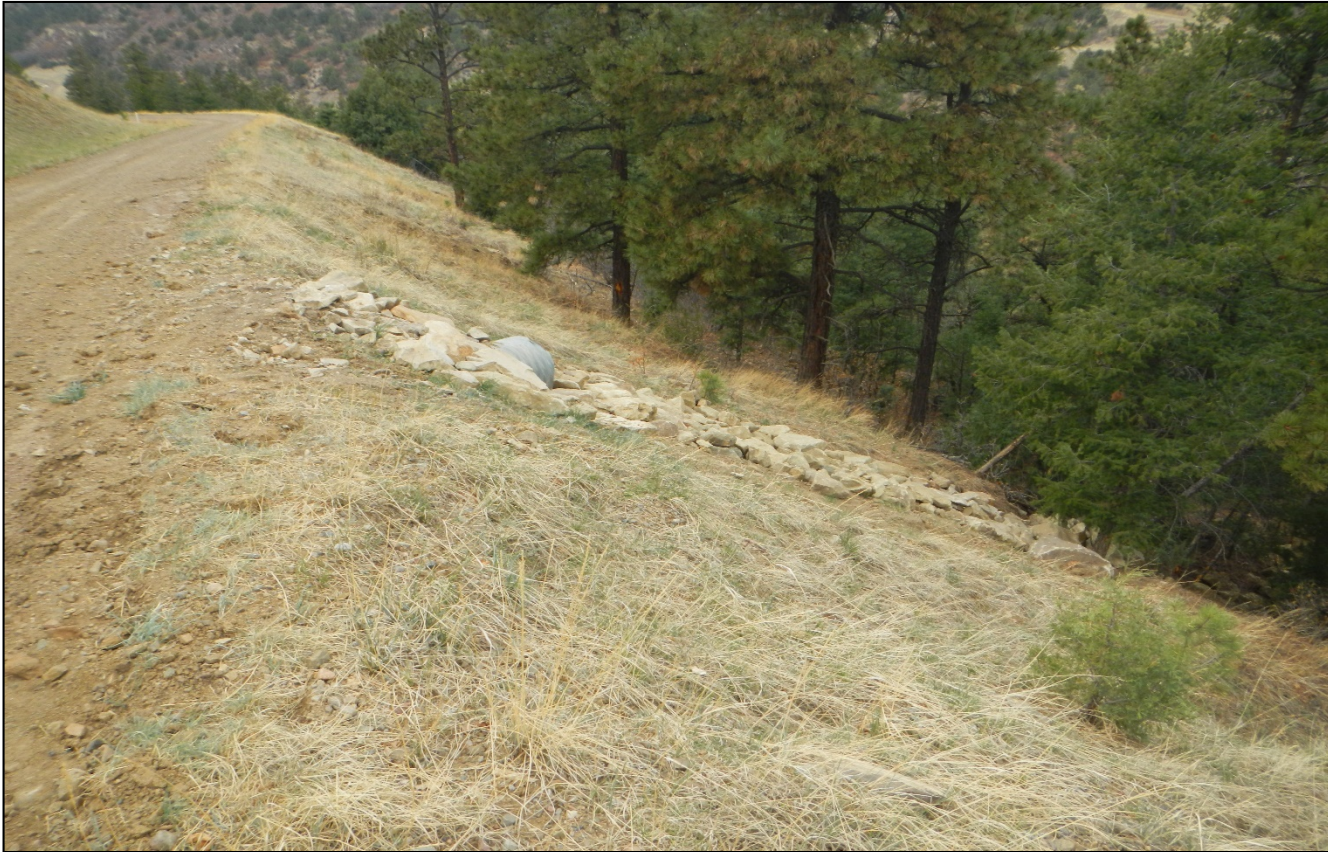
**Photo 2.** Culvert outlet protection has been installed at the culvert where erosion was observed.

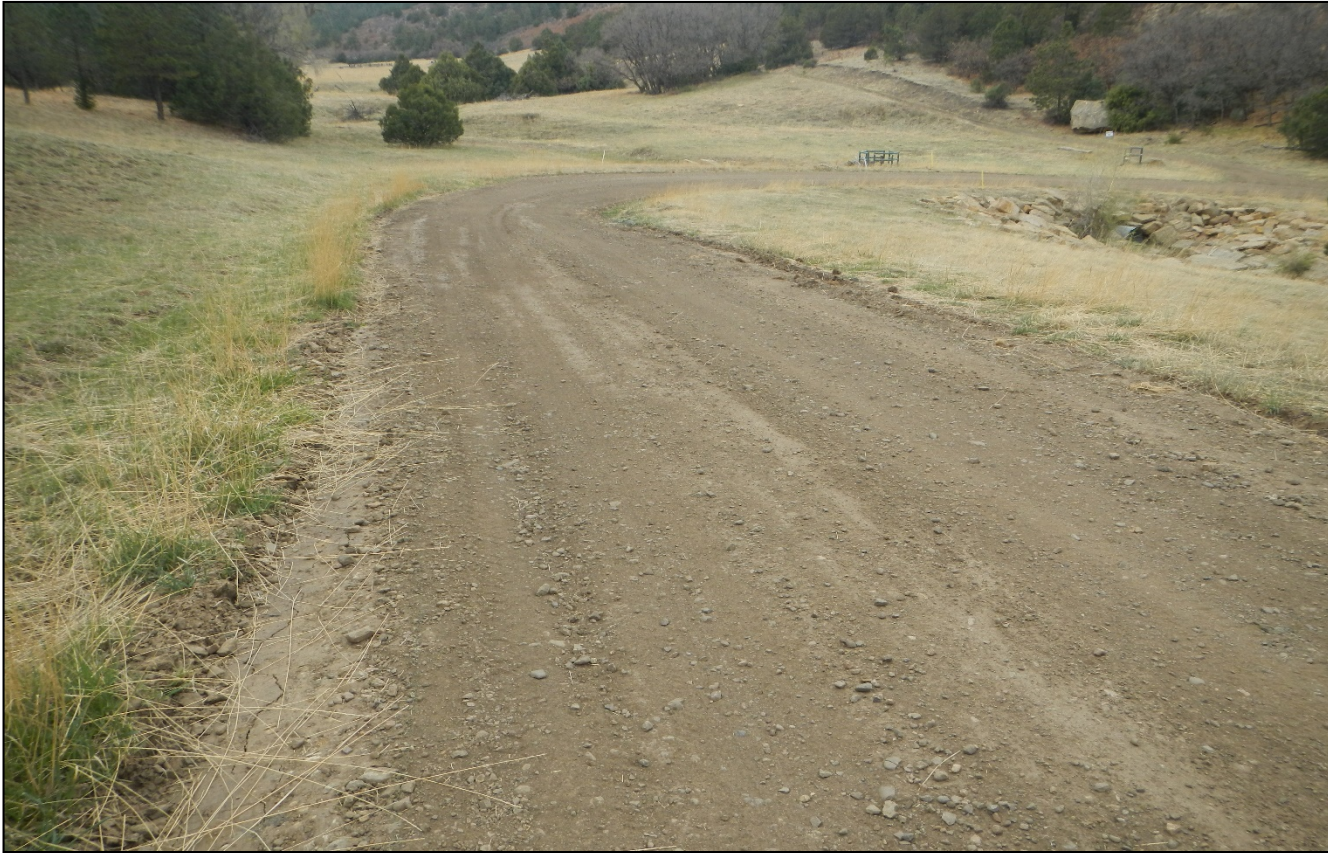
**Photo 3.** The road has been graded where erosion was previously occurring.

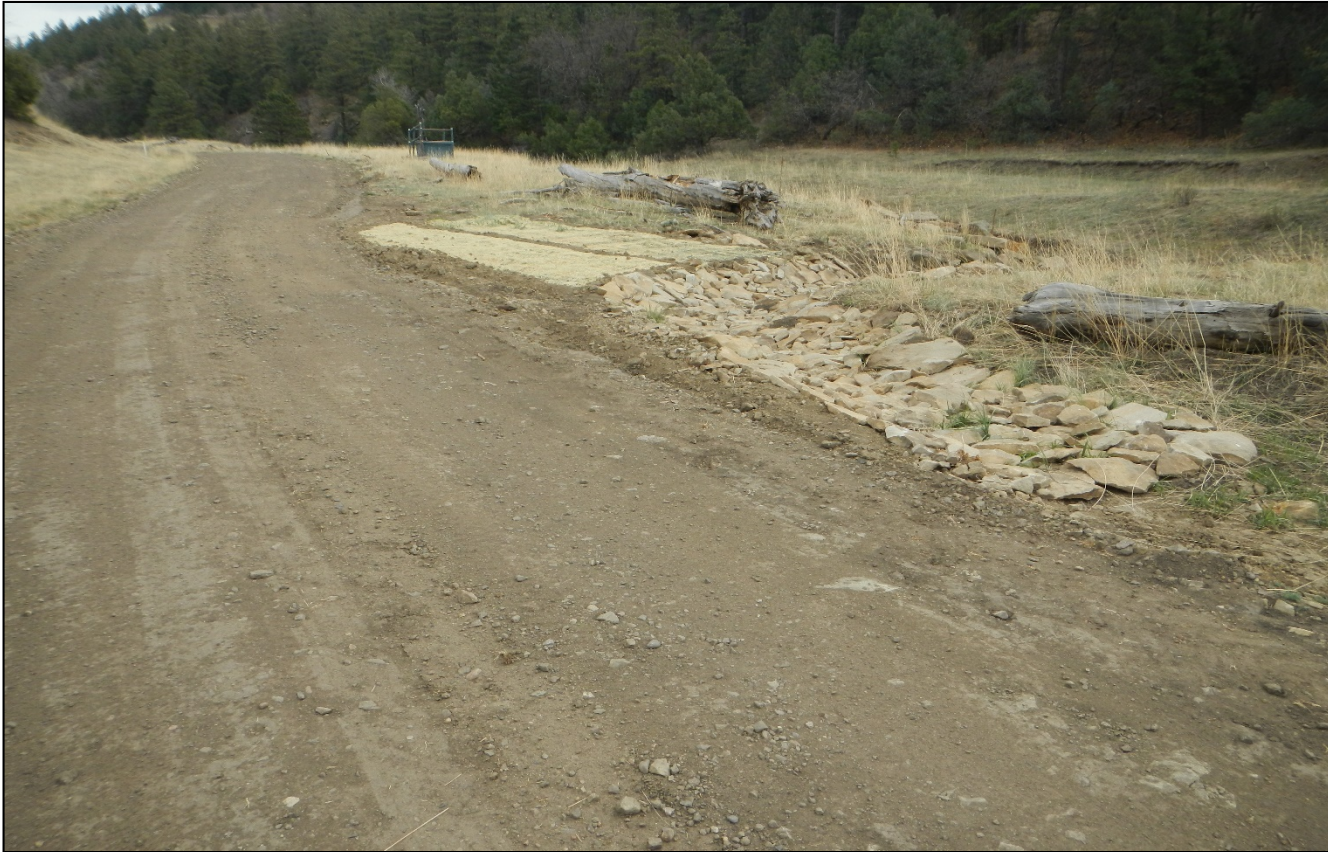
**Photo 4.** Culvert outlet protection has been installed at the culvert where erosion was previously observed.

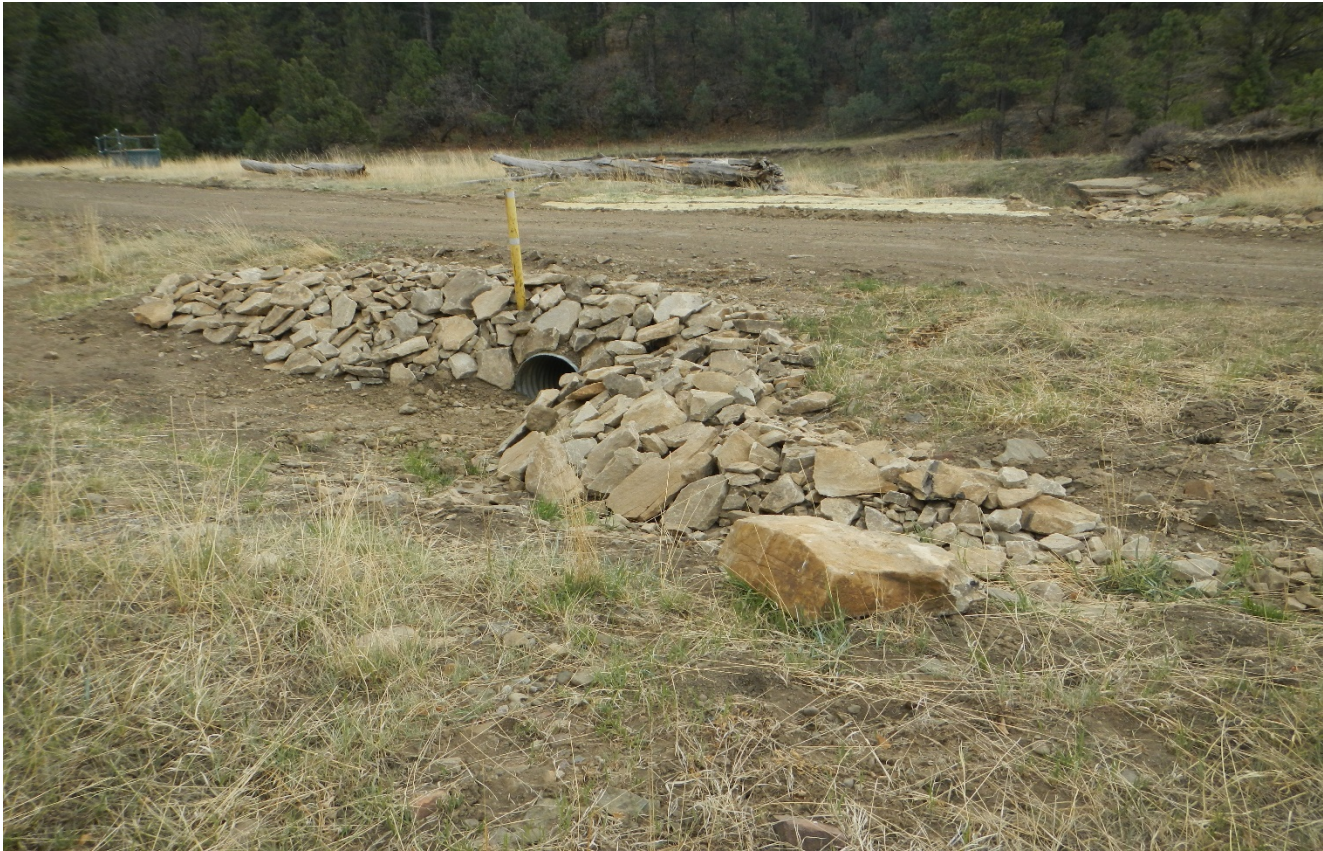
**Photo 5.** Facing toward the culvert inlet along the main road.

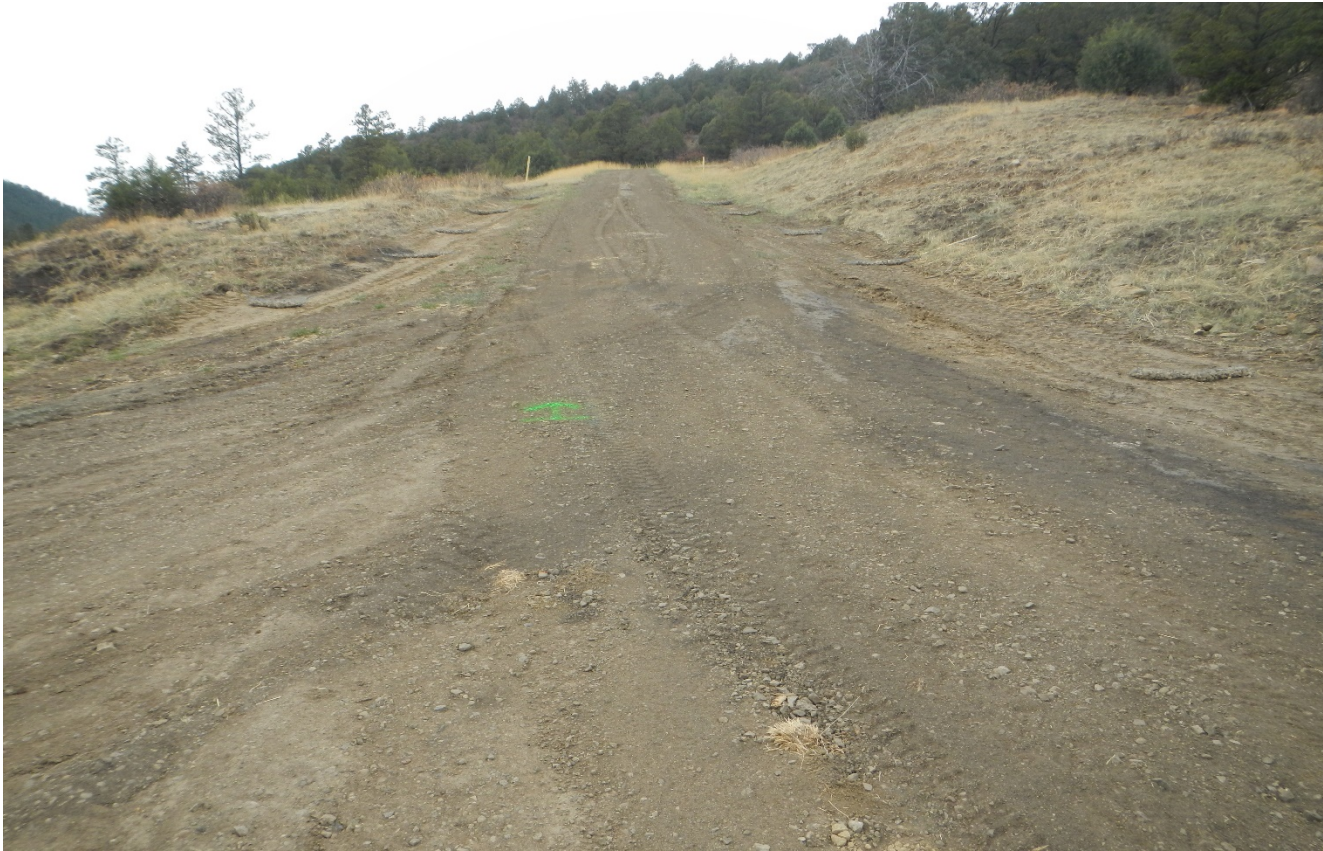
**Photo 6.** Facing toward the access road. The erosion along the sides of the access road have been repaired.

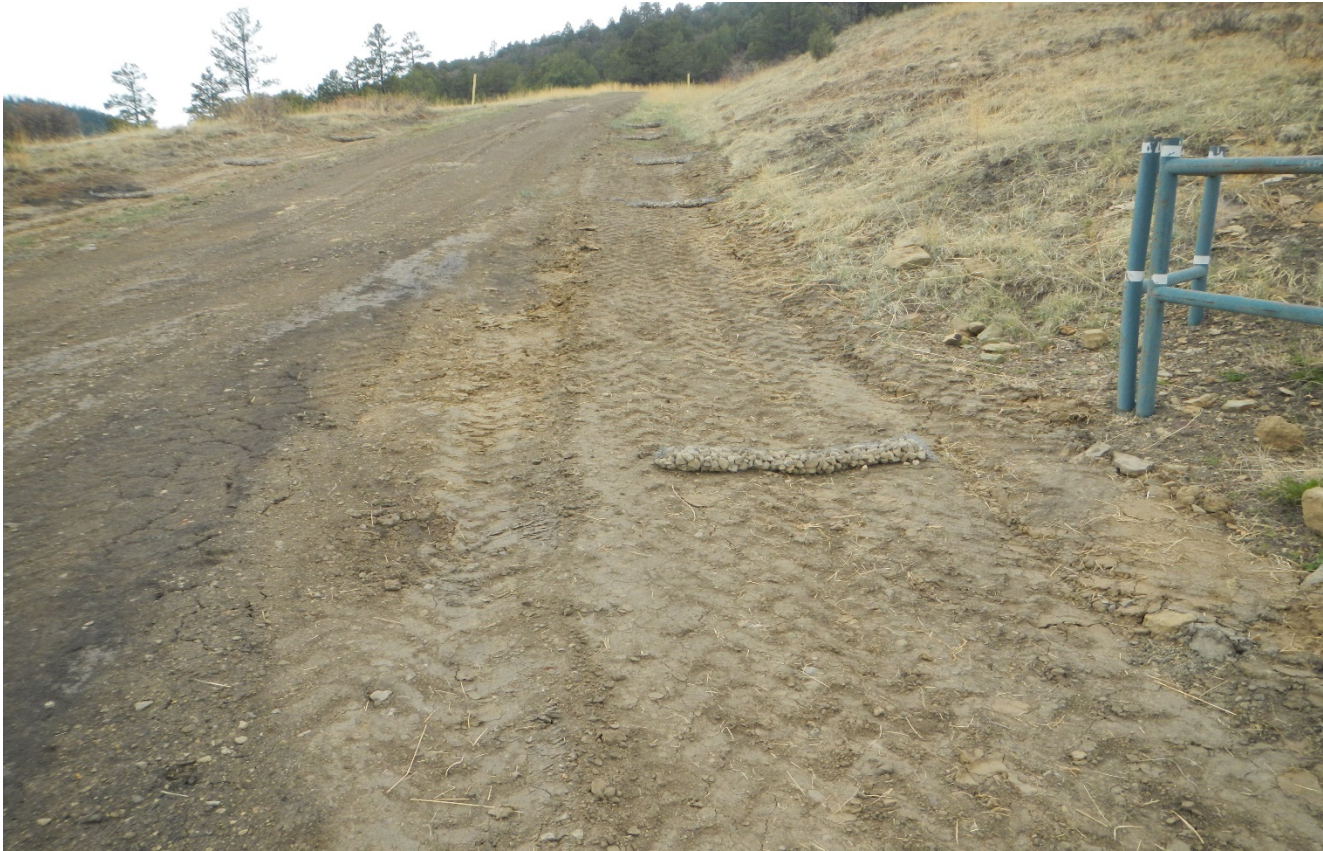
**Photo 7.** Rock wattles have been placed on the side of the access road. It is uncertain if the rock wattles will withstand the stormwater flow. These will need to be monitored and maintained to ensure stormwater does not displace or flow around.

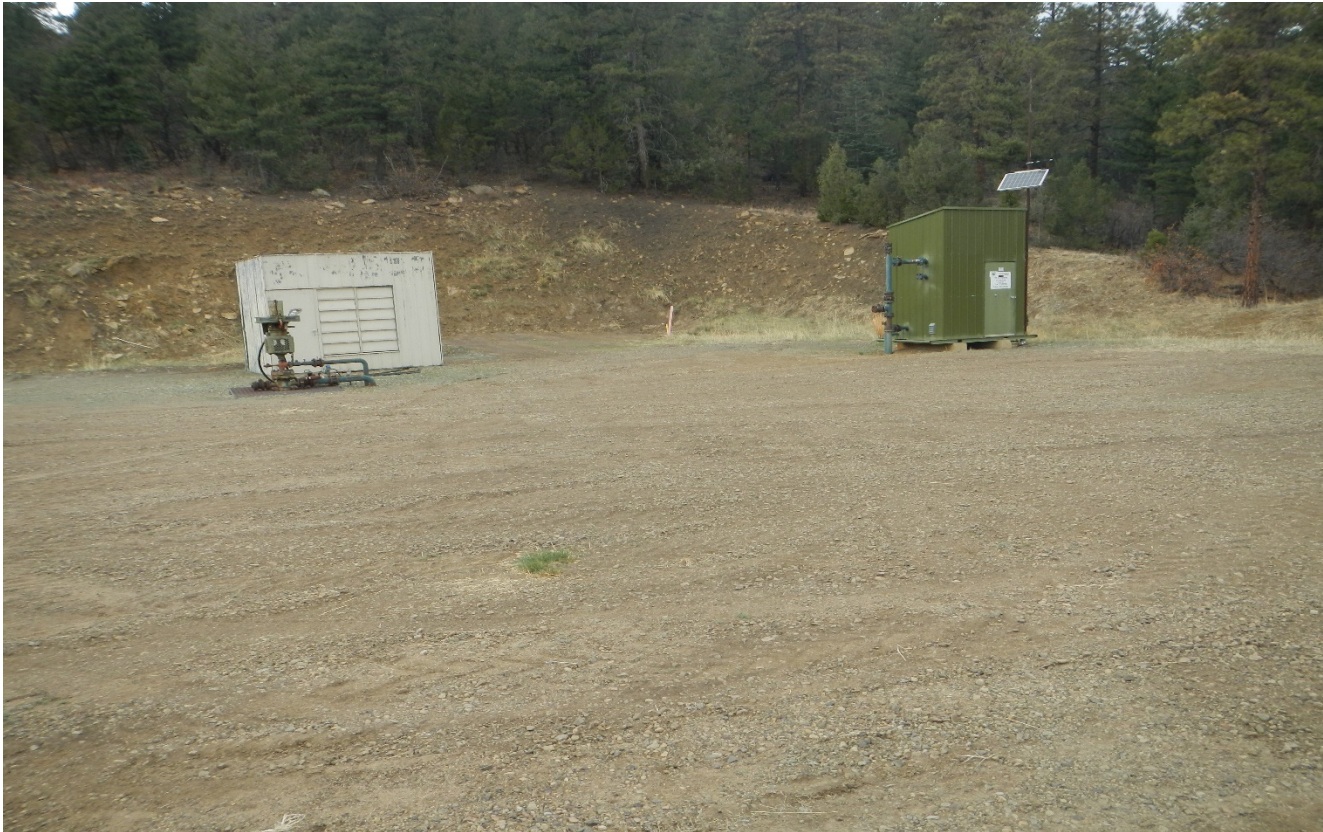
**Photo 8.** Facing toward the location.

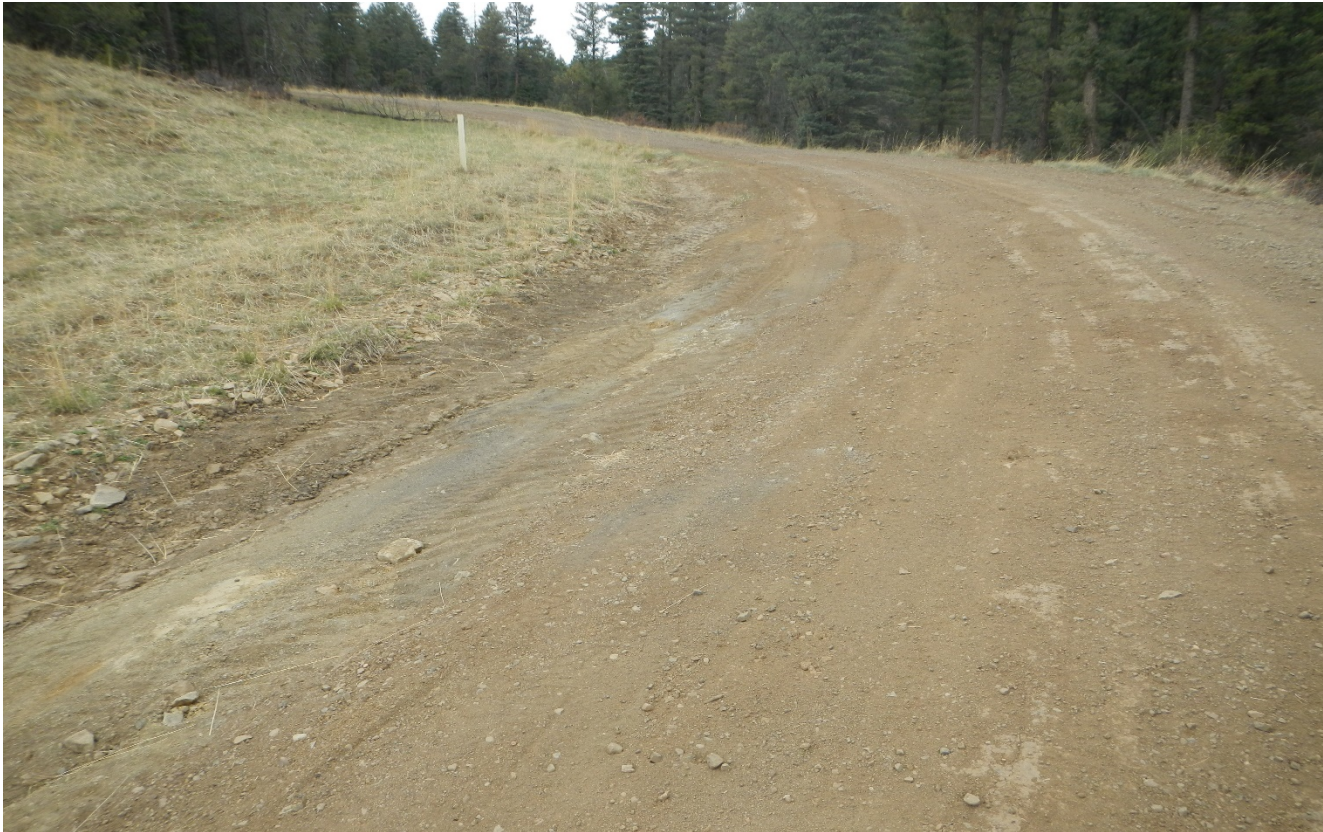
**Photo 9.** The area of erosion along the road has been graded and repaired.

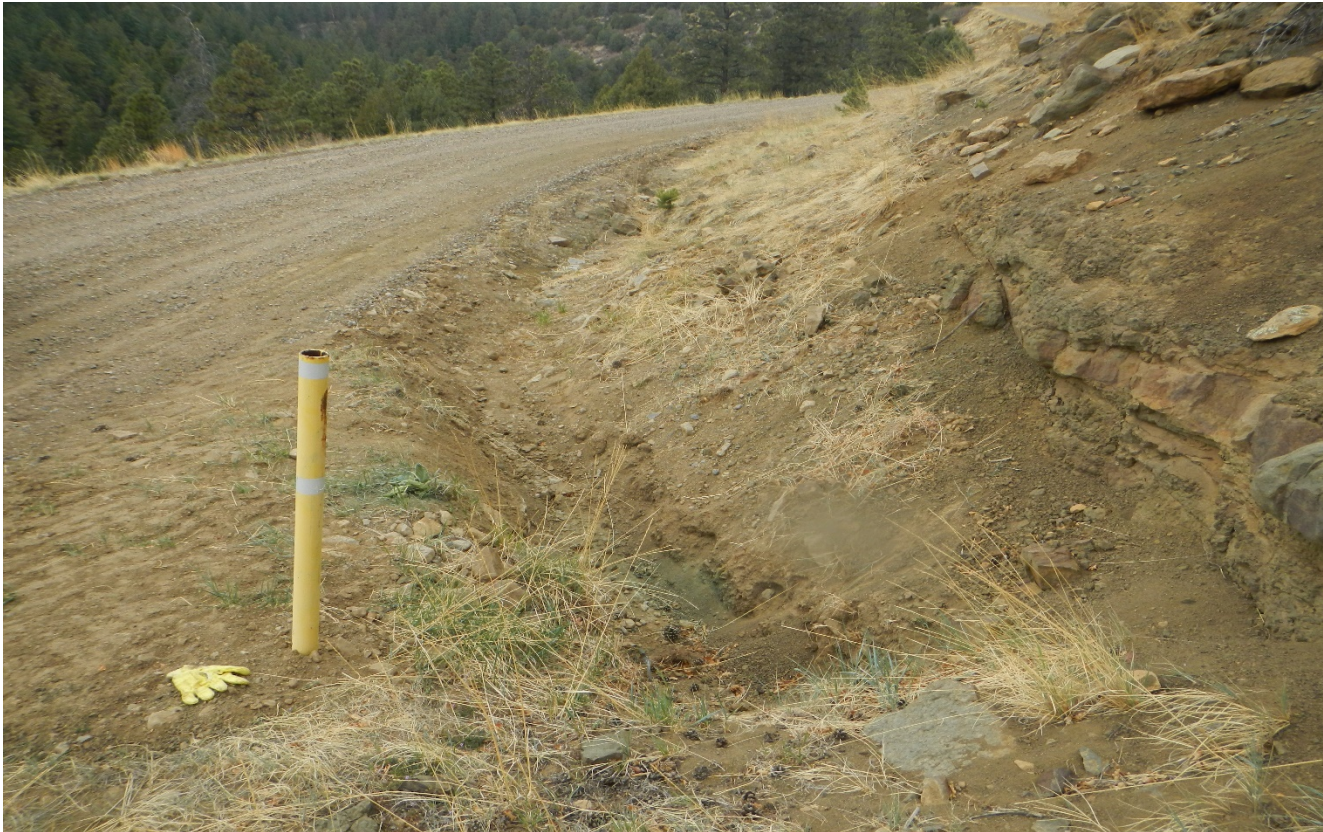
**Photo 10.** The culvert inlet has been cleaned out of sediment and maintained.
