Inspection Photos

API: 071-09301

Operator: TIMBER CREEK OPERATING

Inspection Date: 5/11/2020

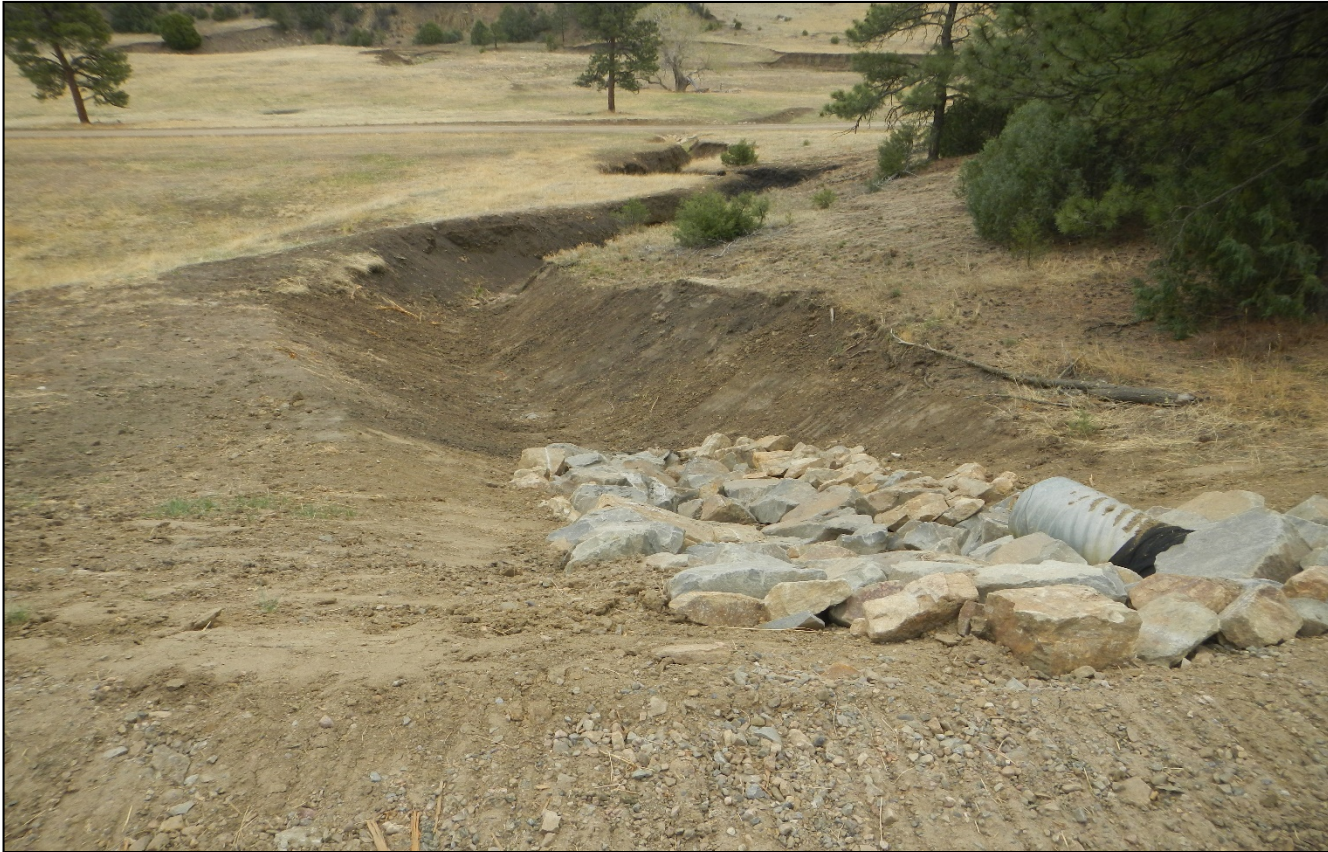
Photo 1. Outlet protection has been installed at the culvert. It appears stormwater from the road has been directed to this area causing this erosion gully. Disturbance areas caused by erosion may need to be reclaimed.

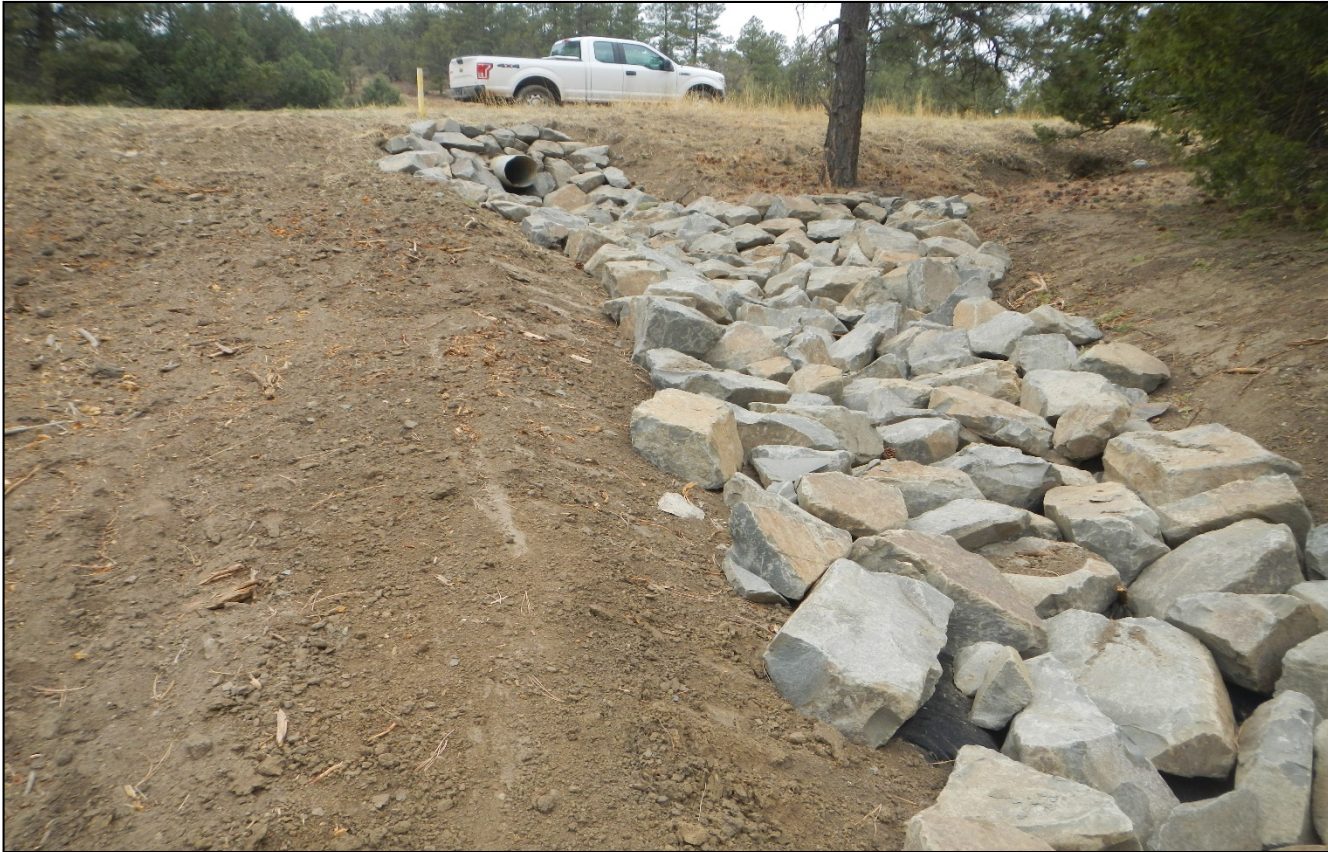
Photo 2. Further up the road, outlet protection has been installed where erosion was during previous inspection.

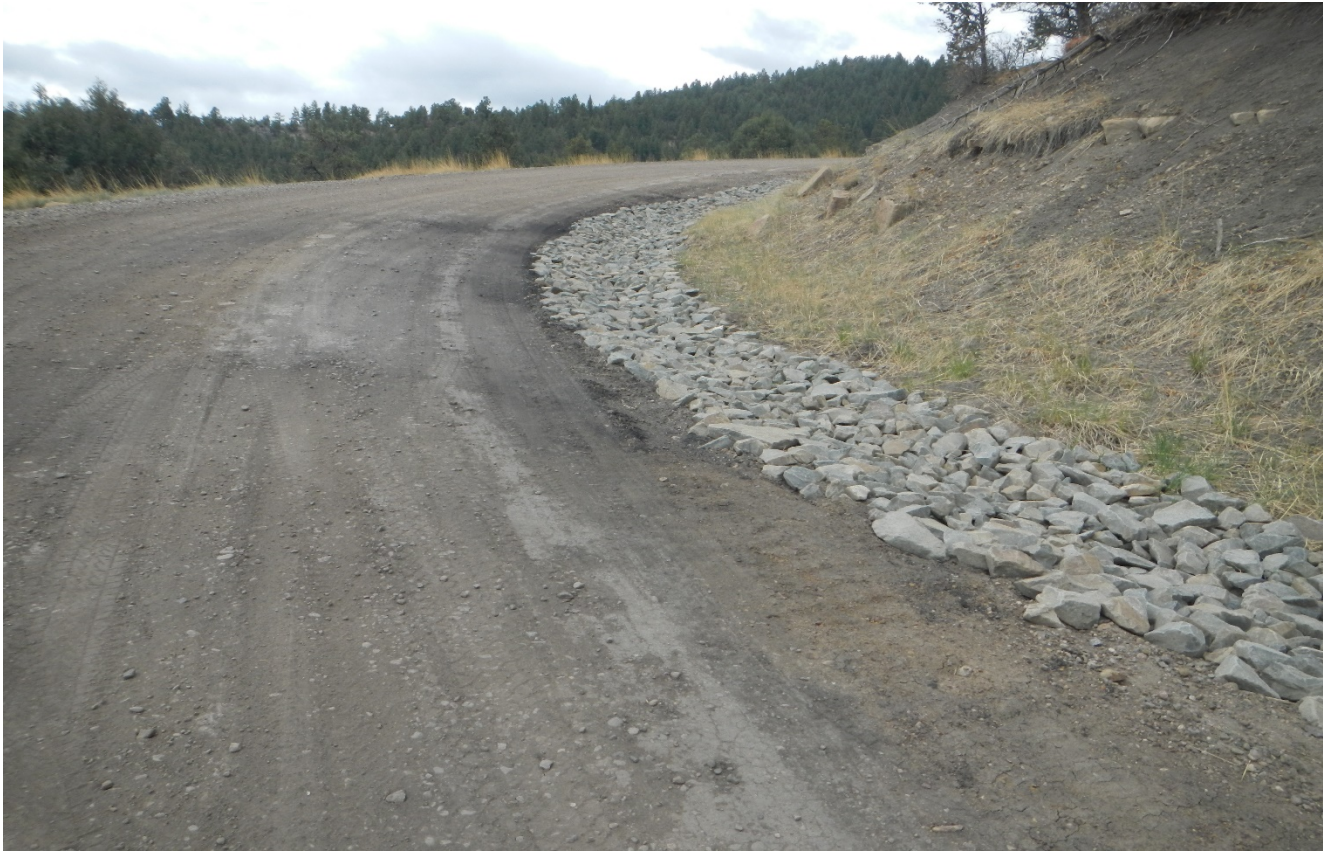
Photo 5. Further up the main road. Rock rip/rap has been installed along the side of the road to prevent erosion.

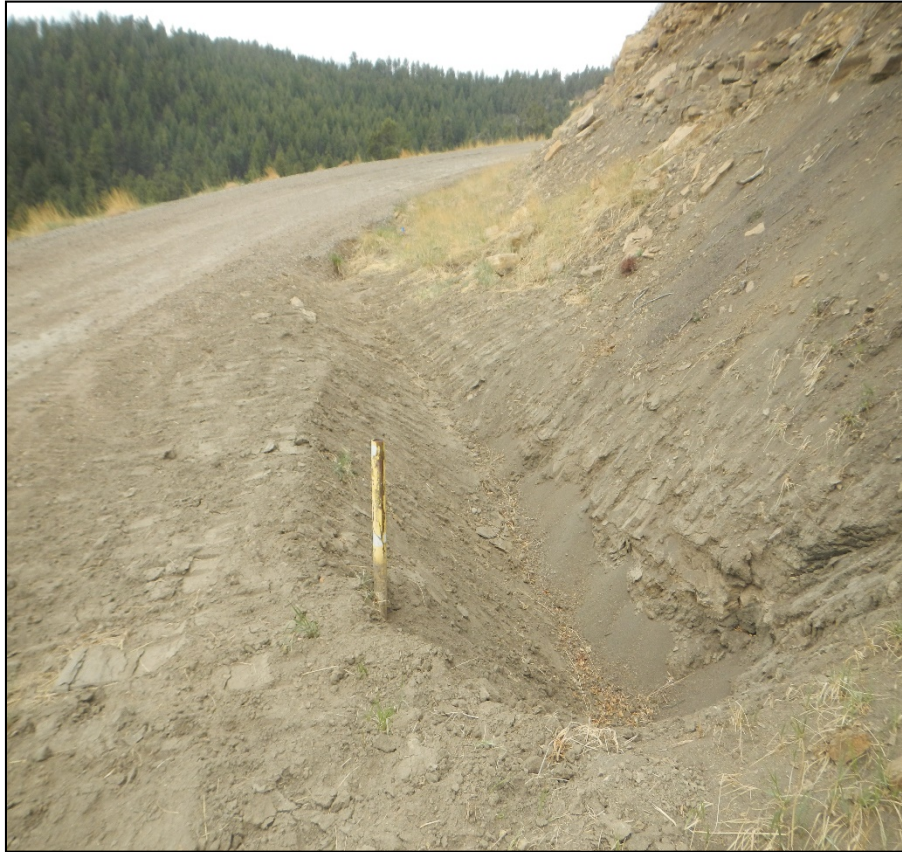
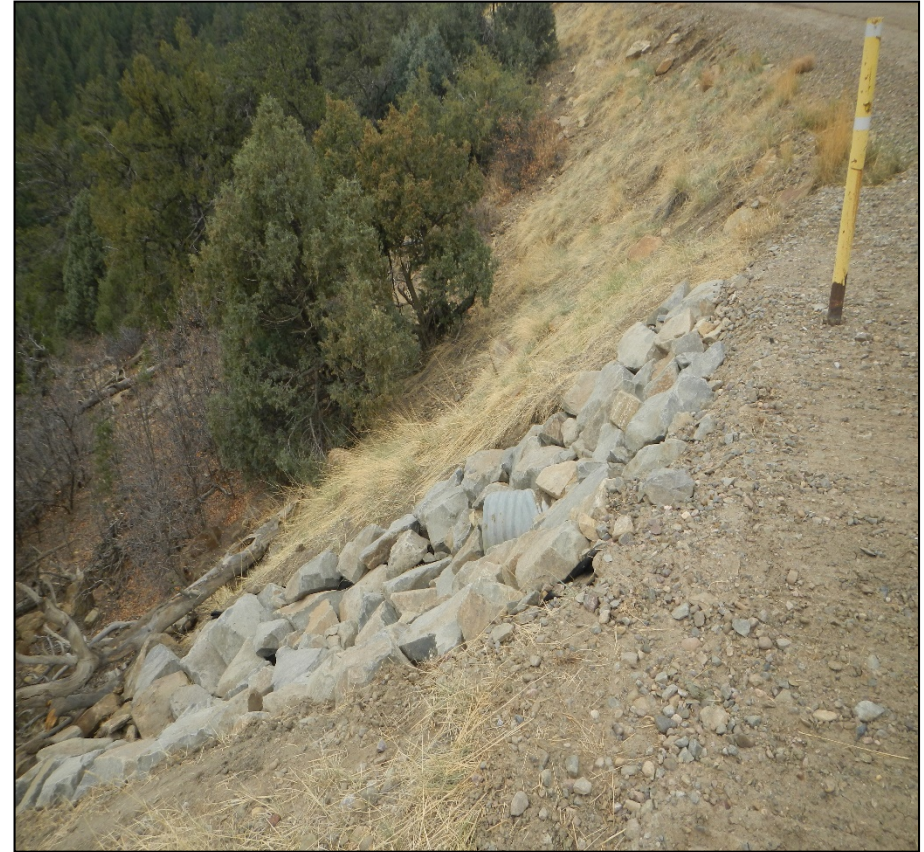
Photo 6. The culvert inlet has been maintained and sediment removed. Outlet protection has been installed at culvert outlet where erosion was previously observed.

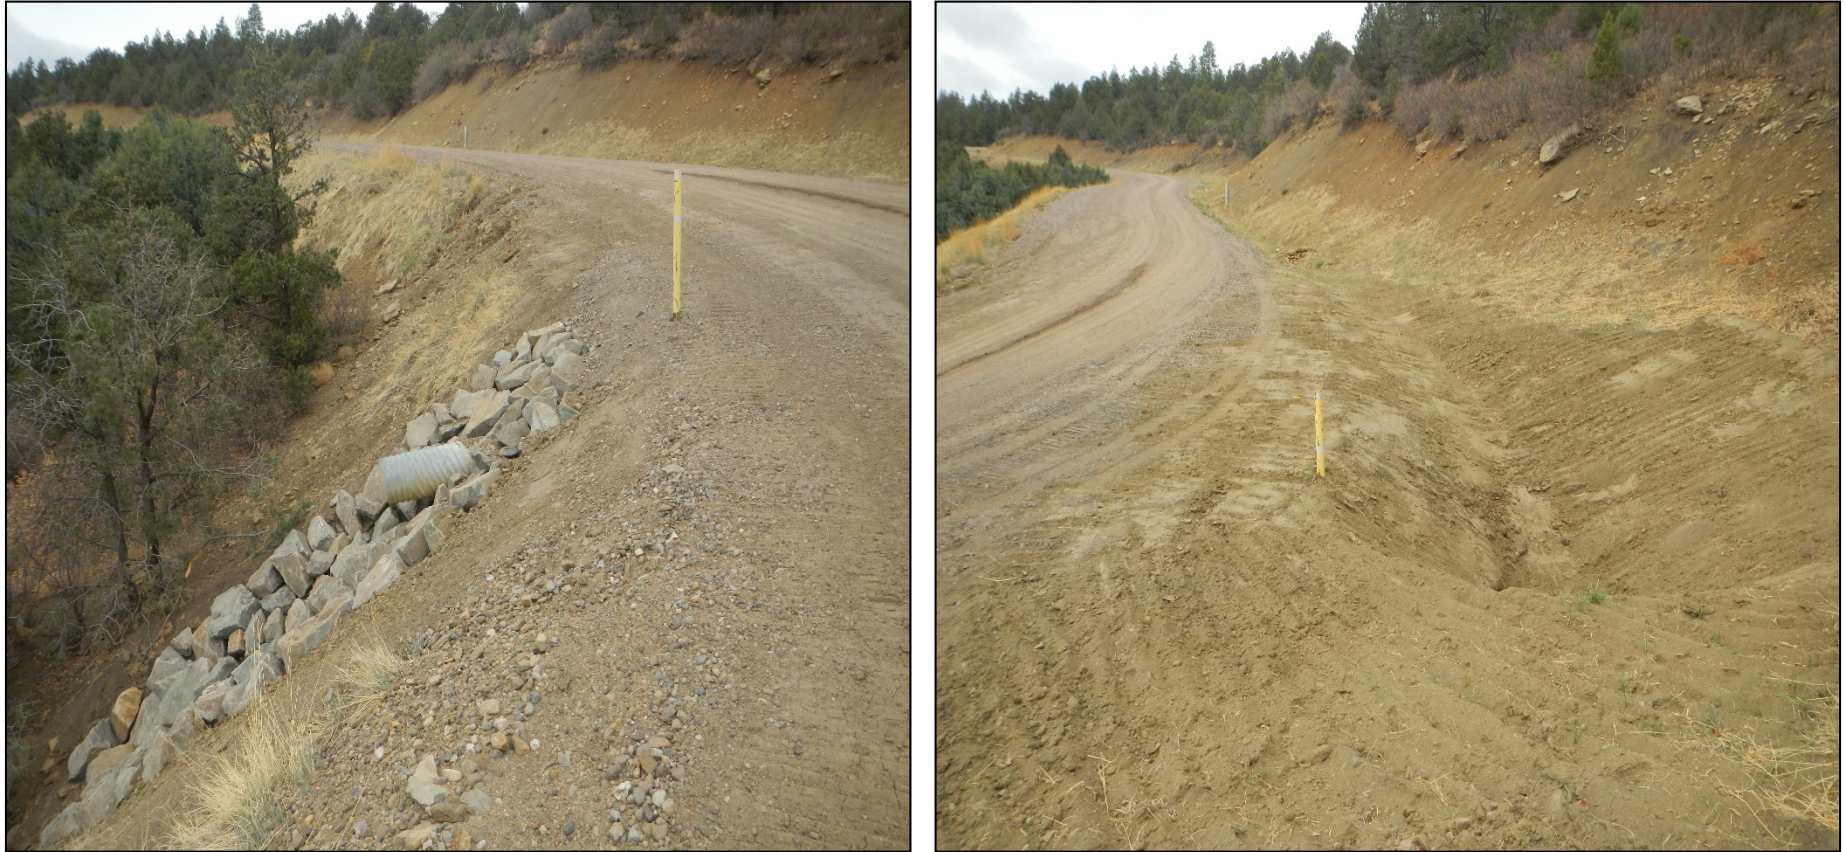
Photo 7. Further up the main road toward the location. The culvert inlet has been maintained and sediment removed. Outlet protection has been installed at culvert outlet where erosion was previously observed.

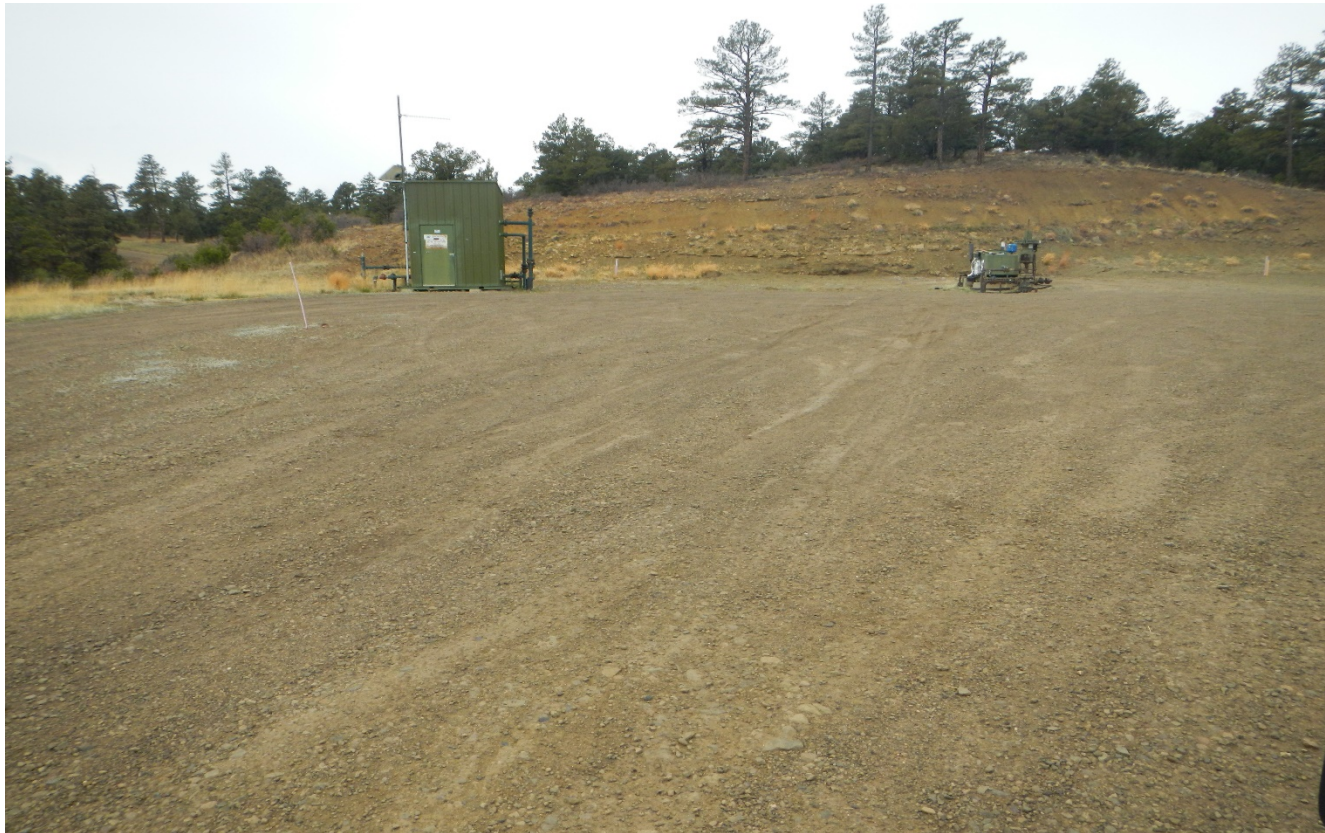
Photo 9. Facing toward the location. Well sign is posted at the meter shed.
