Inspection Photos

API: 071-09122

Operator: EVERGREEN NATURAL RESOURCES

Inspection Date: 5/11/2020

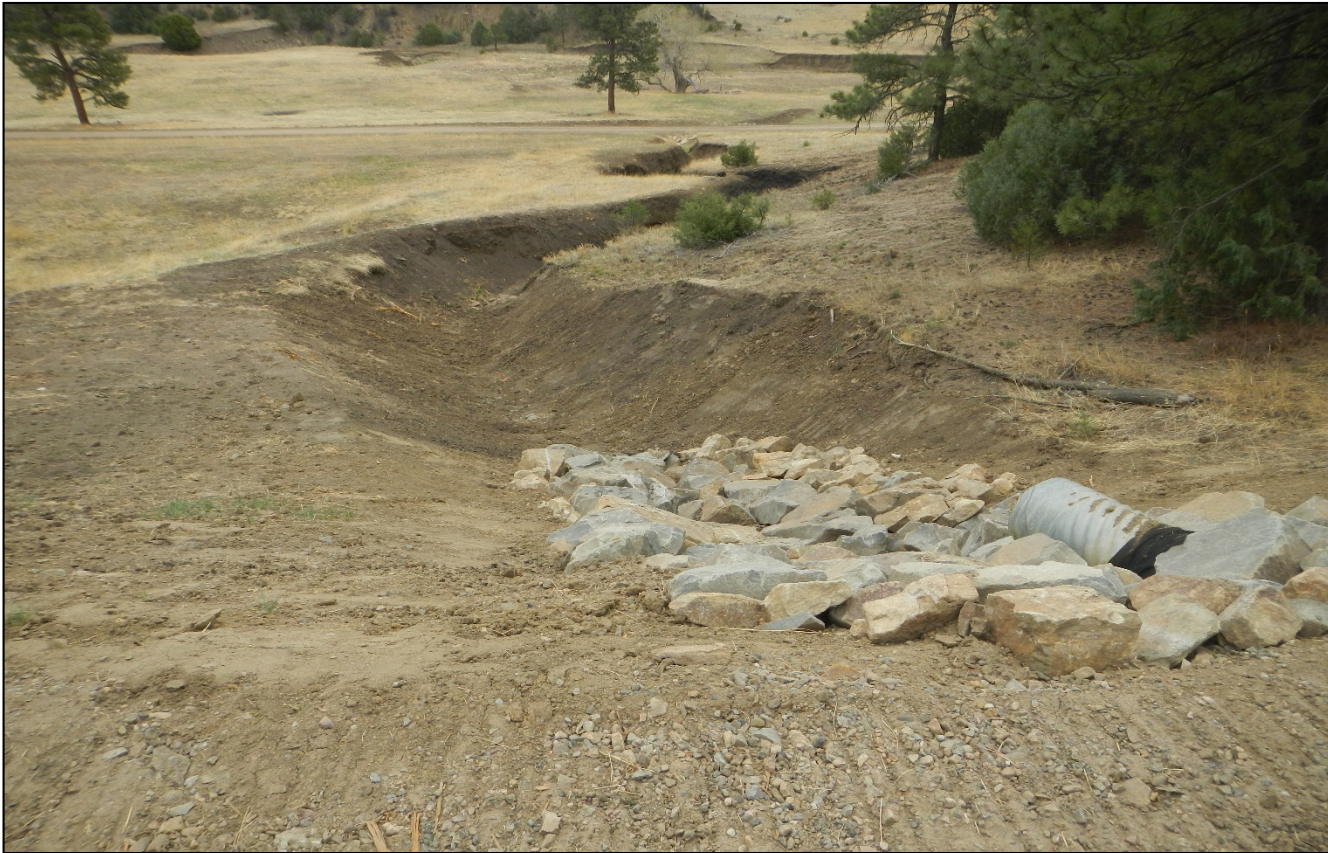
Photo 1. Outlet protection has been installed at the culvert. It appears stormwater from the road has been directed to this area causing this erosion gully. Disturbance areas caused by erosion may need to be reclaimed.

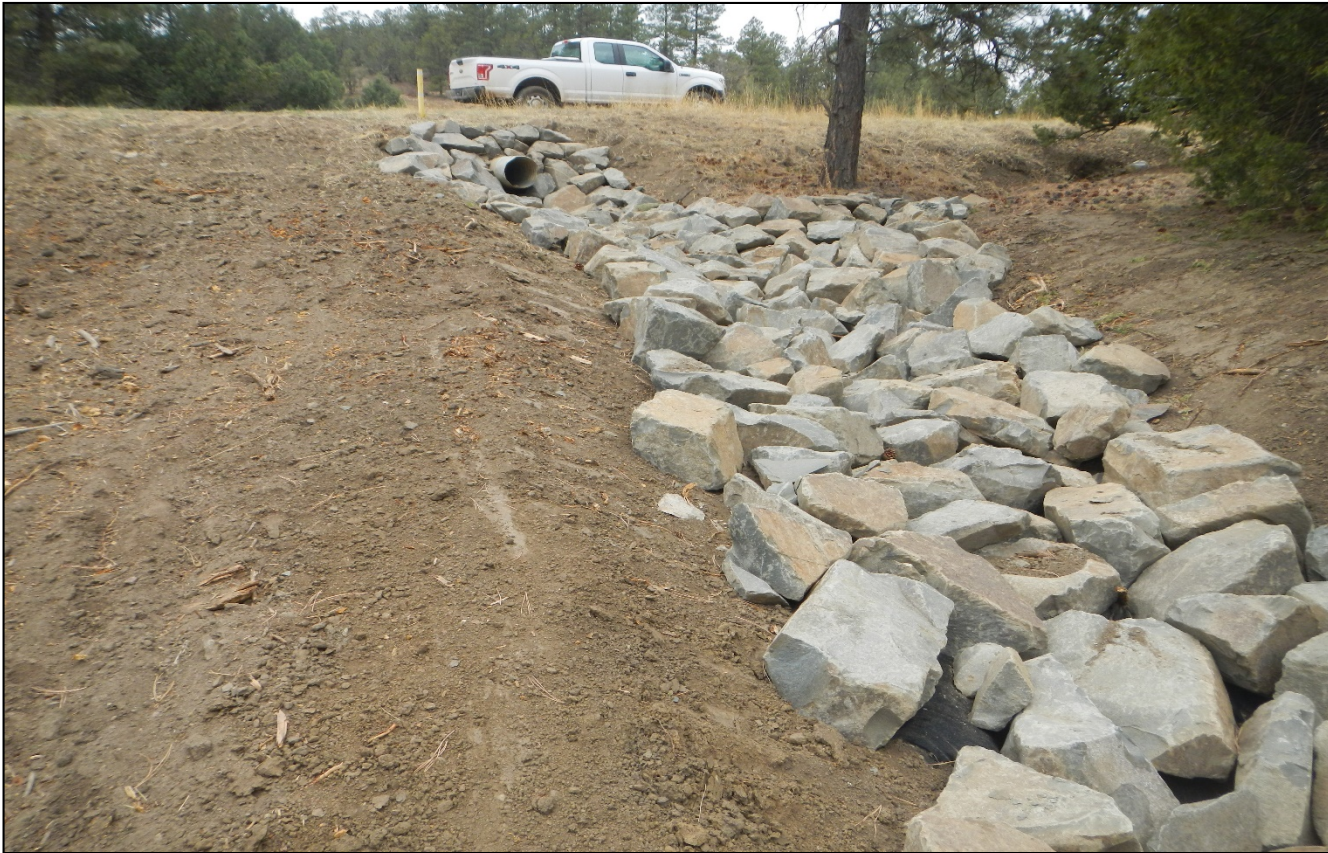
Photo 2. Further up the road, outlet protection has been installed where erosion was during previous inspection.

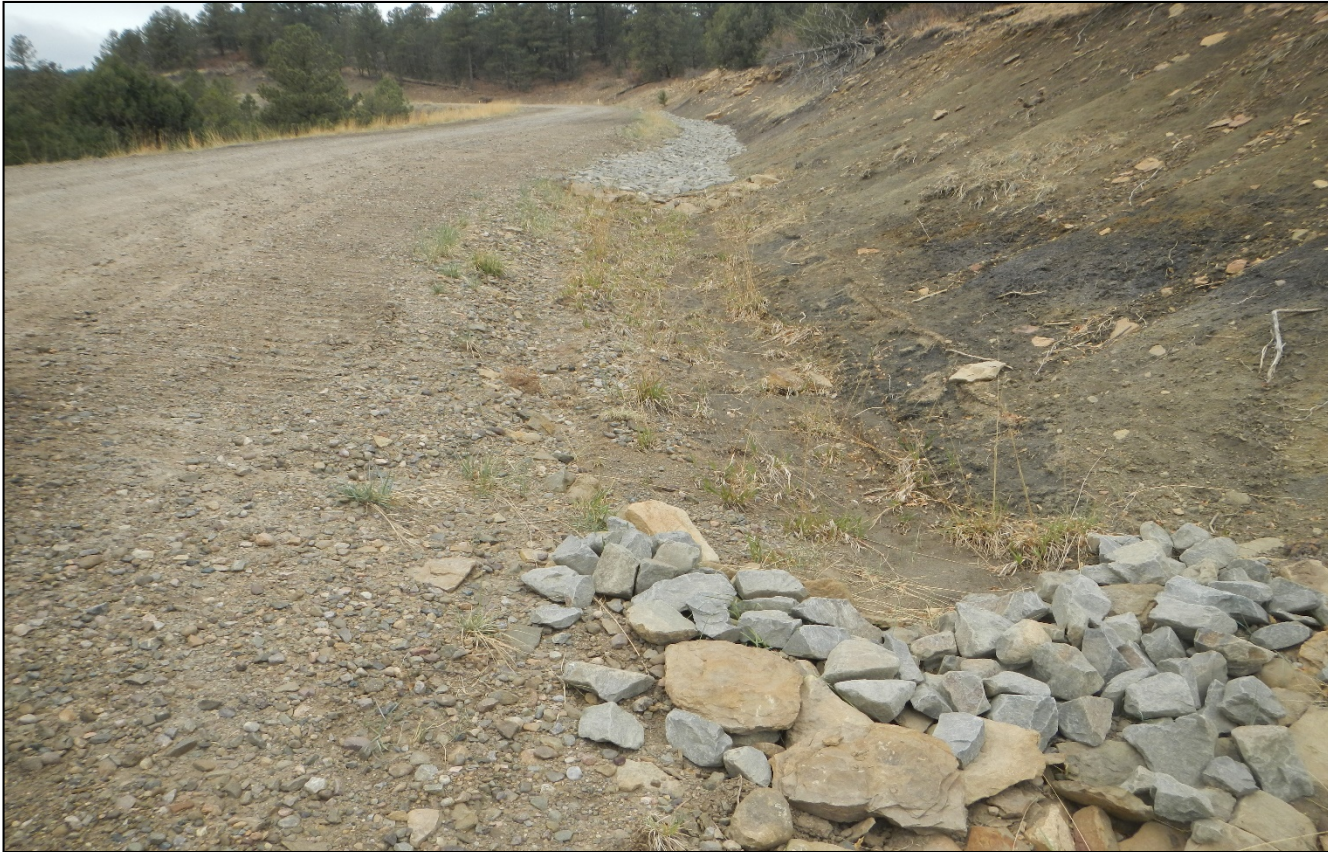
Photo 3. Additional rock rip/rap and check dams have been installed along the side of the road to prevent erosion.

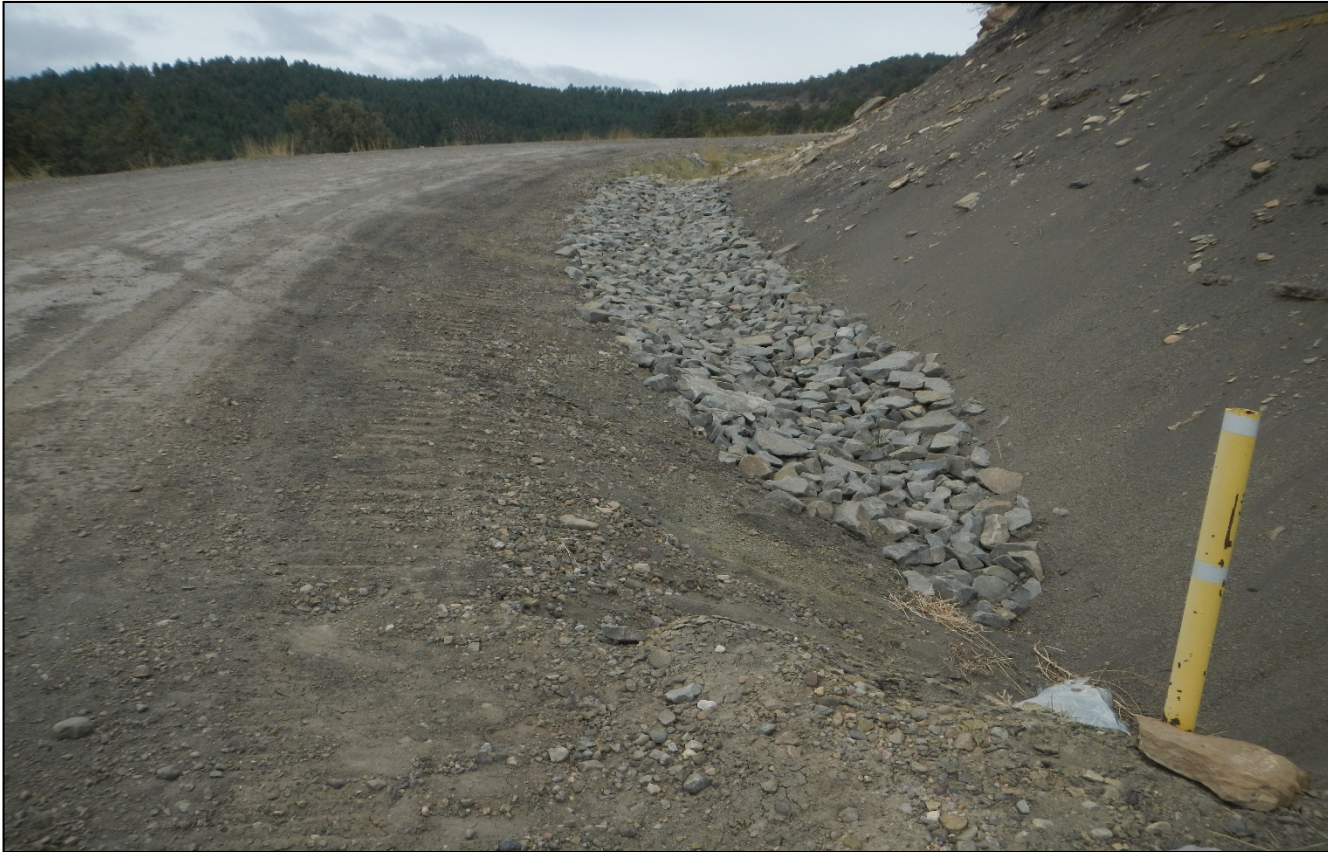
Photo 4. Rock rip/rap has been installed along the side of the road to prevent erosion. The culvert has been maintained and sediment cleaned out.

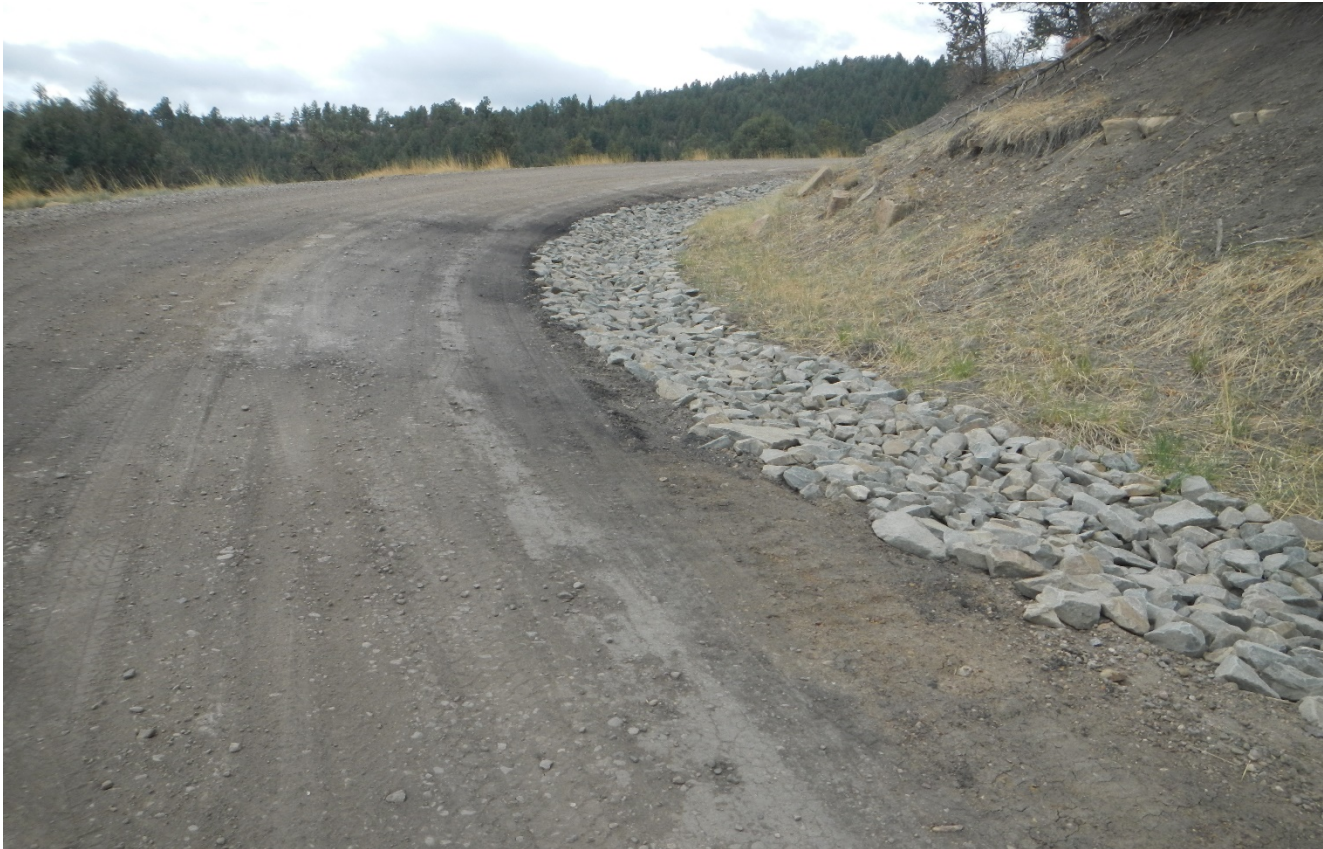
Photo 5. Further up the main road. Rock rip/rap has been installed along the side of the road to prevent erosion.

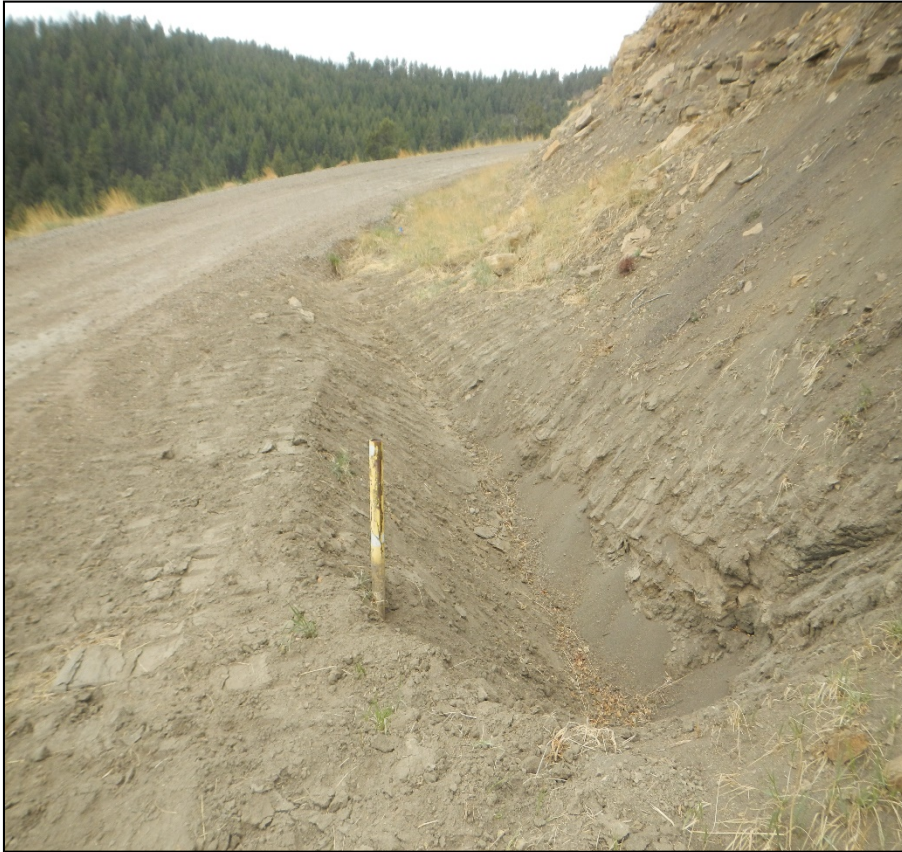
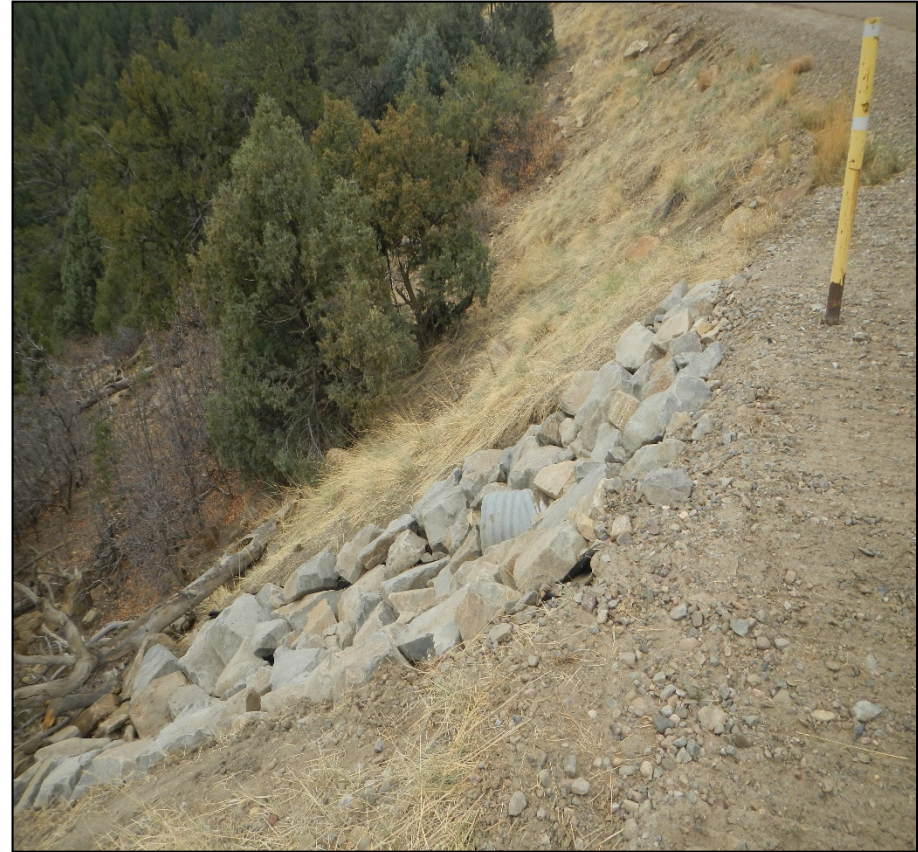
Photo 6. The culvert inlet has been maintained and sediment removed. Outlet protection has been installed at culvert outlet where erosion was previously observed.

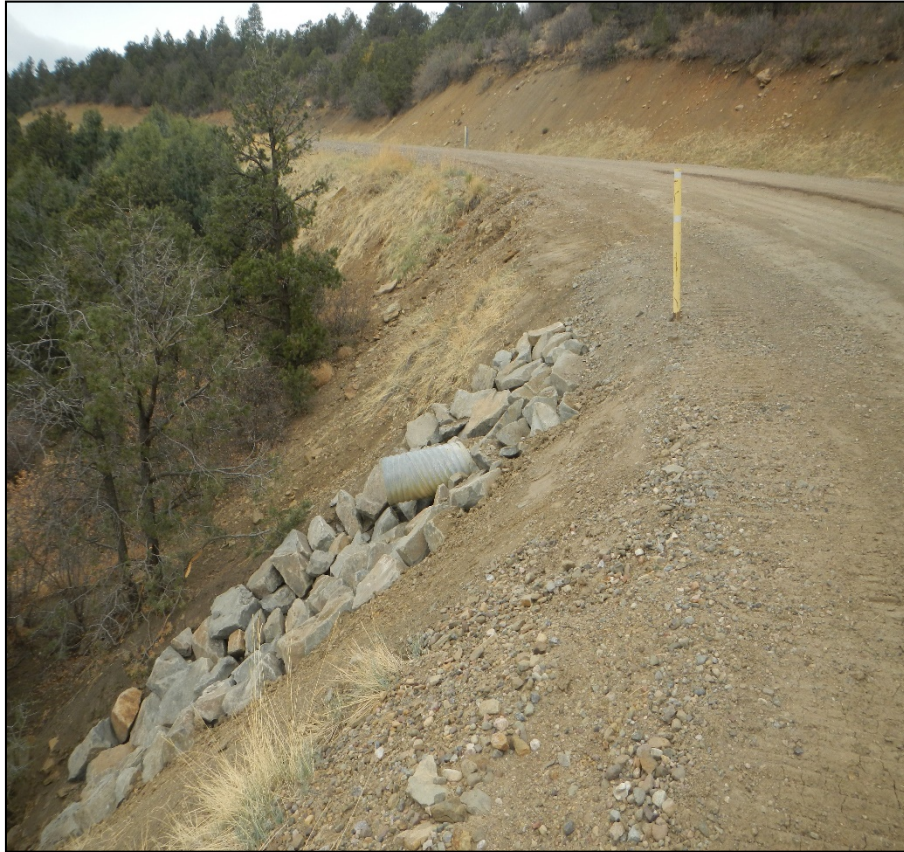
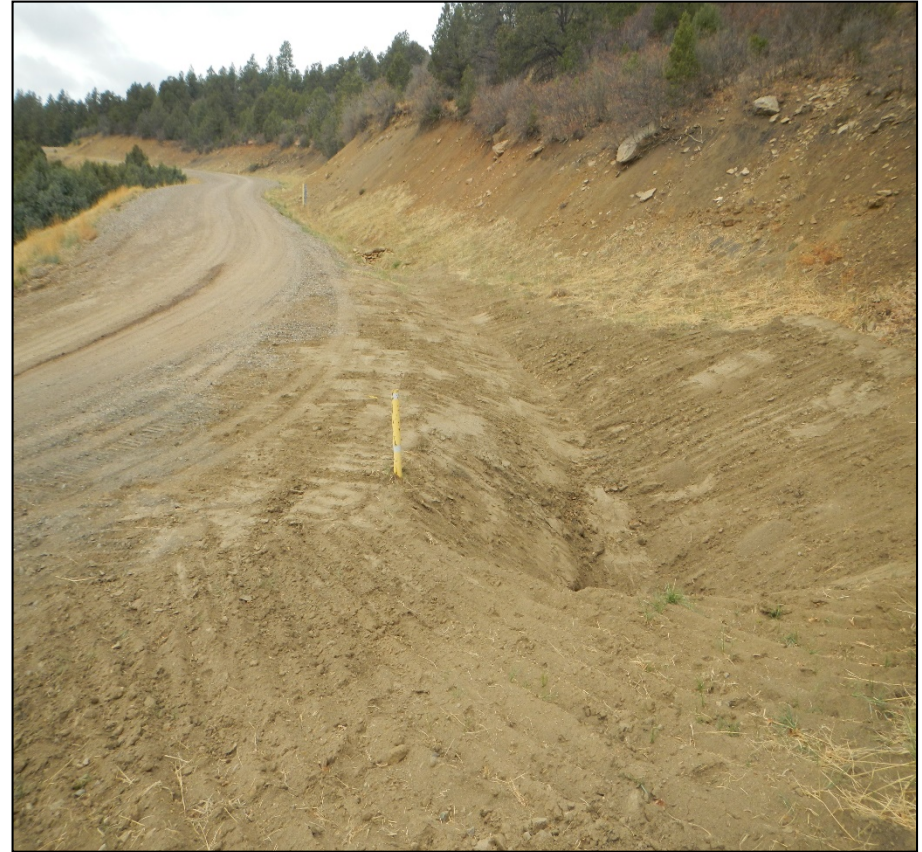
Photo 7. Further up the main road toward the location. The culvert inlet has been maintained and sediment removed. Outlet protection has been installed at culvert outlet where erosion was previously observed.

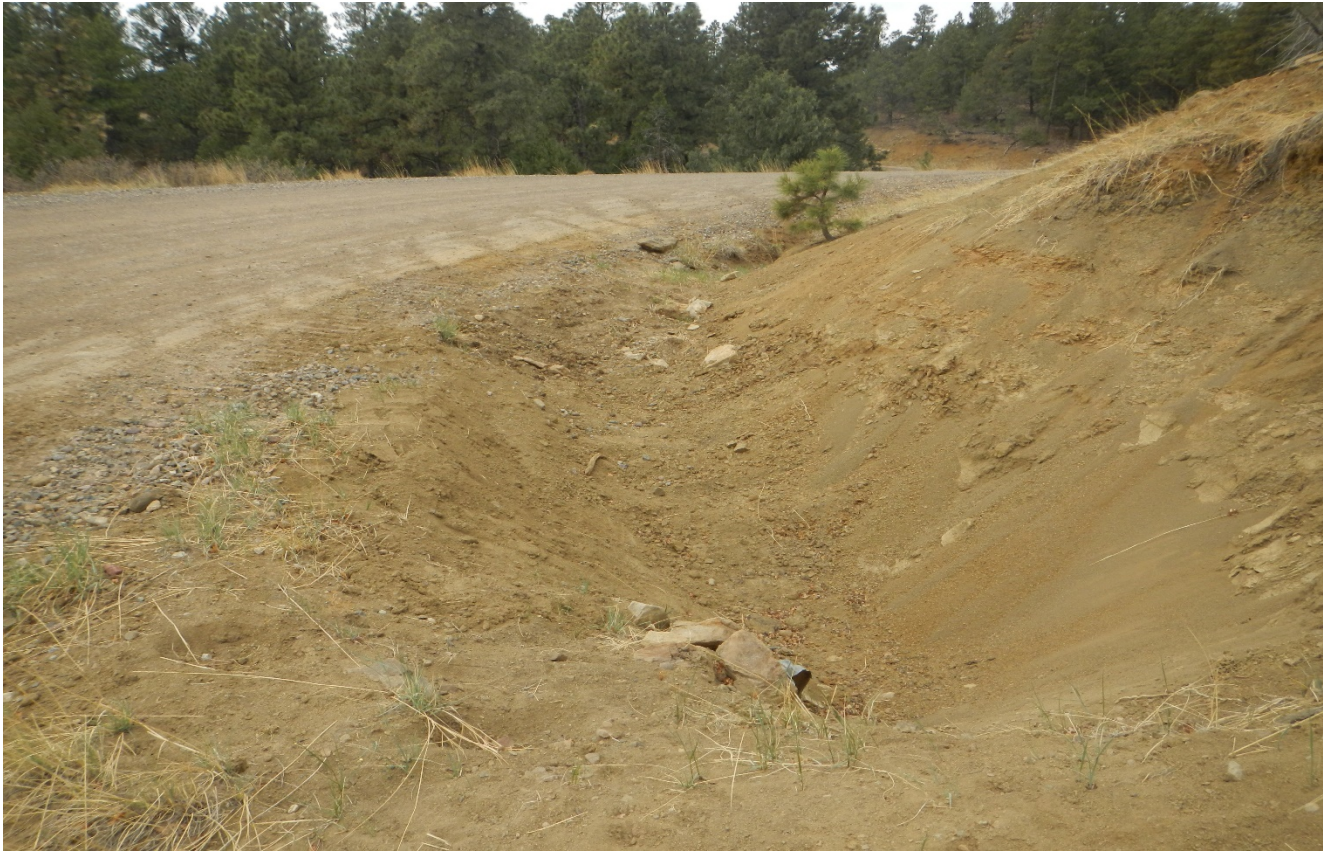
Photo 8. This culvert along the main road has filled in with sediment.

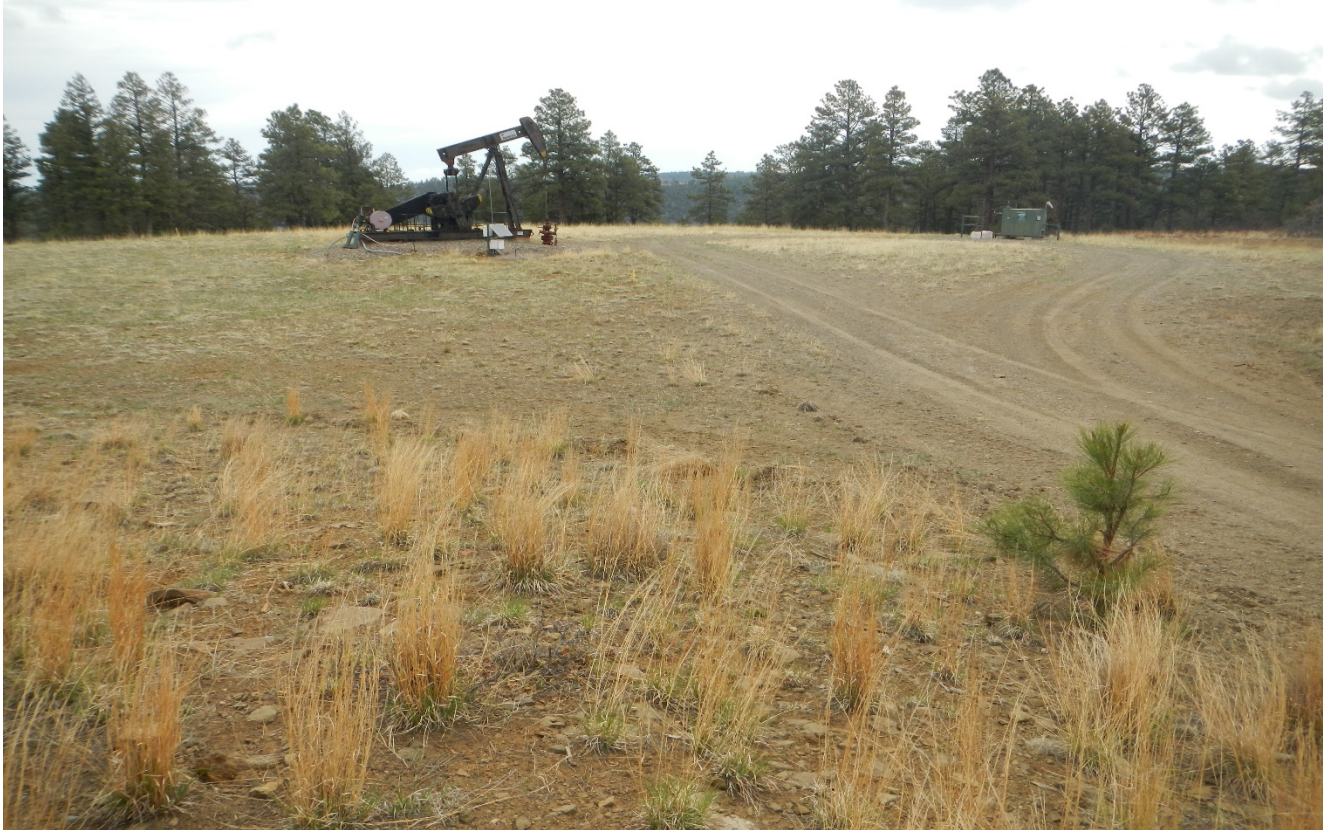
Photo 9. Facing southeast toward the location. Vegetation is well established in the interim area.
