Inspection Photos

API: 071-09034

Operator: EVERGREEN NATURAL RESOURCES

Inspection Date: 5/11/2020

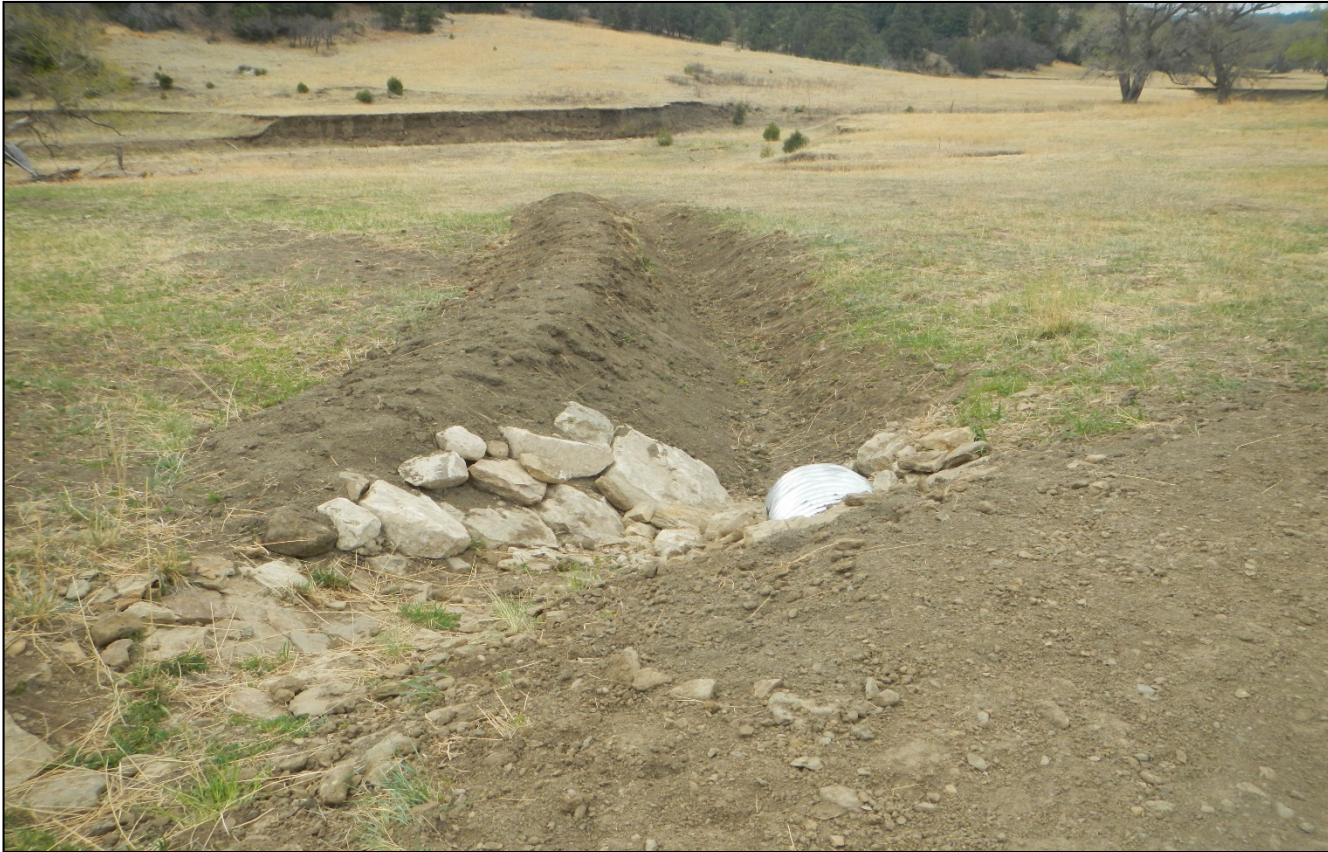
Photo 1. The culvert outlet has been repaired. Additional outlet protection may be needed to prevent erosion of the diversion ditch.

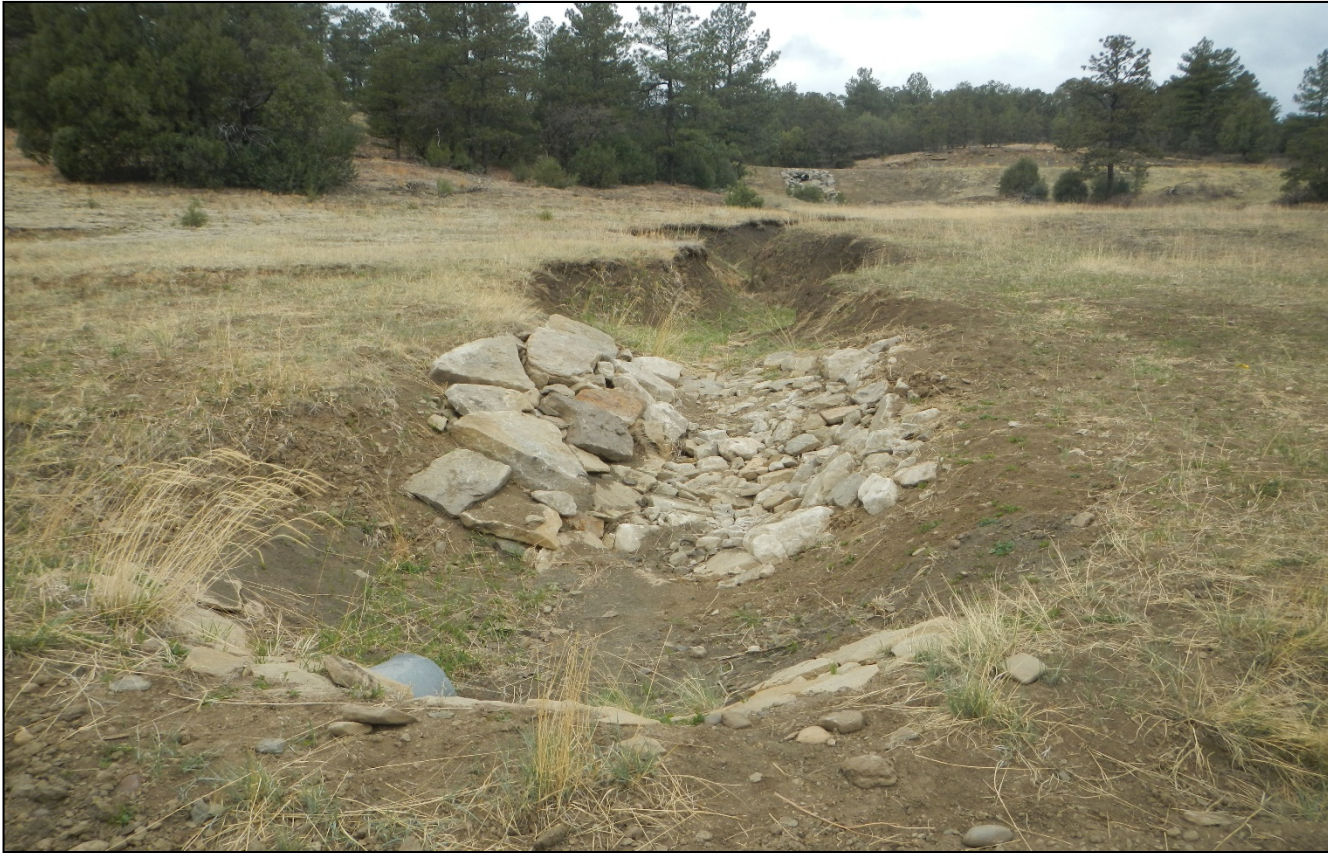
Photo 2. Facing toward the culvert inlet. Additional culvert inlet protection was installed. Disturbance areas caused by erosion may need to be reclaimed.

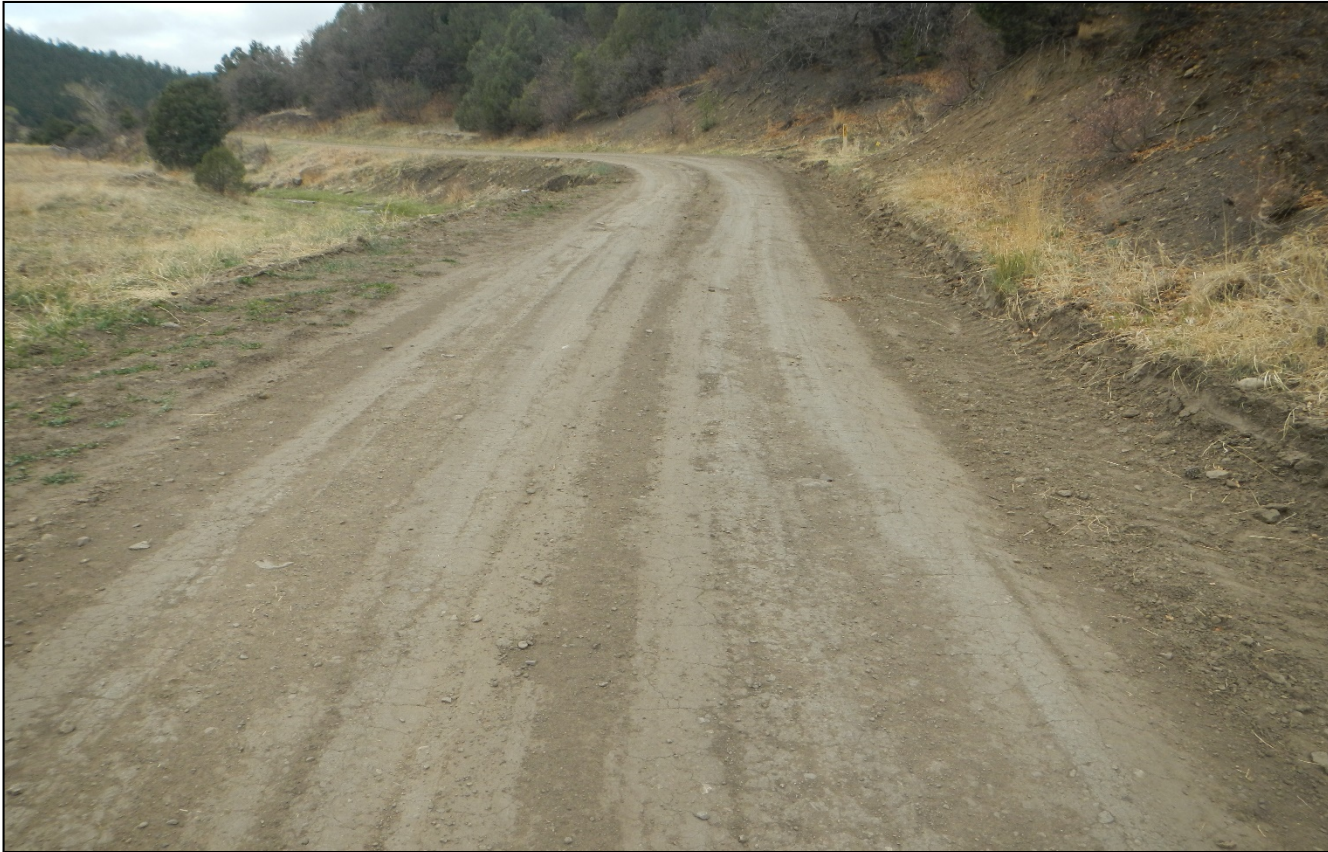
Photo 3. The vehicle rutting along the road has been repaired.

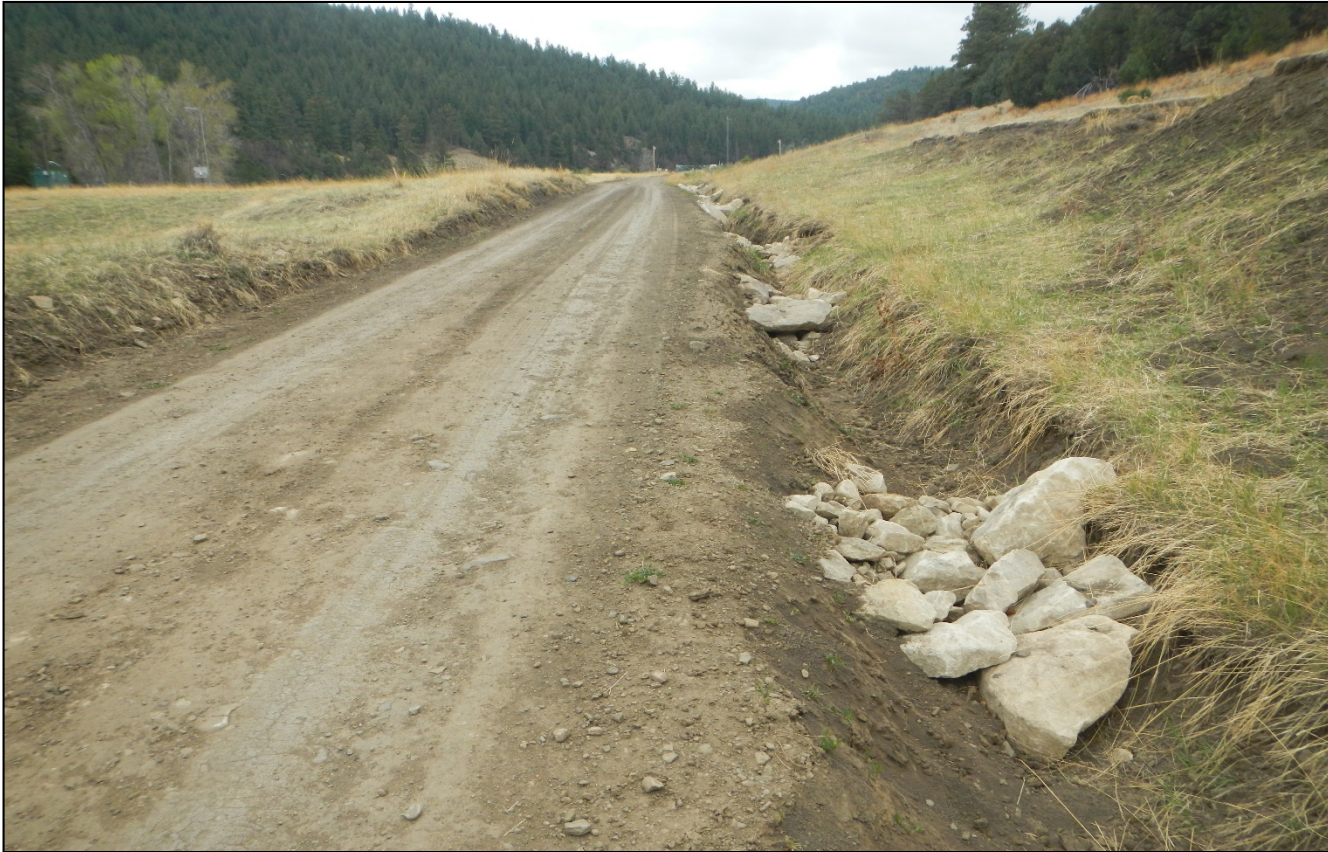
Photo 4. Rock check dams have been installed along the side of the road where erosion occurred. This will need to be monitored to ensure stormwater does not flow around the check dams causing further erosion.

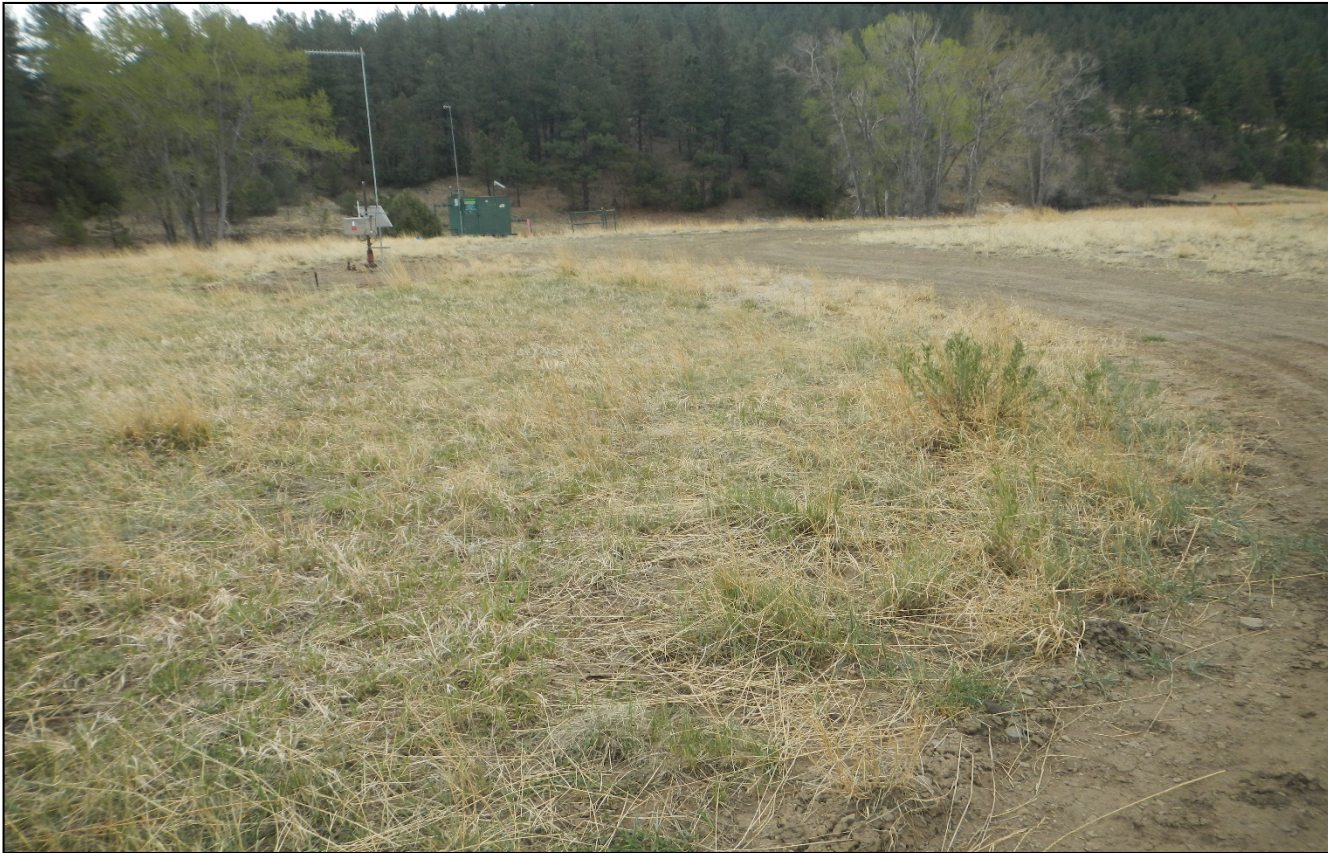
Photo 5. Facing toward the location.
