Inspection Photos

API: 071-08508

Operator: EVERGREEN NATURAL RESOURCES

Inspection Date: 5/11/2020

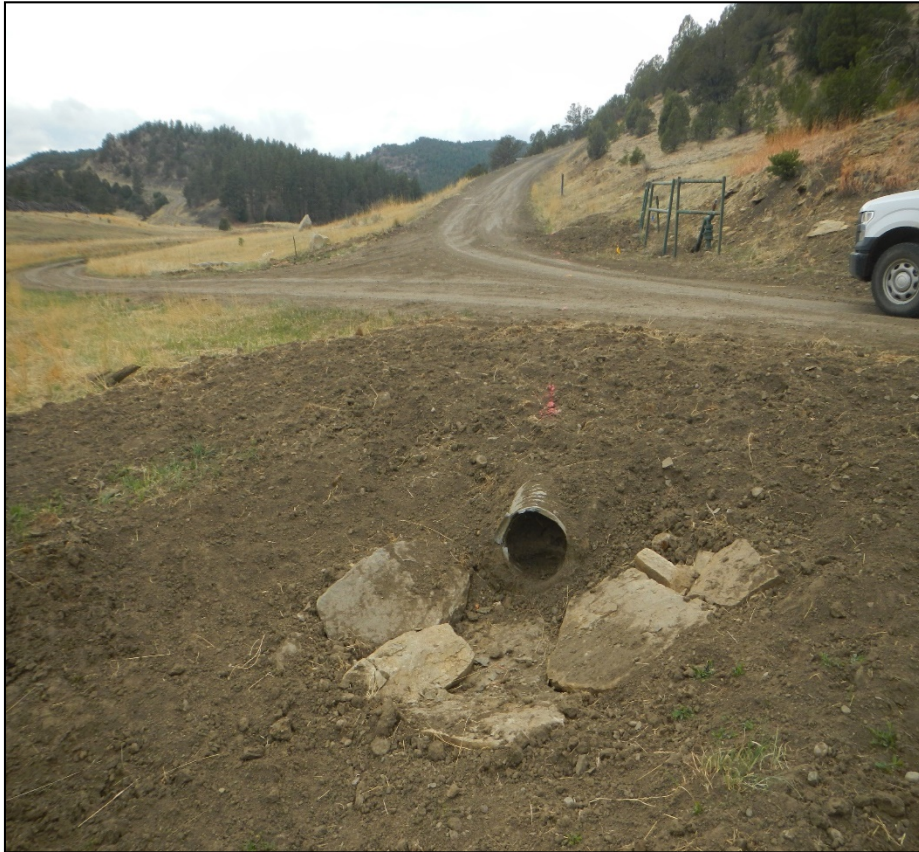
Photo 1. The culvert along the main road has been repaired however, the culvert is filled in with sediment which will create issues.

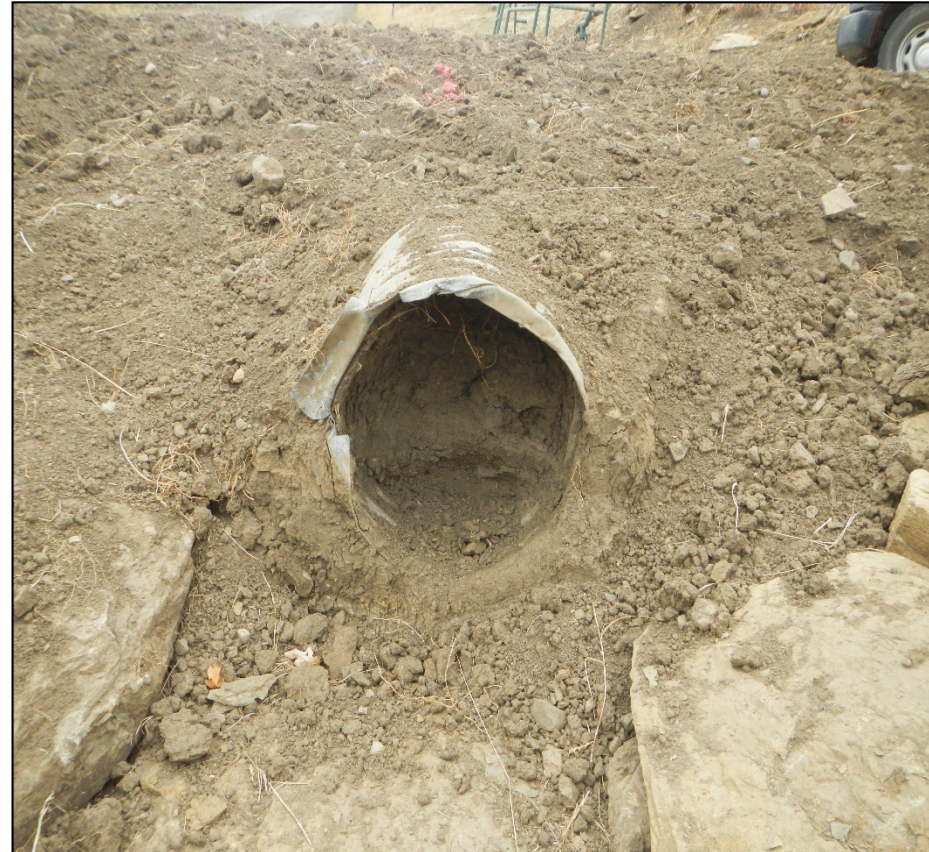
Photo 2. The culvert was observed to be full of sediment on both ends. This culvert will likely need to be replaced.

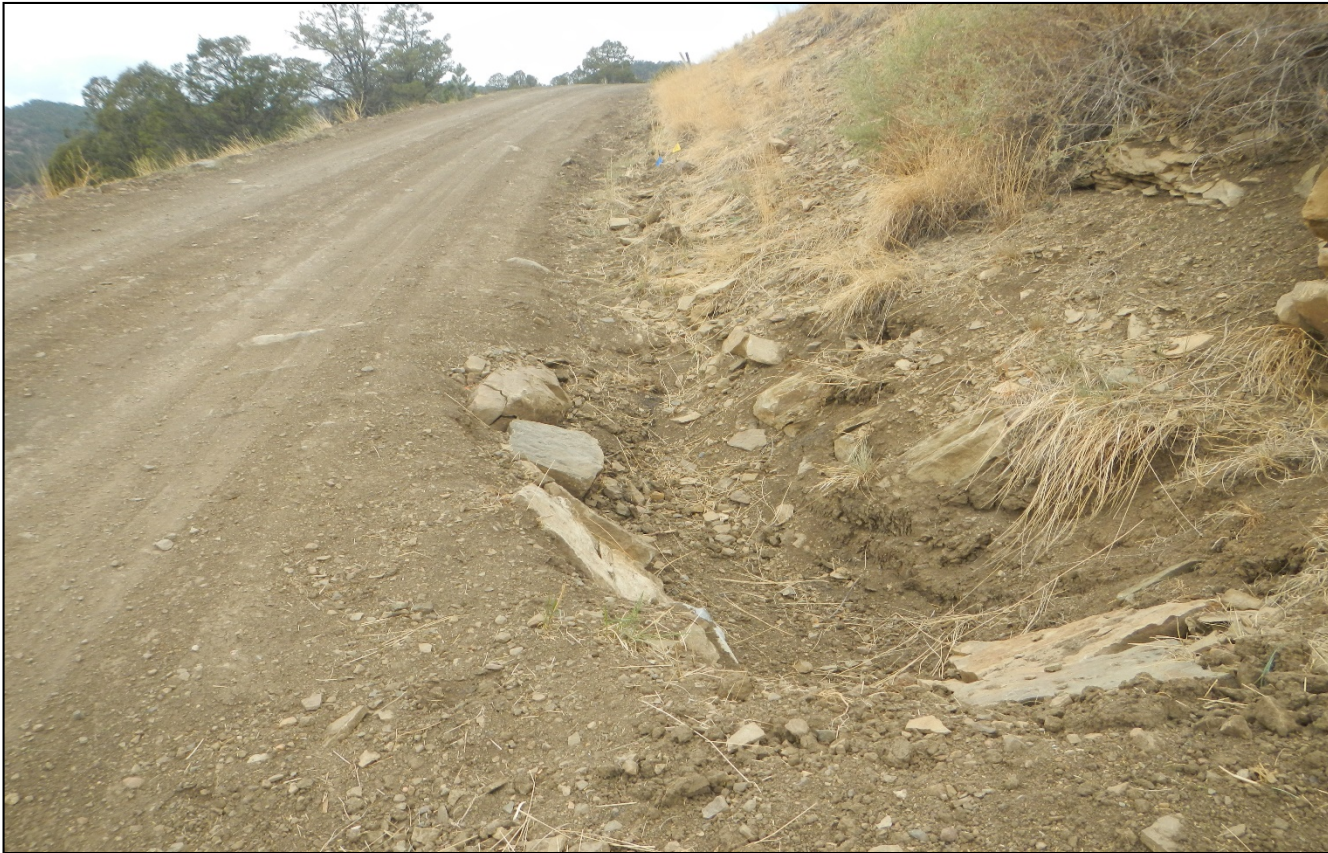
Photo 3. The culvert inlets along the road leading to the location have been repaired.

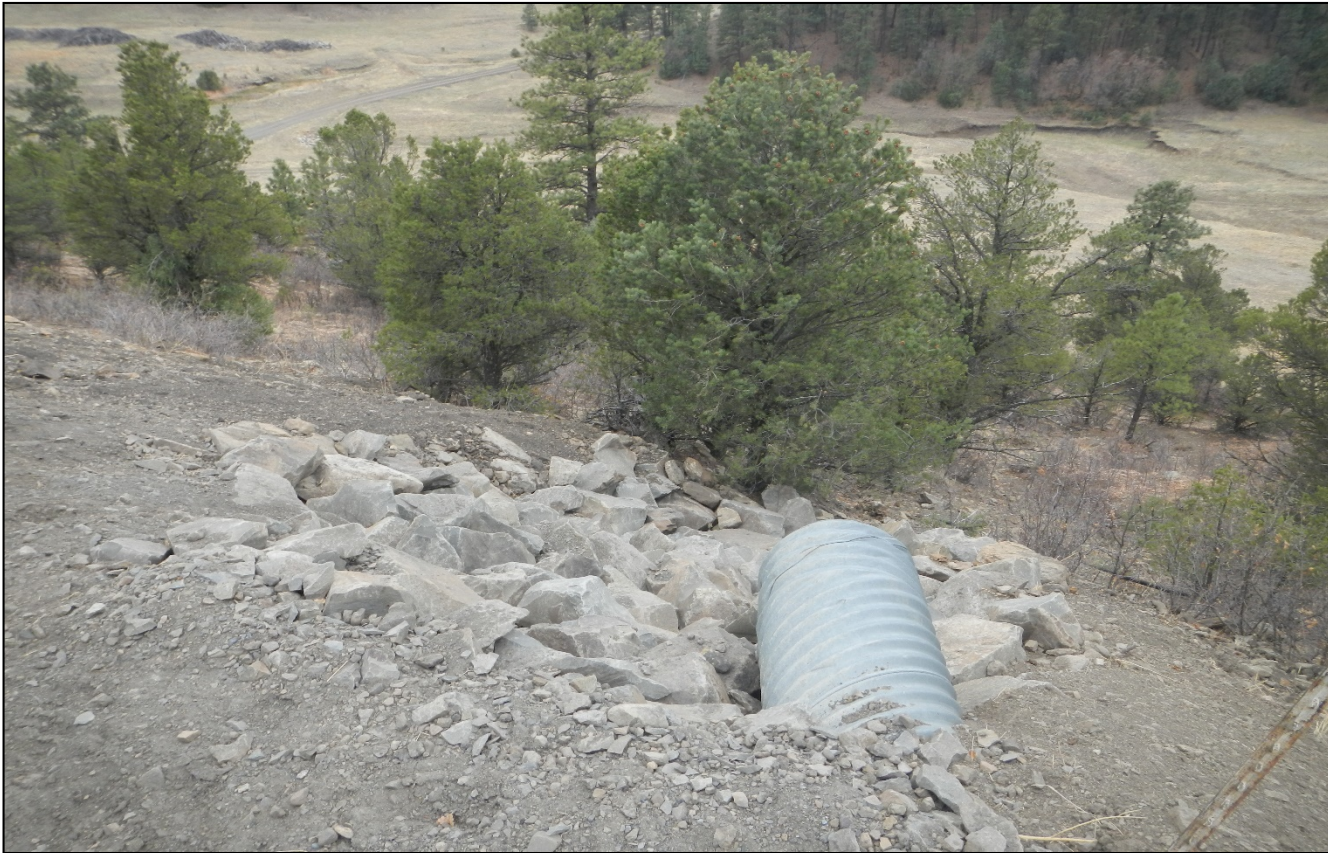
Photo 3. Culvert outlet protection has been installed on some of the culverts leading to the location.
