Inspection Photos
Operator Name: Caerus Piceance LLC
Location: 413481

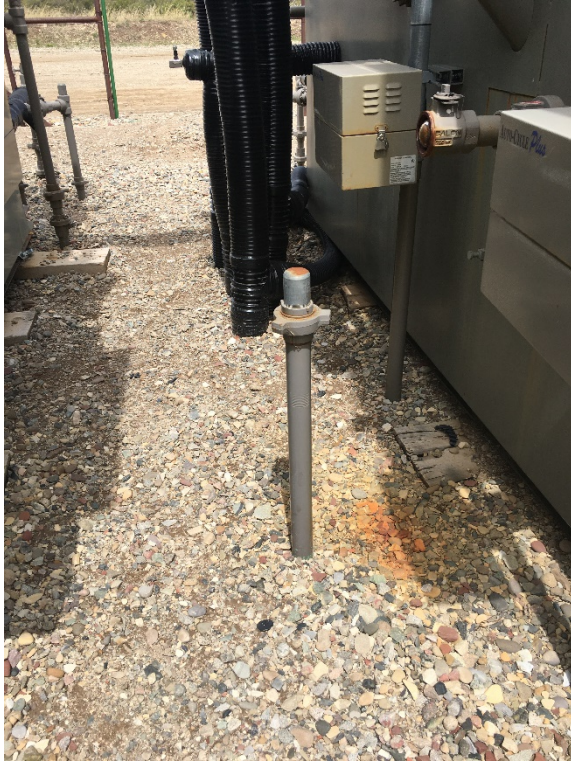
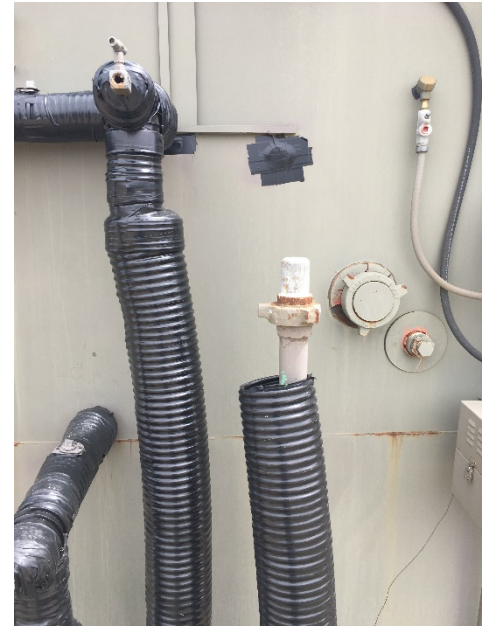
2" unmarked risers

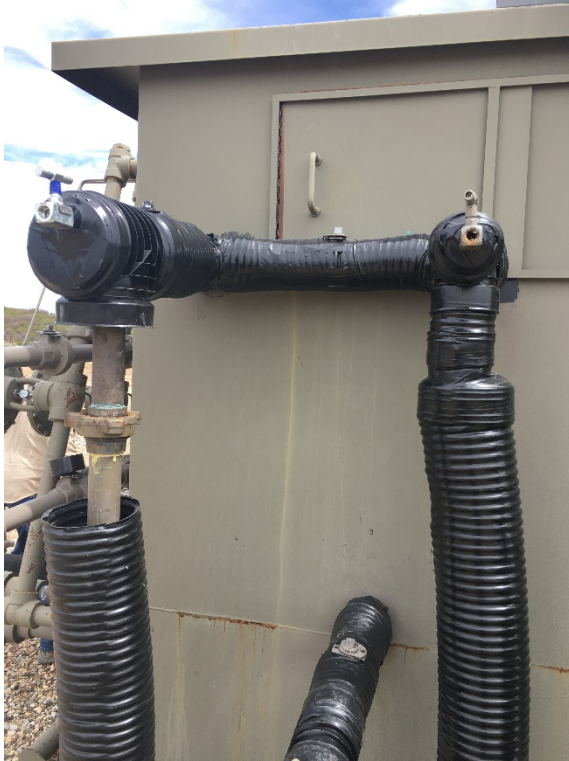
Flowline failure was on produced water dump line. (left side) Wells are still producing. Operator has manifold at separator and is dumping produced water and oil into one dumpline and into one tank.
