Inspection Photos

5/07/2020

Operator: CAERUS PICEANCE LLC # 10456

Location ID: 335618

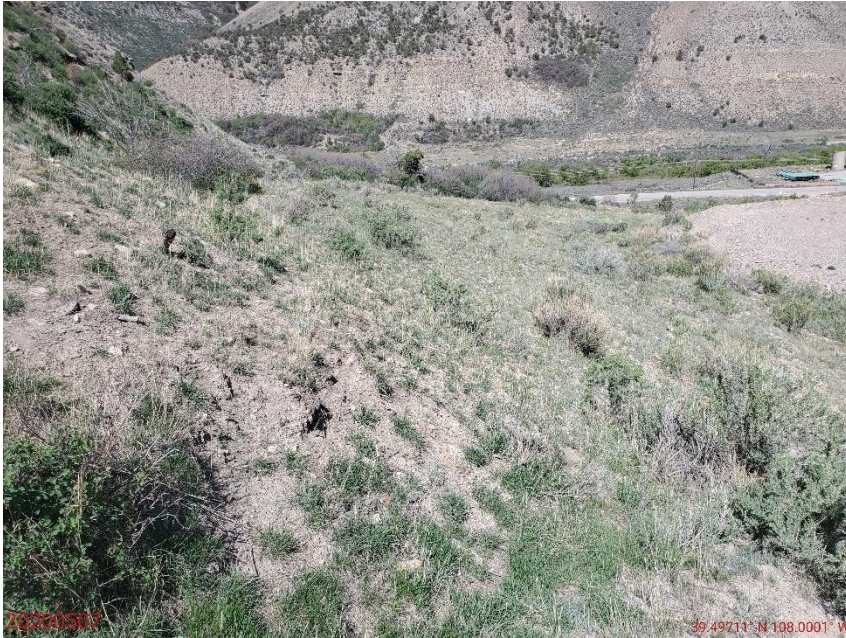
Photo 1: Photo taken south end of the Location, facing west. Photo 1-4 provide an overview of the Location and current interim areas from west, northwest, northeast to east.

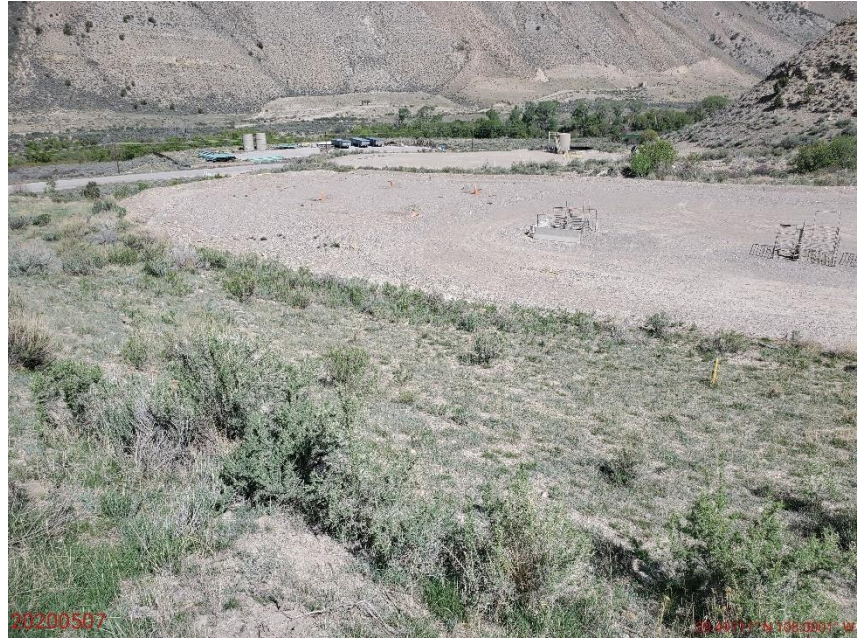
Photo 2: See comments under photo 1.

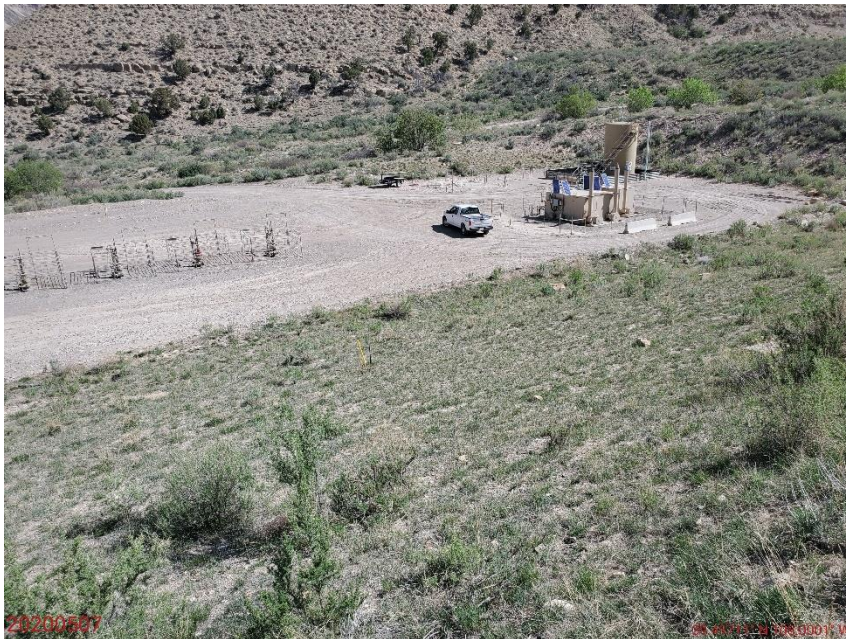
Photo 3: See comments under photo 1.

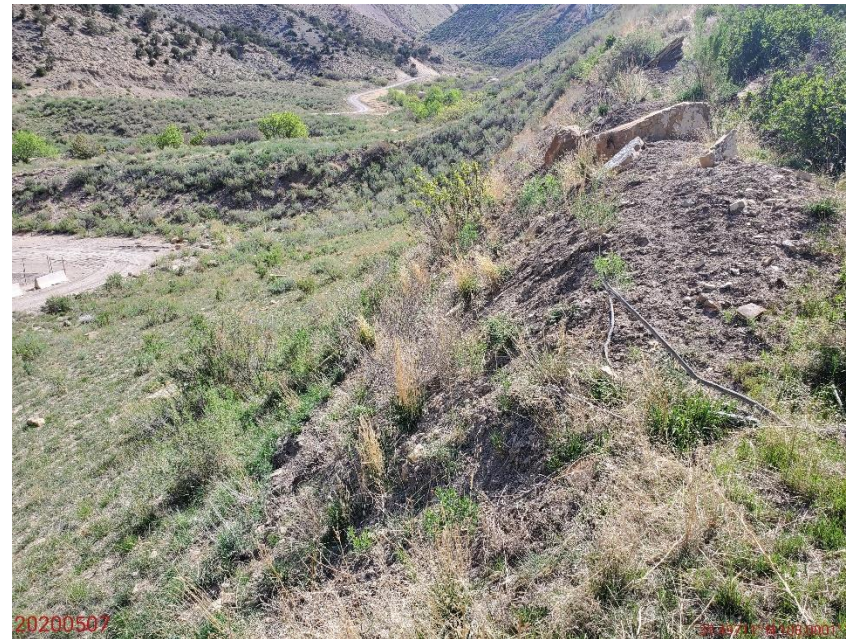
Photo 4: See comments under photo 1.

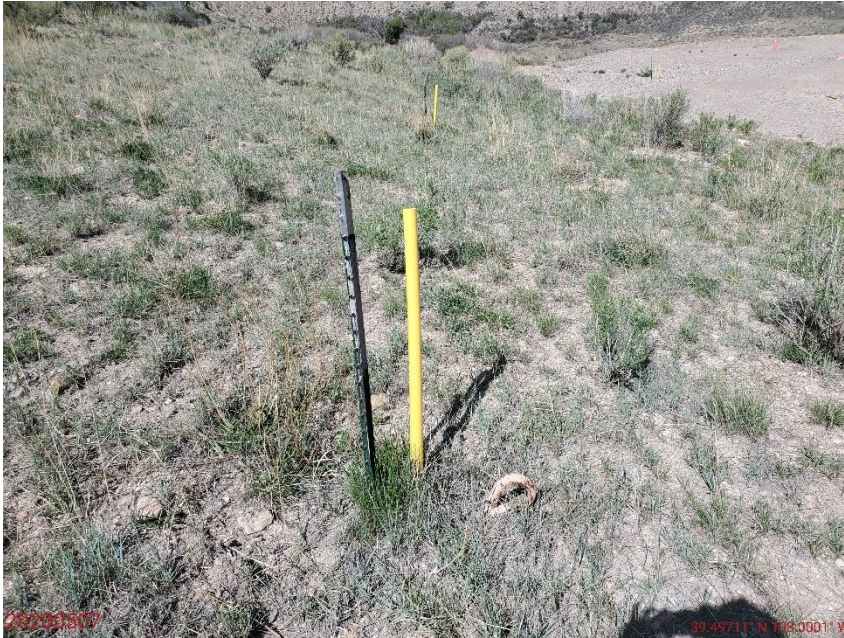
Photo 5: Photo taken from the north end of the Location. Photo shows anchors have been properly marked in accordance with Rule 1003.a

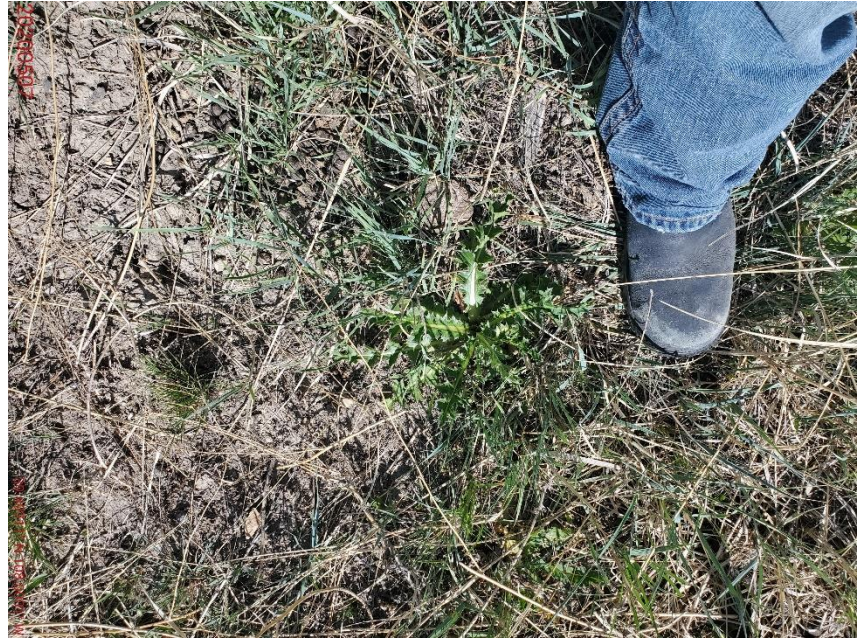
Photo 6: Photo taken from the southwest interim areas. Photo shows what appears to be Carduus nutans rosette. This is a Colorado State Listed Noxious weed and requires management.

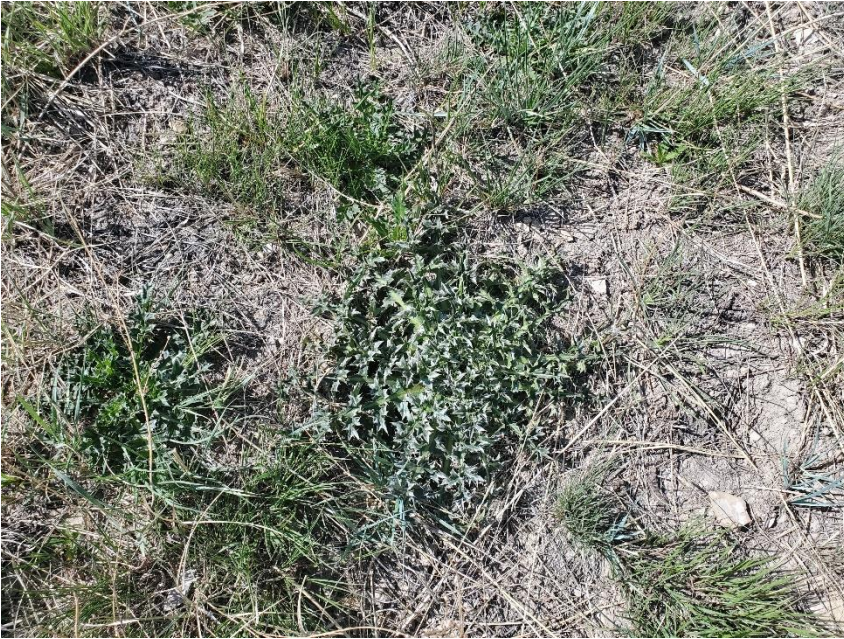
Photo 7: Photo taken from the western interim areas. Photo shows what appears to be Carduus nutans rosette. This is a Colorado State Listed Noxious weed and requires management.

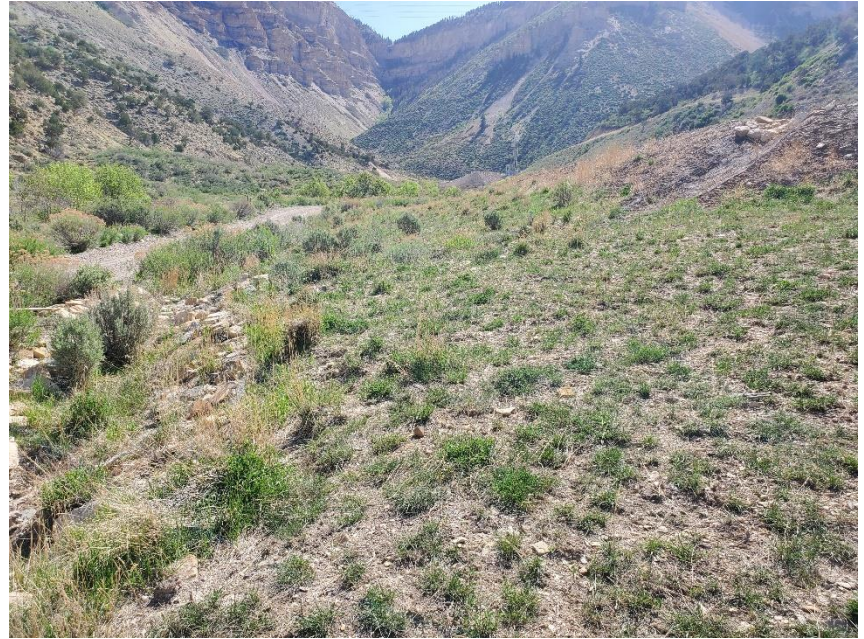
Photo 8: Photo taken from the northwest interim areas, facing east. Photo shows overview of the interim areas.

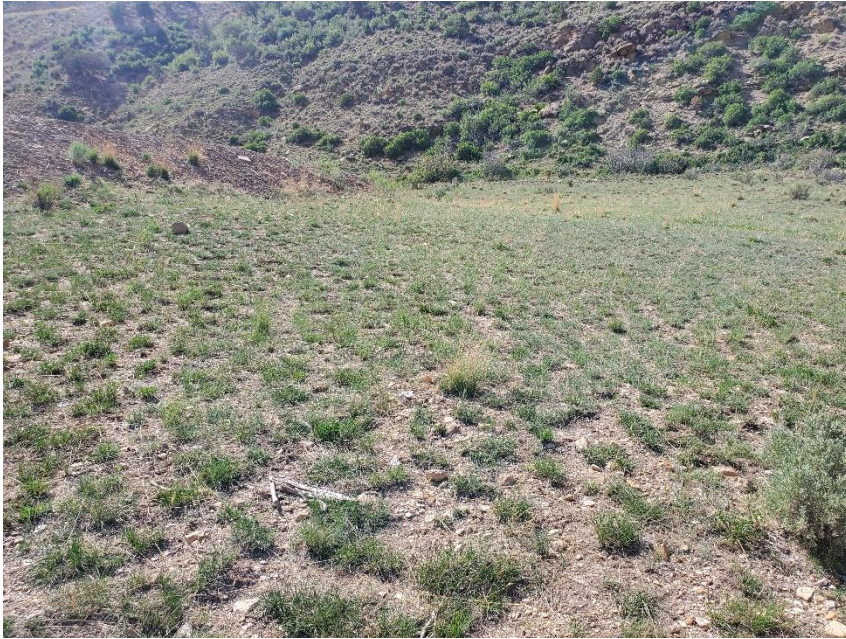
Photo 9: Photo taken from the northwest interim areas, facing south. Photo shows overview of the interim areas.

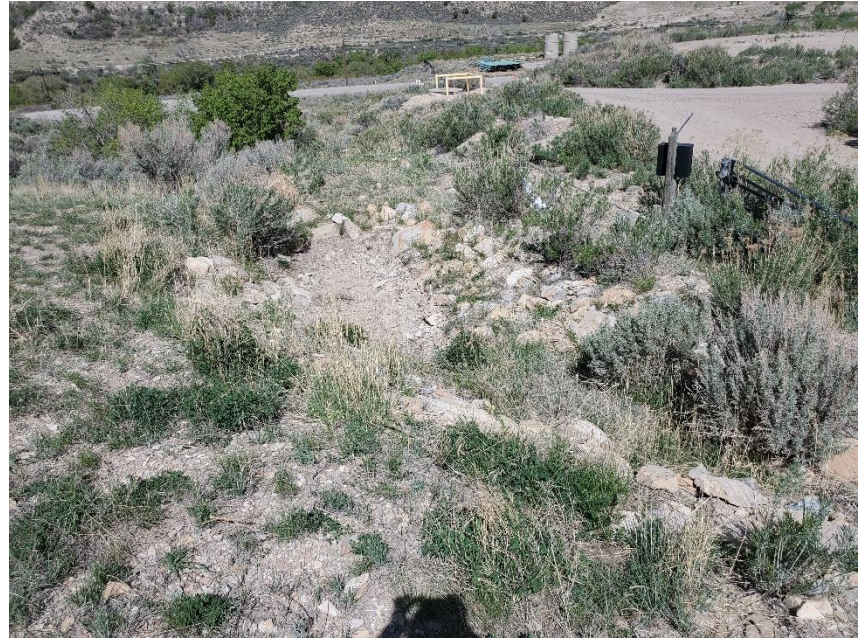
Photo 10: Photo taken from the northwest interim areas. Photo shows sediment trap.

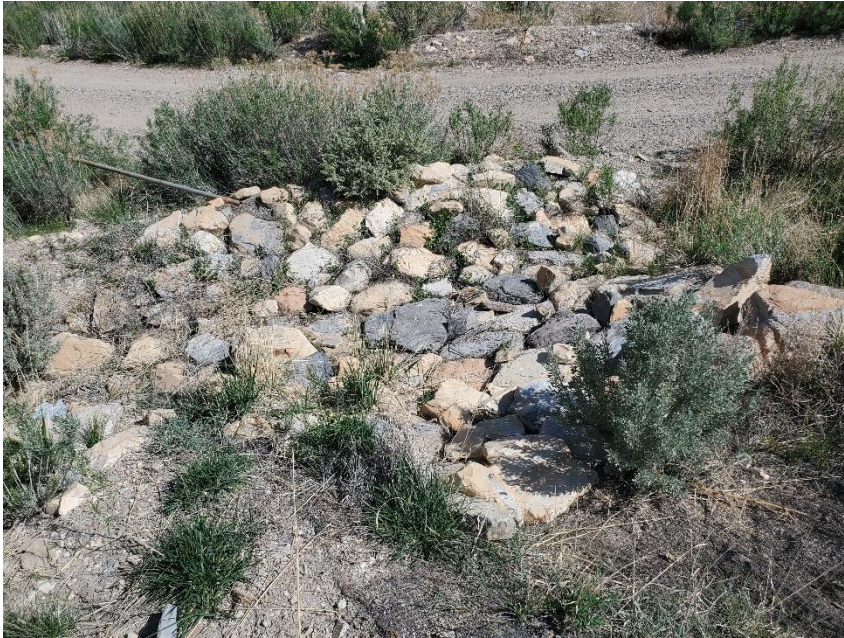
Photo 11: Photo of sediment trap adjacent to the access road northwest of the Location.

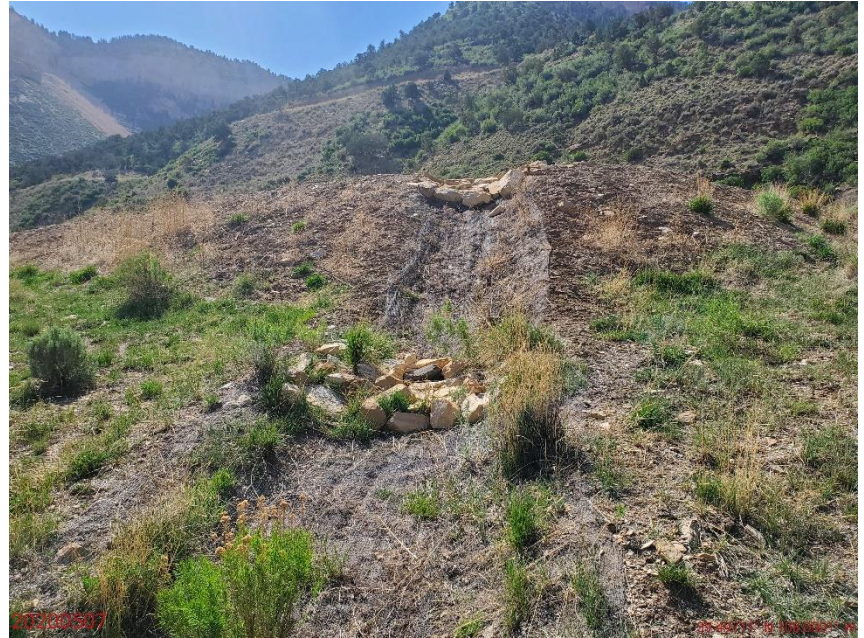
Photo 12: Photo taken from the northwest corner of the fill slope/pad. Photo shows rock checks and outlet.

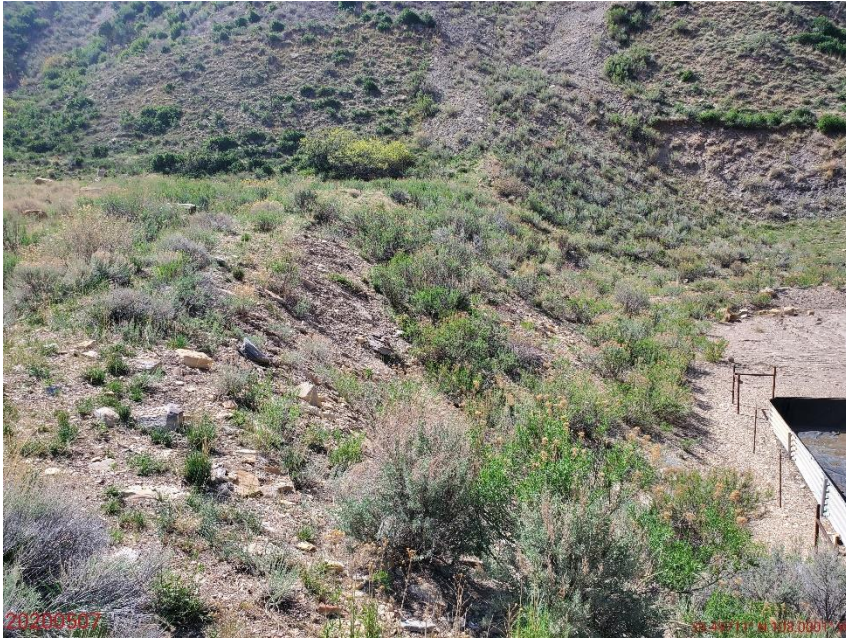
Photo 13: Photo taken from northeast corner of the Location, facing south. Photo provides overview of the Location and interim areas.

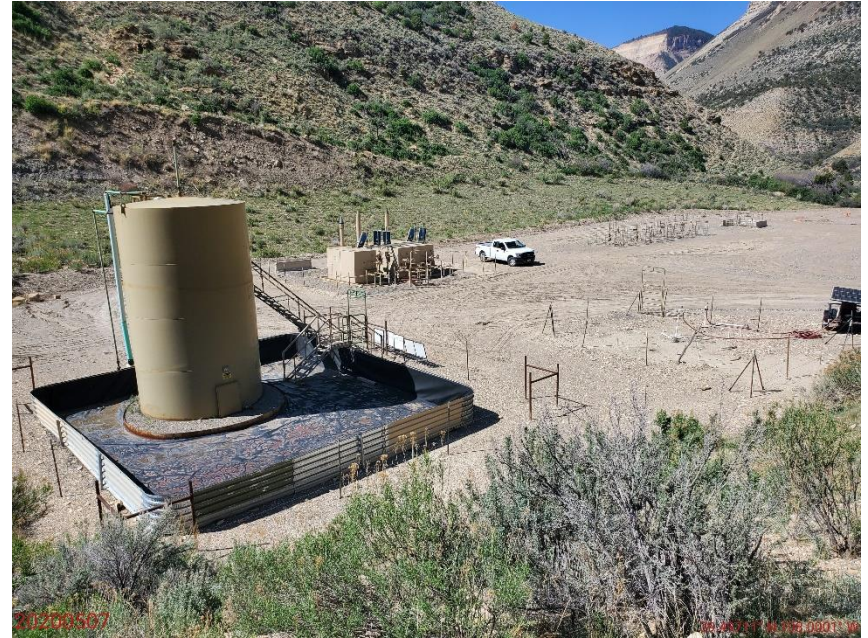
Photo 14: Photo taken from northeast corner of the Location, facing southwest. Photo provides overview of the Location and interim areas.

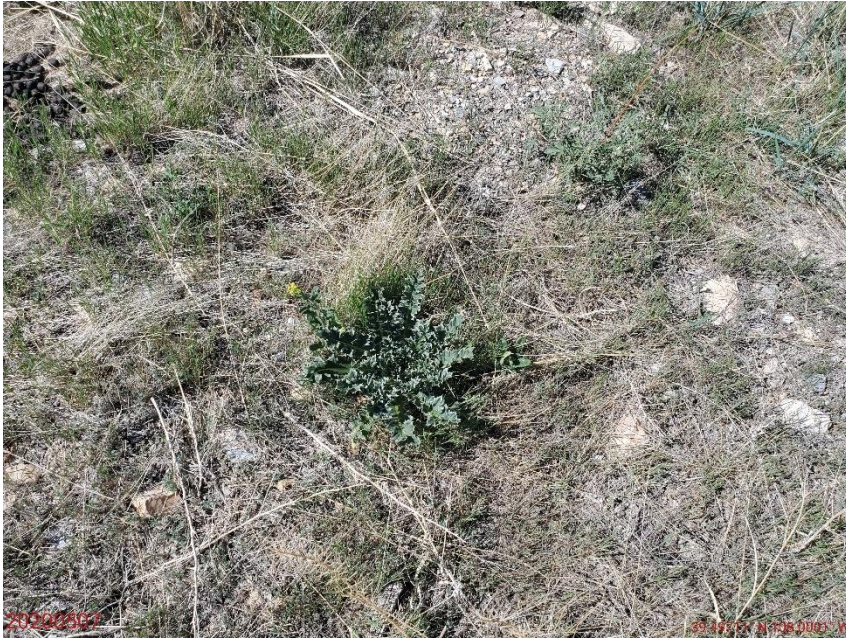
Photo 15: Photo taken from the east end of the Location. Photo shows what appears to be Carduus nutans rosette. This is a Colorado State Listed Noxious weed and requires management.

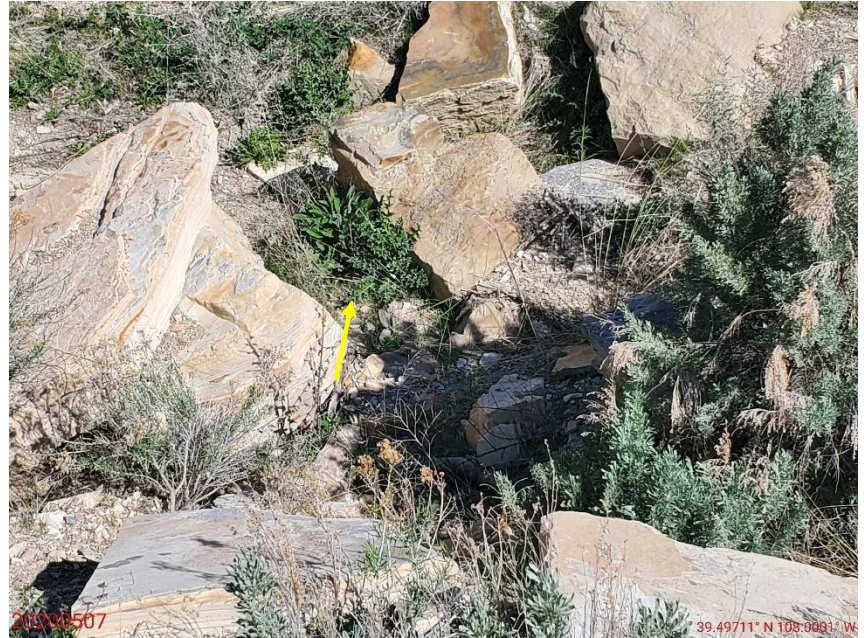
Photo 16: Photo taken from the east end of the Location. Photo shows what appears to be Carduus nutans rosette. This is a Colorado State Listed Noxious weed and requires management.

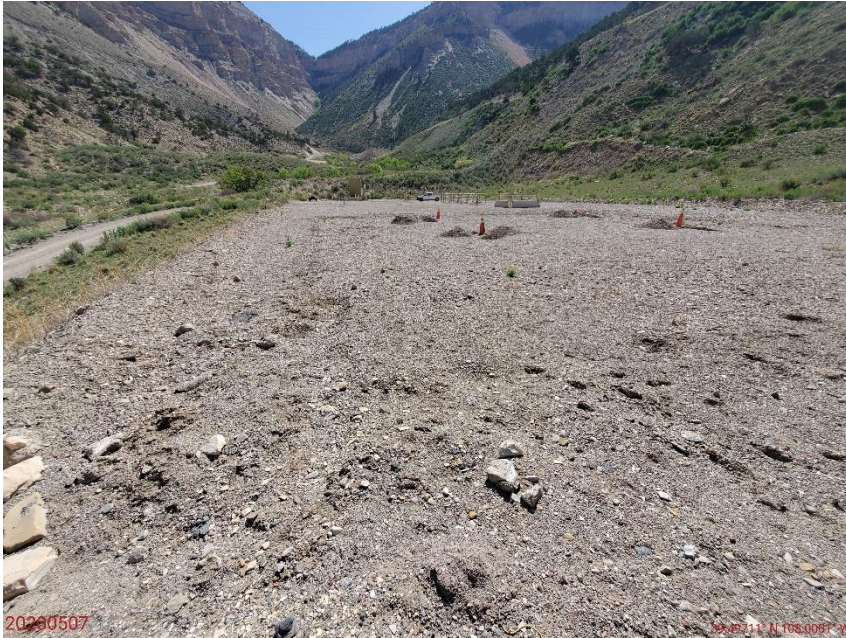
Photo 17: Photo taken from the northwest corner of the pad, facing east. Photo shows areas where a tank battery was Located. Facility has since been remove resulting in areas no longer needed for production subject to 1003 interim reclamation. Areas are being proposed for use by Operator to store drill cuttings from the NPR O04 Pad, to eventually be utilized for interim reclamation.

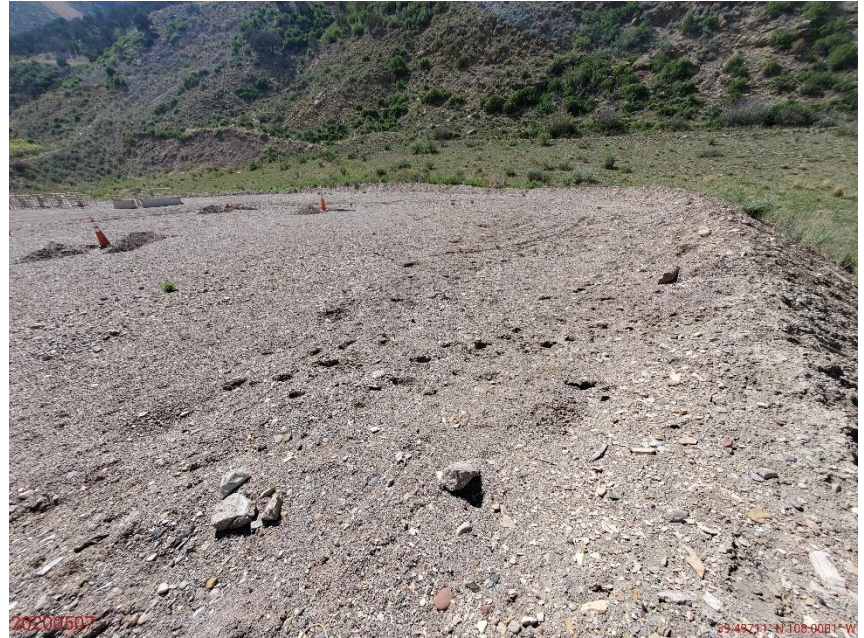
Photo 18: Photo taken from the northwest corner of the pad, facing south. See comments under photo 17

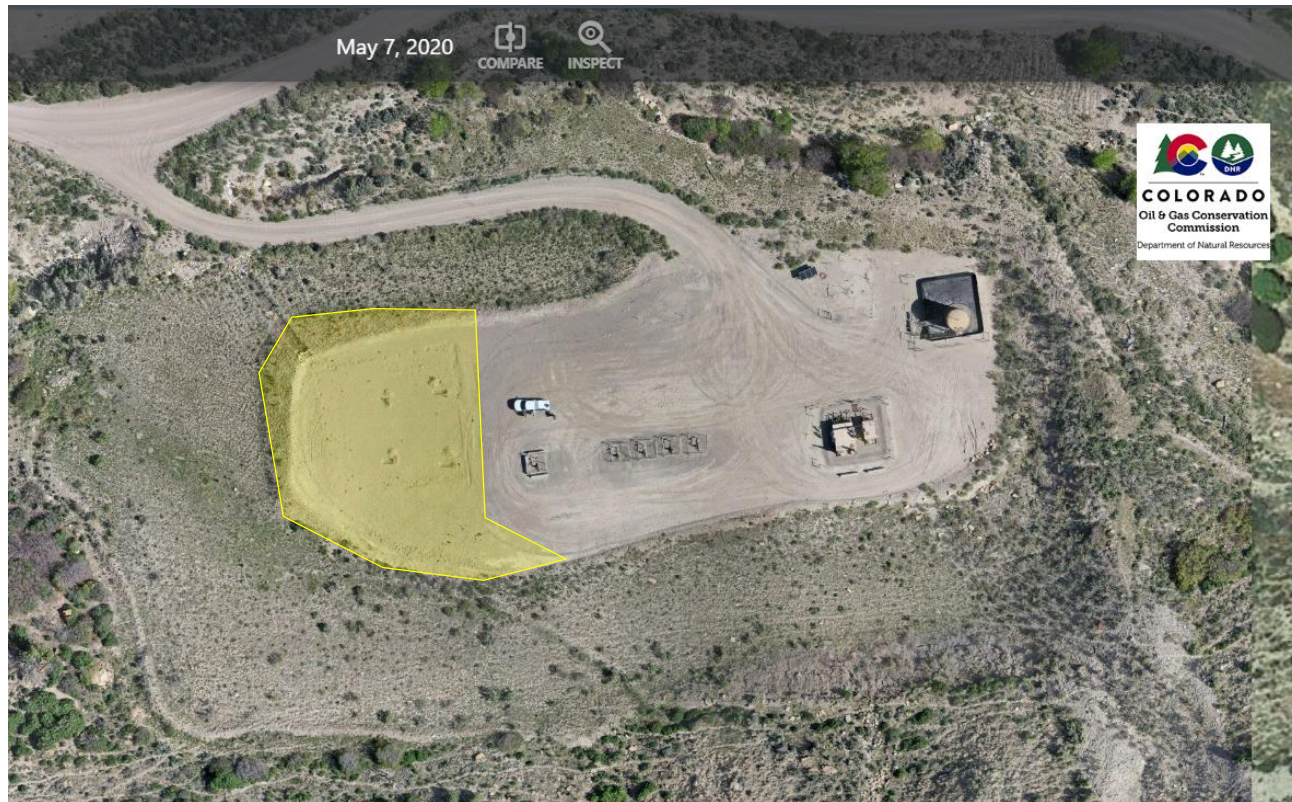
Photo 19: On 5/7/2020, Reclamation Specialist Trujillo utilized a SUA to capture aerial imagery of the Location. Photo shows areas on the west end of the Location where a tank battery existed. Facility has since been removed resulting in areas no longer needed for production subject to 1003 interim reclamation (yellow polygon). Areas are being proposed for use by Operator to store drill cuttings from the NPR 004 Pad, to eventually be utilized for interim reclamation.

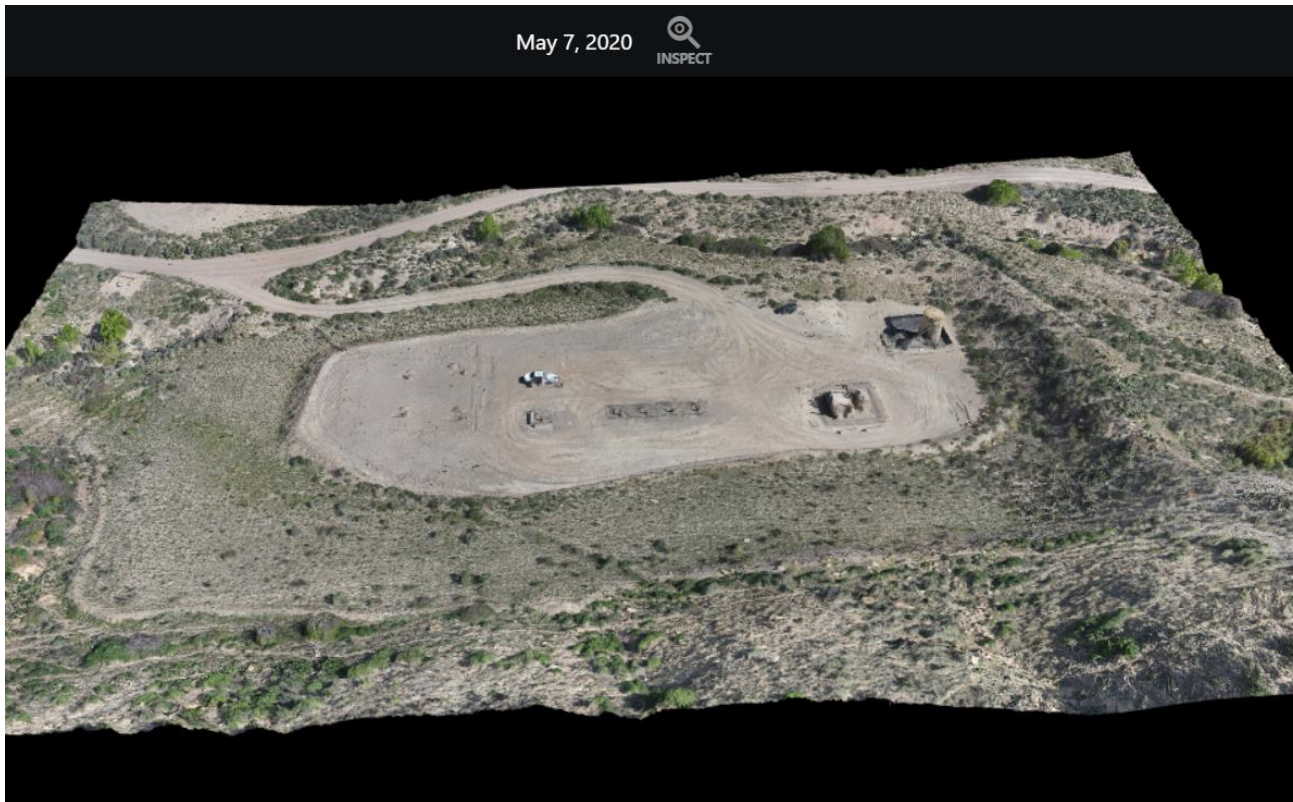
Photo 20: On 5/7/2020, Reclamation Specialist Trujillo utilized a SUA to capture aerial imagery of the Location to create a 3-D model of the disturbance area. Model shows overview of the Location, and the topography from the south of the Location, facing North.

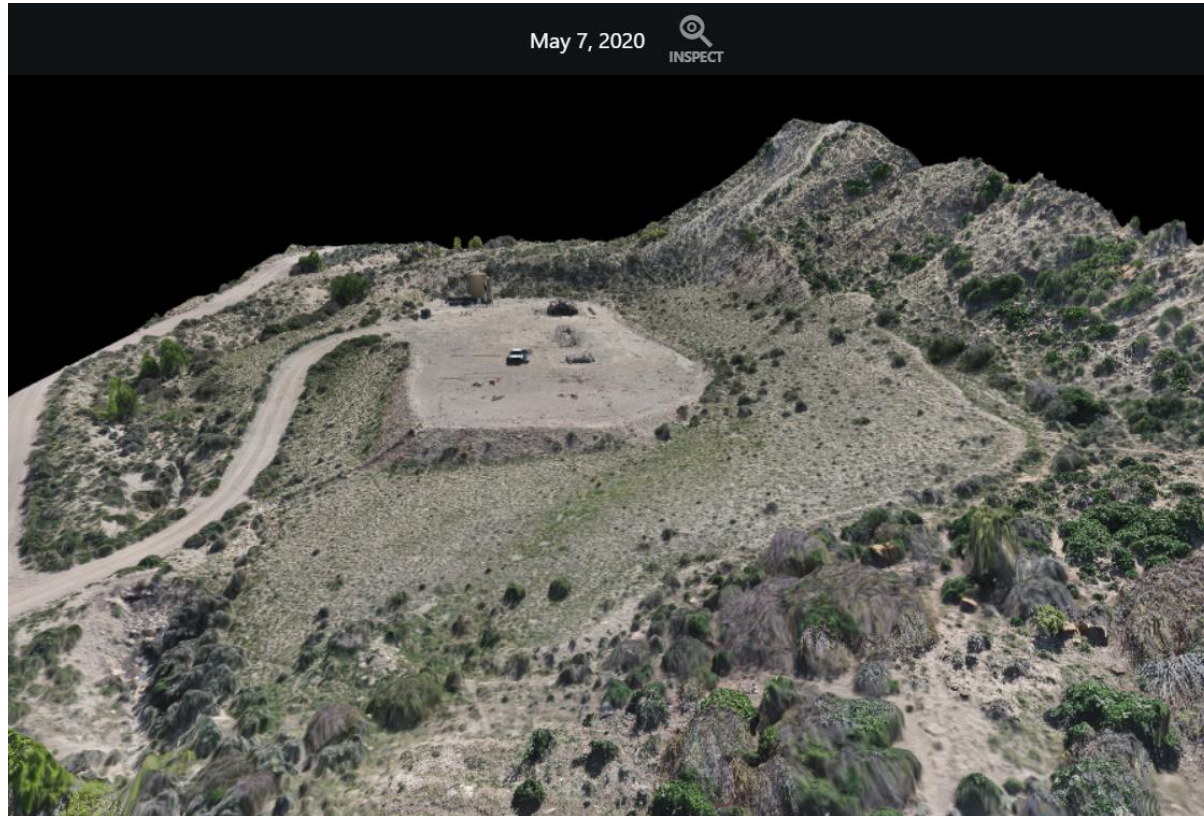
Photo 21: On 5/7/2020, Reclamation Specialist Trujillo utilized a SUA to capture aerial imagery of the Location to create a 3-D model of the disturbance area. Model shows overview of the Location, and the topography from the west of the Location, facing east.

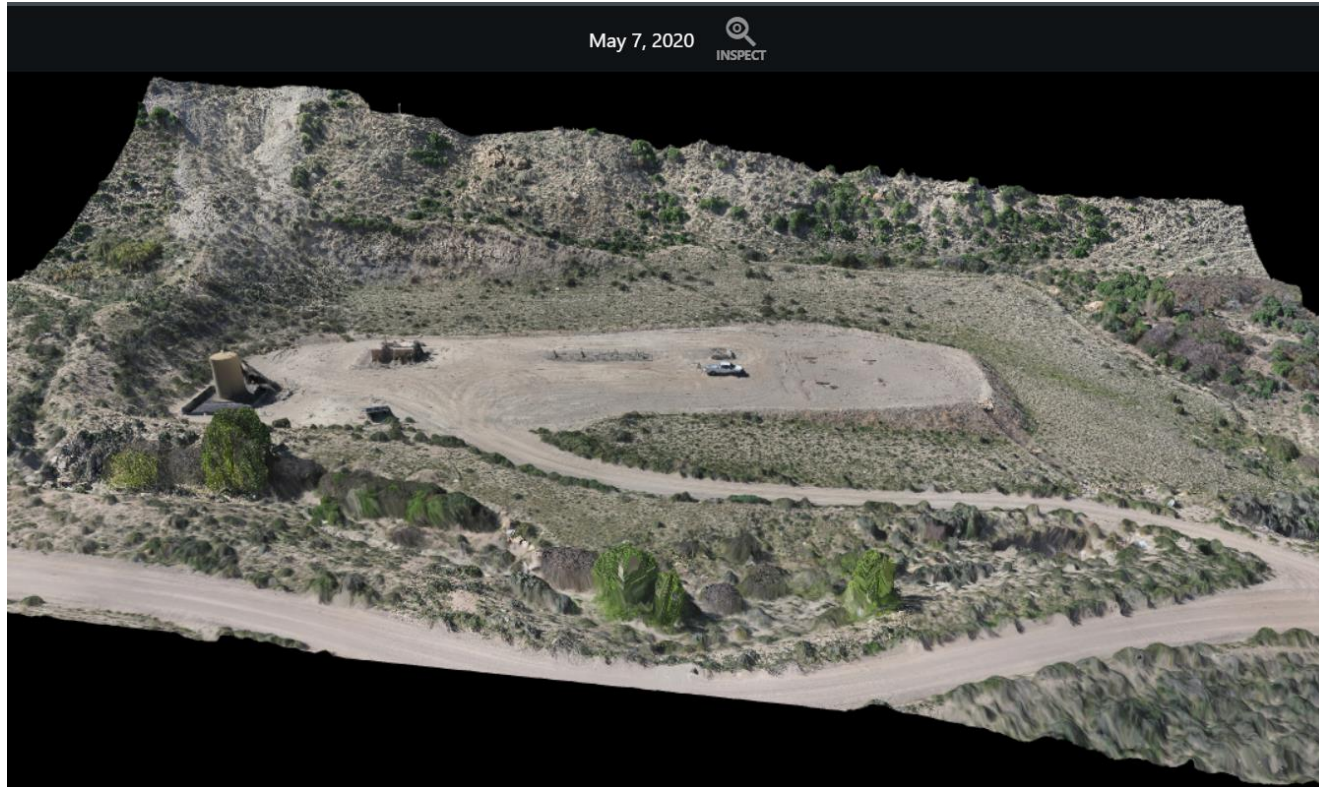
Photo 22: On 5/7/2020, Reclamation Specialist Trujillo utilized a SUA to capture aerial imagery of the Location to create a 3-D model of the disturbance area. Model shows overview of the Location, and the topography from the north of the Location, facing south.

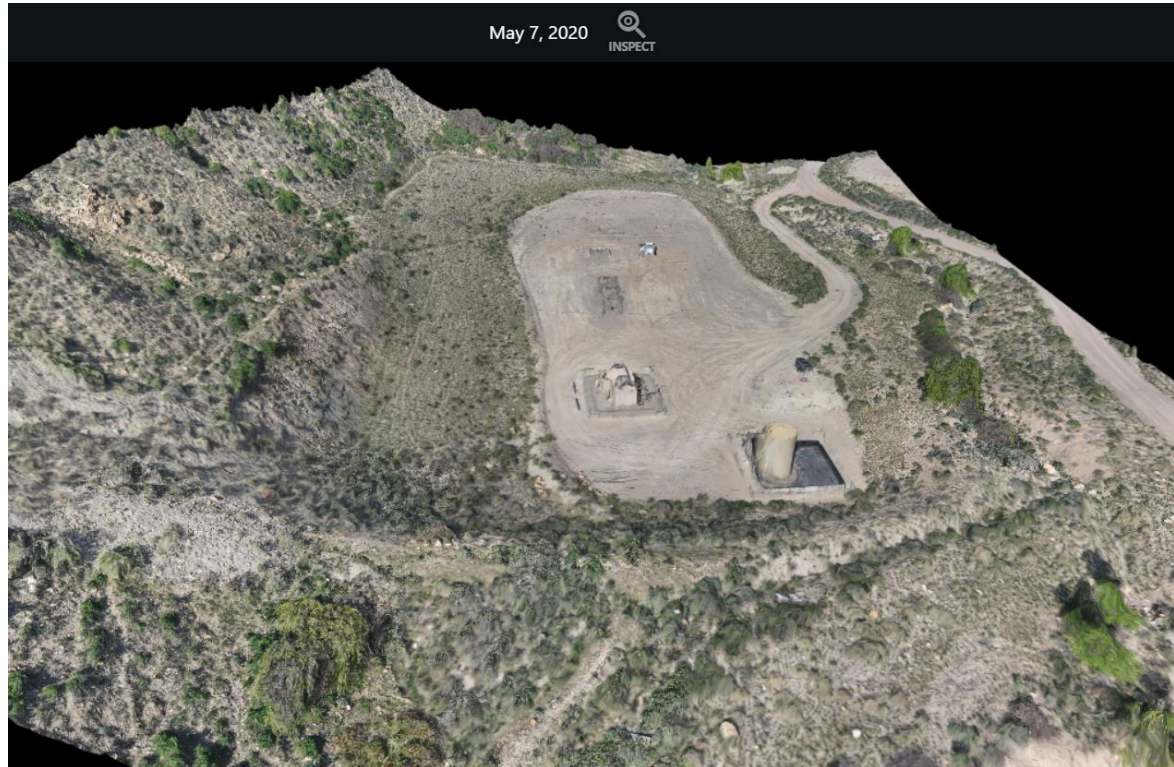
Photo 23: On 5/7/2020, Reclamation Specialist Trujillo utilized a SUA to capture aerial imagery of the Location to create a 3-D model of the disturbance area. Model shows overview of the Location, and the topography from the east of the Location, facing west.
