Inspection Photos  
Operator: BP America  
API#: 067-07446  
Date: 5/12/2020

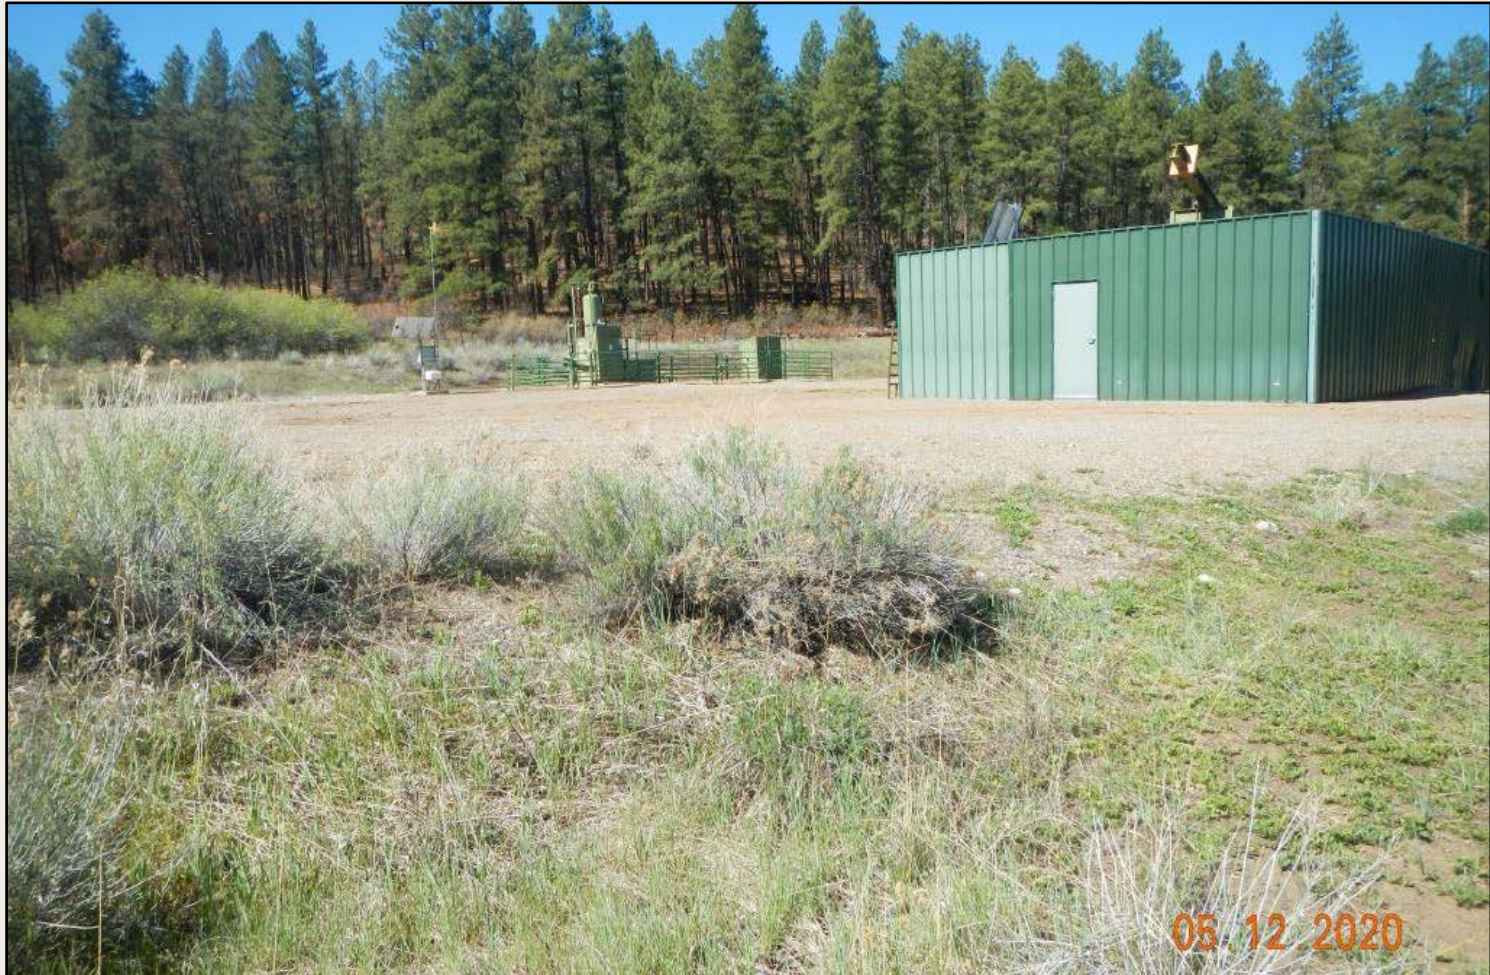
Photo 1. View of the project area from the southeastern corner facing center.

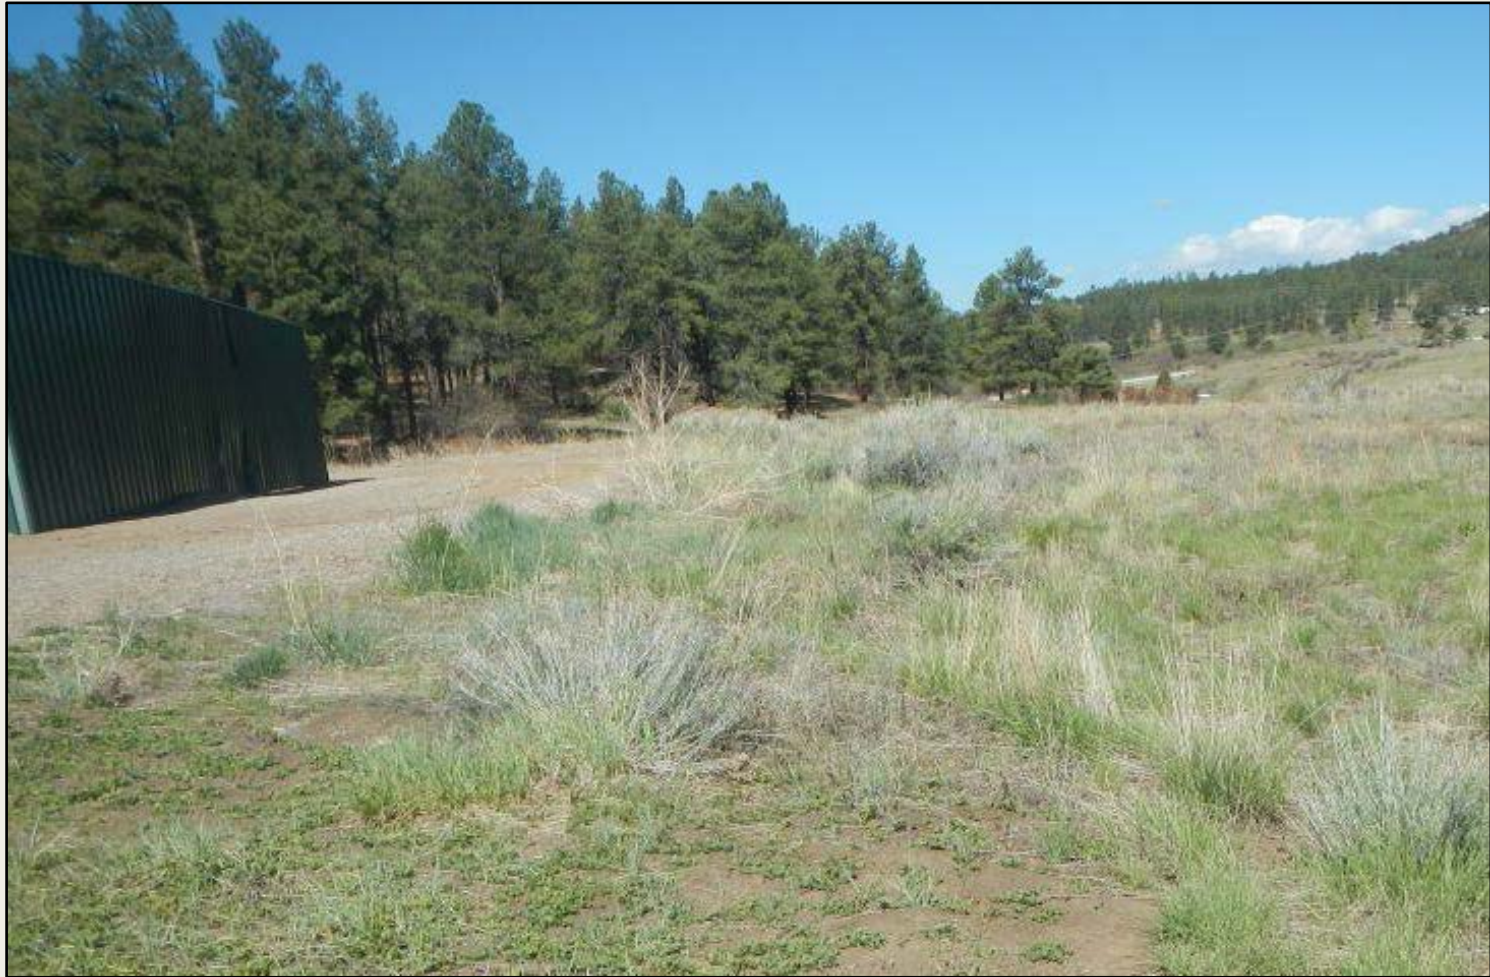
Photo 2. View of the eastern fill slope from the southeastern corner facing northward. Revegetation is progressing with grasses such as smooth brome, intermediate wheatgrass, as well as shrubby rubber rabbitbrush.

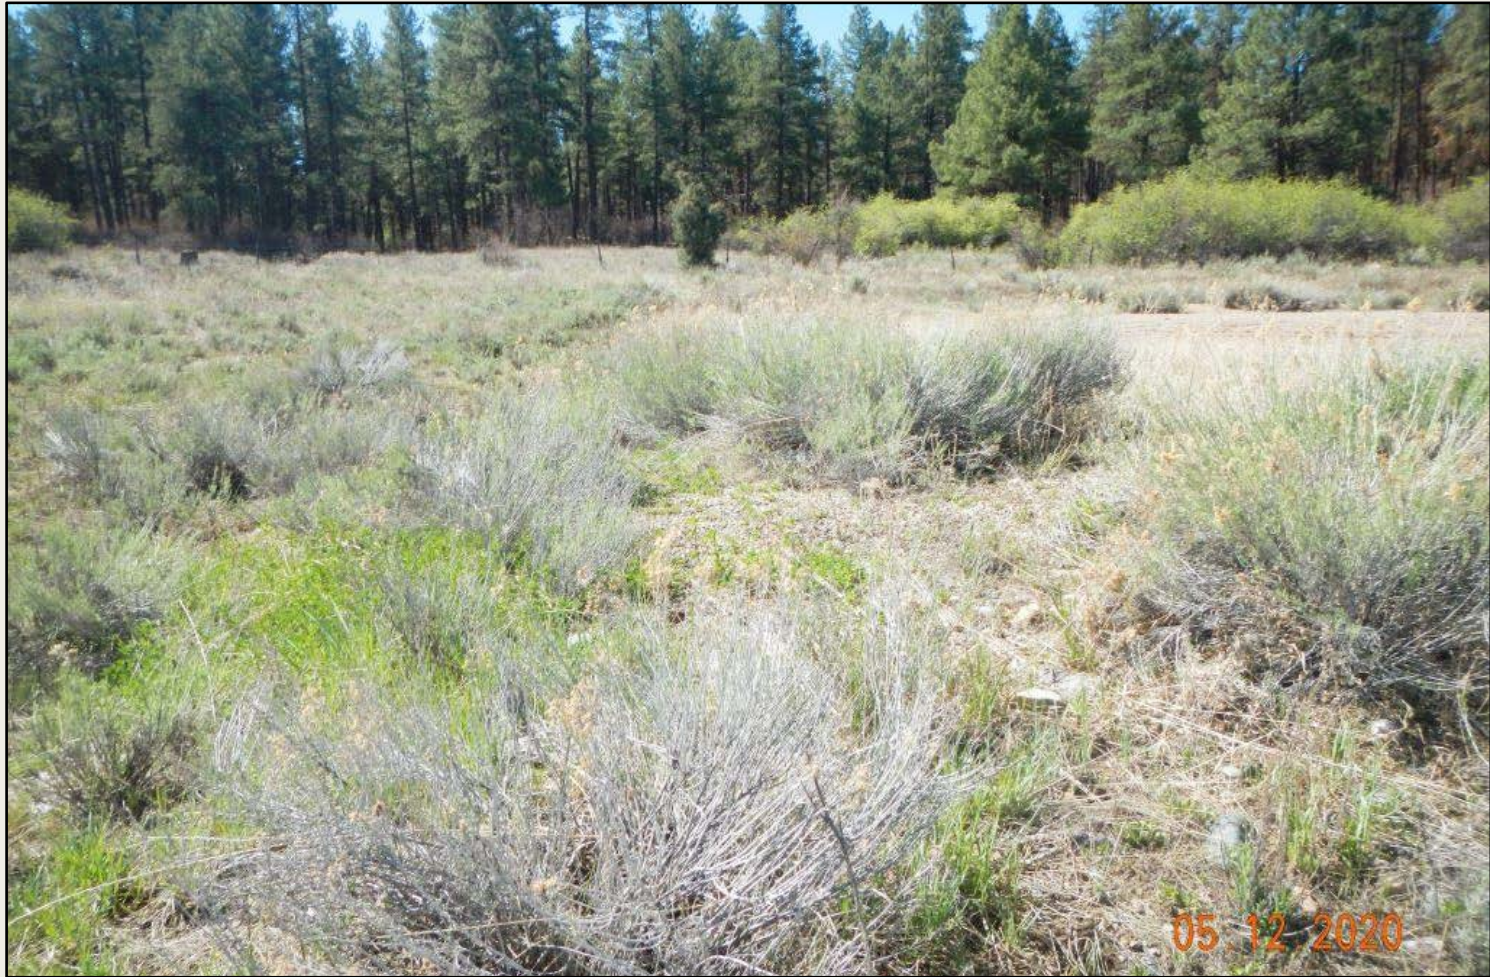
Photo 3. View of the southern project area from the southeastern corner facing westward.

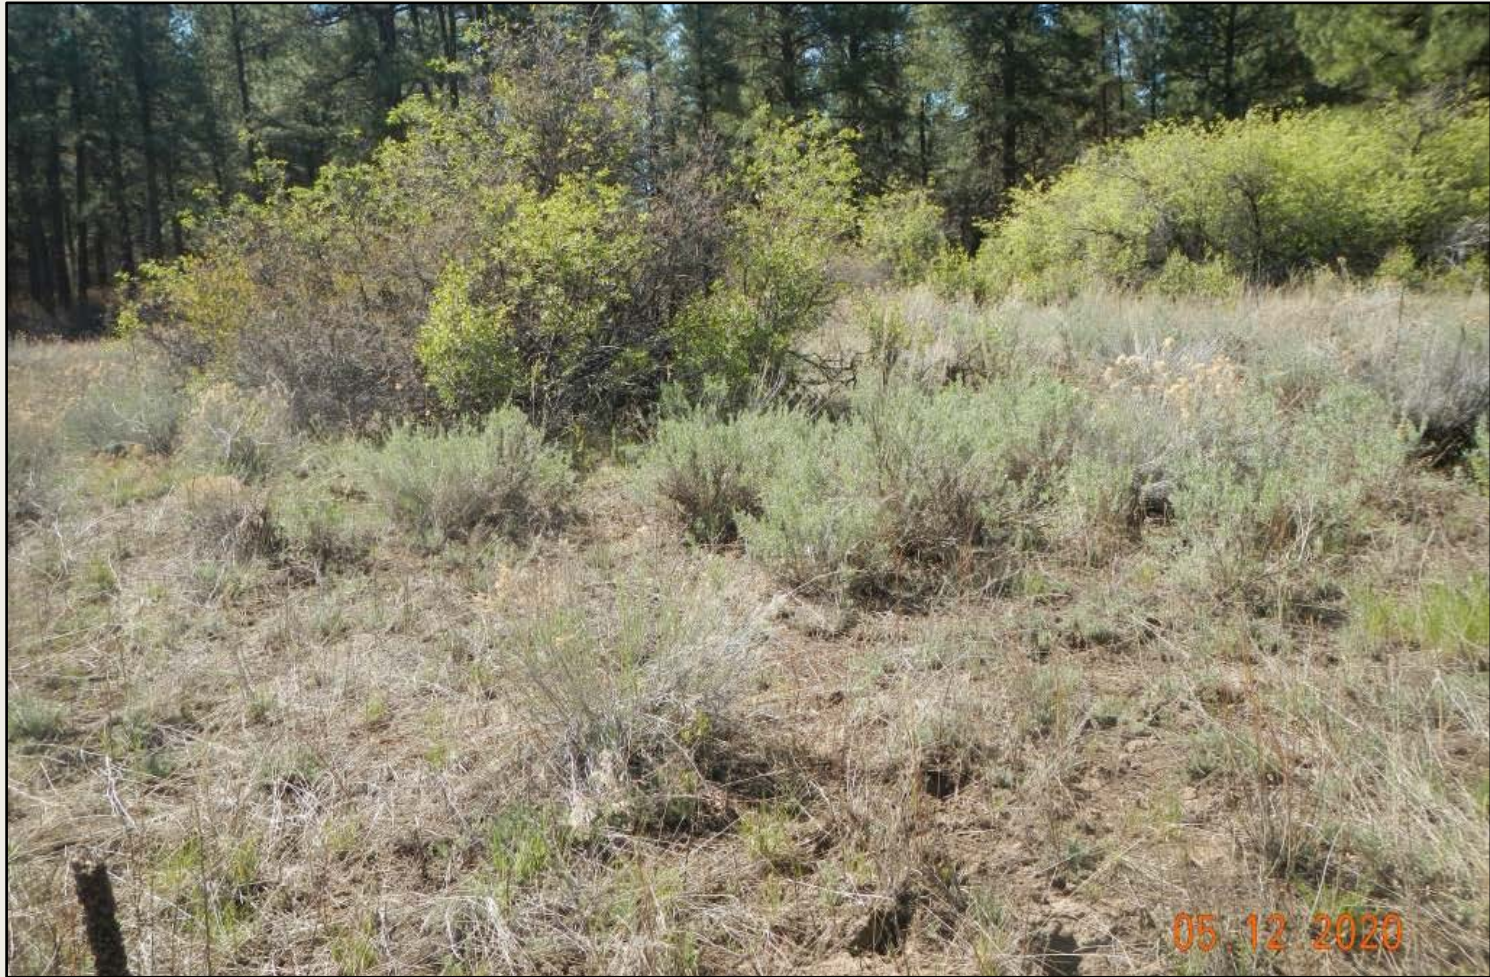
Photo 4. View of reference area vegetation comprised of mixed ponderosa pine woodland, opening to sagebrush shrubland, with shrubs such as river hawthorn (*Crataegus rivularis*).
