Inspection Photos

Location Name: MARALEX RESOURCES INC FEDERAL-68S97W /29SWNW

Location ID: 312424

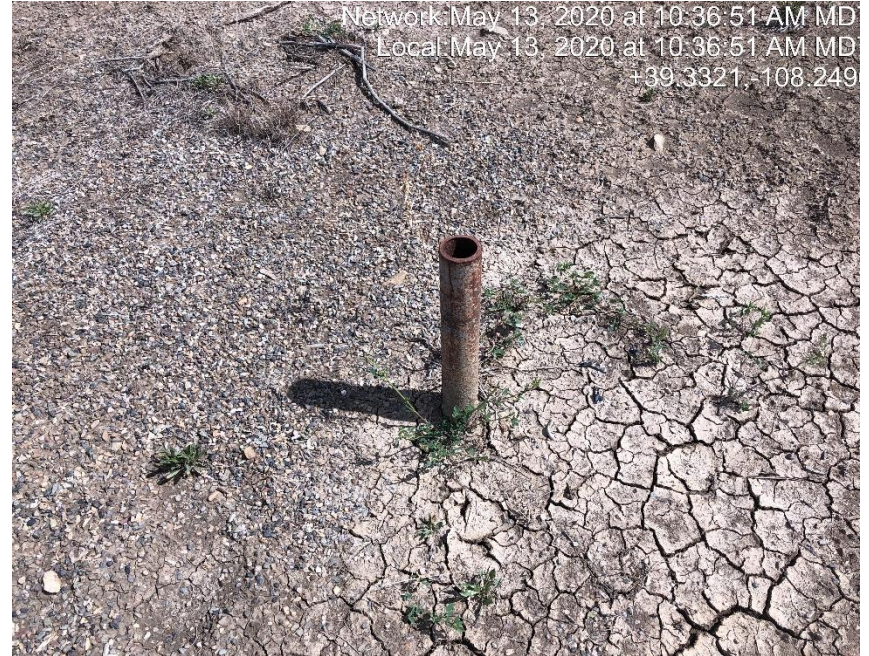
Photo #1170 Flow line riser not LO/TO.

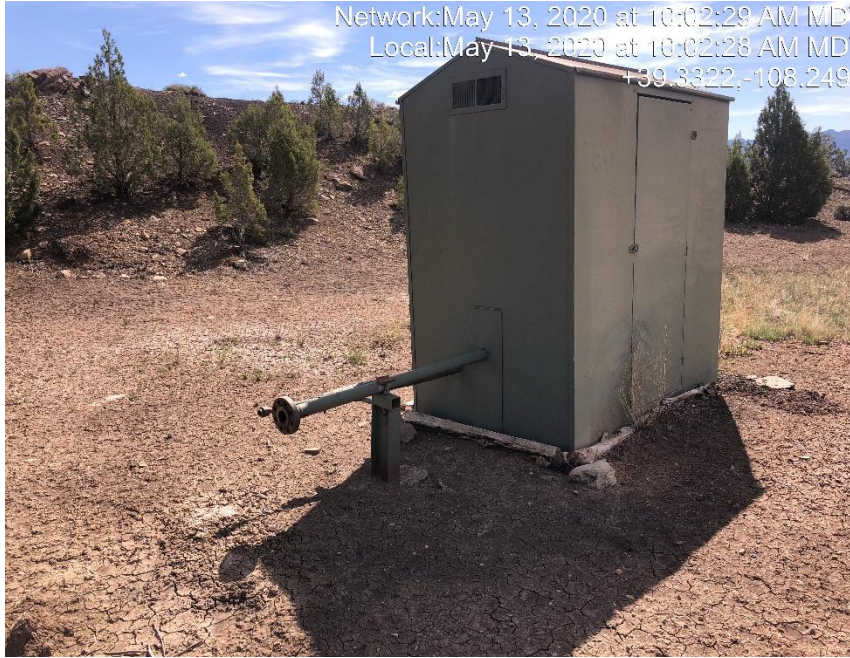
Photo #1166 Unused meter run.

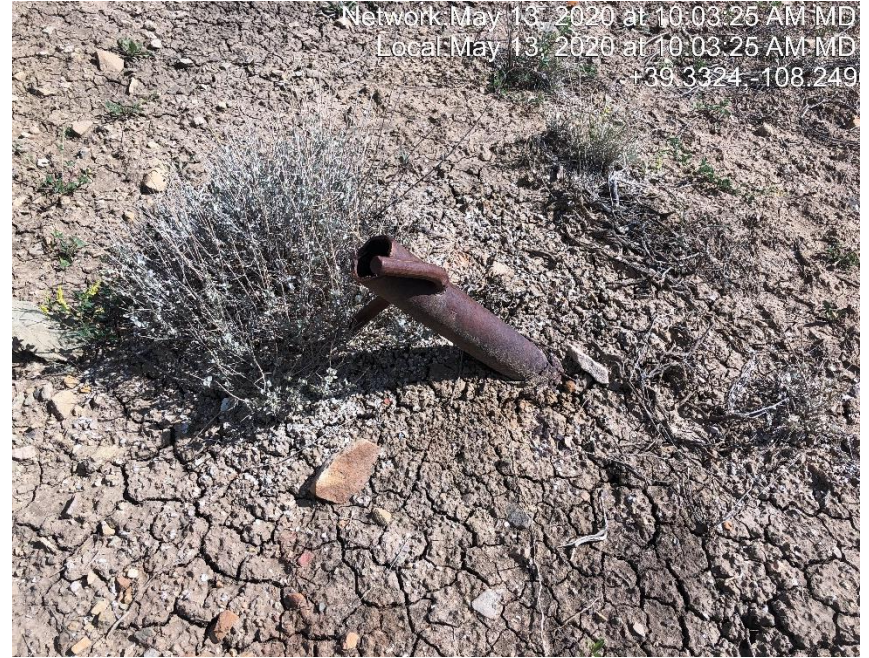
Photo #1168 Multiple unmarked deadman.

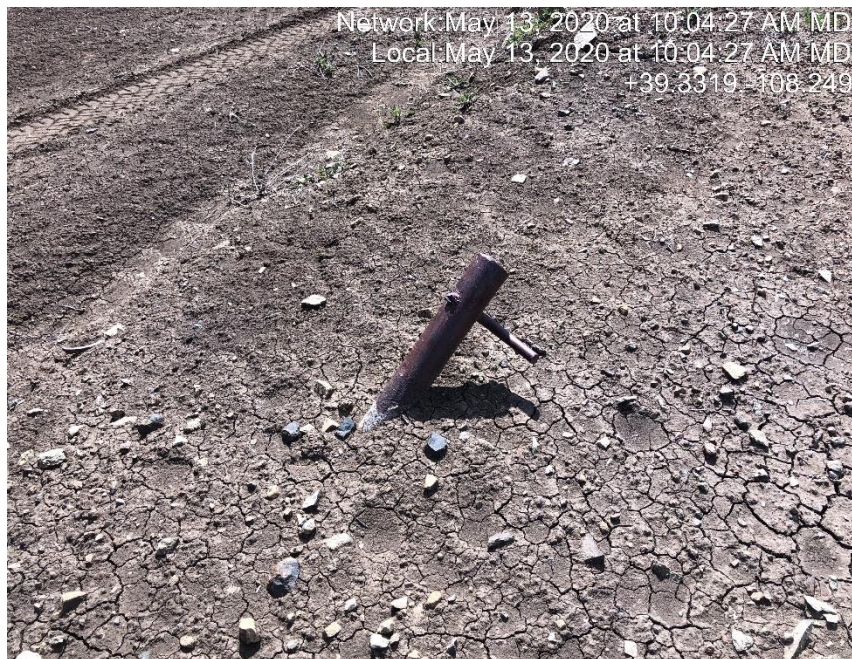
Photo #1169 Multiple unmarked deadman.
