Inspection Photos

Location Name: MARALEX RESOURCES INC SULFUR GULCH-69S98W /2SWSW

Location ID: 312662

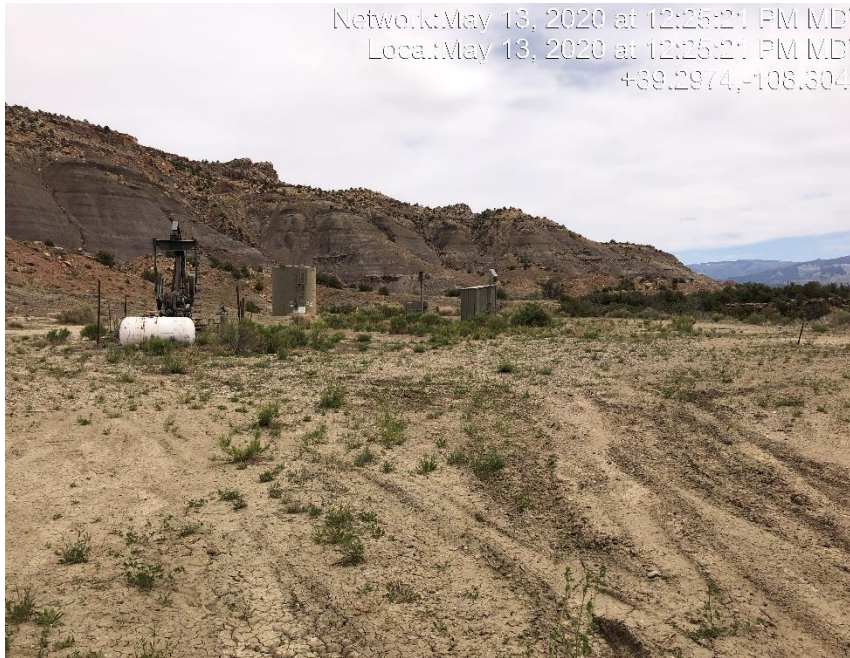
Photo #1174 from entrance to location

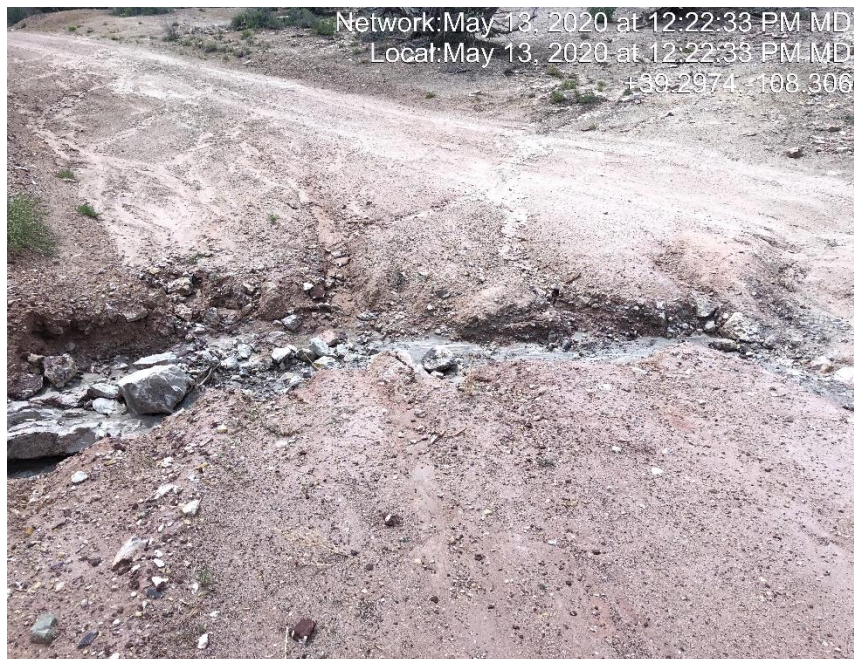
Photo #1173 Access road has not been adequately maintained.

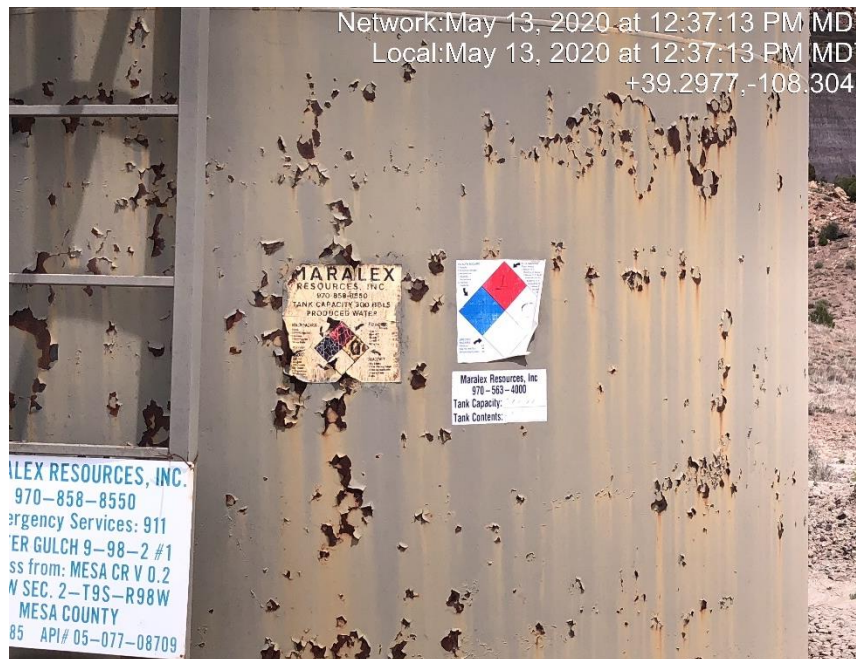
Photo #1175 Tank label and placards are weathered and not legible.

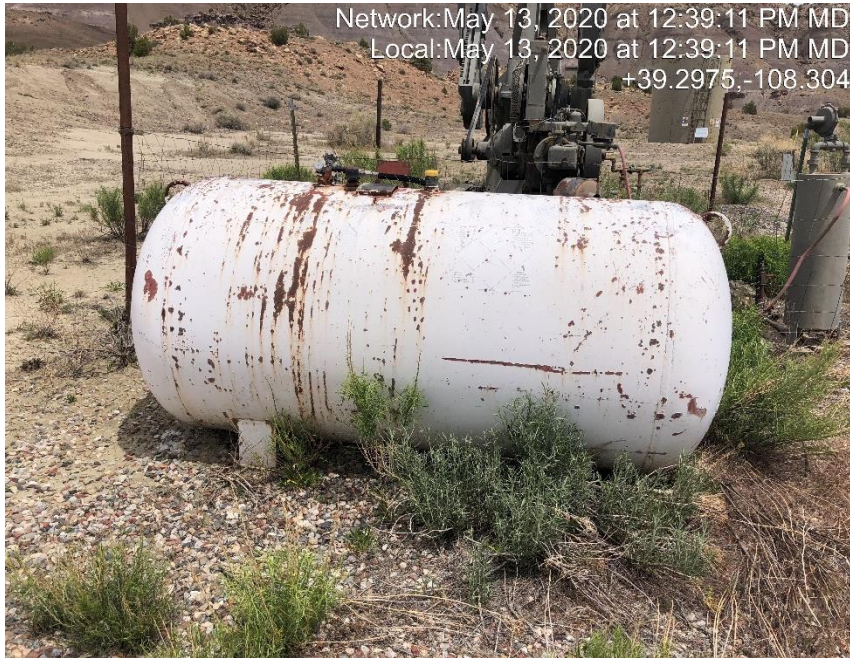
Photo #1179 Tank by wellhead is not properly labeled.

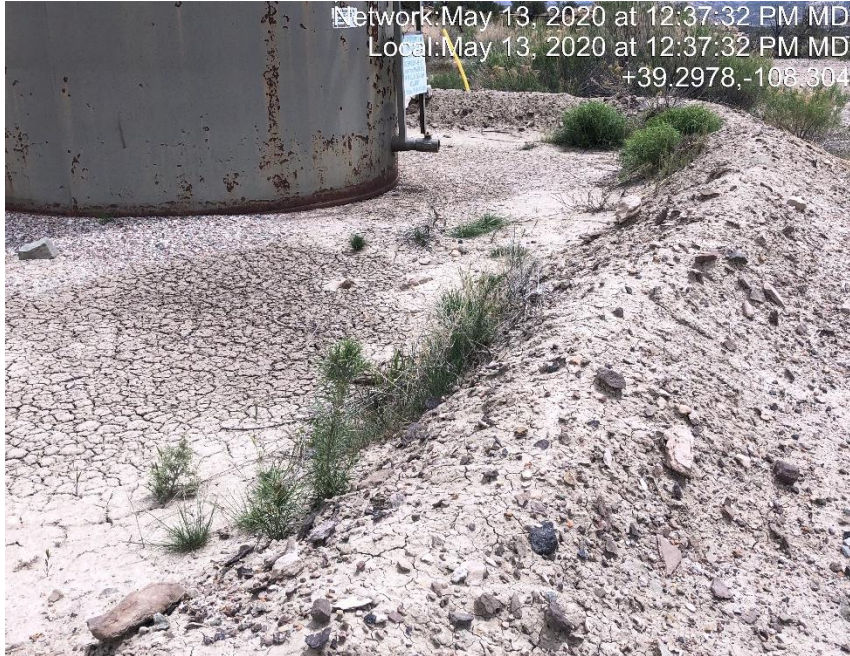
Photo #1176 weeds and debris inside tank containment.

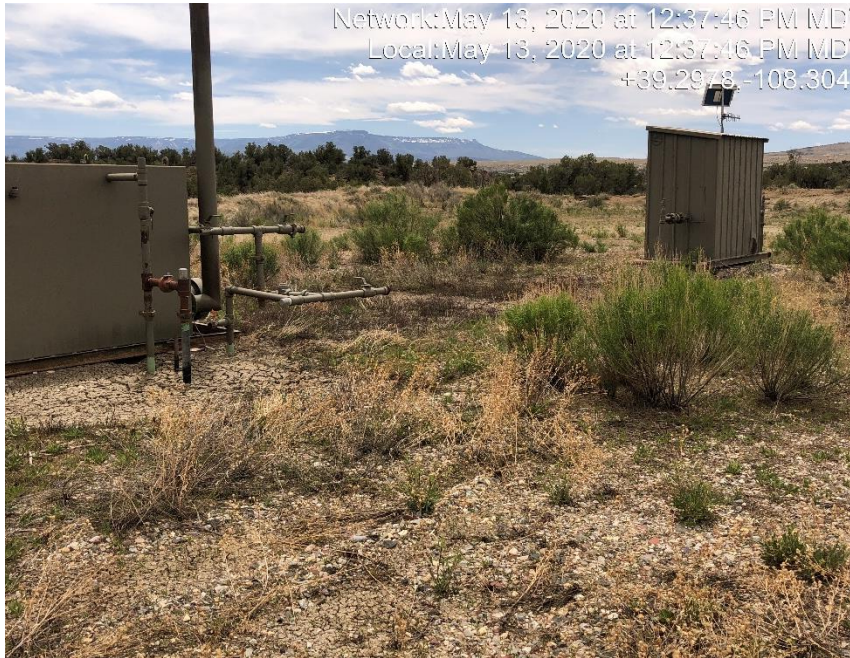
Photo #1177 Multiple places with weeds and debris on location.
