Inspection Photos

Location Name: Silver Spur Minerals 35-2H

API: 05-057-06490

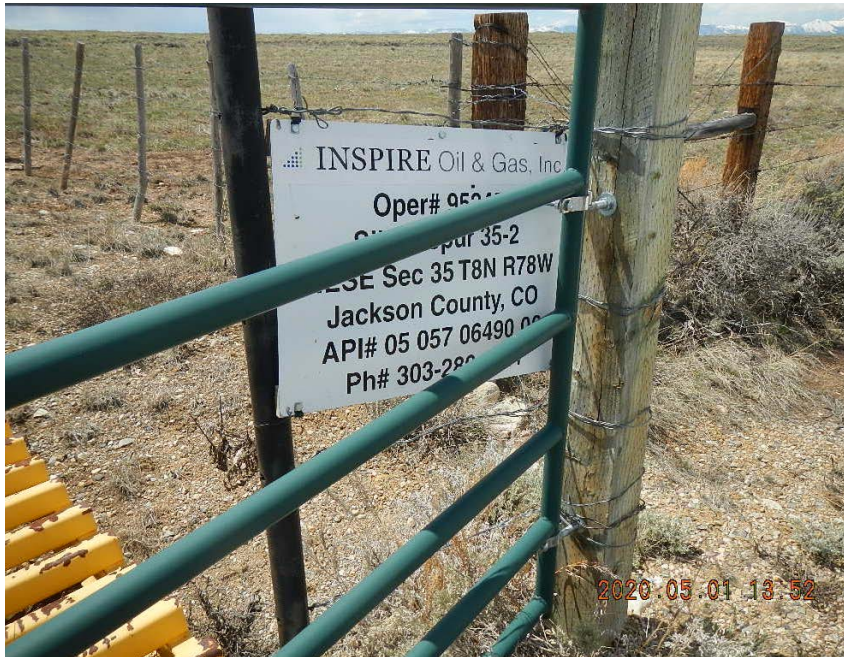
Location sign off of Hwy 14. (Note: phone number was not active on 9/3/2019 and has not changed since).

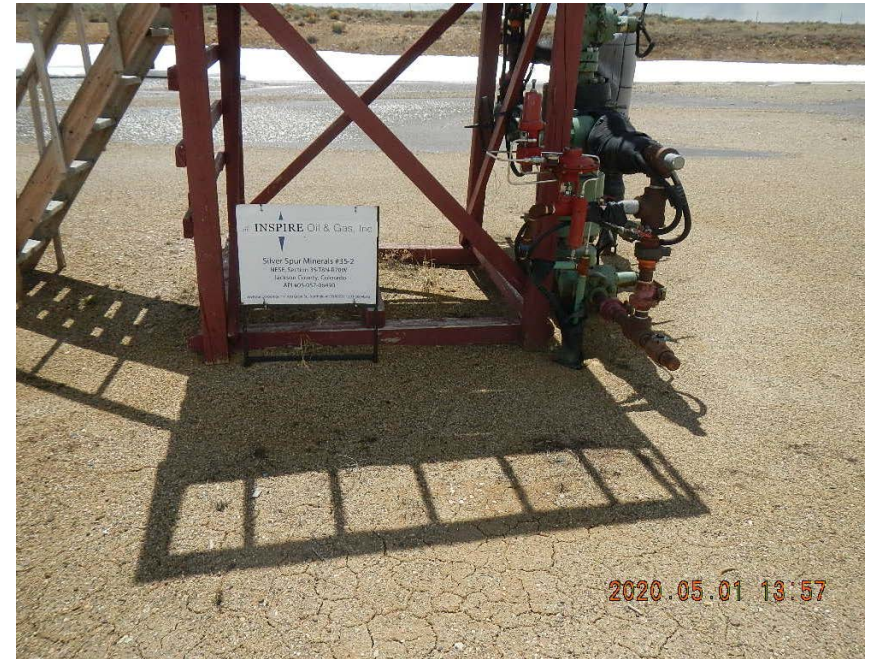
Well sign. (Note: phone number was not active on 9/3/2019 and has not changes since then).

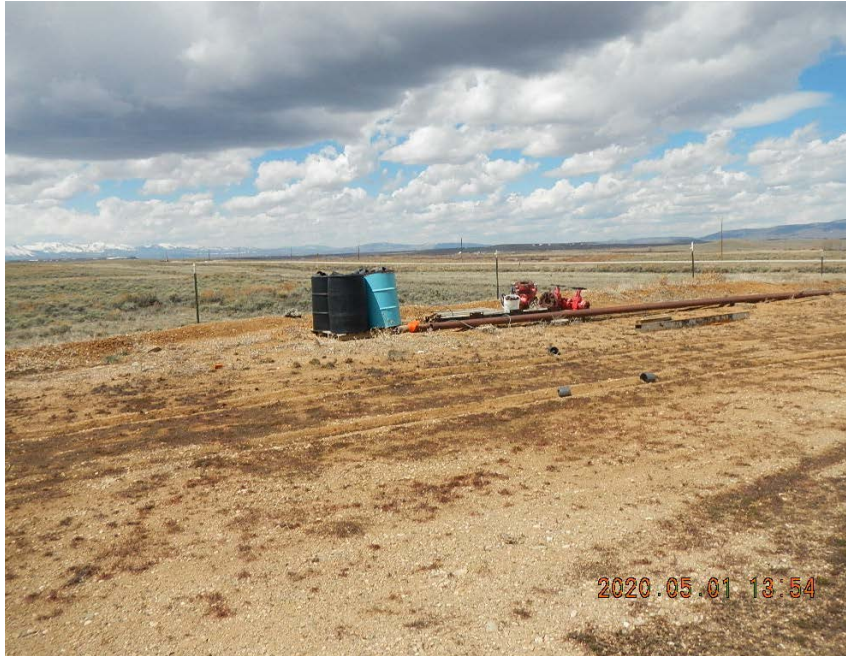
Equipment stored on Location.

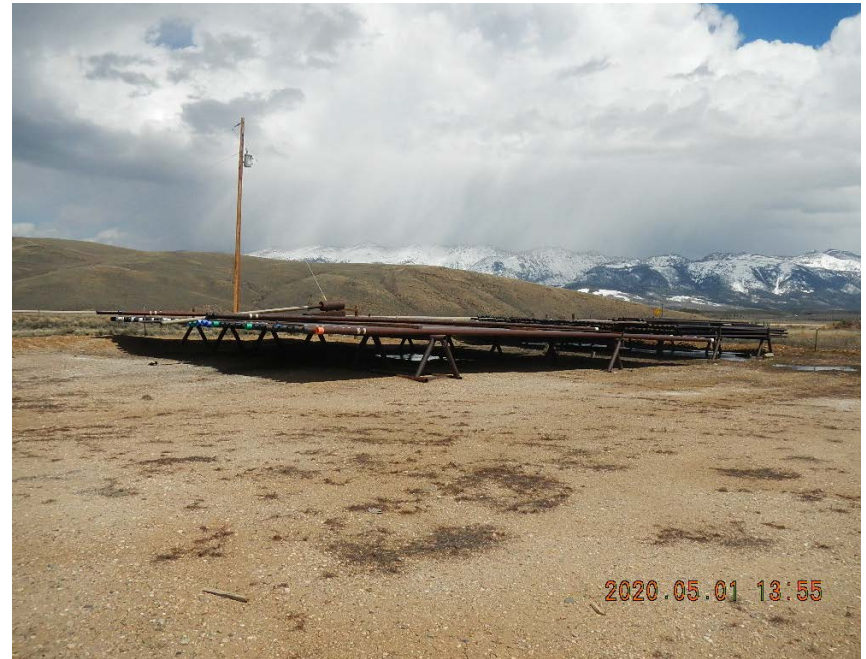
Equipment stored on Location.

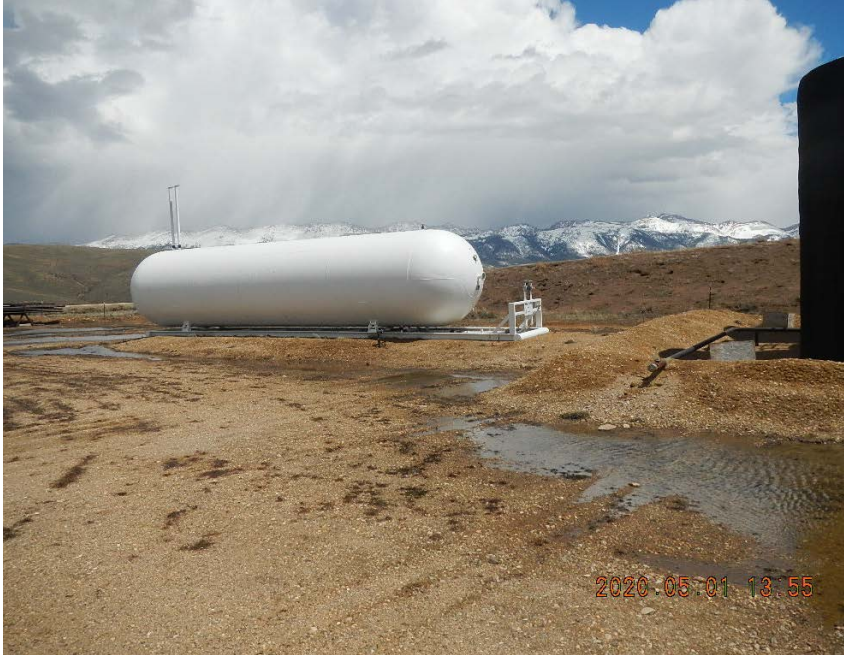
Propane tank not labeled or placard.

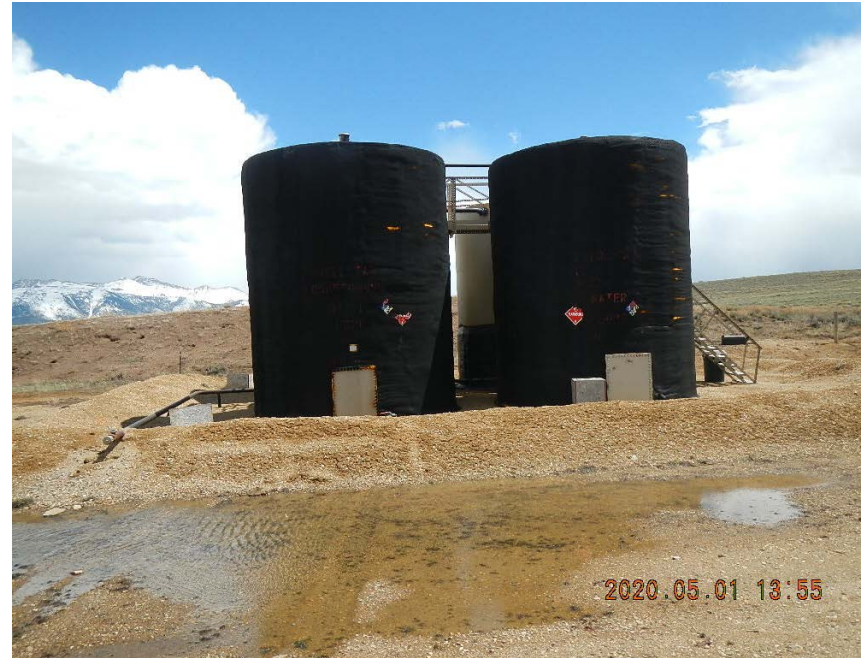
Tank signage, labels, and placards are illegible.

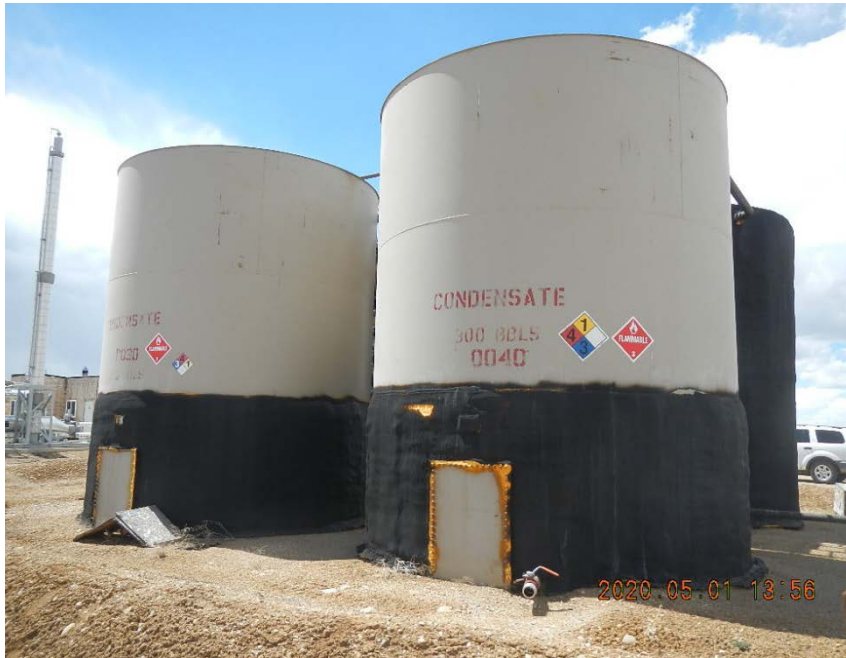
Tank signage, labels, and placards are illegible.

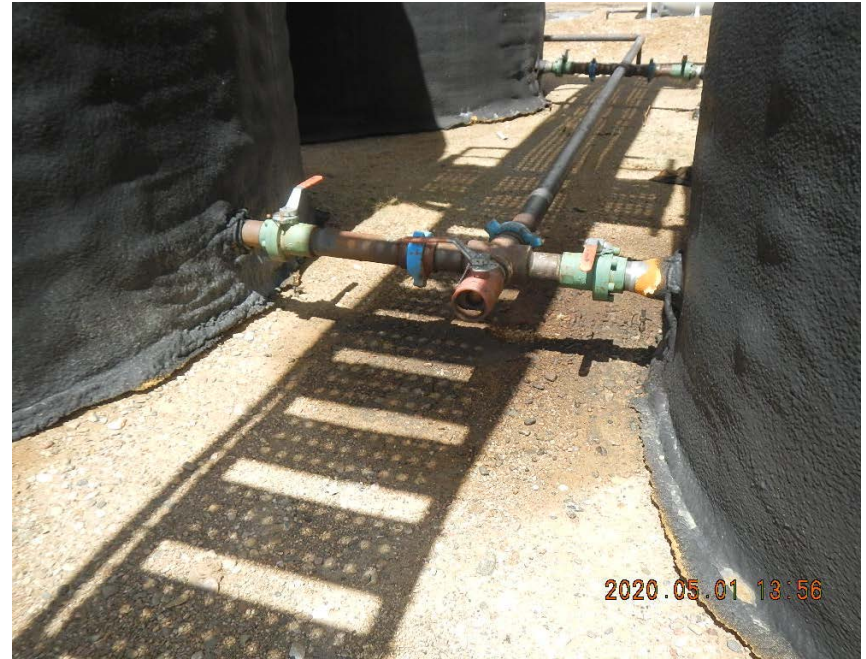
Tank 0030, staining beneath hammer unions.

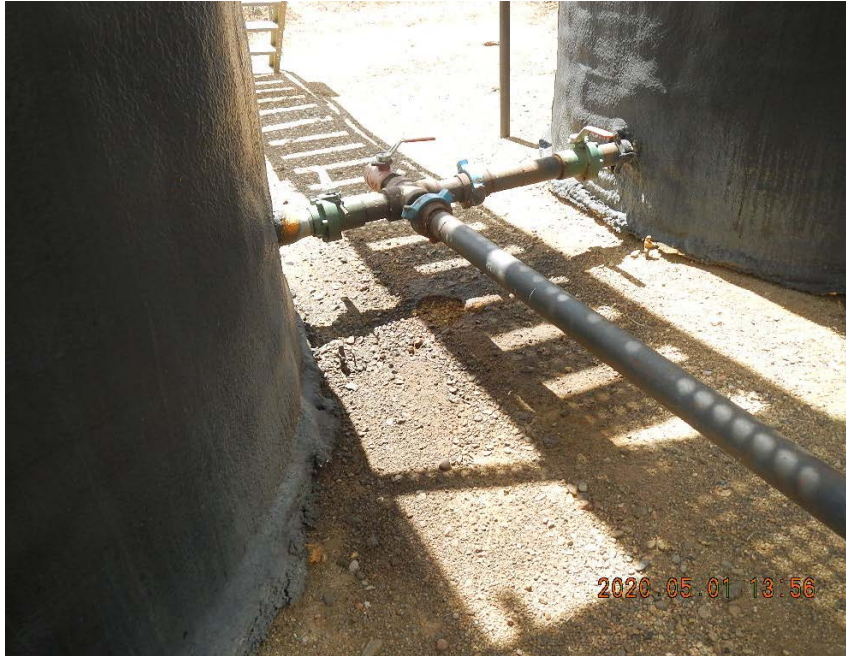
Tank 0030, staining beneath hammer unions.

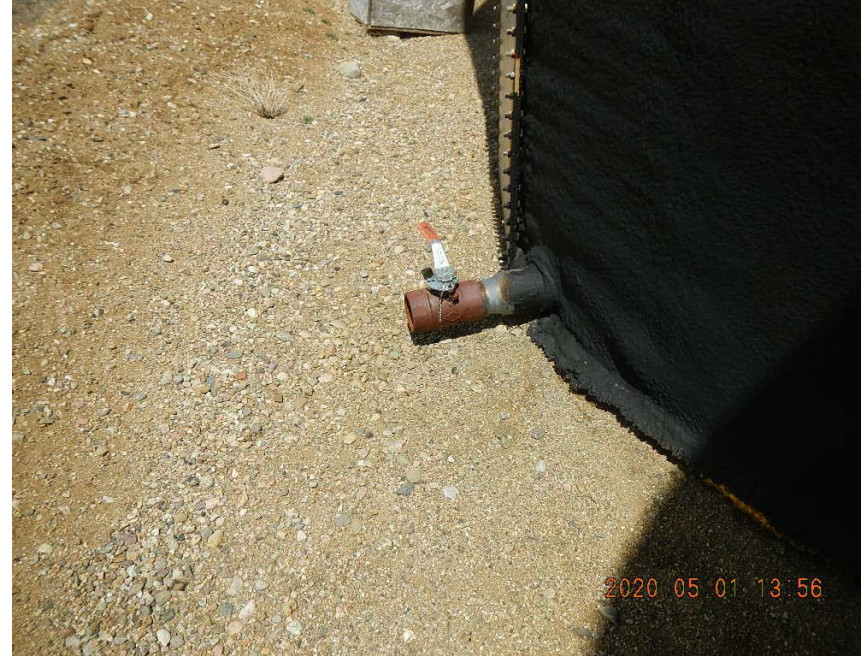
Valve with handle not blind plugged. Note: There was evidence of livestock accessing Facility.

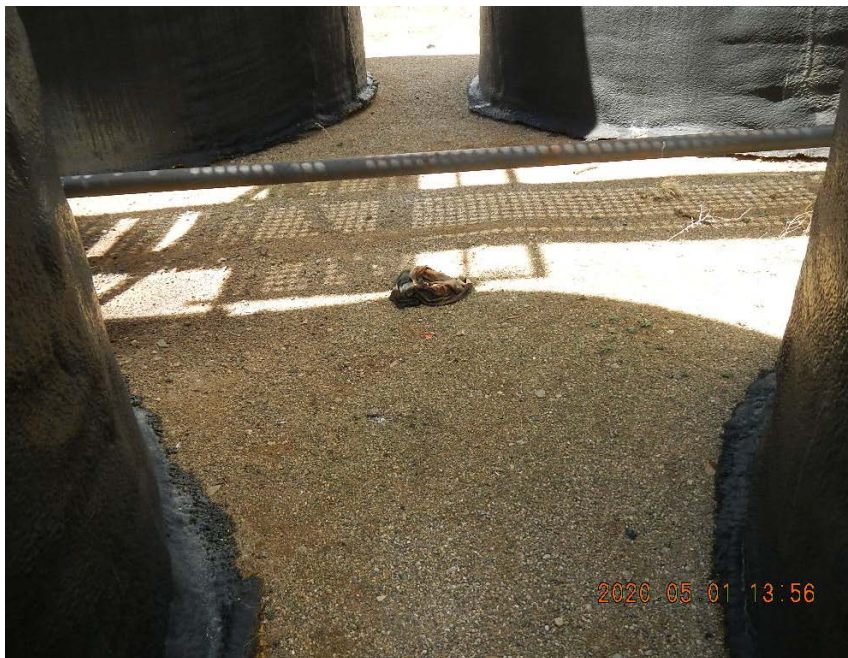
Trash through out Location.

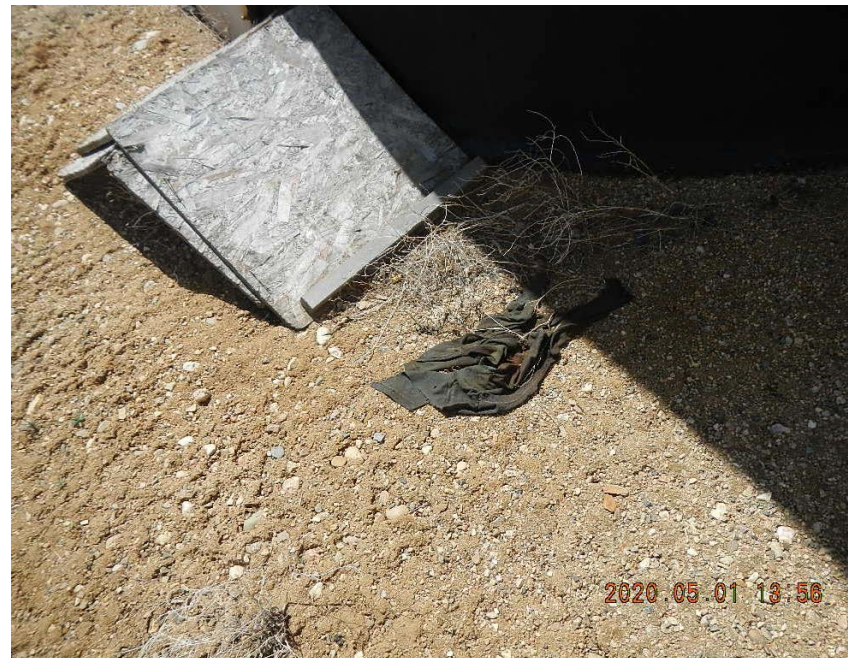
Trash through out Location.

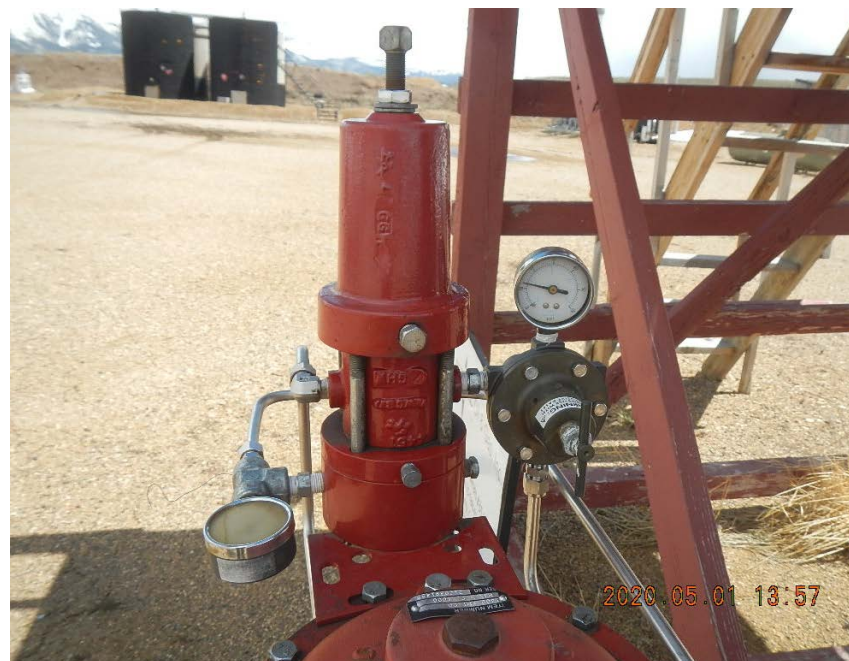
Pressure on gauge.
