Inspection Photos  
Operator: BP America  
API#: 067-08649  
Date: 5/12/2020

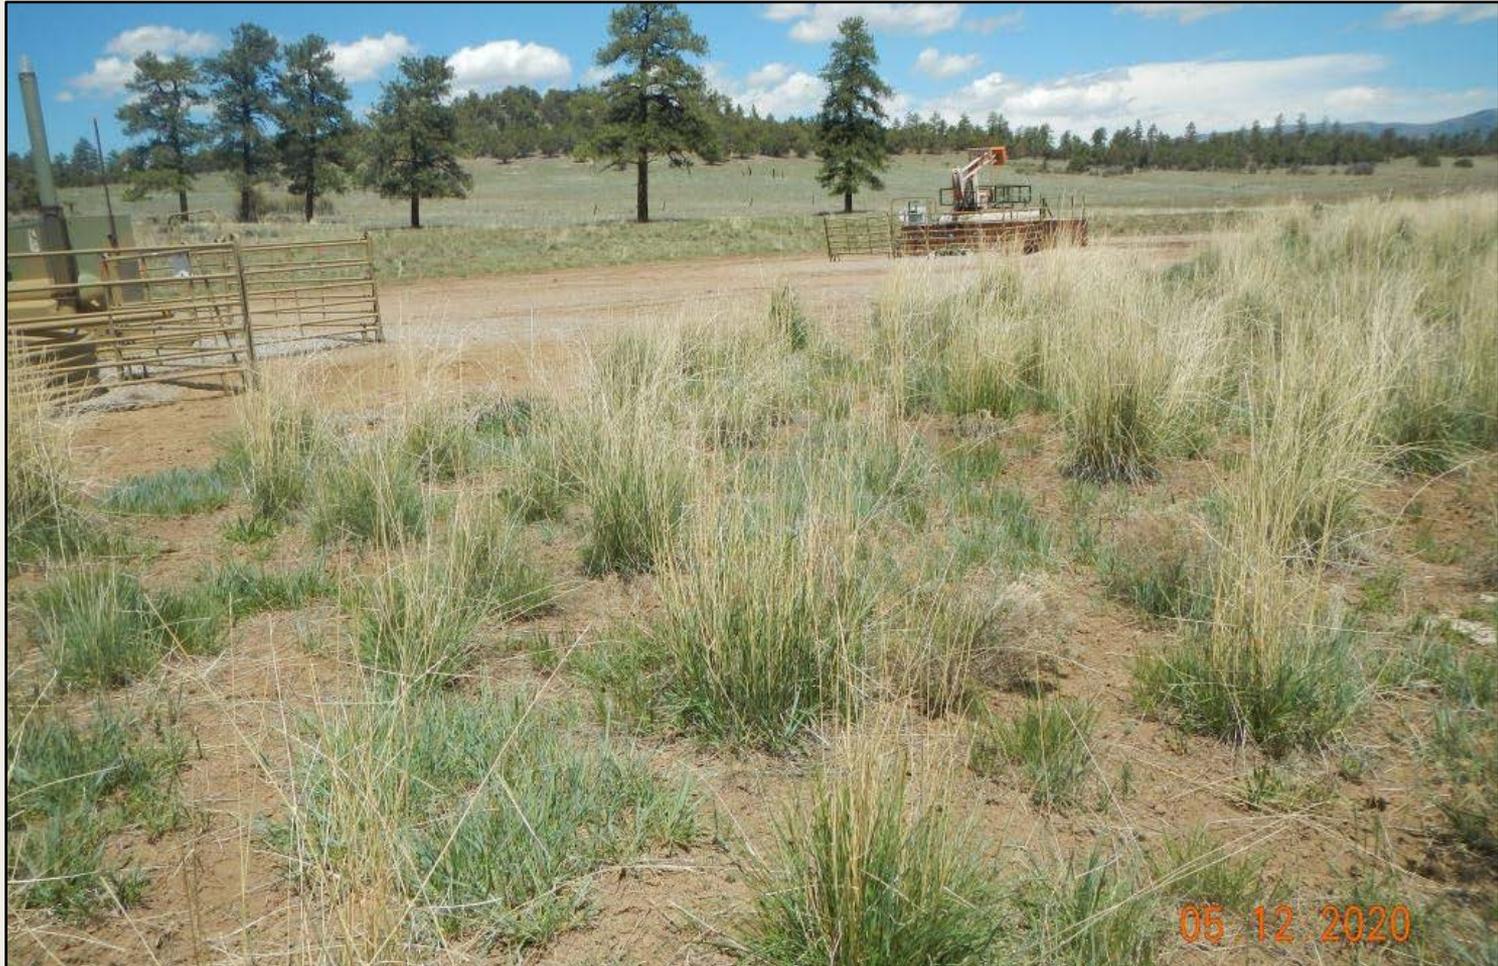
Photo 1. View of the project area from the southeastern corner facing center.

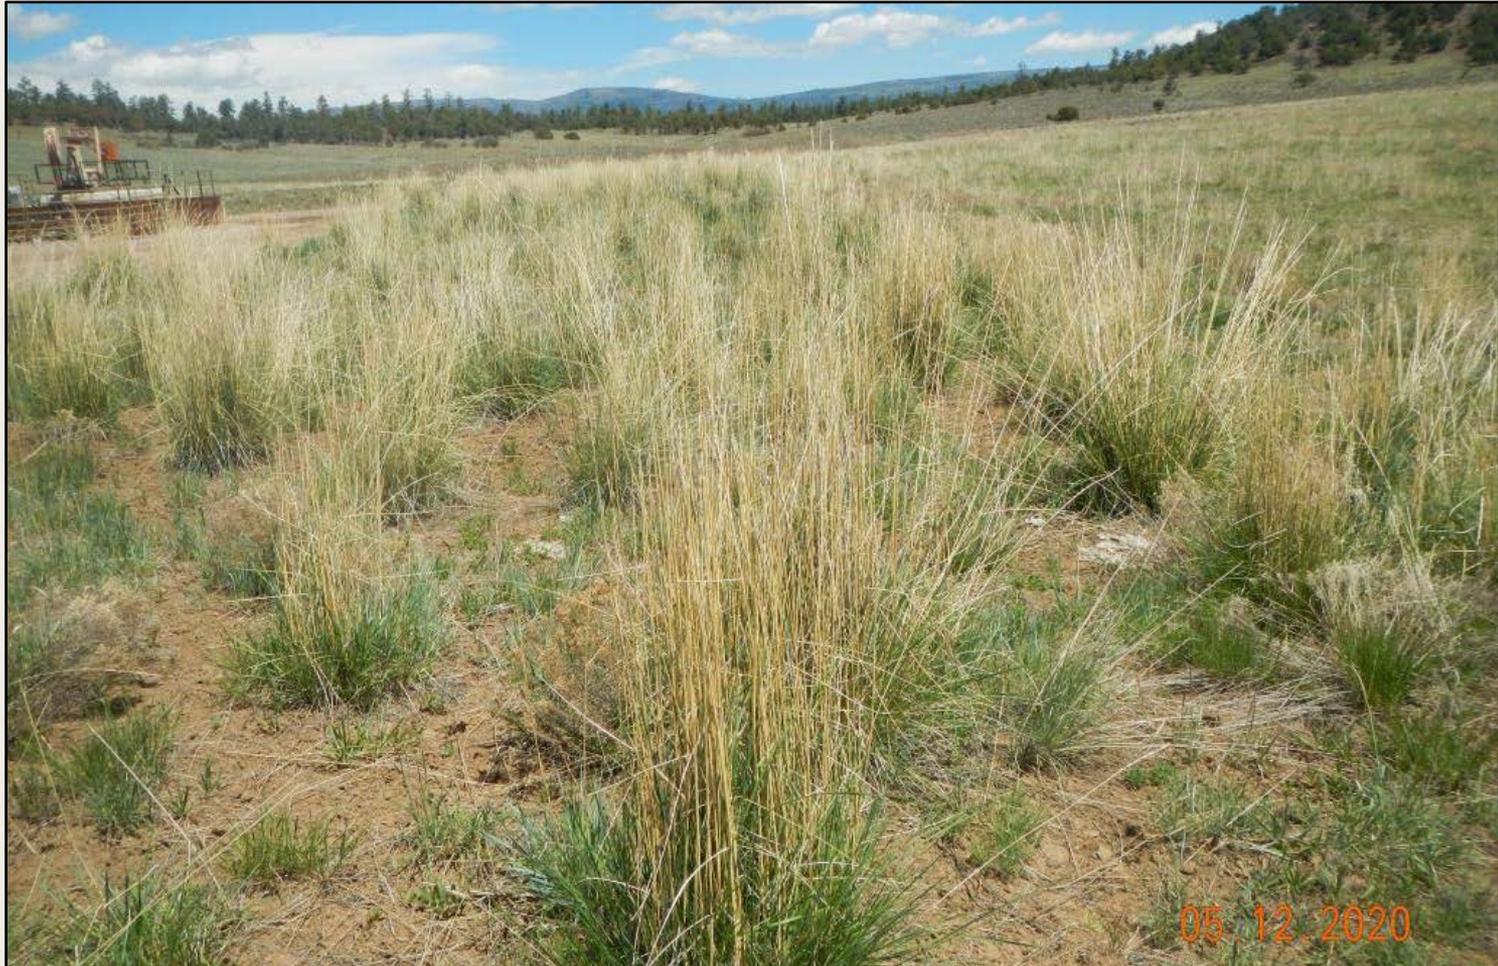
Photo 2. View of the eastern fill slope from the southeastern corner facing northward. Revegetation is progressing with grasses such as intermediate wheatgrass, crested wheatgrass, and western wheatgrass.

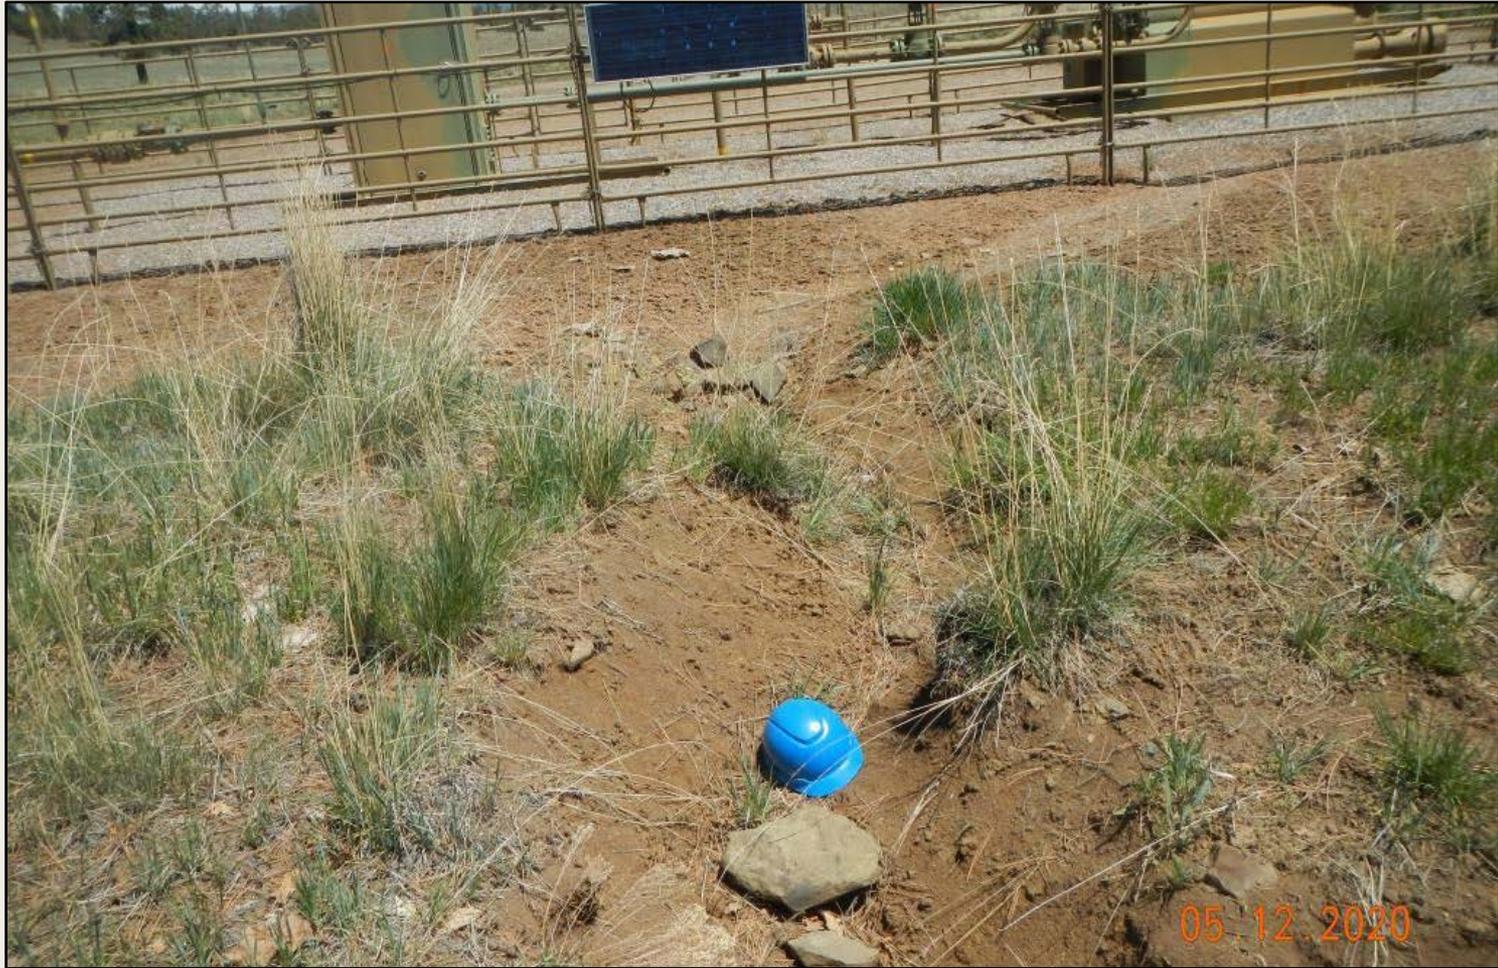
Photo 3. View of erosional channel approximately 2 feet wide and deep in the southern project area (facing upstream). Hard hat in place for scale.

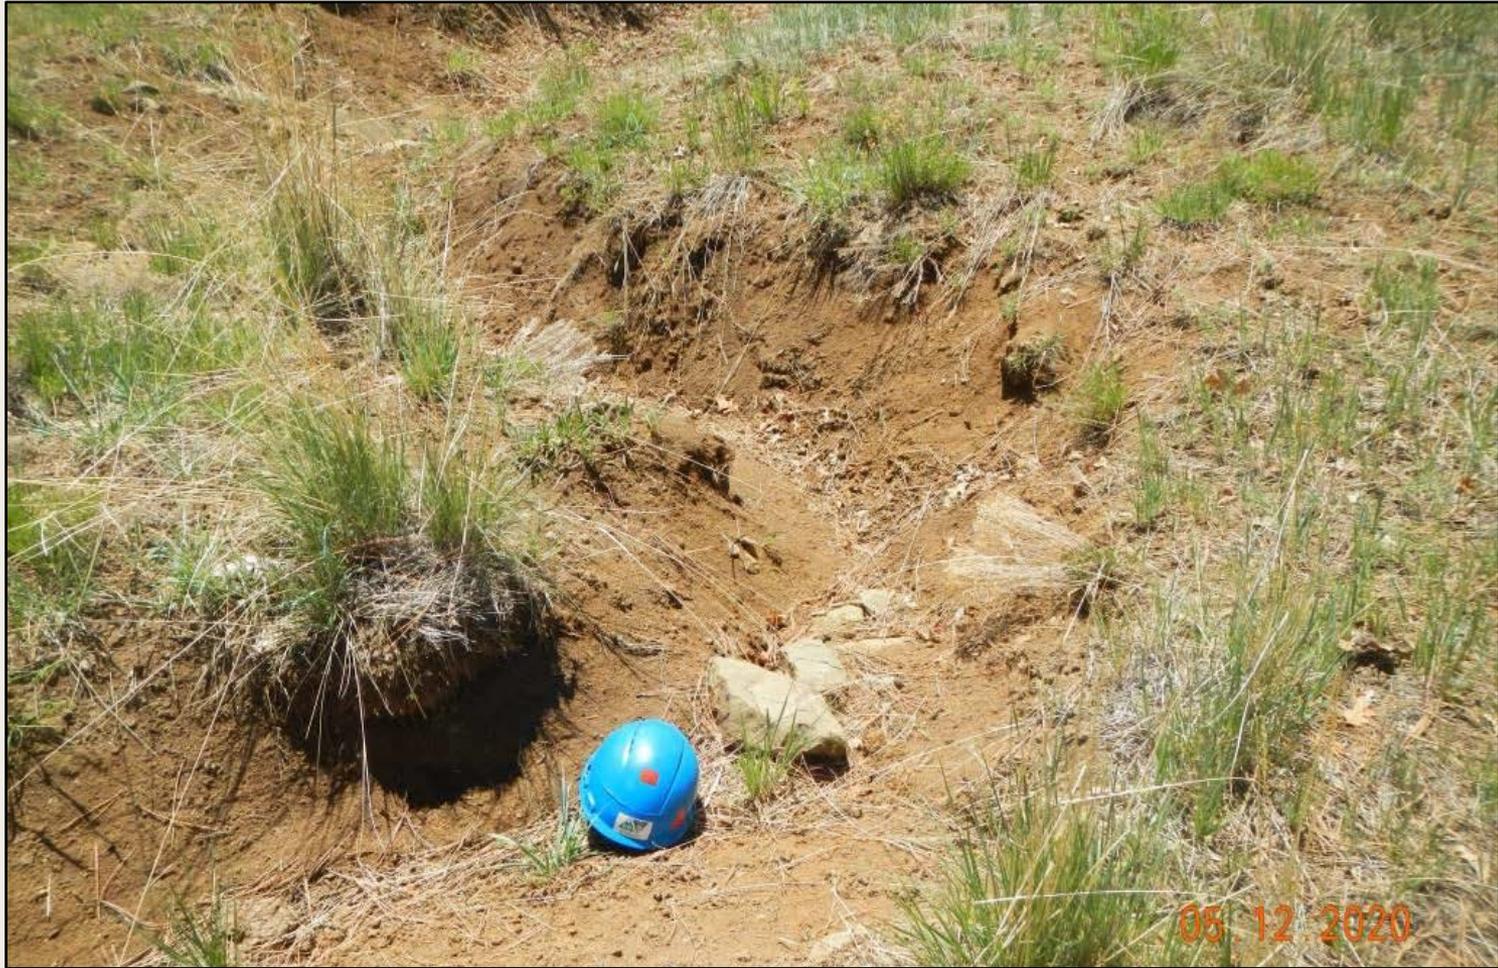
Photo 4. View of erosional channel approximately 2 feet wide and deep in the southern project area (facing downstream). Hard hat in place for scale.

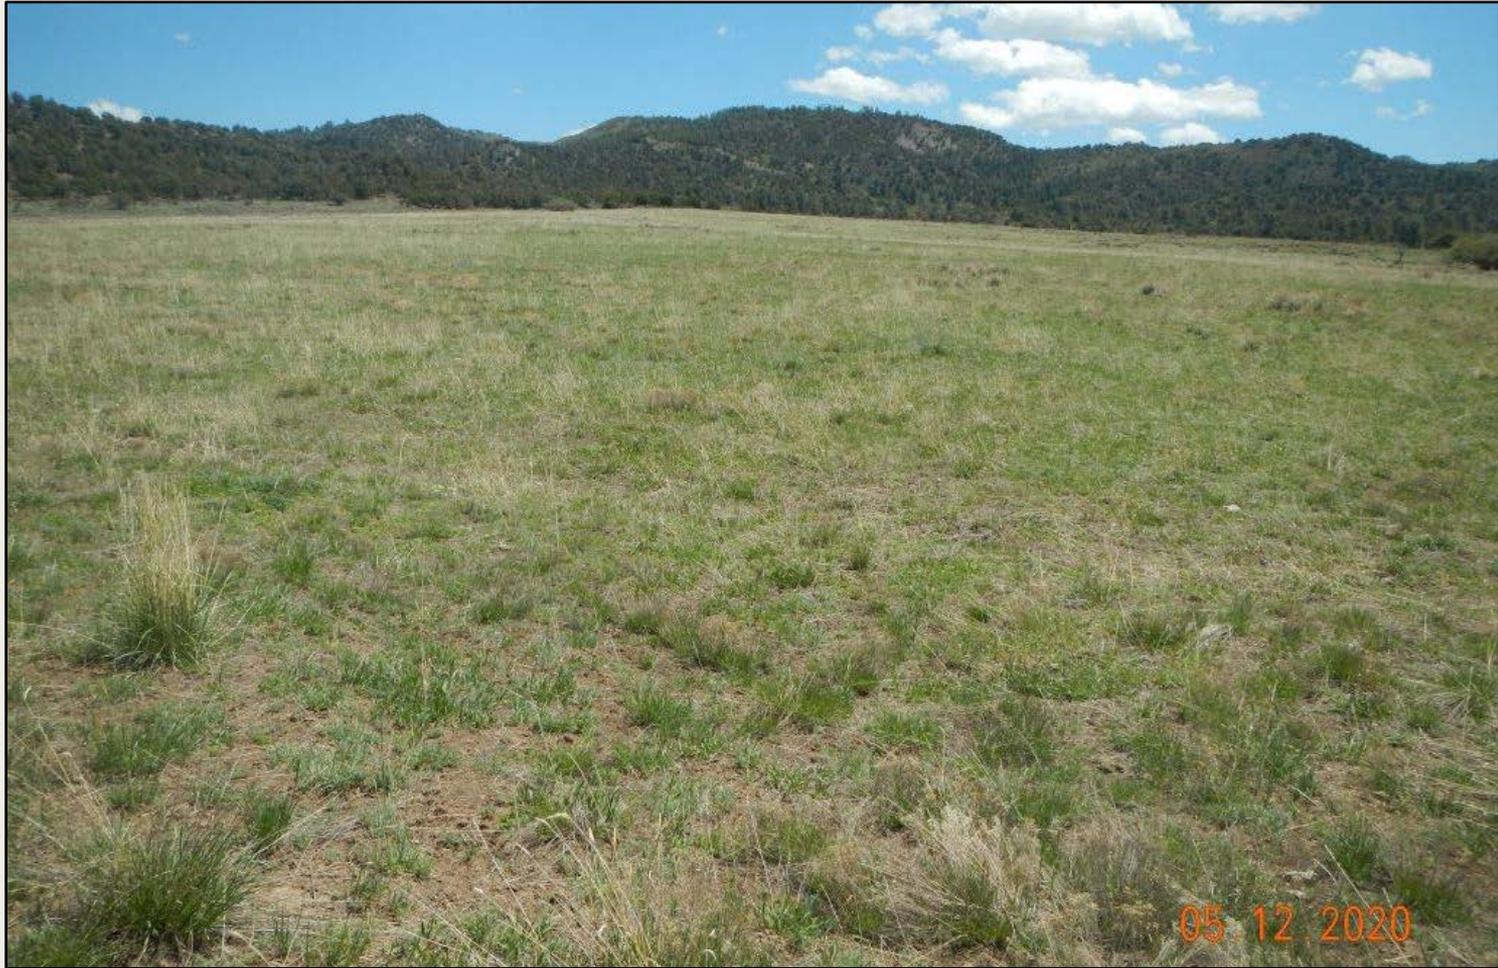
Photo 5. View of reference area vegetation comprised of open grass field with mixed native grasses such as western wheatgrass, or non-native grass such as crested wheatgrass.
