Inspection Photos  
Operator: BP America  
API#: 067-07068  
Date: 5/12/2020

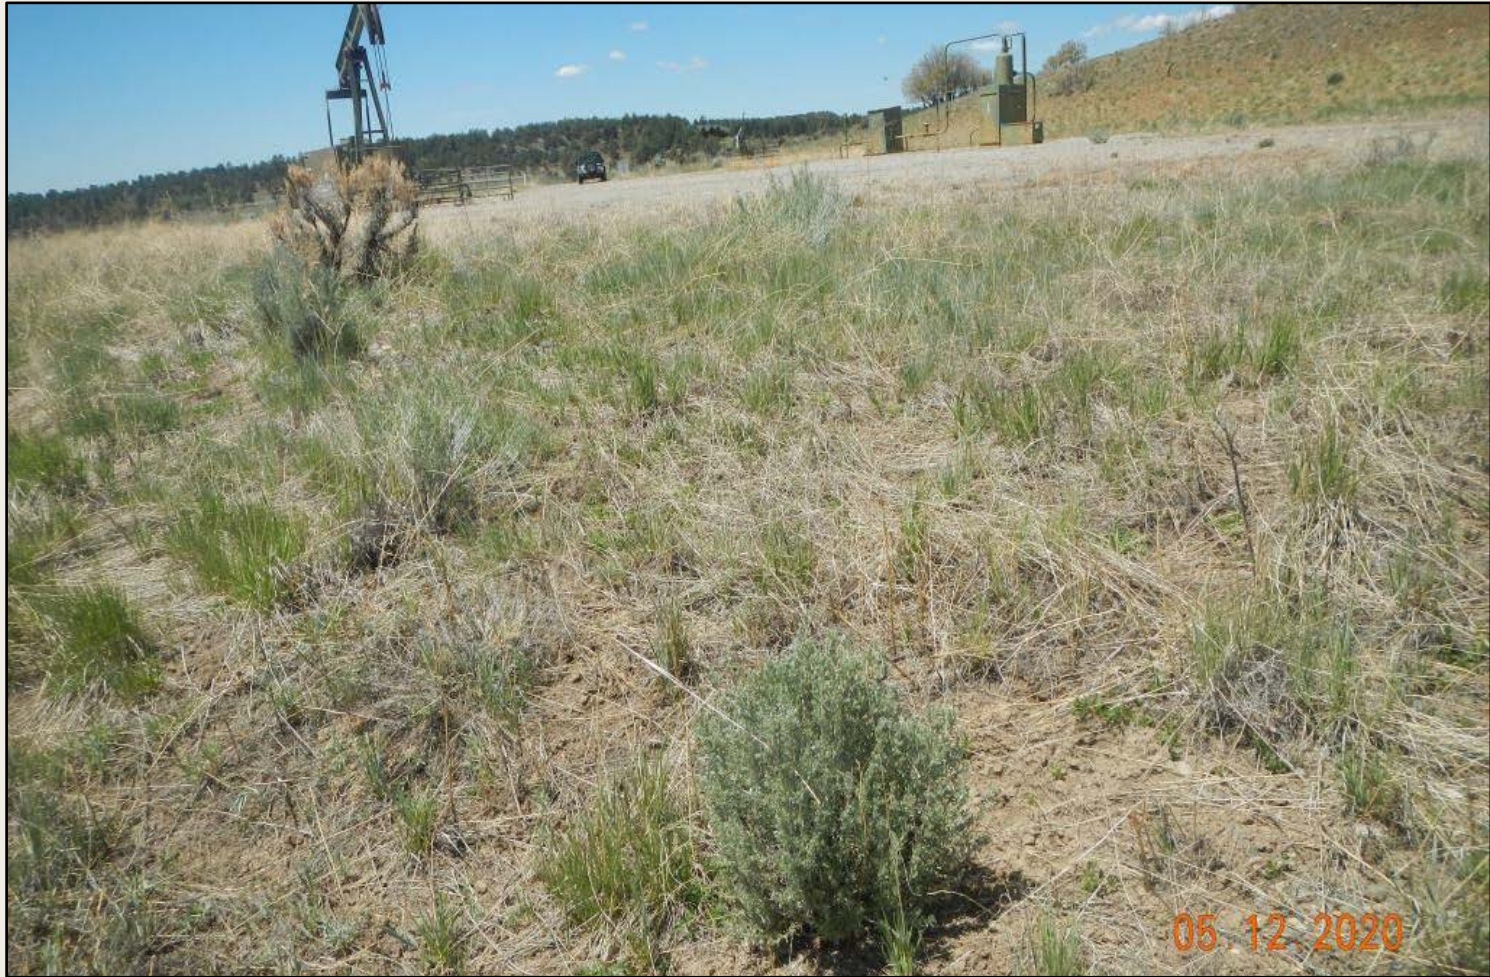
Photo 1. View of the project area from the southeastern corner facing center.

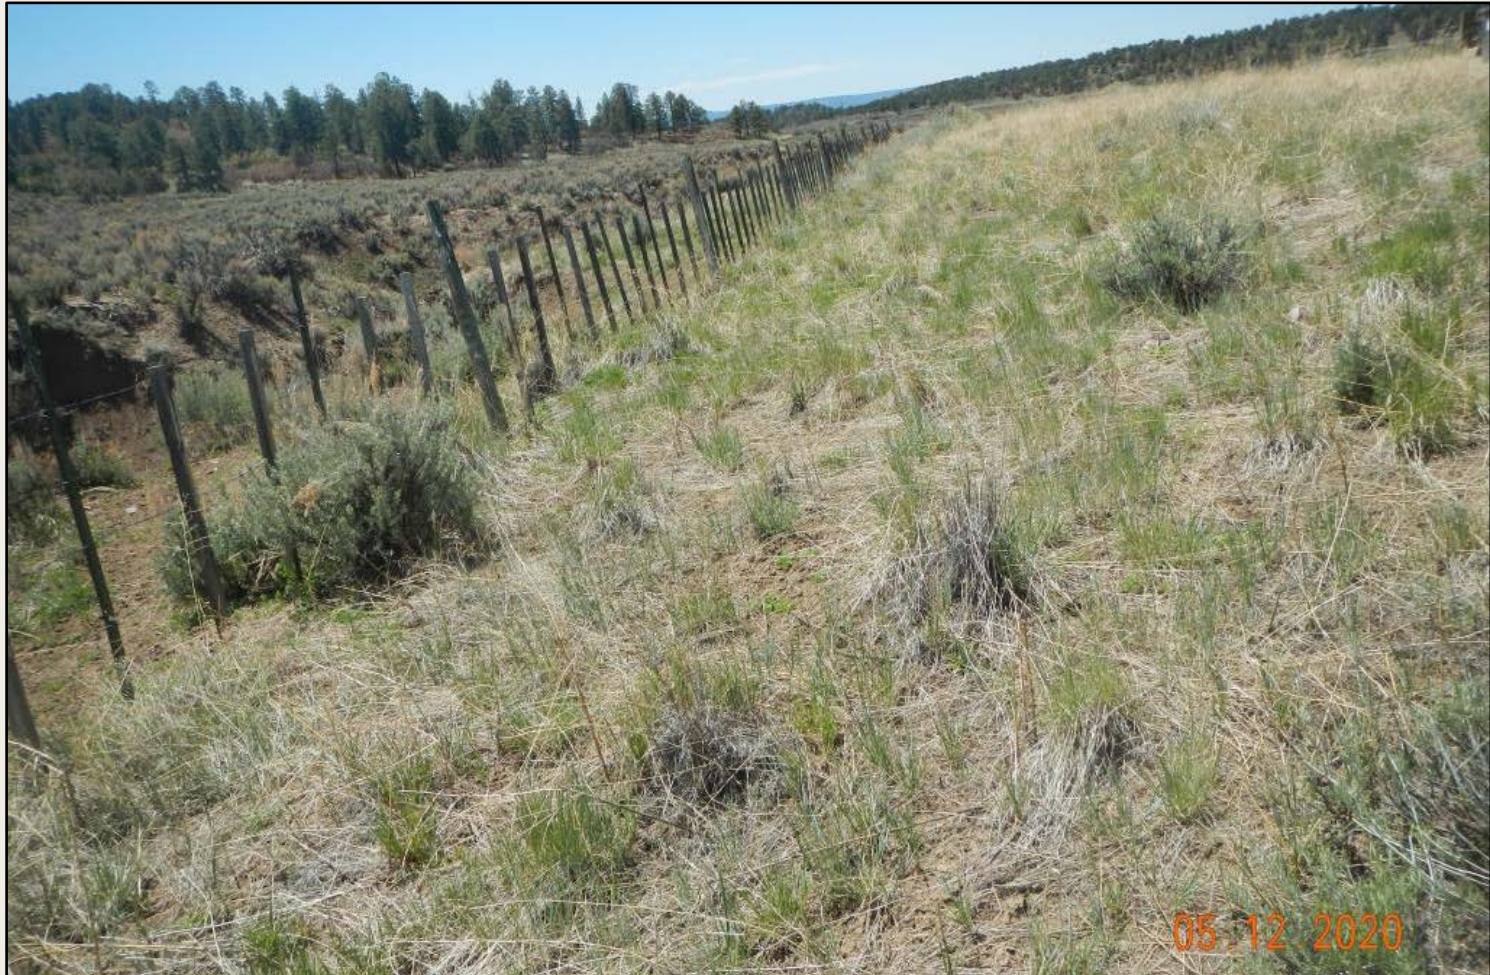
Photo 2. View of the southern project area from the southeastern corner facing southwestward. An approximately 20-foot deep arroyo runs along the southern edge of the project area.

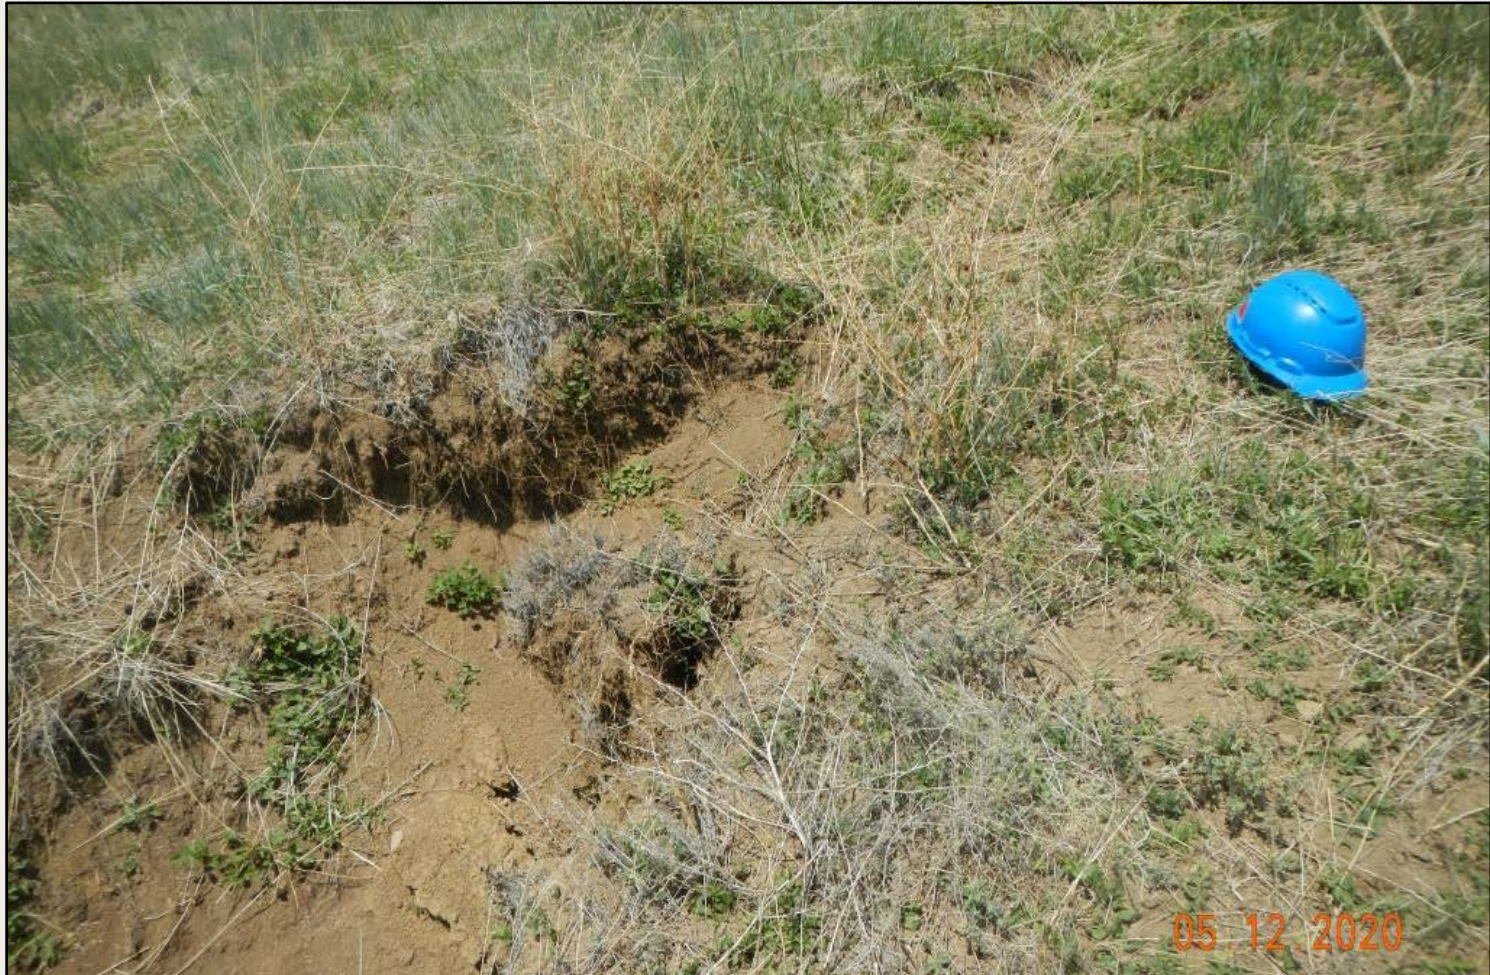
Photo 3. View of erosional head-cut in the southwestern project area (facing upstream). Hard hat in place for scale.

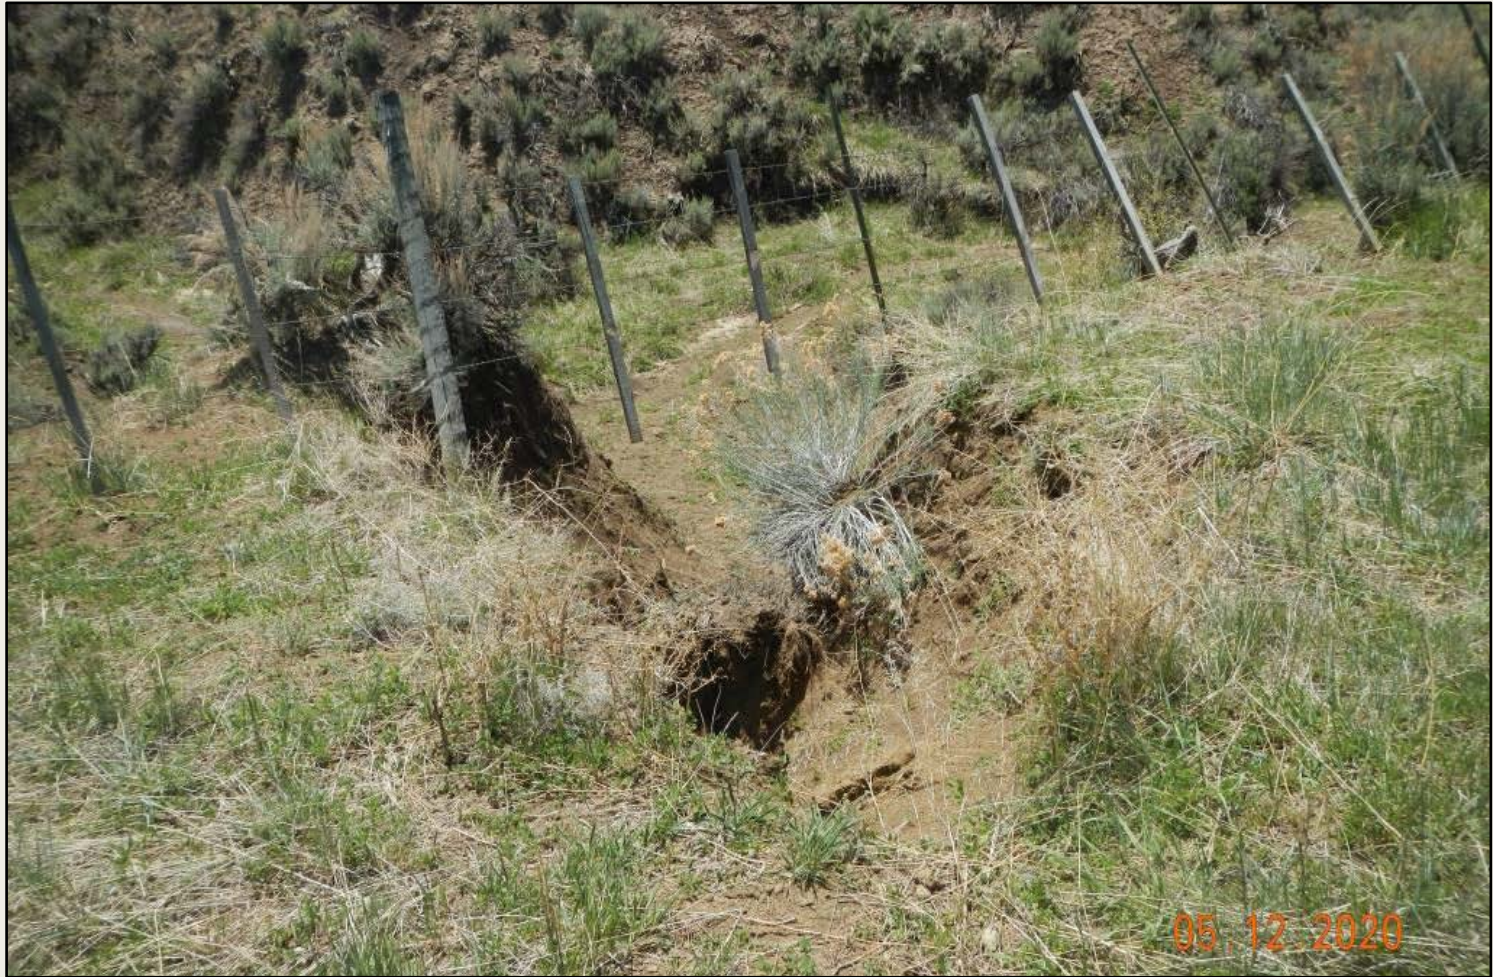
Photo 4. View of erosional head-cut in Photo 3, facing downstream. Stabilization is needed here.

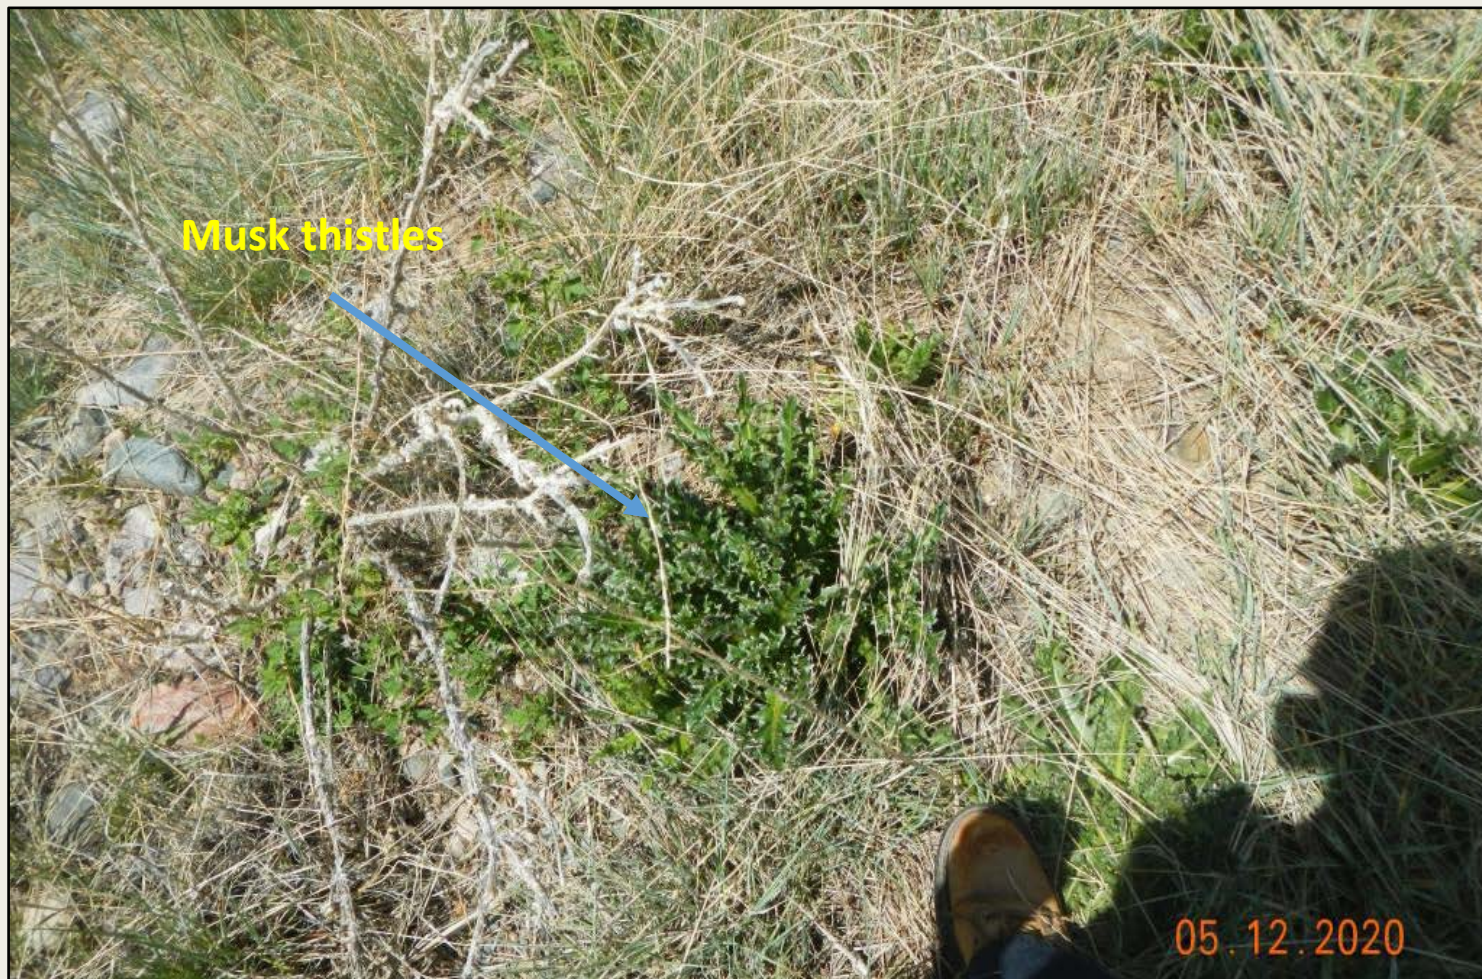
Photo 5. View of musk thistles observed within the interim reclamation area. Approximately 200 individuals observed.

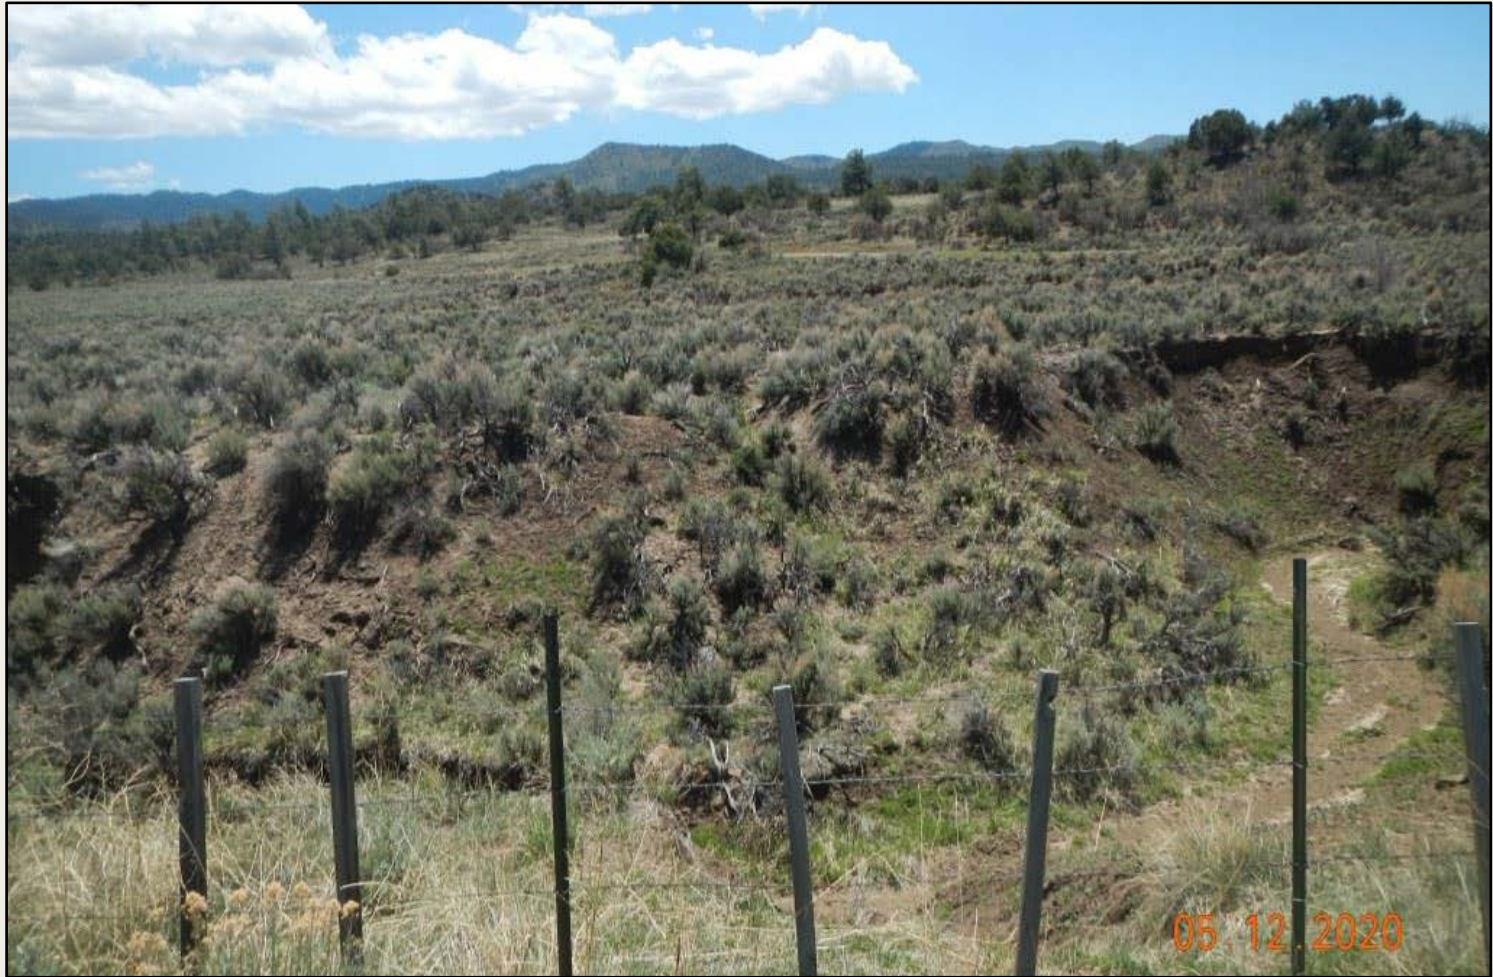
Photo 6. View of reference area vegetation (beyond fence) comprised of sagebrush shrubland with grasses such as blue grama and sand dropseed.
