Inspection Photos  
Operator: BP America  
API#: 067-09076  
Date: 5/12/2020

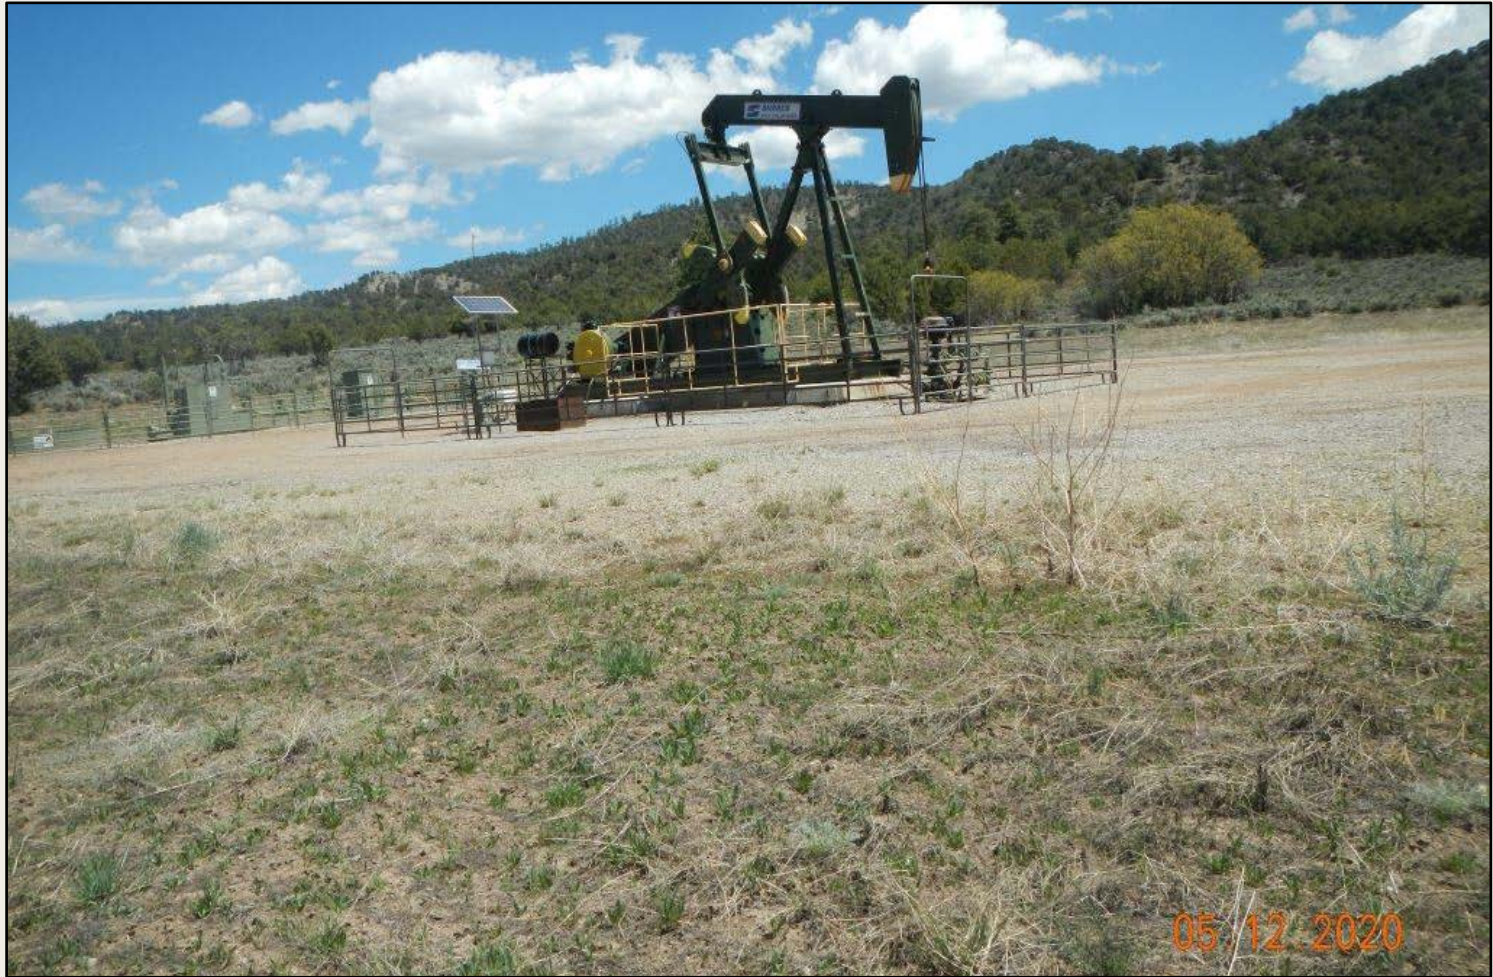
Photo 1. View of the project area from the southwestern corner facing center.

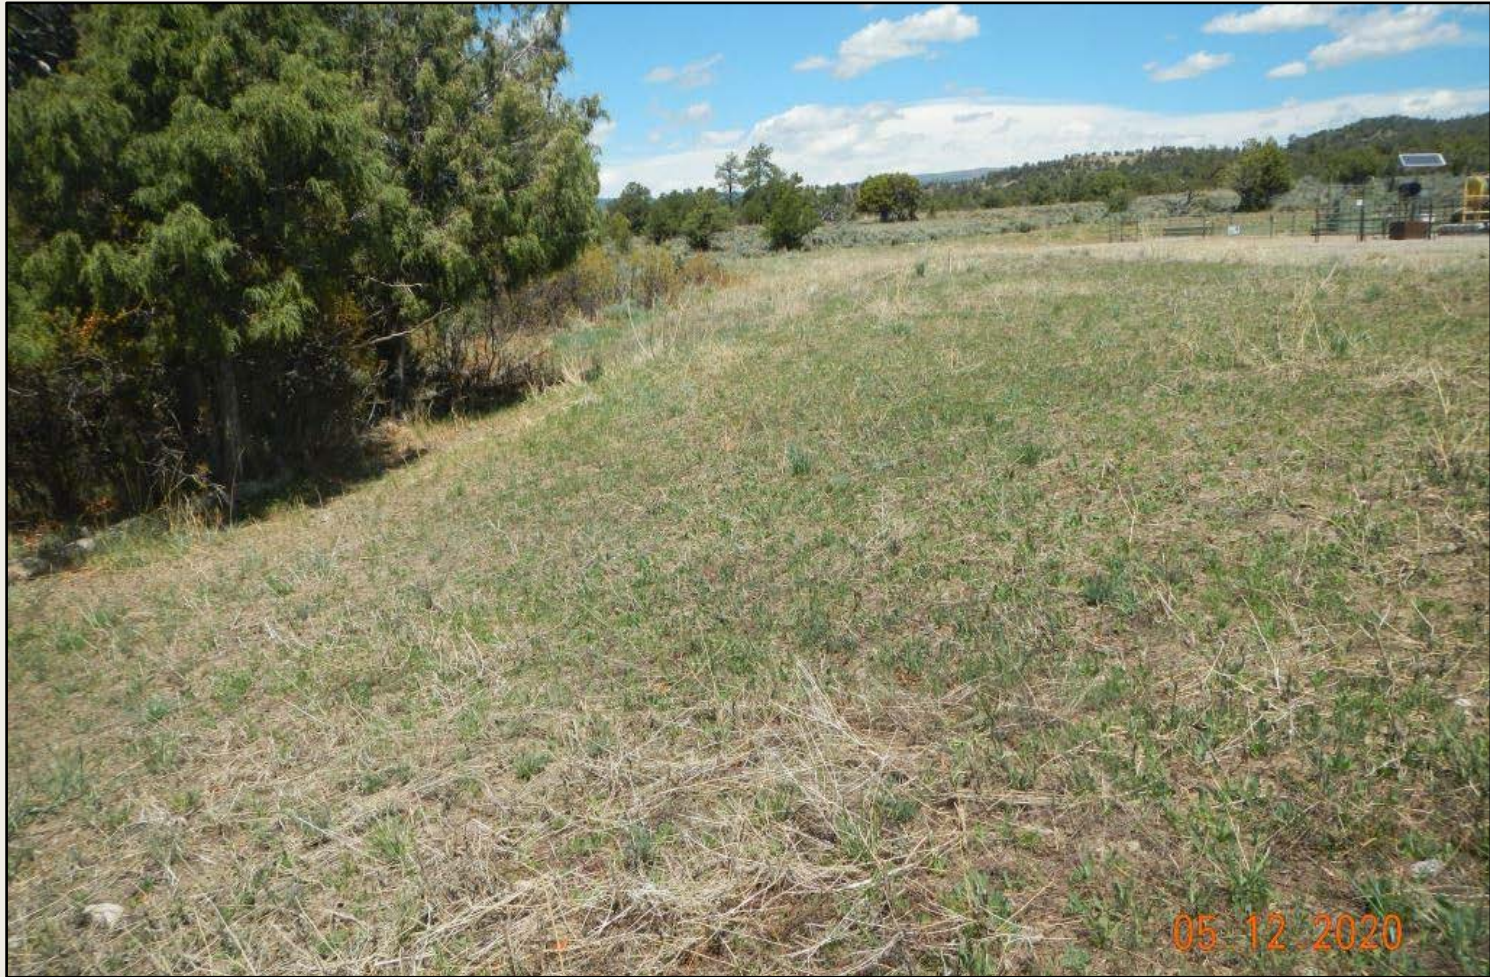
Photo 2. View of the western project area from the southwestern corner facing northward. Revegetation is progressing with grasses such as western wheatgrass.

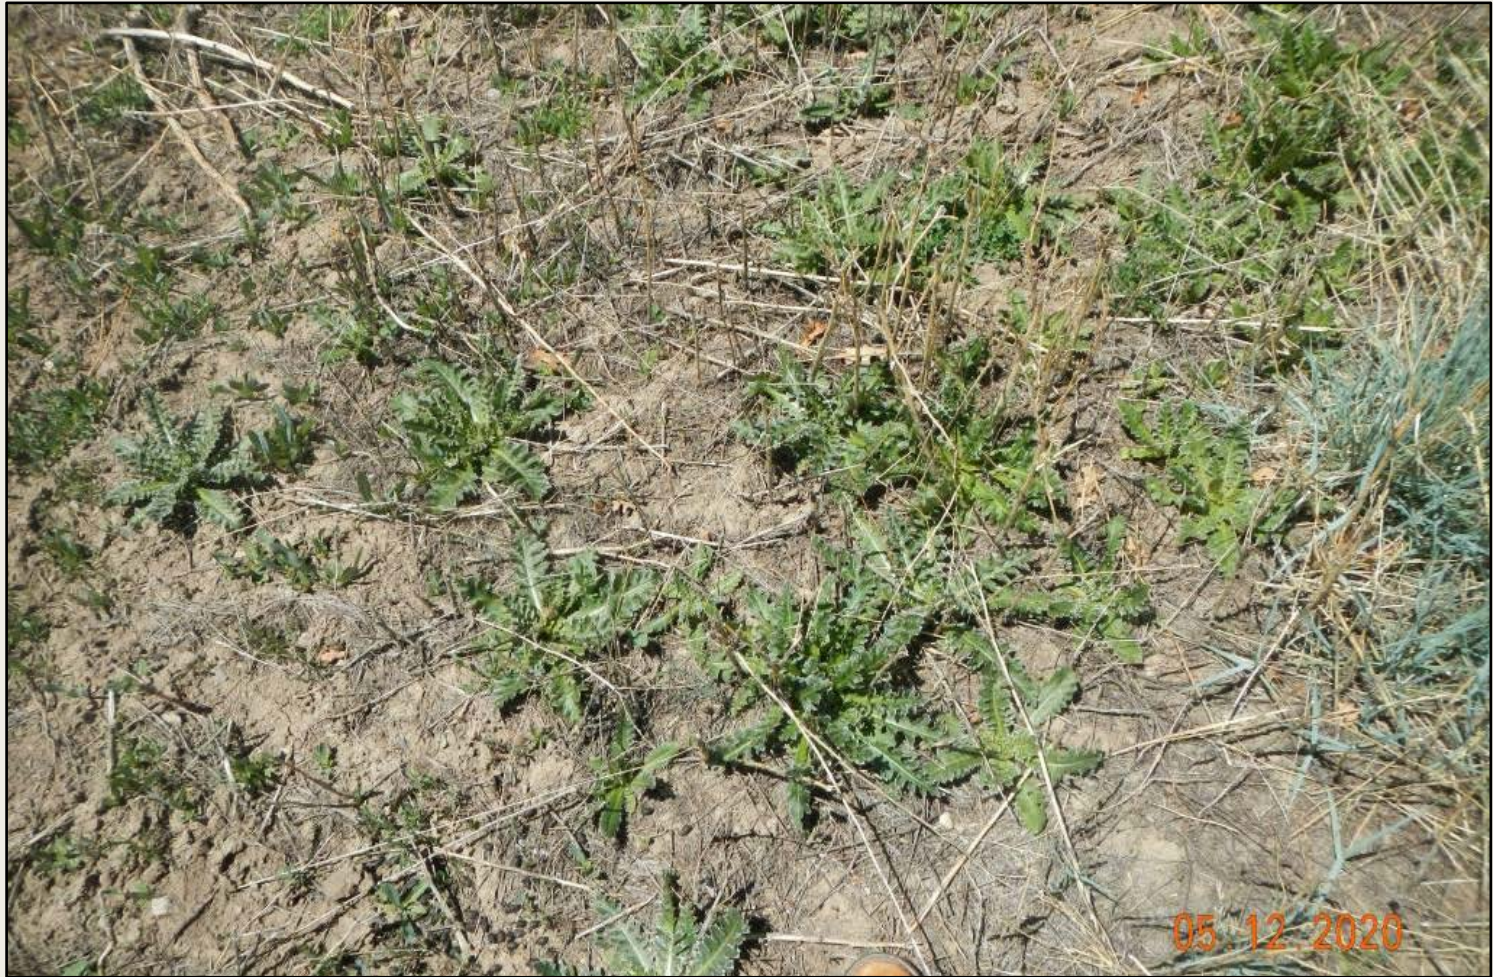
Photo 3. View of dense musk thistles within the western project area. Approximately 300 individuals observed.

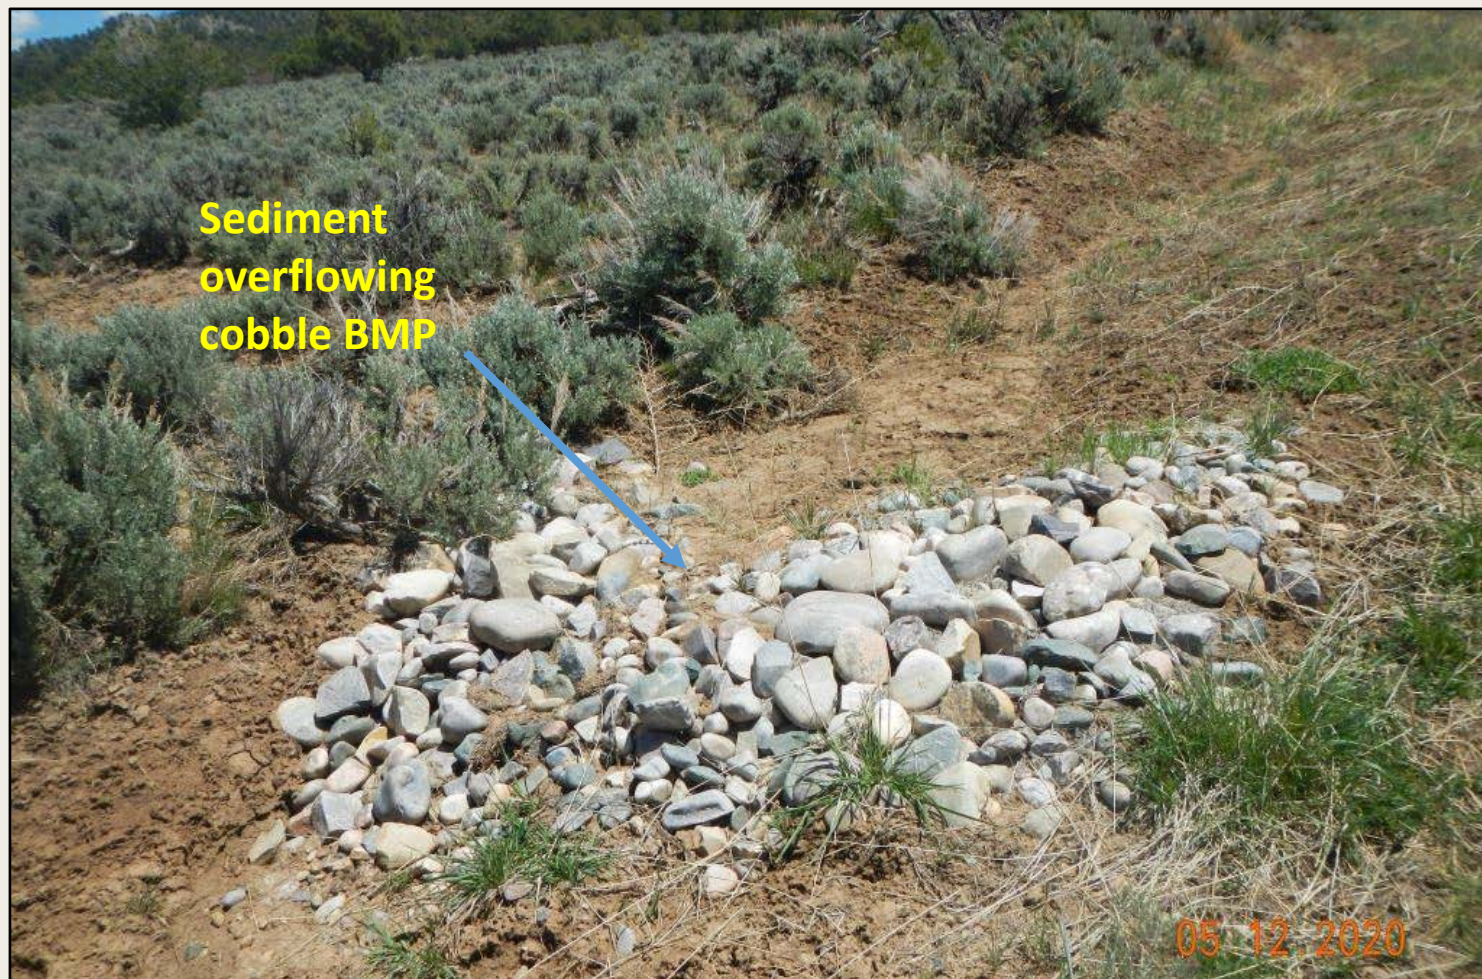
Photo 4. View of stormwater BMP in the northern project area, that is full of sediment.

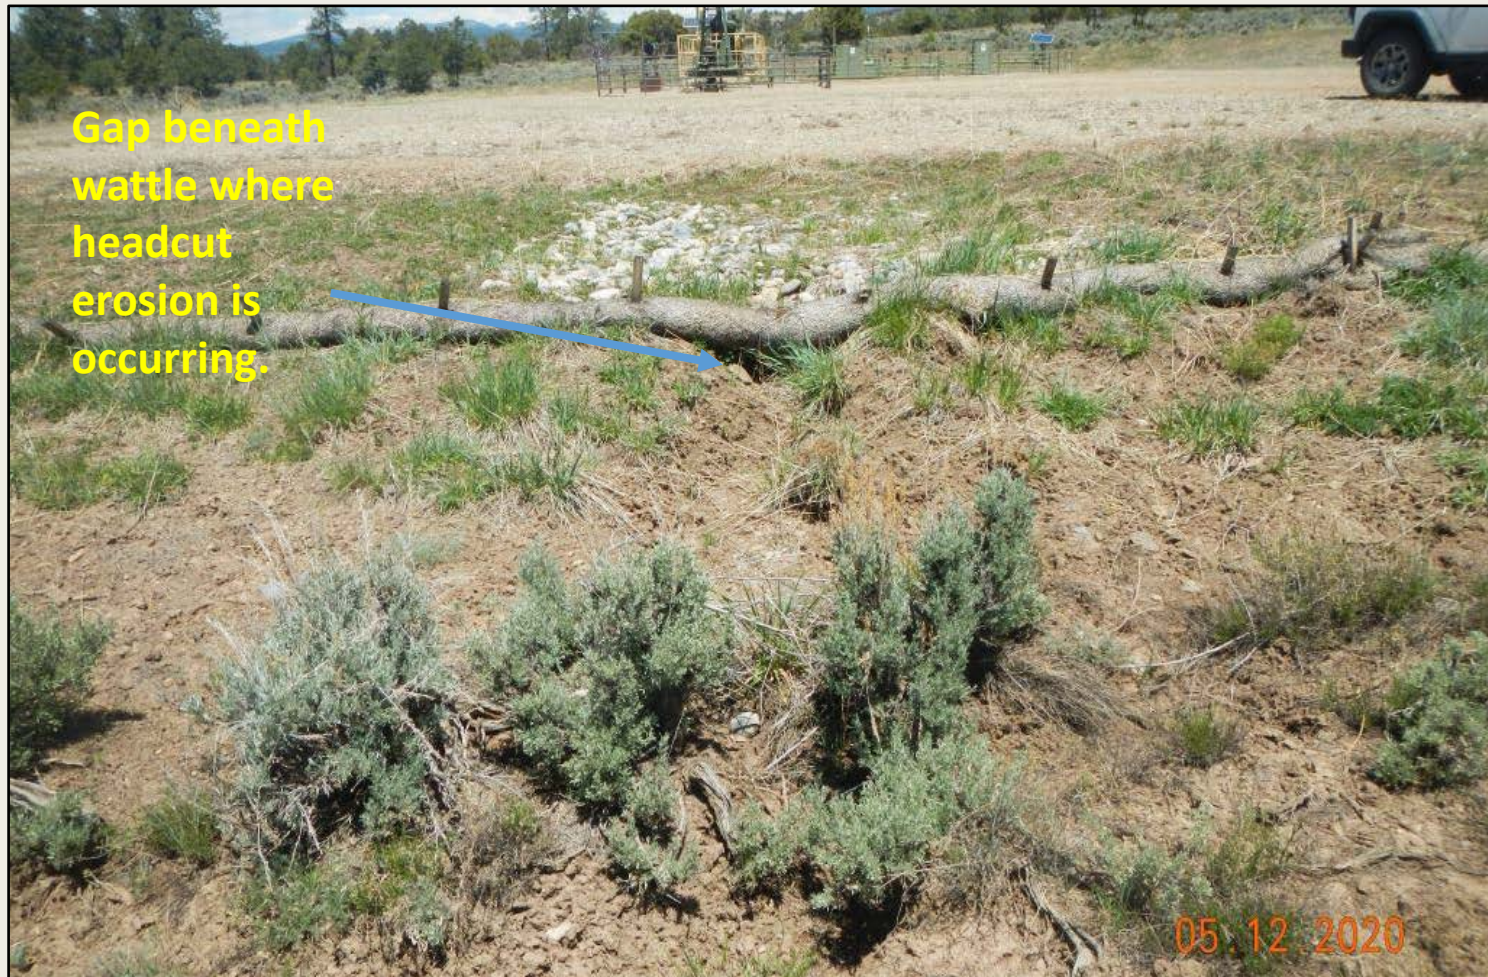
Photo 5. View of wattle and cobble BMPs in the southern project area. Large gap and headcut present beneath the wattle. Improved BMPs are needed here.

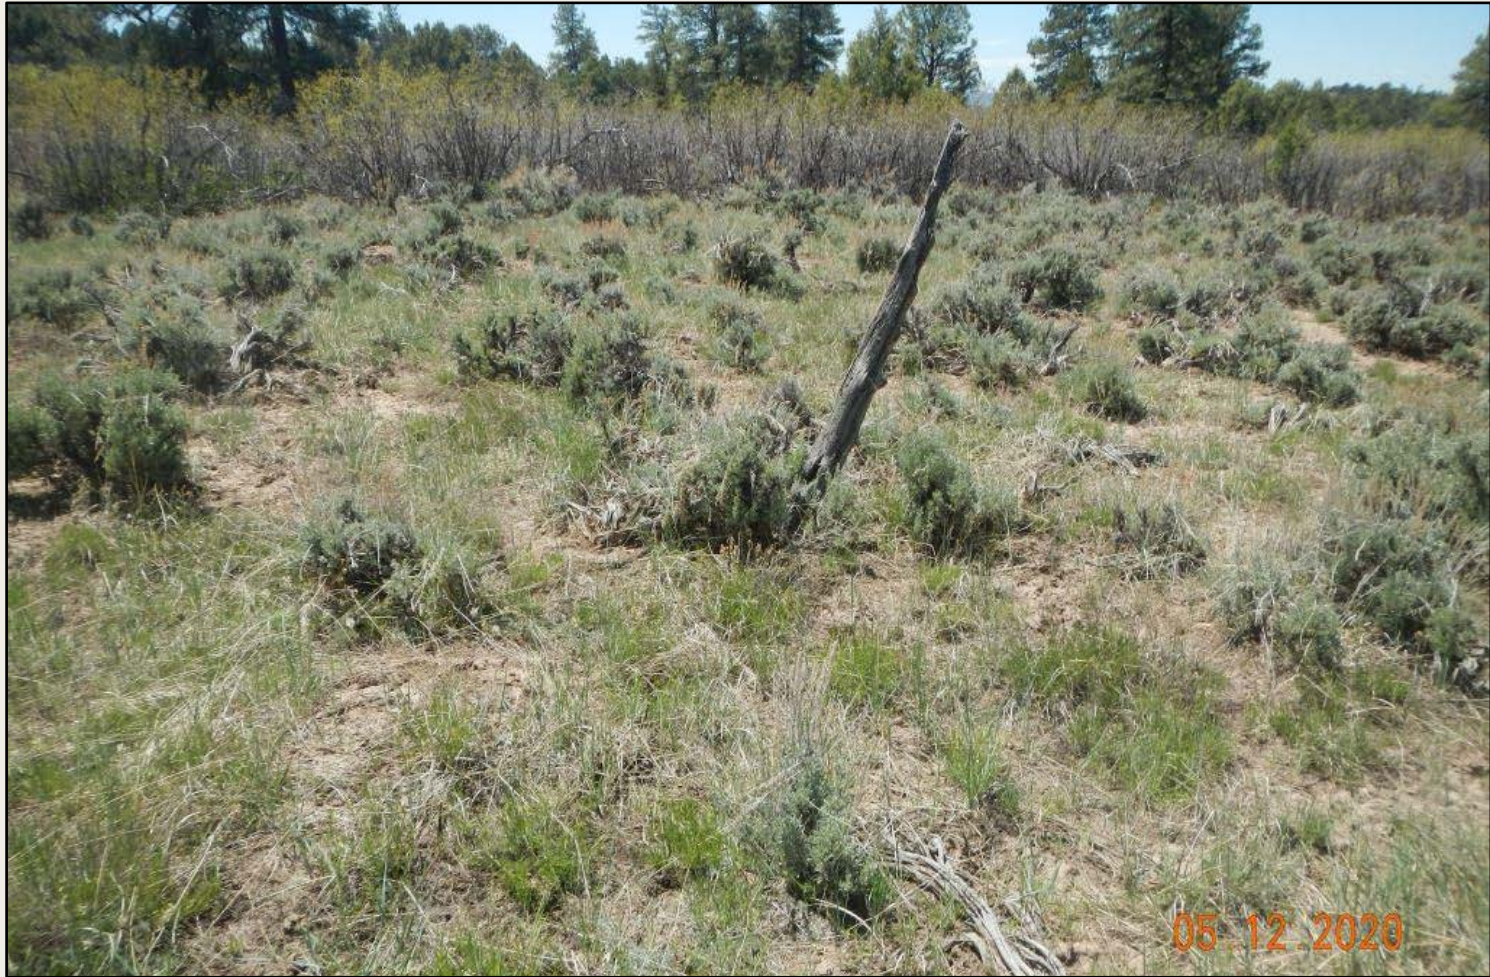
Photo 6. View of reference area vegetation comprised of sagebrush shrubland with grasses such as western wheatgrass, and sand dropseed, in a mosaic with gambel oak and Ponderosa pine woodland.
