**Inspection Photos**

**Location Name: South Leverich 13-09 Pad**

**Location ID: 335045 & Spill/Release ID: 476157**

**Inspection Date: May 5, 2020**

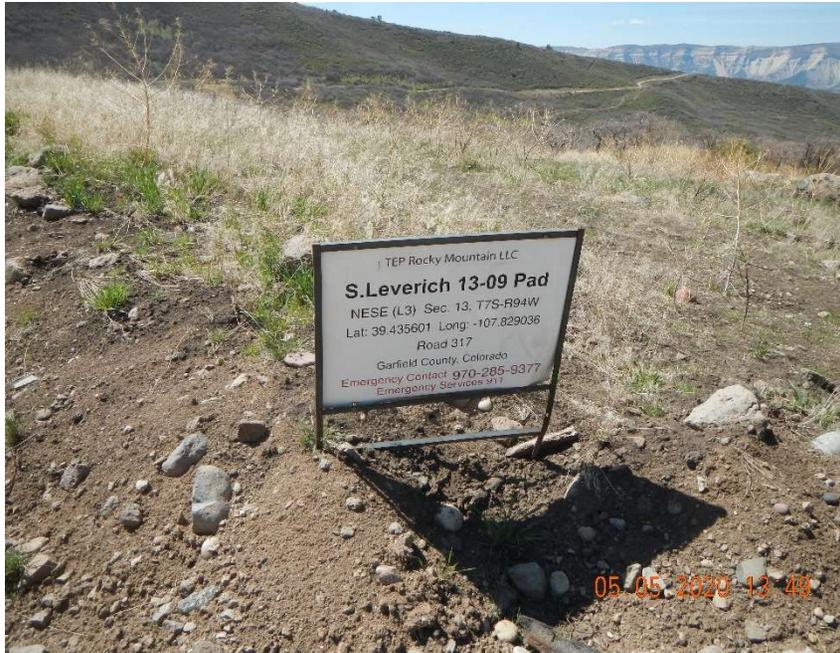
Location sign

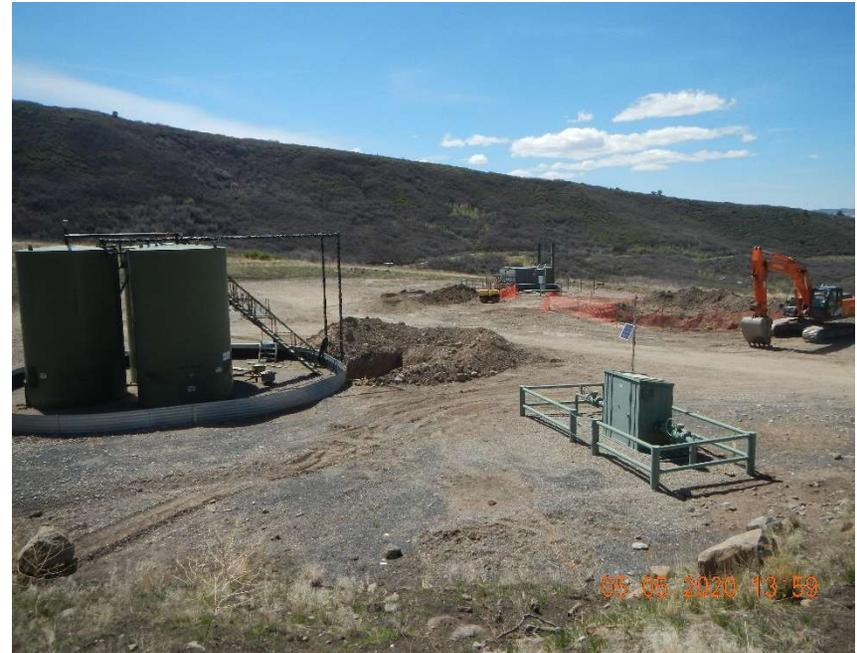
Overview of the location, three excavations were observed at time of inspection

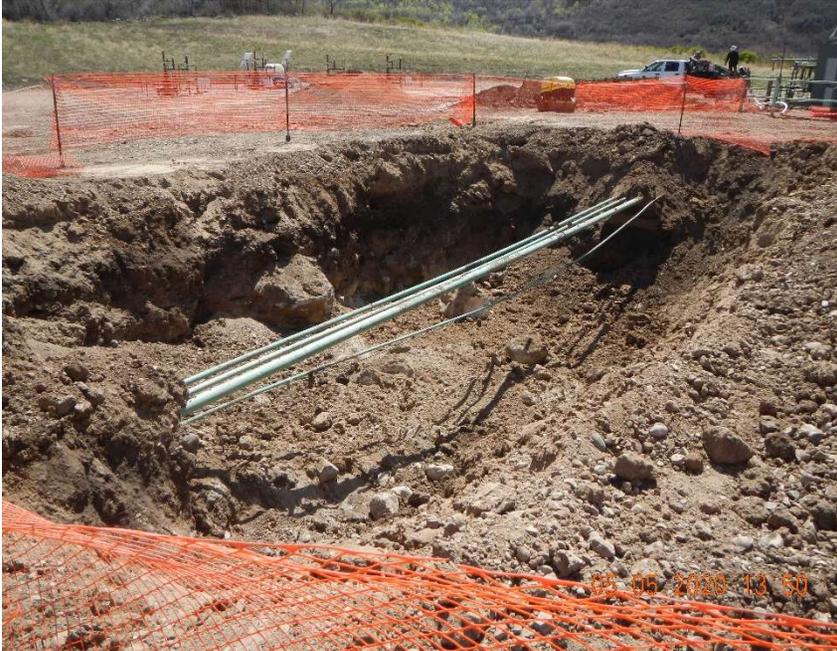
**View of the excavation on the northeast corner of the location where the spill/release occurred. A detectable hydrocarbon odor was present at time of inspection.**

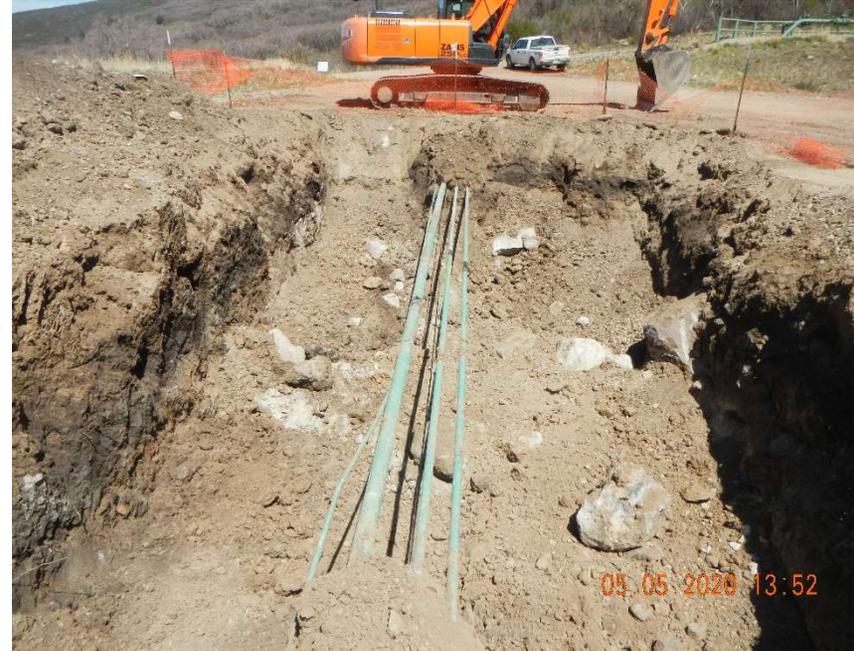
**View of the excavation on the northeast corner of the location where the spill/release occurred. A detectable hydrocarbon odor was present at time of inspection.**

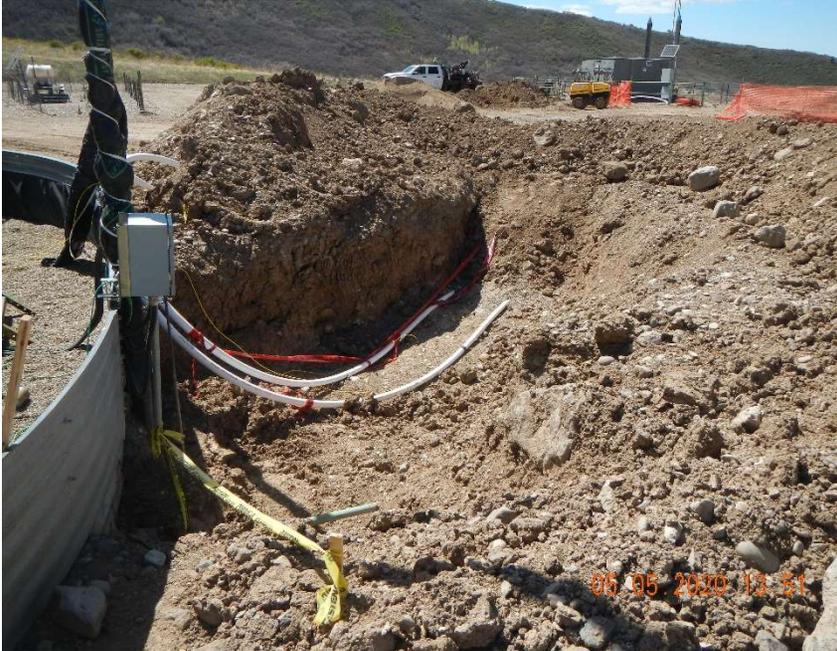
Excavation adjacent to the tank battery

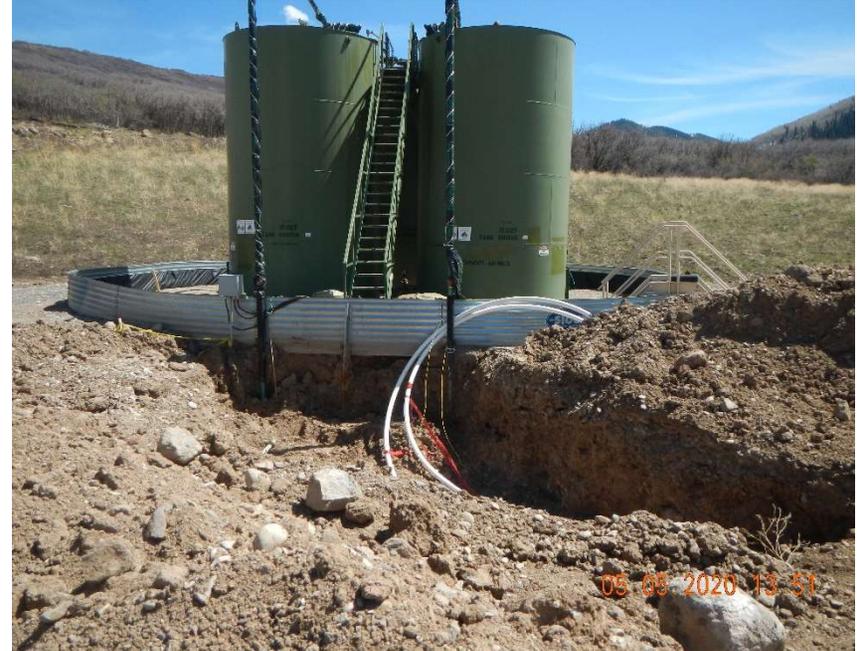
Excavation adjacent to the tank battery

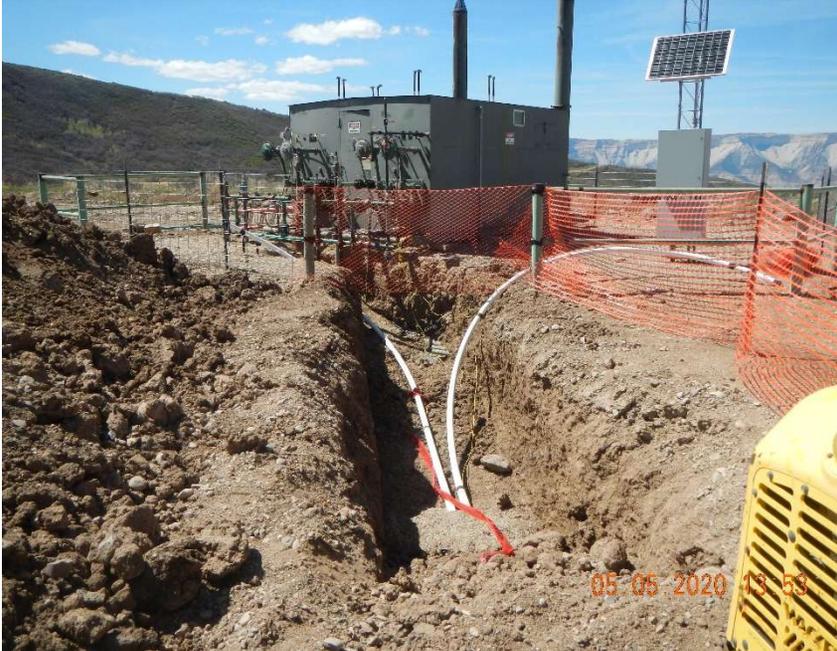
Excavation adjacent to the separators

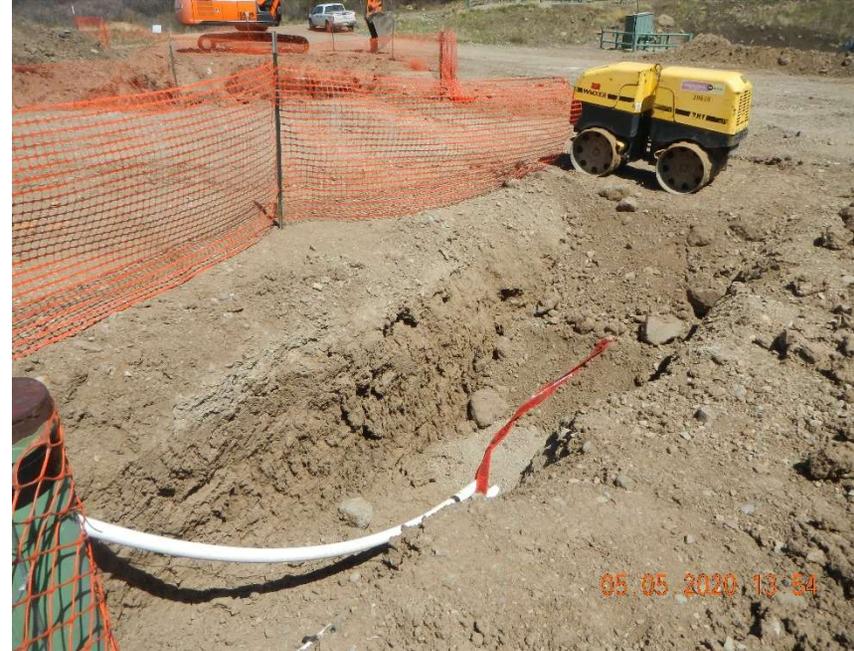
Excavation adjacent to the separators

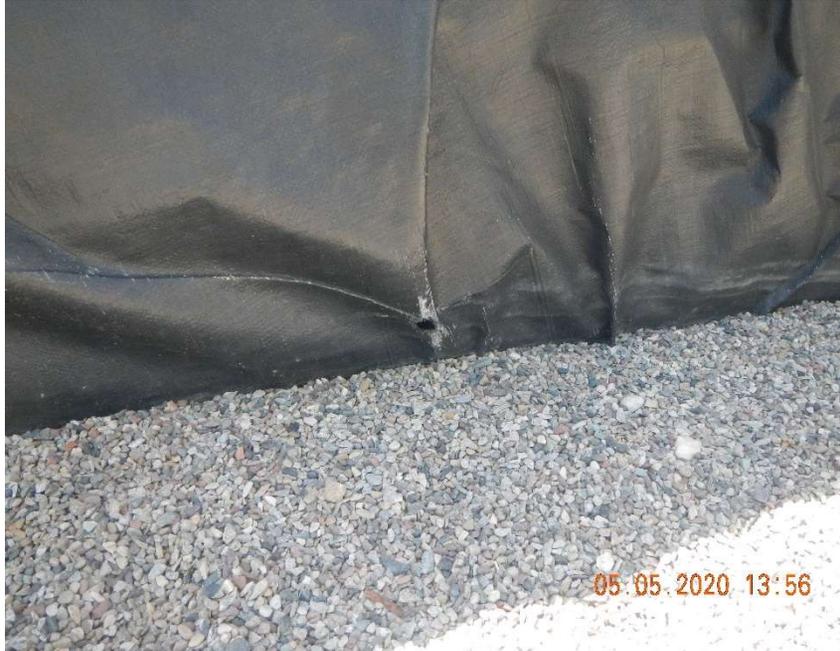
Hole in tank battery secondary containment liner

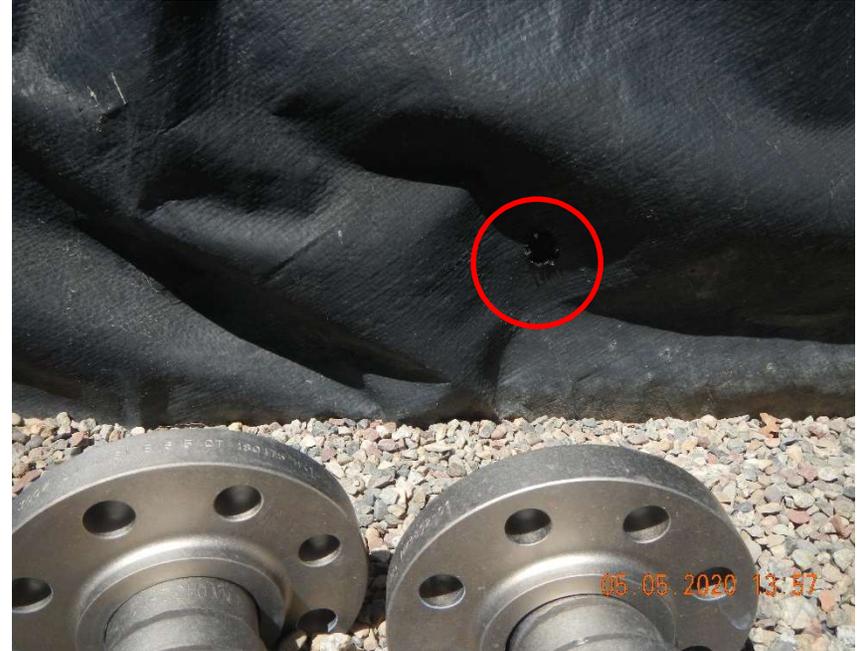
Hole in tank battery secondary containment liner

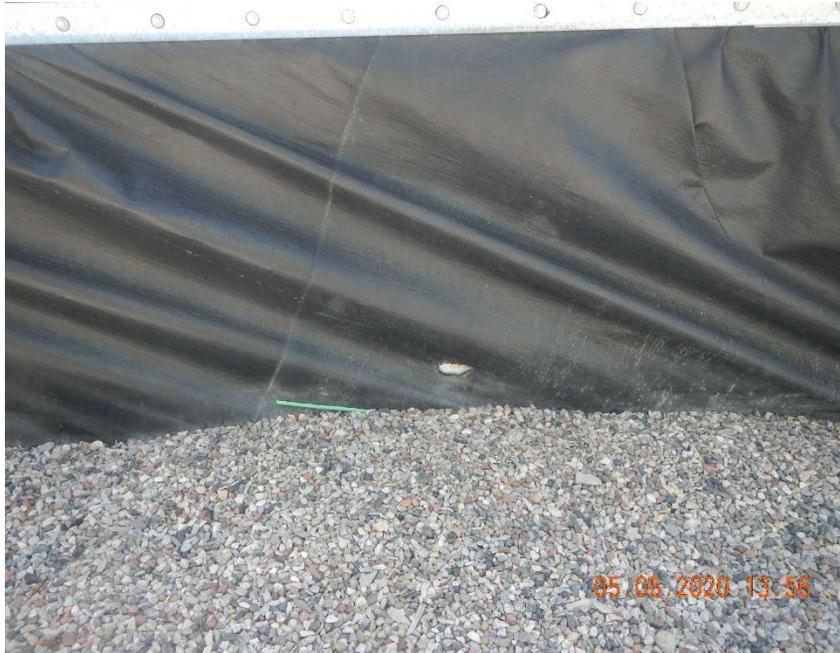
**Hole in tank battery secondary containment liner**

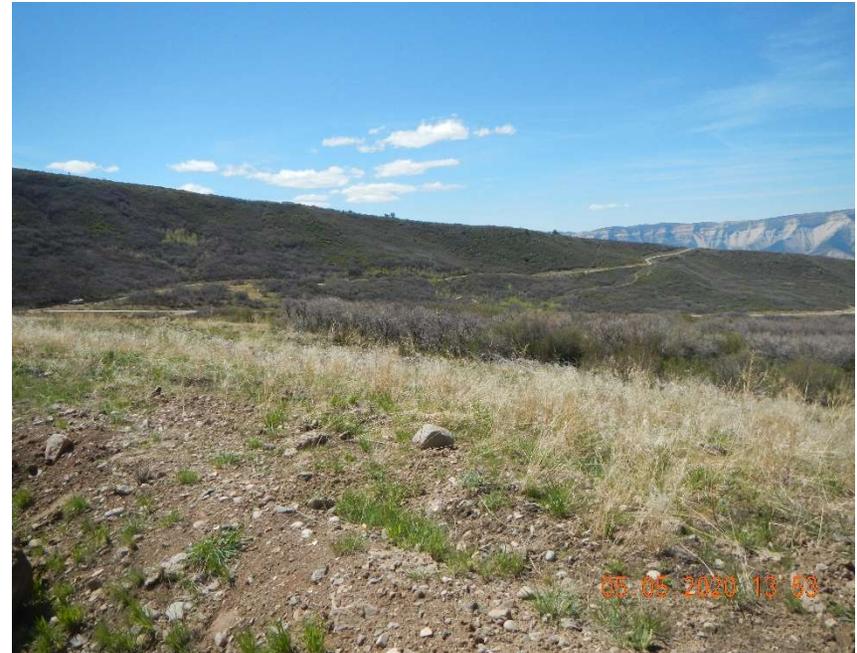
**Looking northeast from the location towards Beaver Creek**
