COLORADO
Oil & Gas Conservation
Commission
Department of Natural Resources

Stagner 7 API: 05-103-07280
Inspection: 700401505

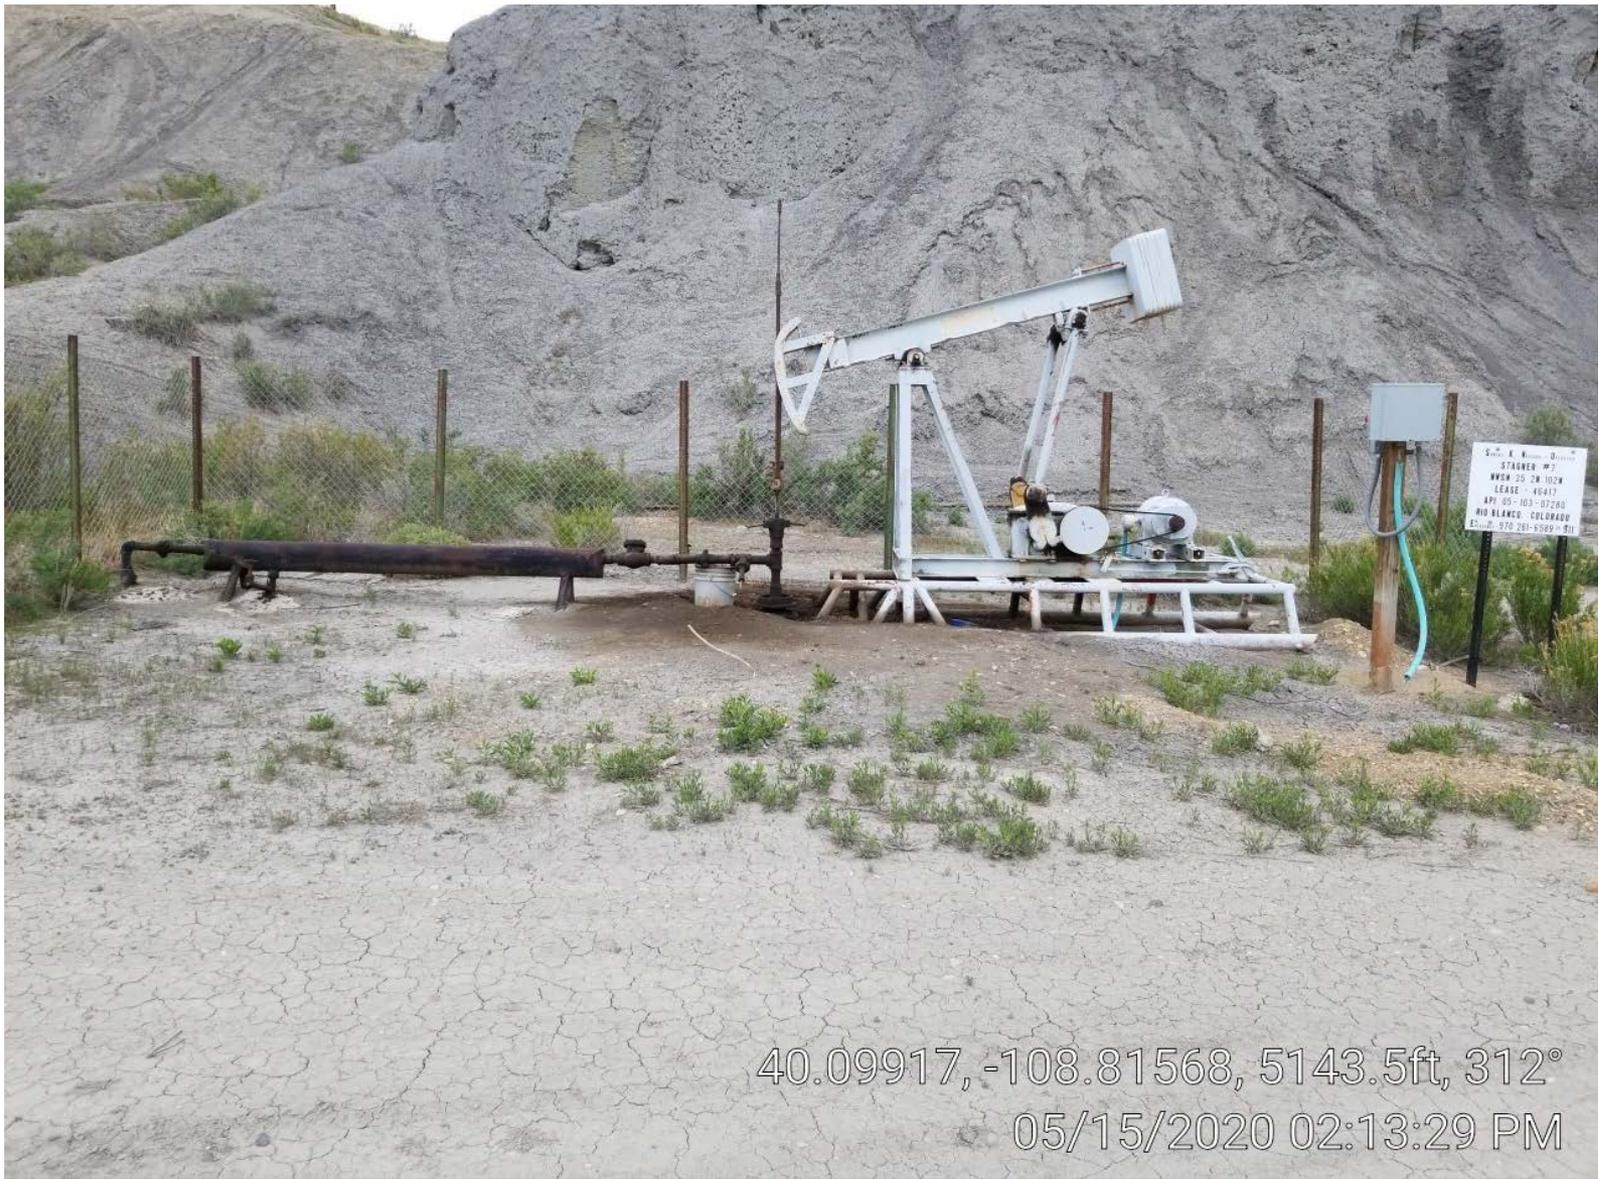
Photo 2. Pump jack.

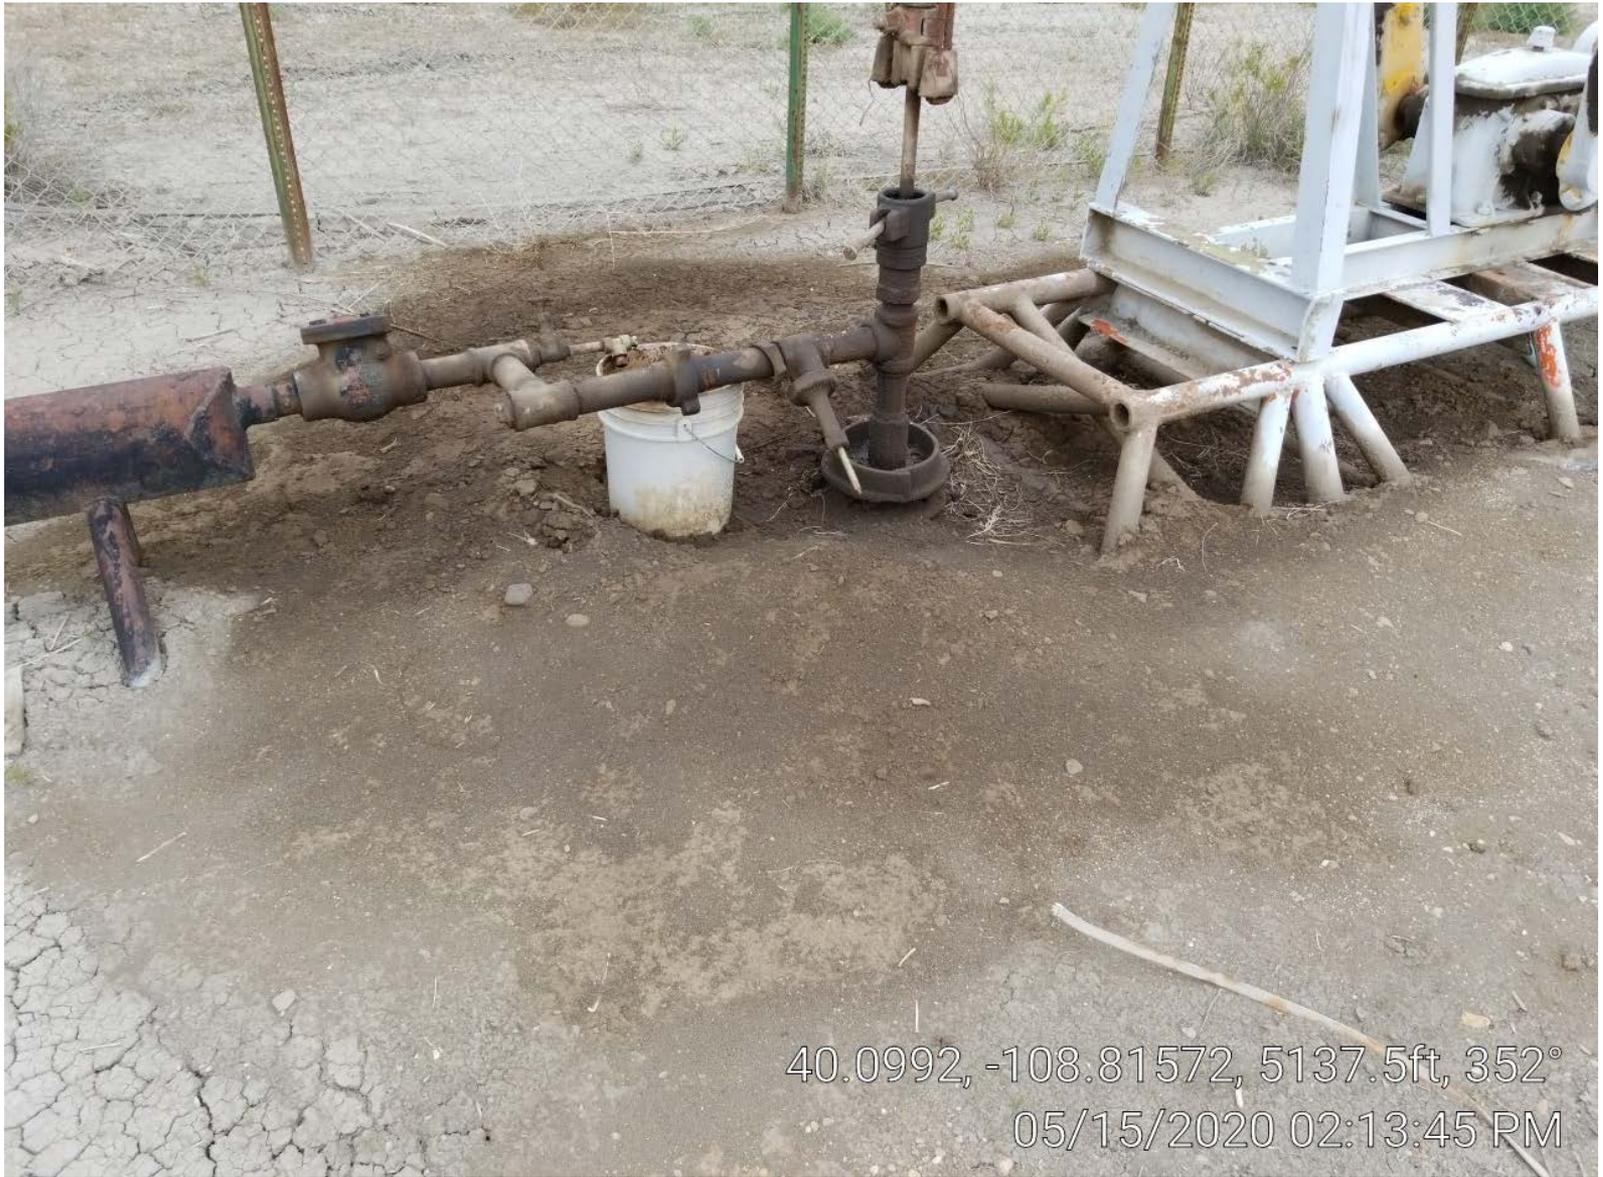
Photo 3. Stained soil.
