COLORADO
Oil & Gas Conservation
Commission
Department of Natural Resources

Stagner 6 API: 05-103-07362
Inspection: 700401509

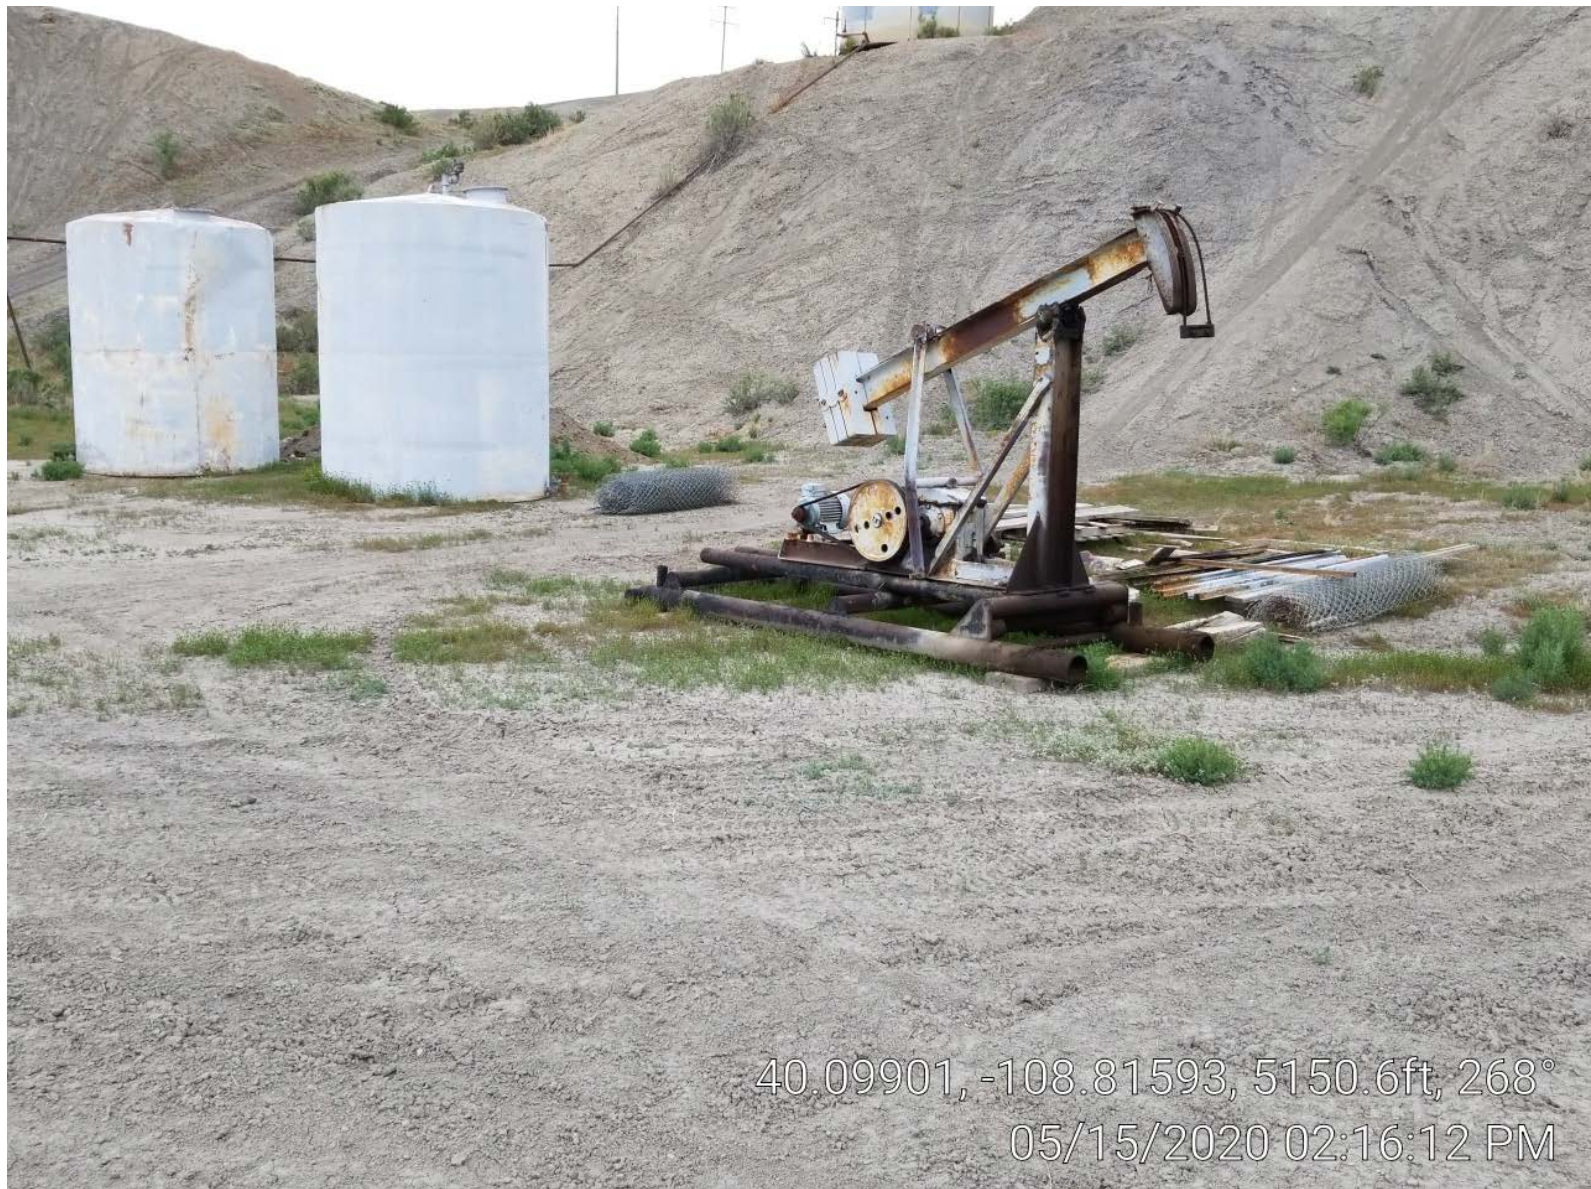
**Photo 3. Unused equipment. Pump jack from
Stagner 2.**

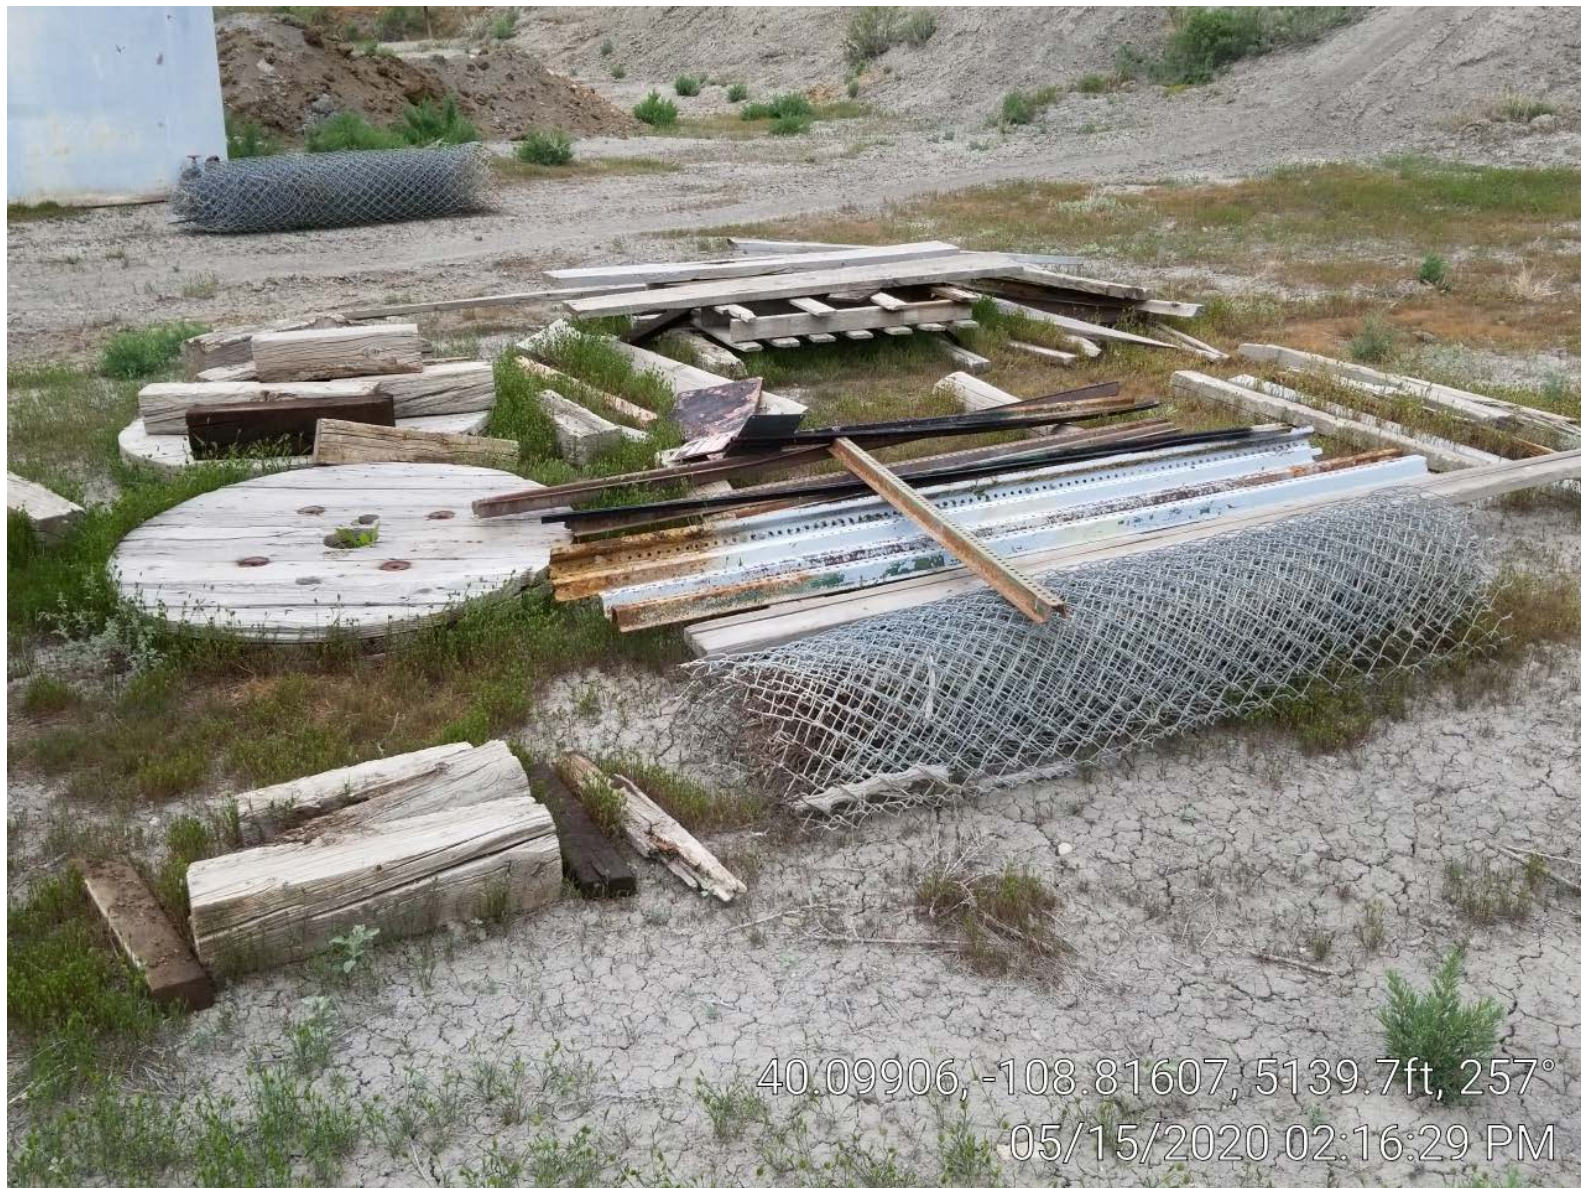
Photo 5. Unused equipment (Stagner2 ?)
