**Inspection Photos**  
**Location Name: Krajack 43-27 #2**  
**API: 05-067-08835**

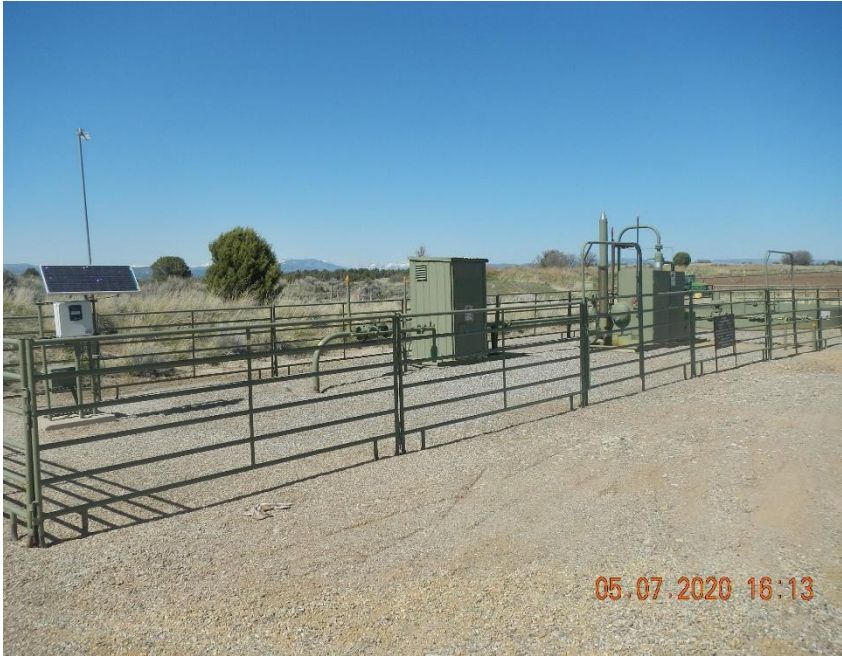
**Krajack 43-27 #2 production equipment.**

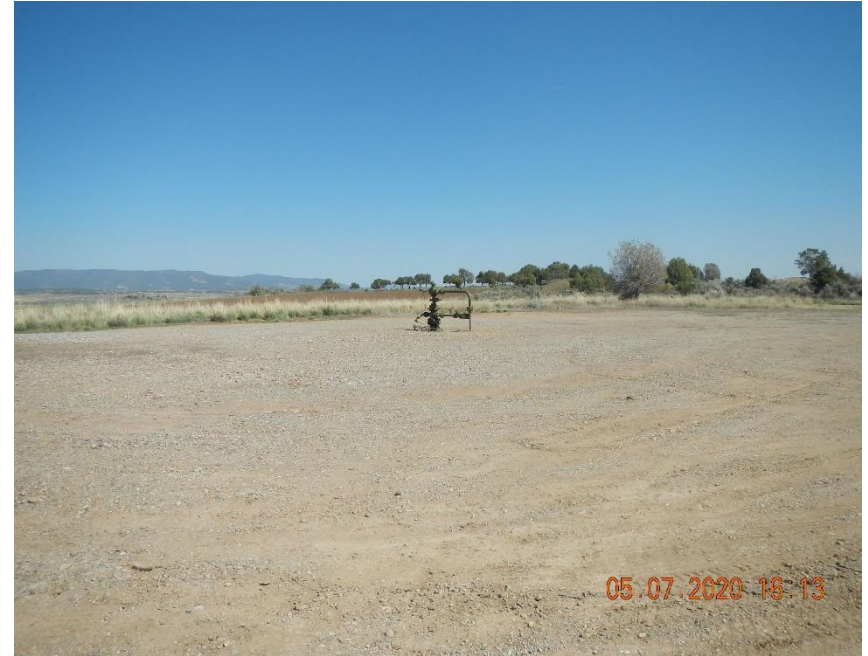
**Krajack 43-27 #2 well head.**

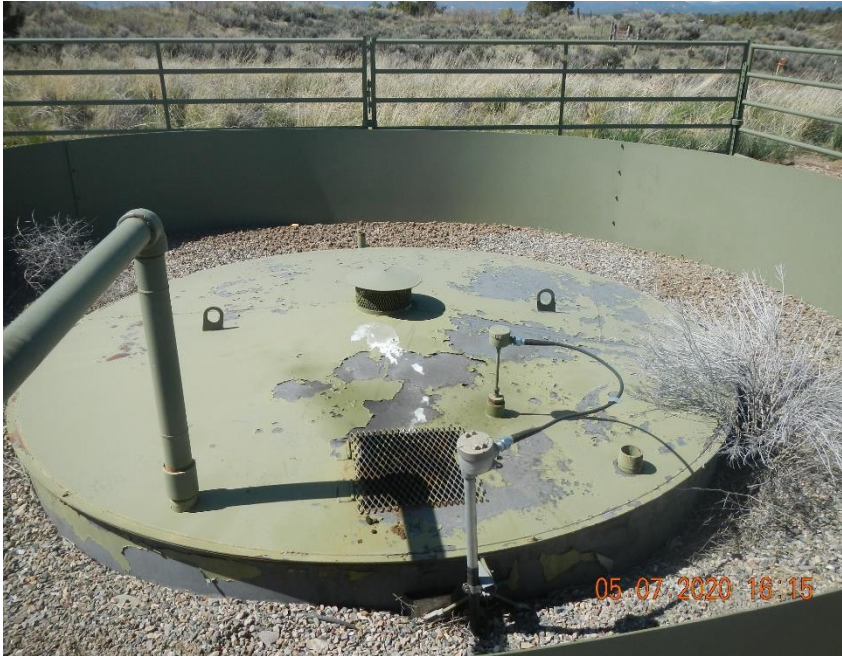
**Weeds present within secondary containment ring. Paint is peeling off of PBV.**

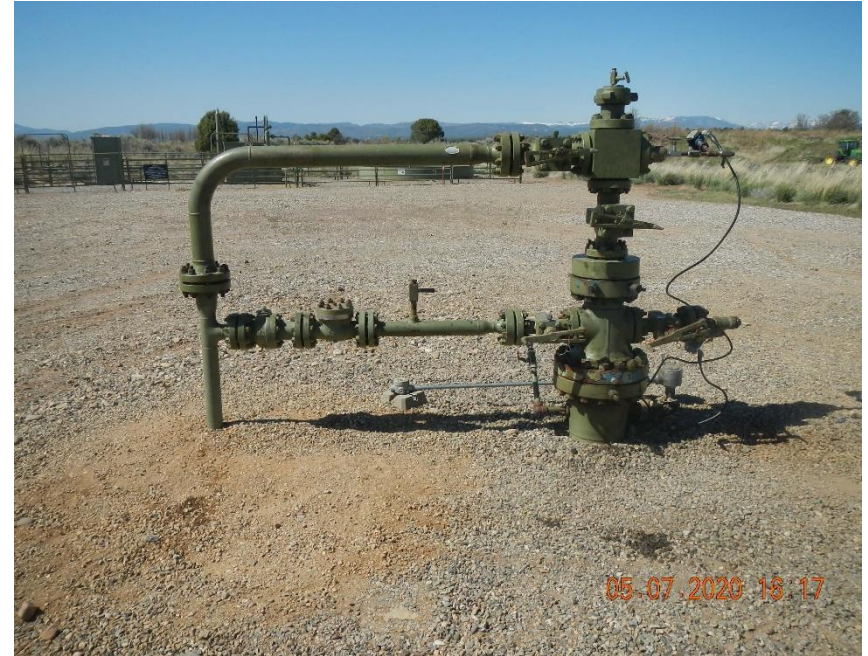
**Stained soil near well head.**
