Inspection Photos

API: 071-07710

Operator: EVERGREEN NATURAL RESOURCES

Inspection Date: 5/18/2020

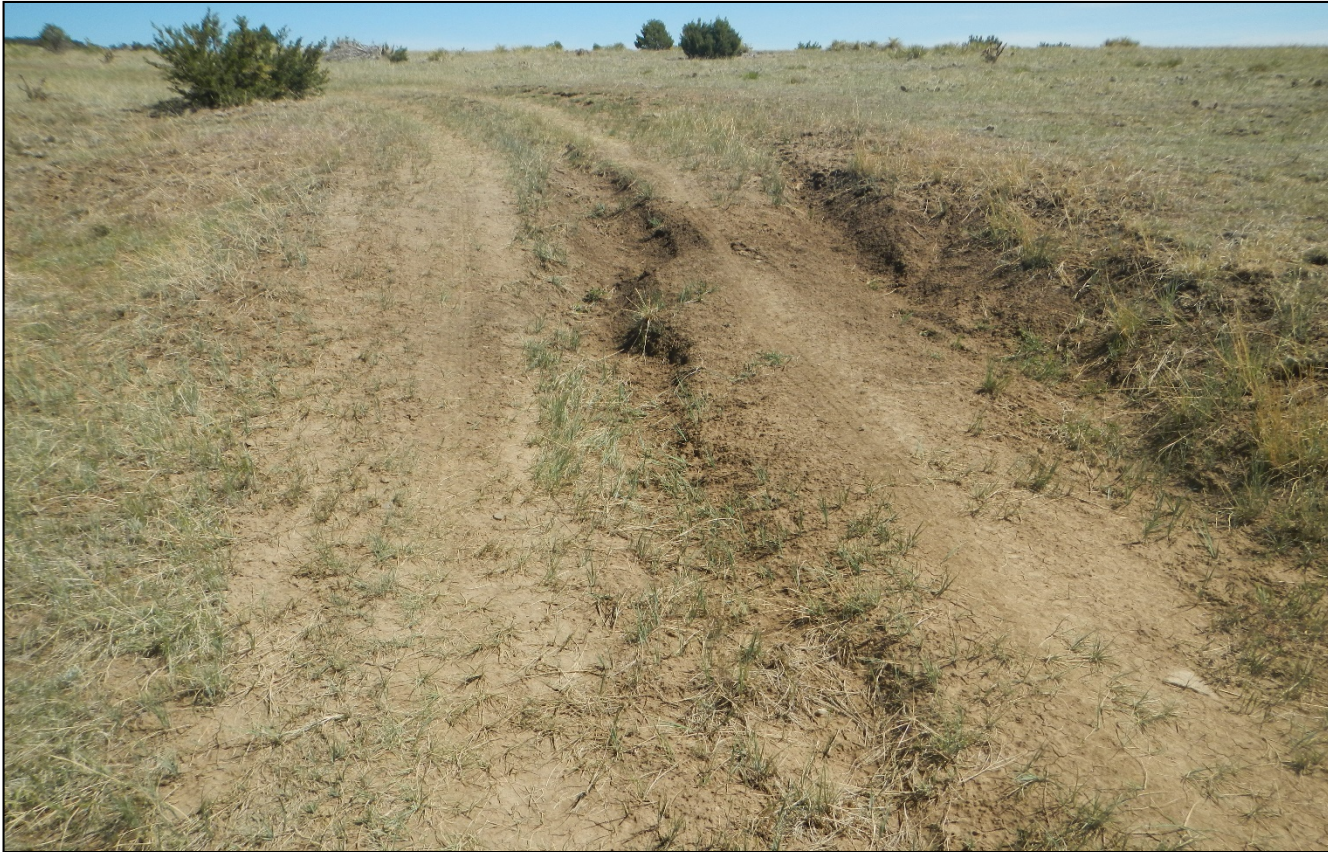
Photo 1. Facing north near the Valent Canyon location. There is an erosion channel forming along this area of the road. Lat/Long:37.34363,-104.60370.

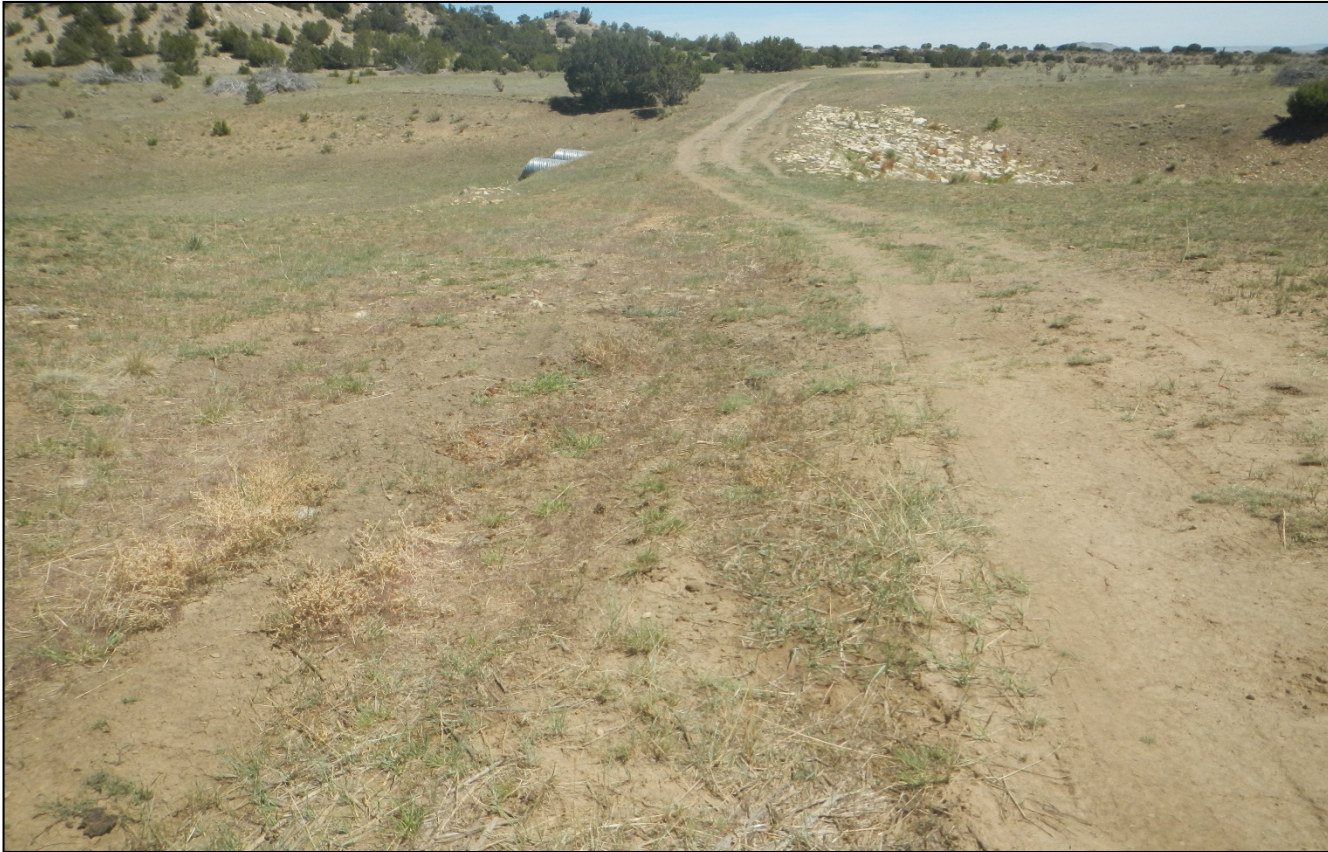
Photo 2. Facing northeast along the access road. The access road has not been reclaimed and culverts remain in the drainage.

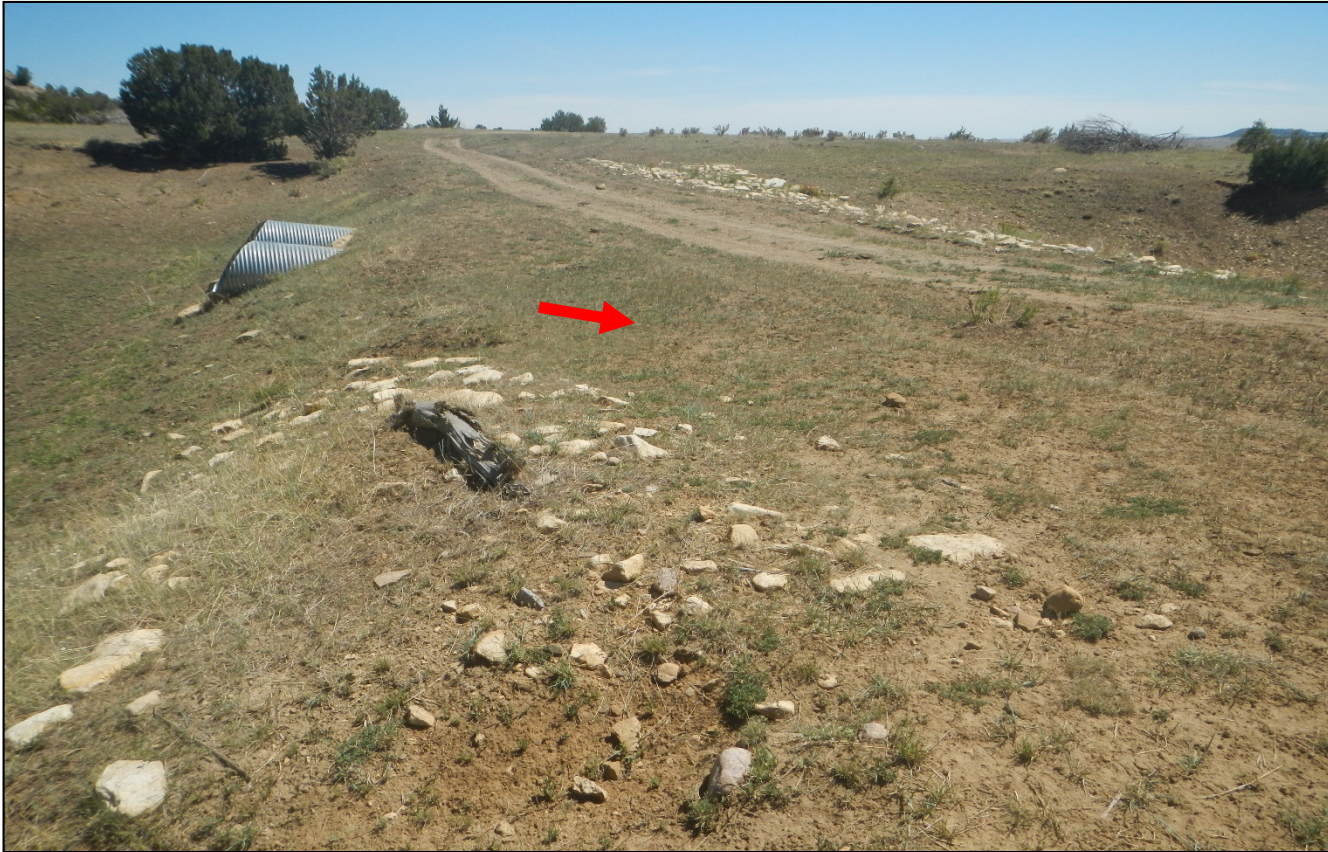
Photo 3. Facing north along the access road. It appears during precipitation events stormwater has previously flowed across the road in area of the red arrow. This has caused rip/rap to be displaced on other side shown in next photo.

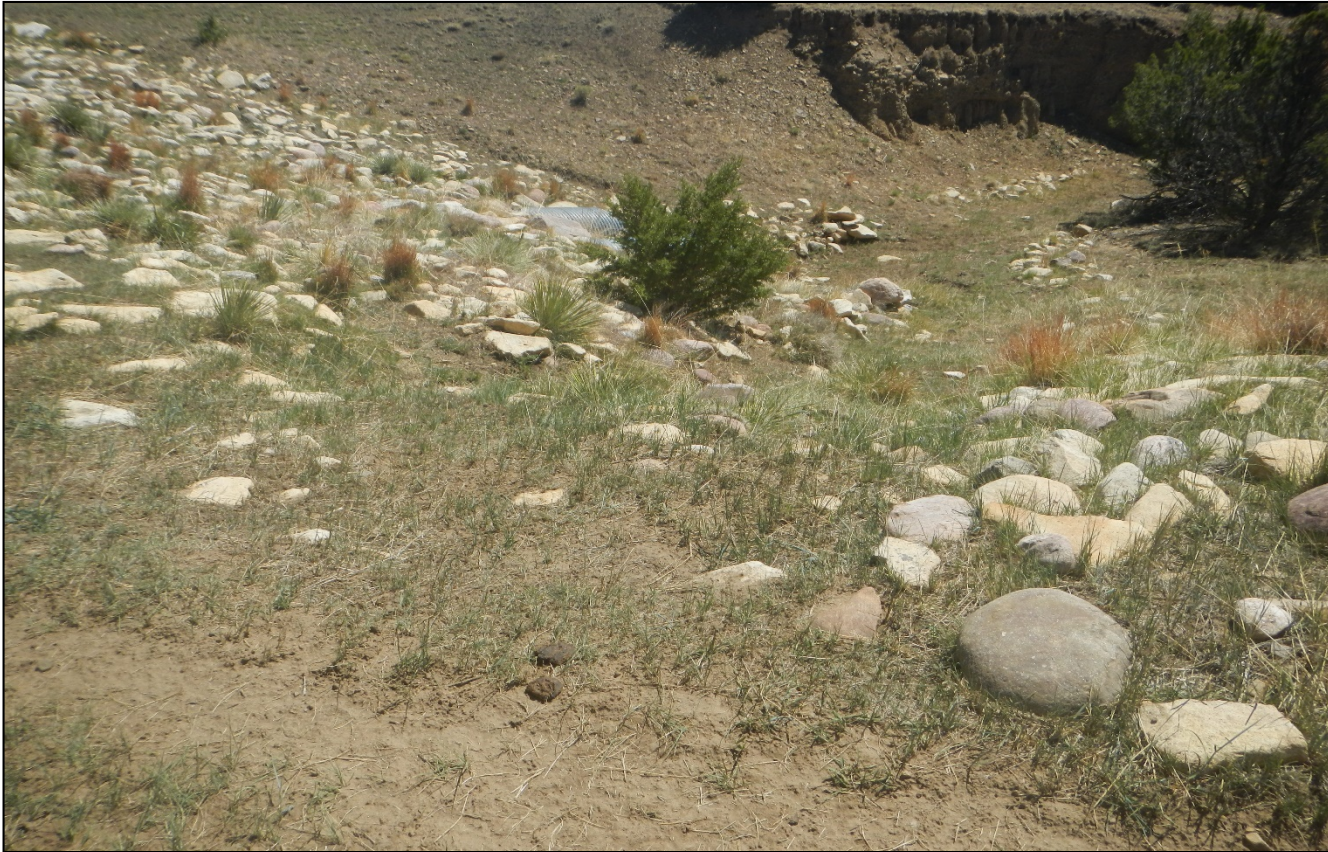
Photo 4. It appears rock rip/rap was displaced from this area of the embankment which could possibly cause erosion to occur in this area if stormwater flows across this embankment.

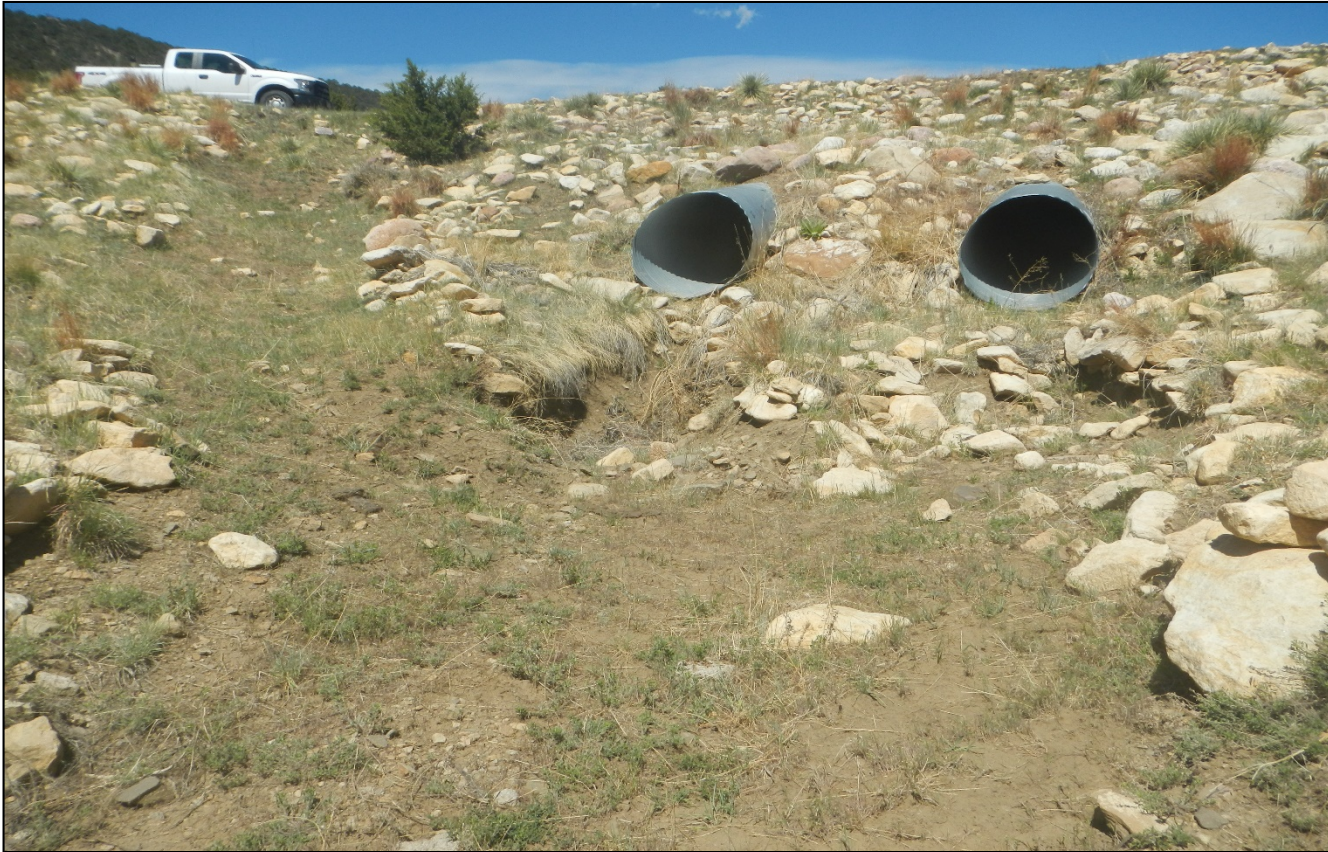
Photo 5. Facing toward the culvert outlet in the drainage shown in previous photos.

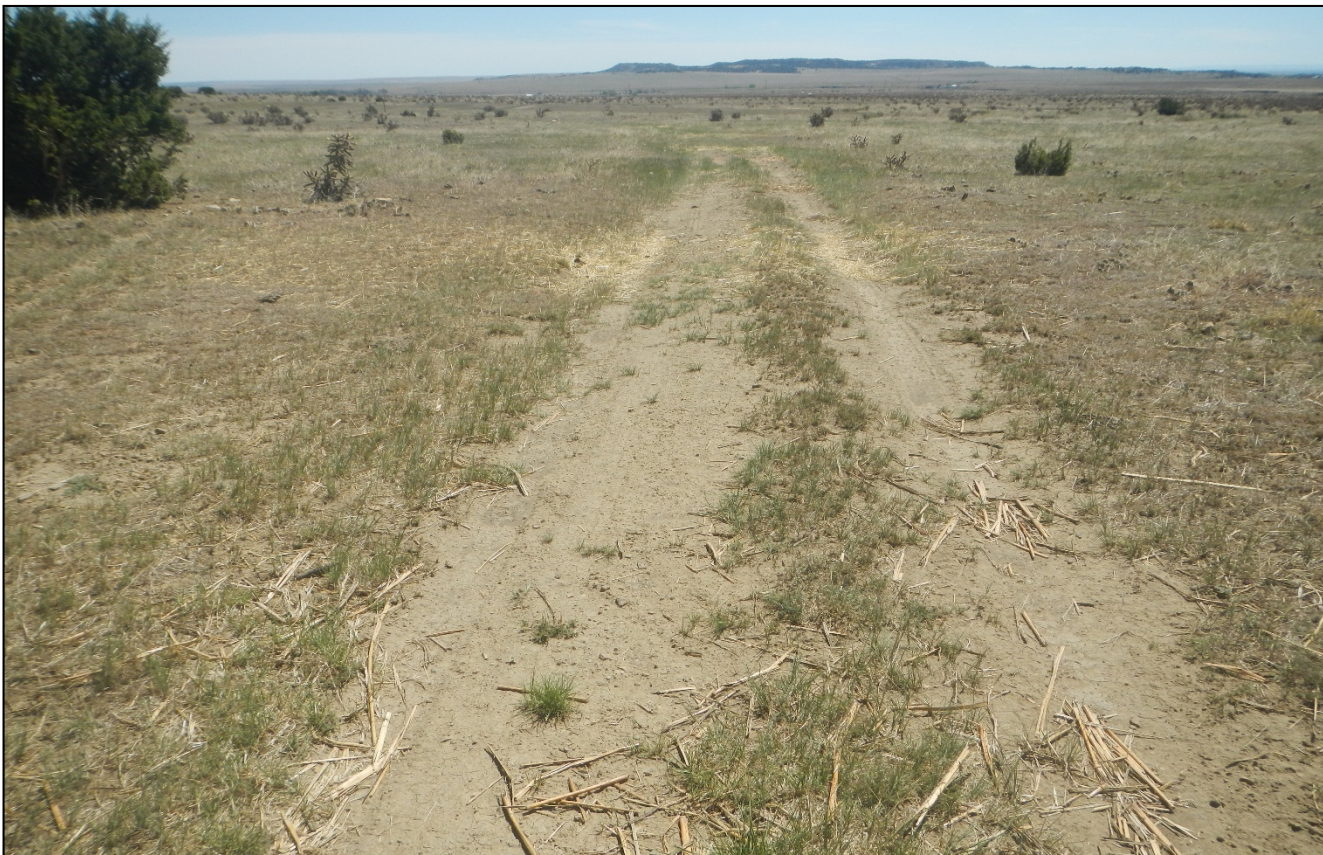
Photo 6. Facing east along the access road.

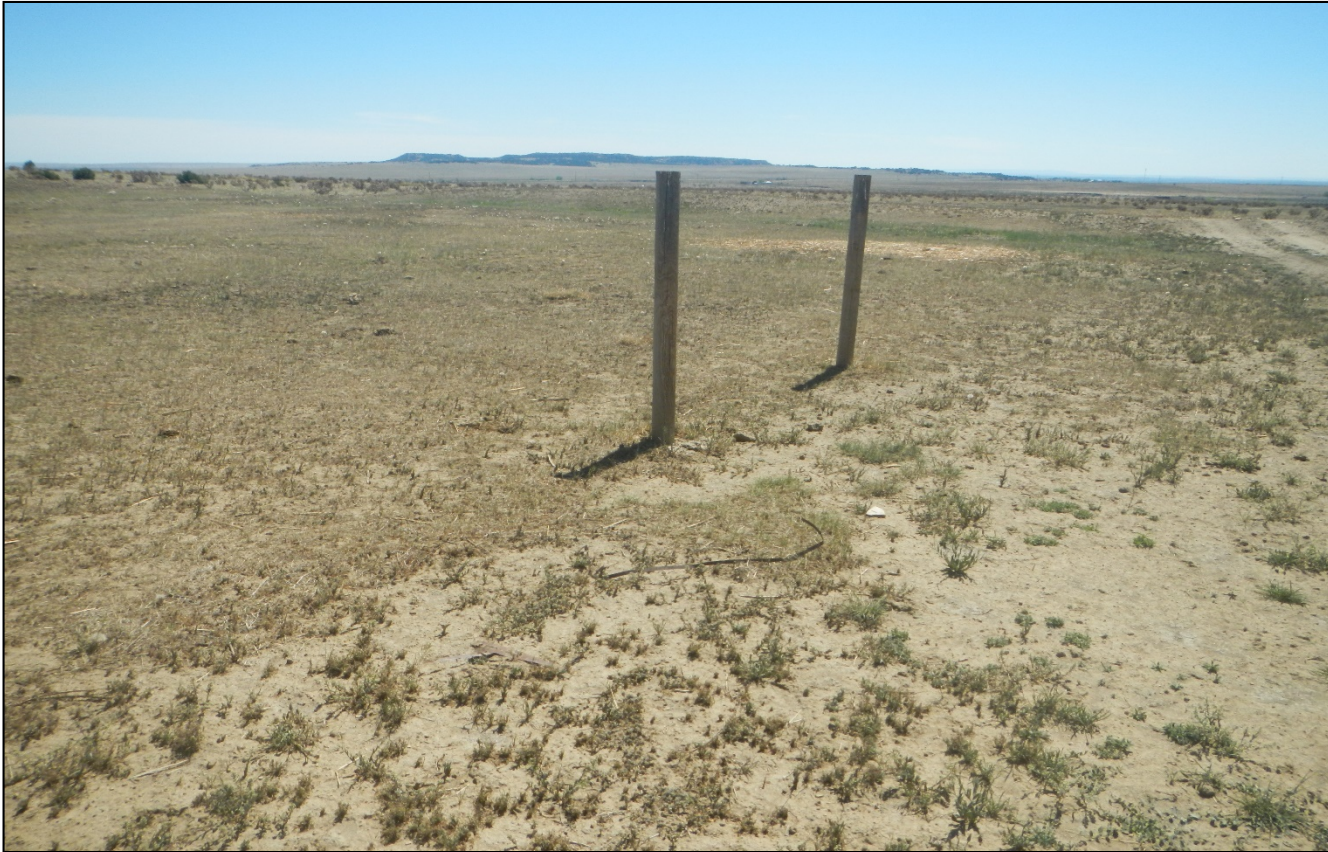
Photo 7. Facing east toward the location. Two fence post remain at the location and need to be removed.

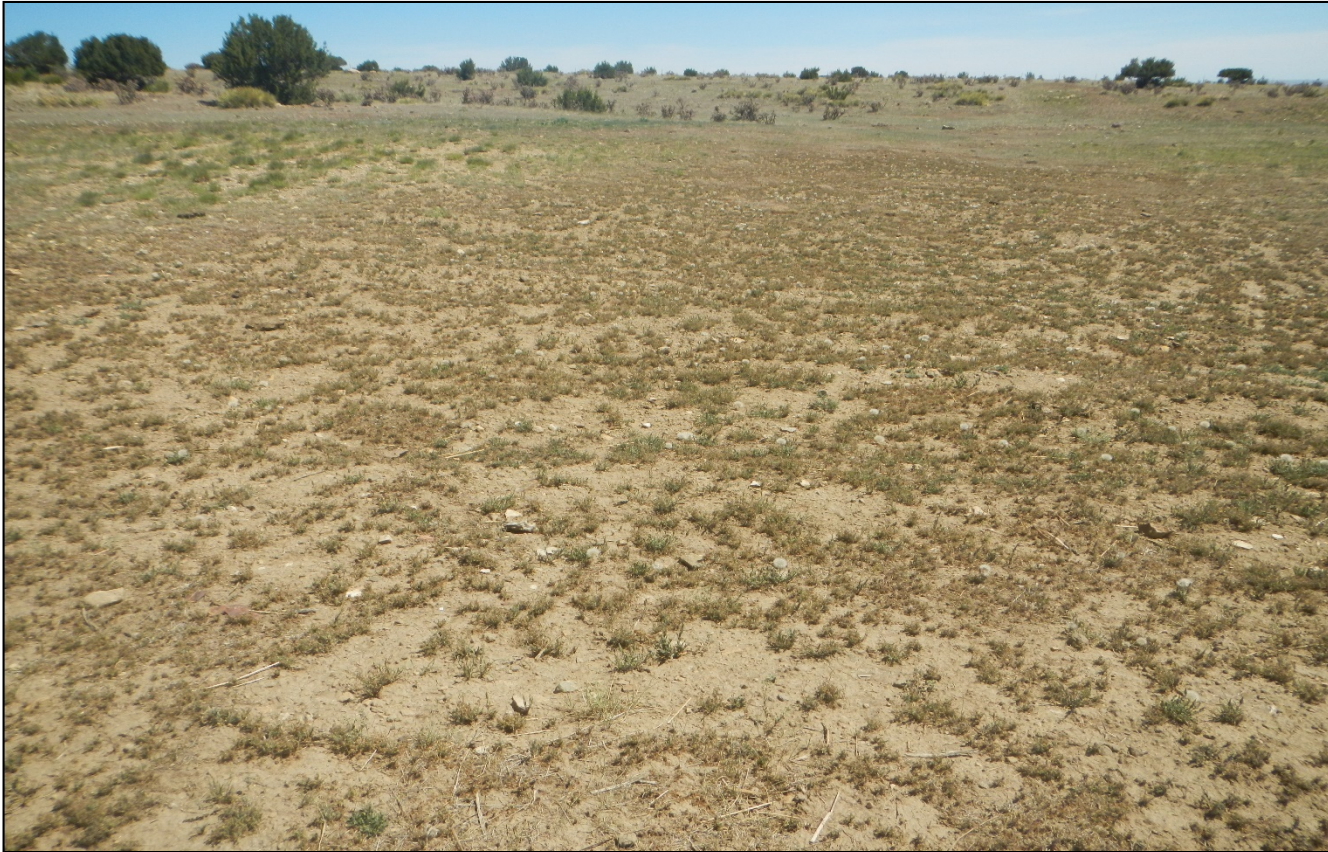
Photo 8. Facing northeast at the east side of the location. This area consist primarily of weeds (Redstem filaree).

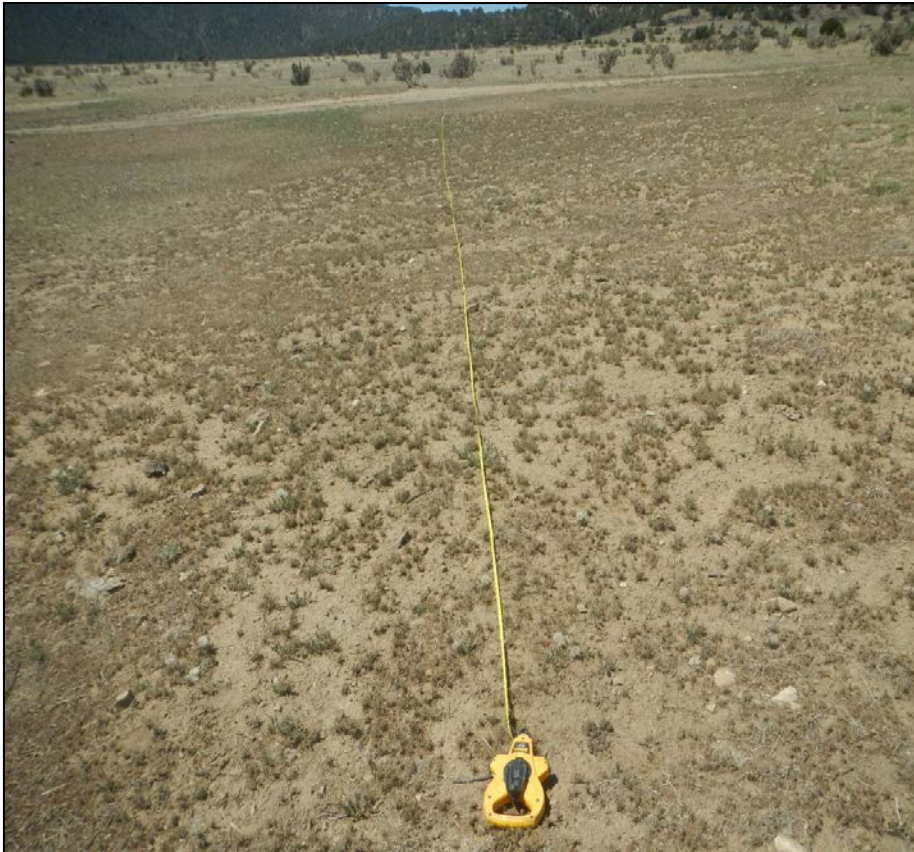
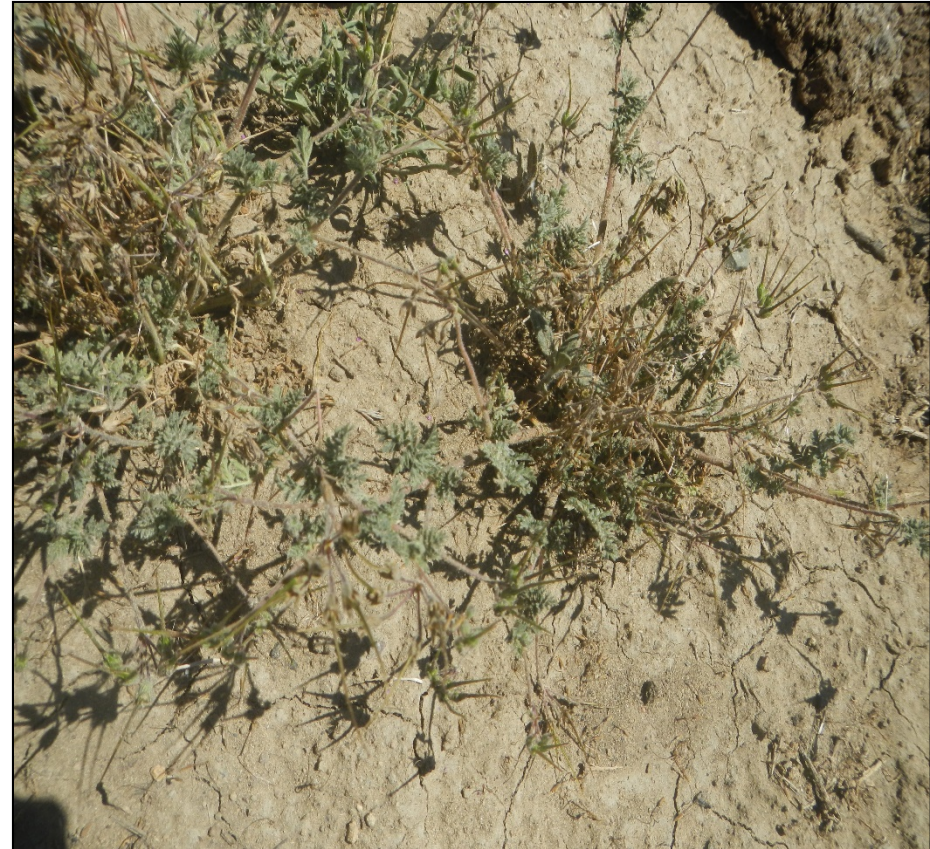
Photo 9. Facing southwest at the east side of the location. This area consist primarily of weeds (Redstem filaree). 100 ft. tape measure shows area that consists of weeds.

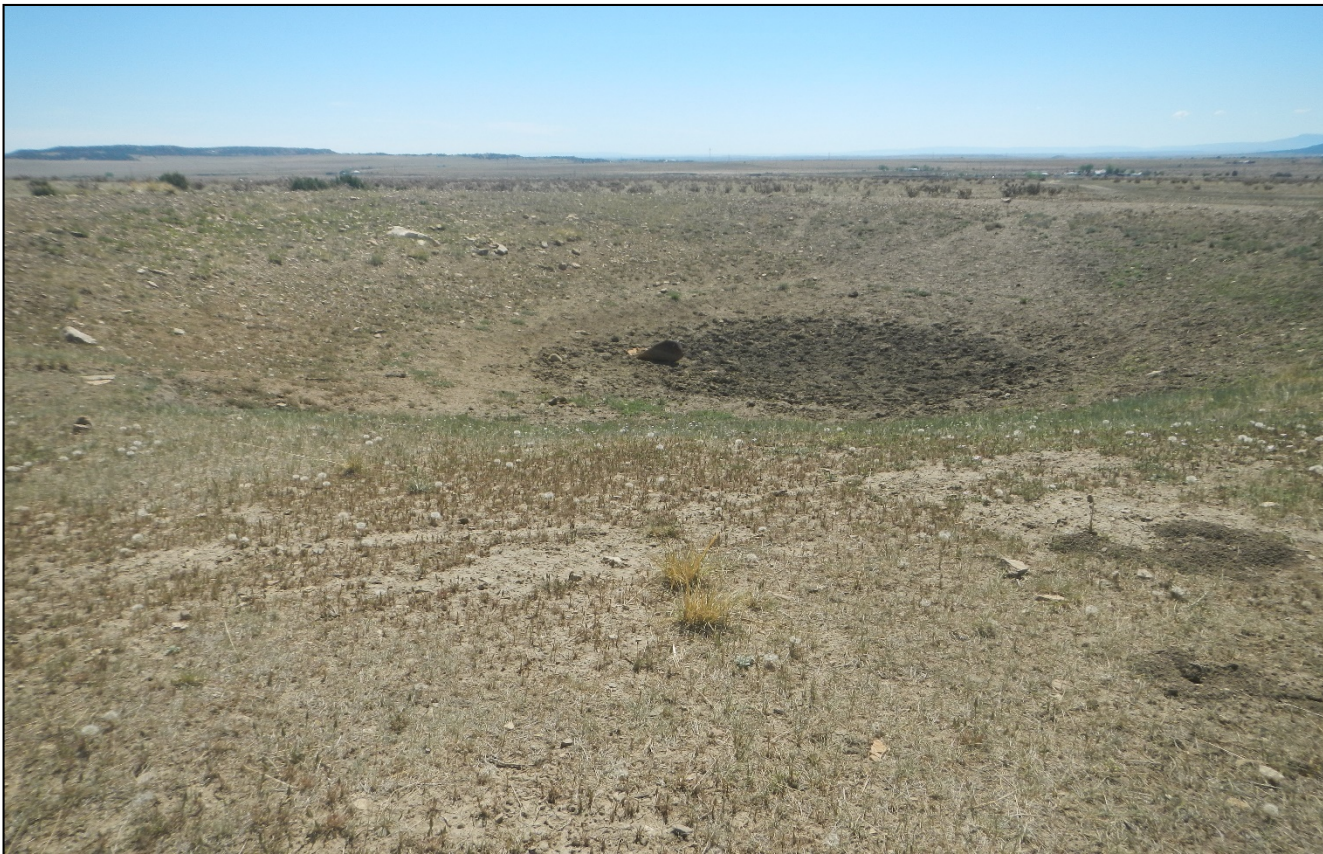
Photo 10. Facing toward the pit that remains per approved variance request.

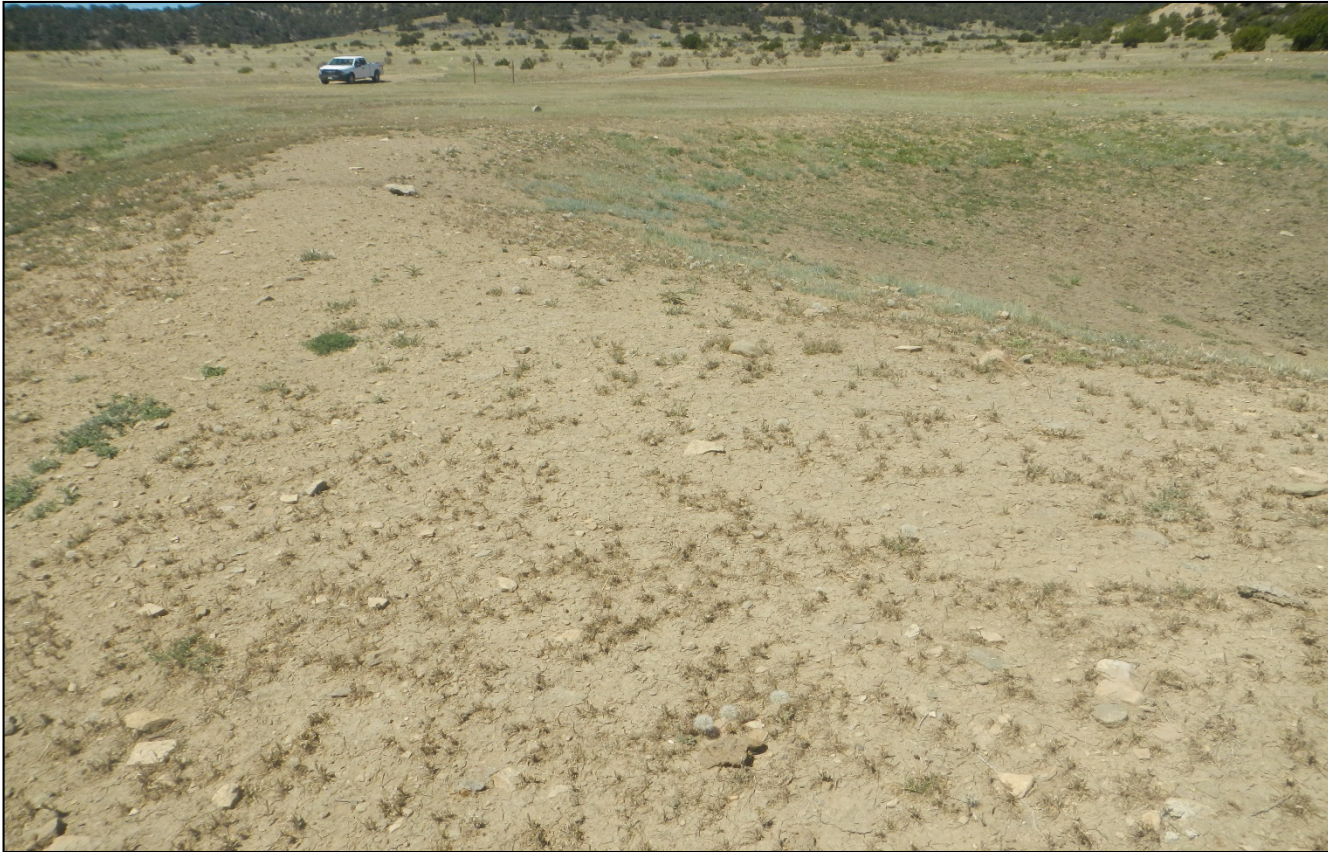
Photo 11. Facing southwest toward the location and pit area. This area of the pit berm is bare of vegetation.

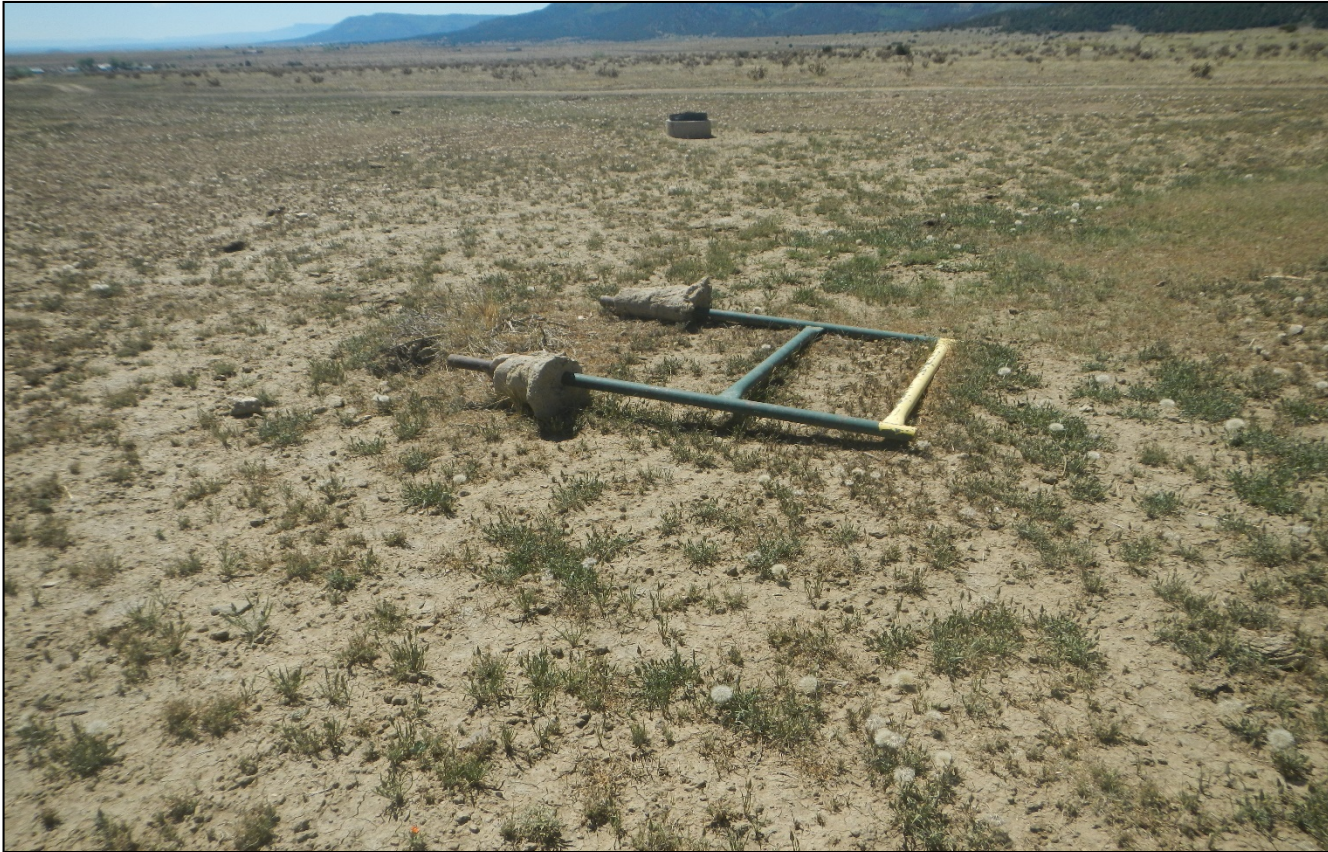
Photo 12. There were 3 metal H-braces found at the location that were apart of the location fence. These H-braces need to be removed from the location.

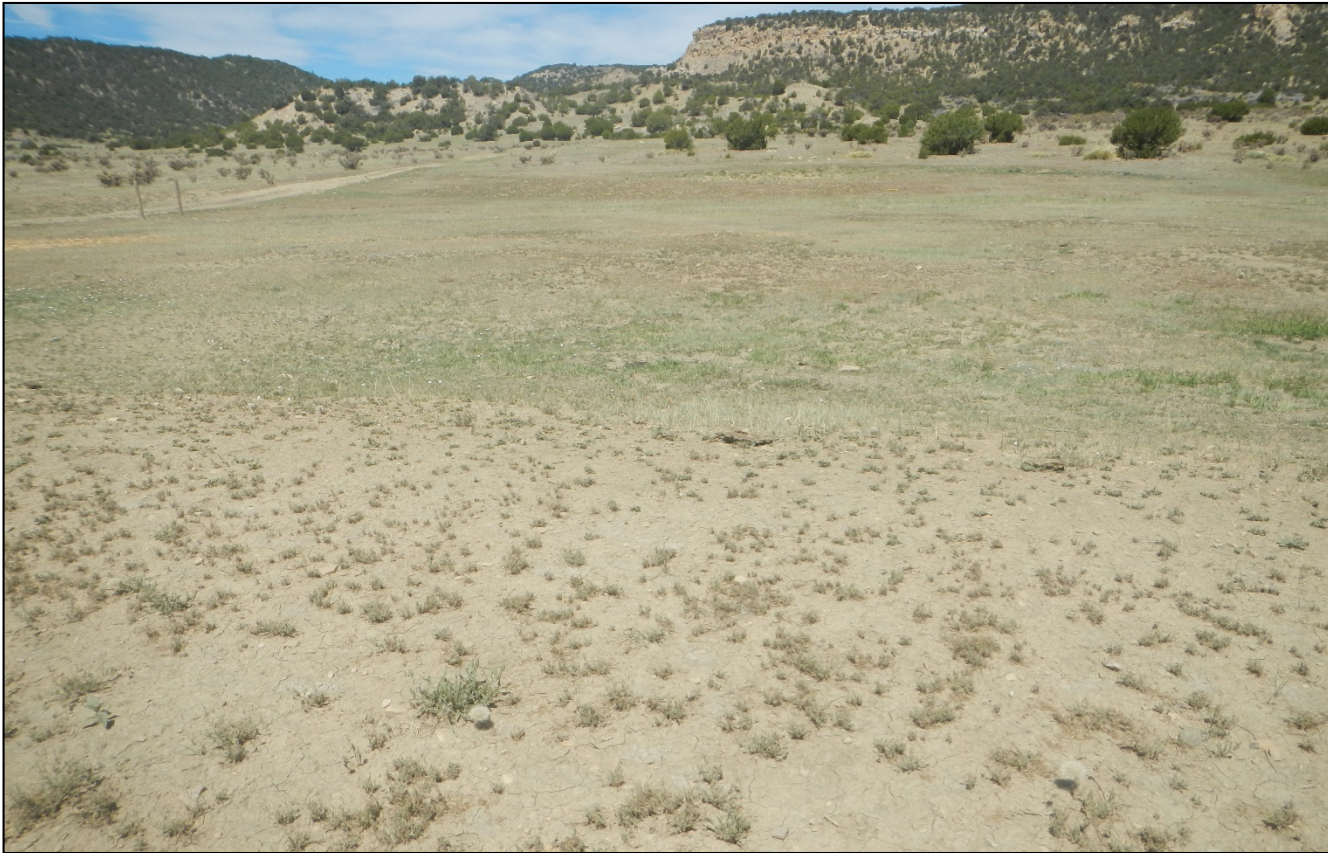
Photo 10. Facing west toward the location.
