Inspection Photos
Operator: Southland Royalty
API#: 007-06222
Date: 5/15/2020

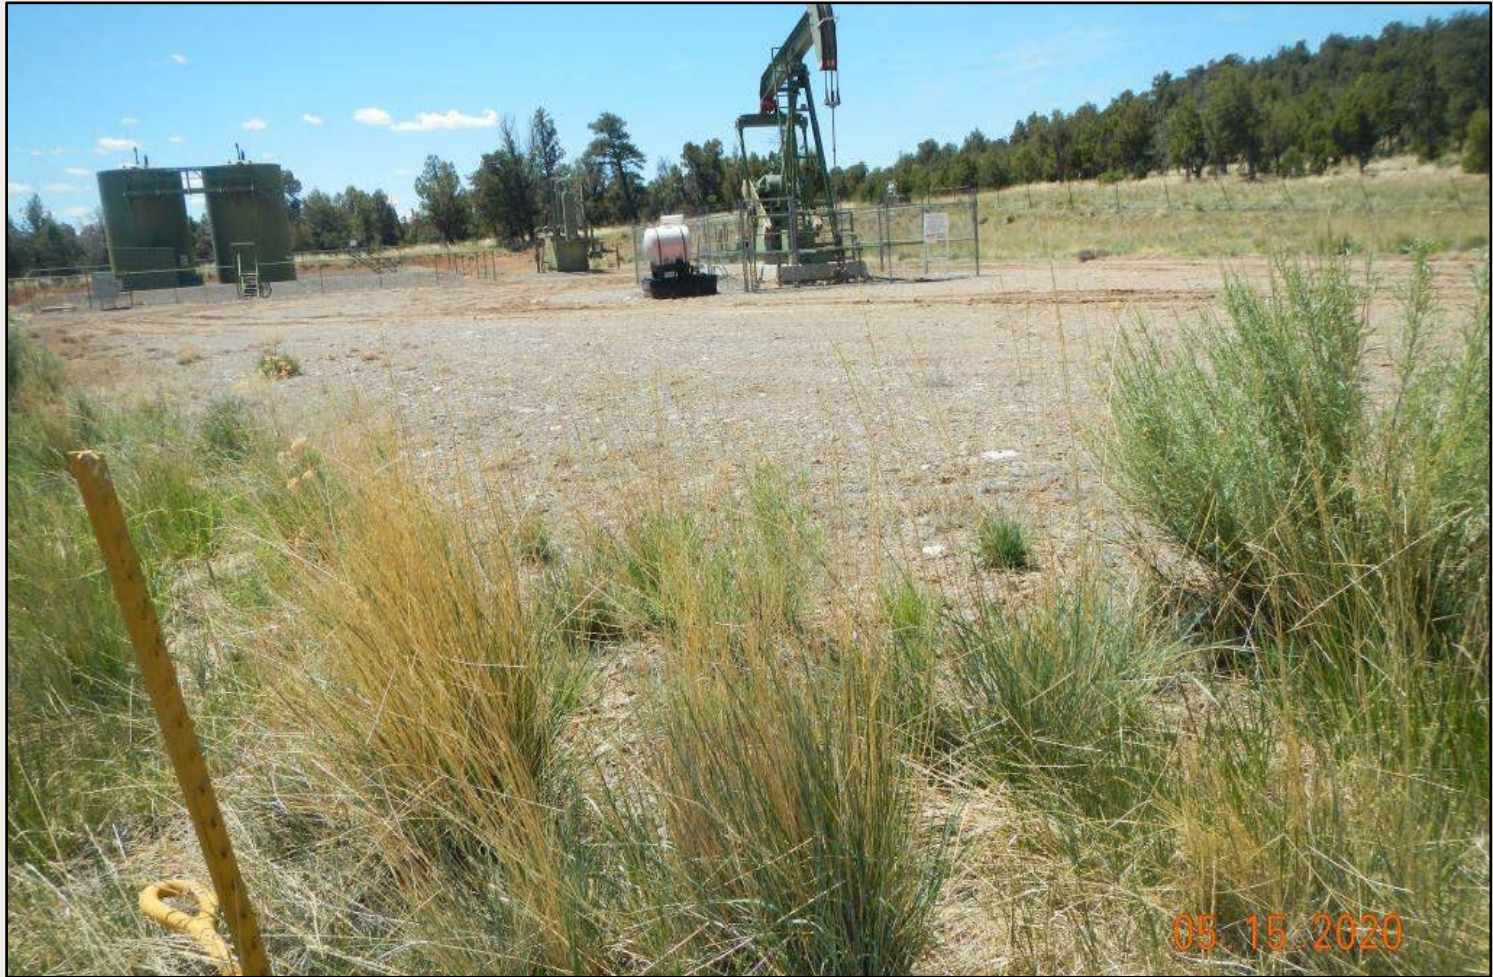
Photo 1. View of the project area from the southeastern corner facing center.

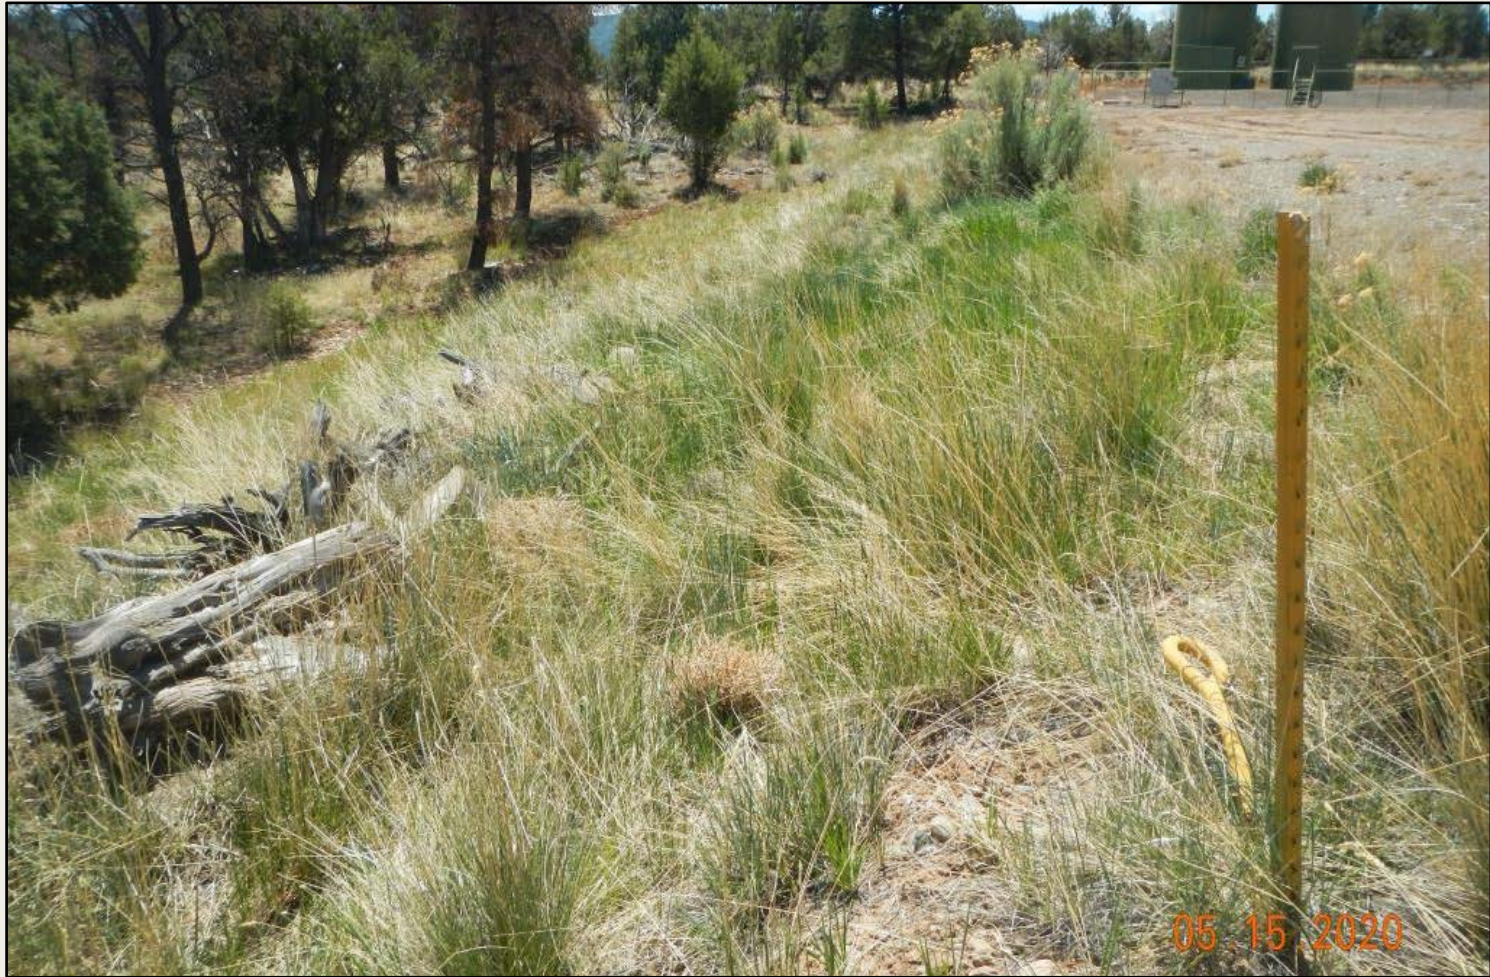
Photo 2. View of the southern project area from the southeastern corner facing westward. Revegetation is progressing on the fill slope with grasses such as western wheatgrass, crested wheatgrass, and Indian ricegrass.

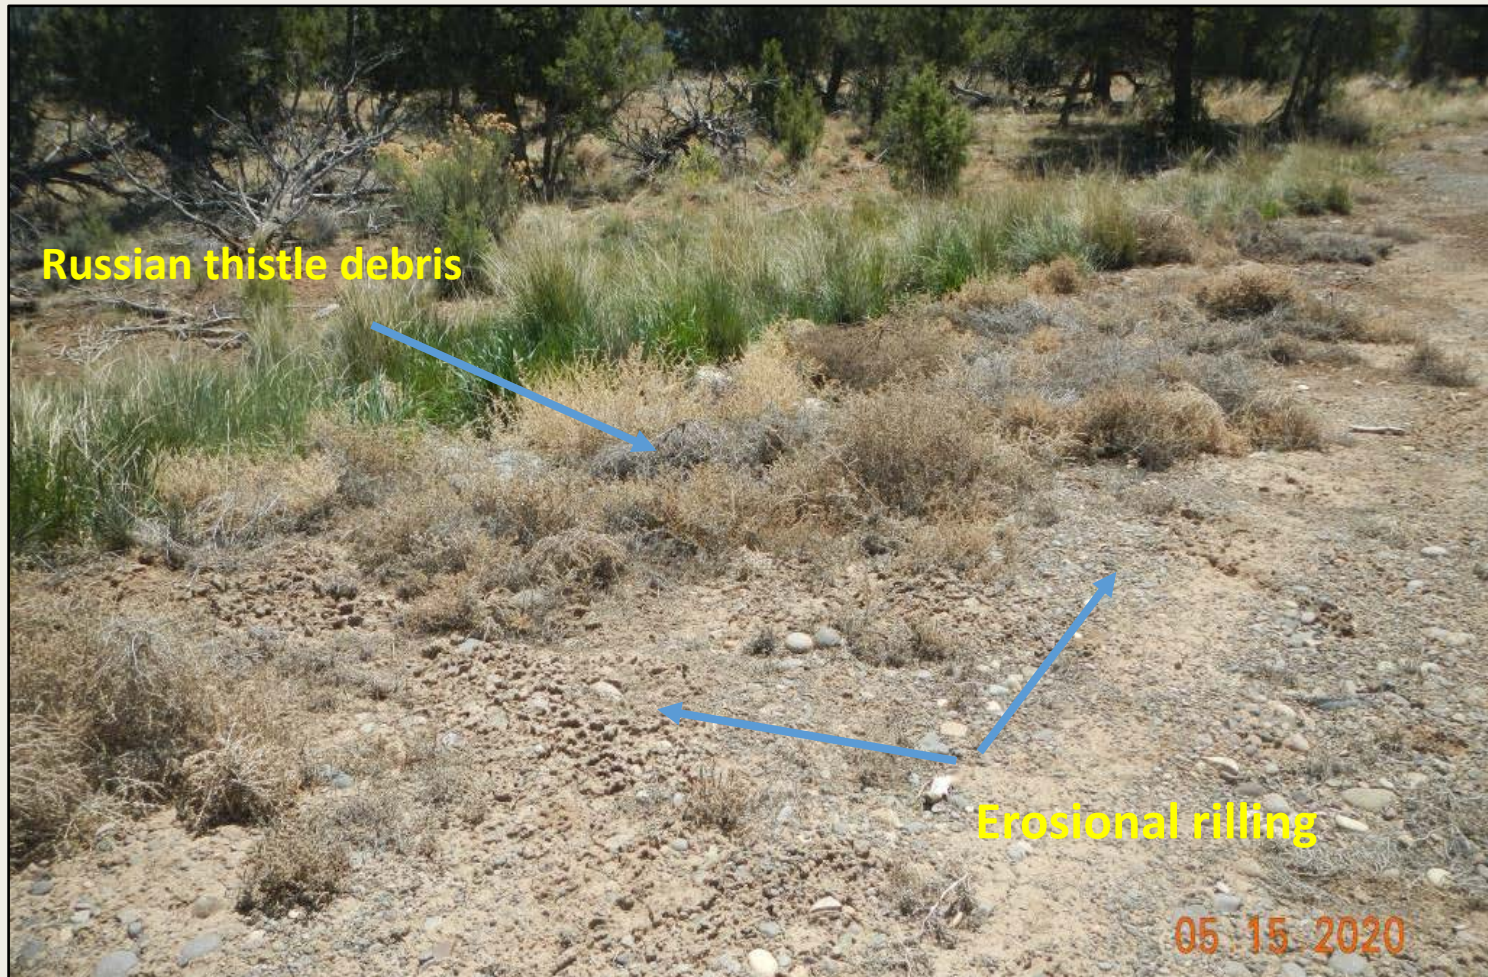
Photo 3. View of erosional rilling where concentrated stormwater flows off of the well pad. Russian thistle debris is also present.

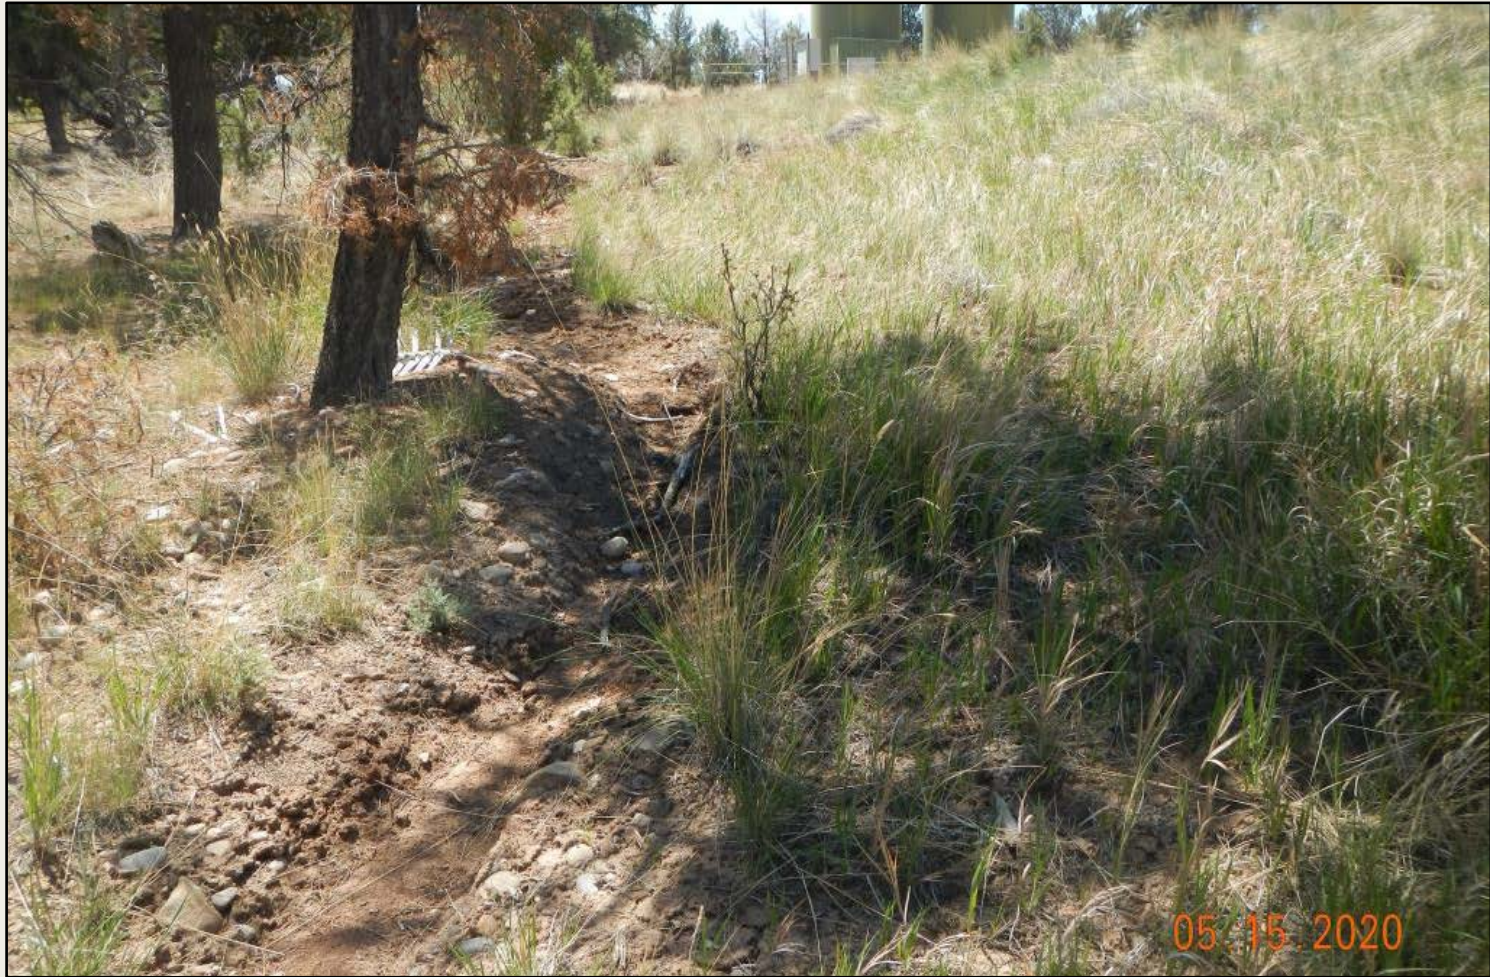
Photo 4. View of erosional channel approximately 1.5 feet wide and 1 foot deep, where stormwater flows exiting the southern well pad become concentrated and channeling off of the project area.

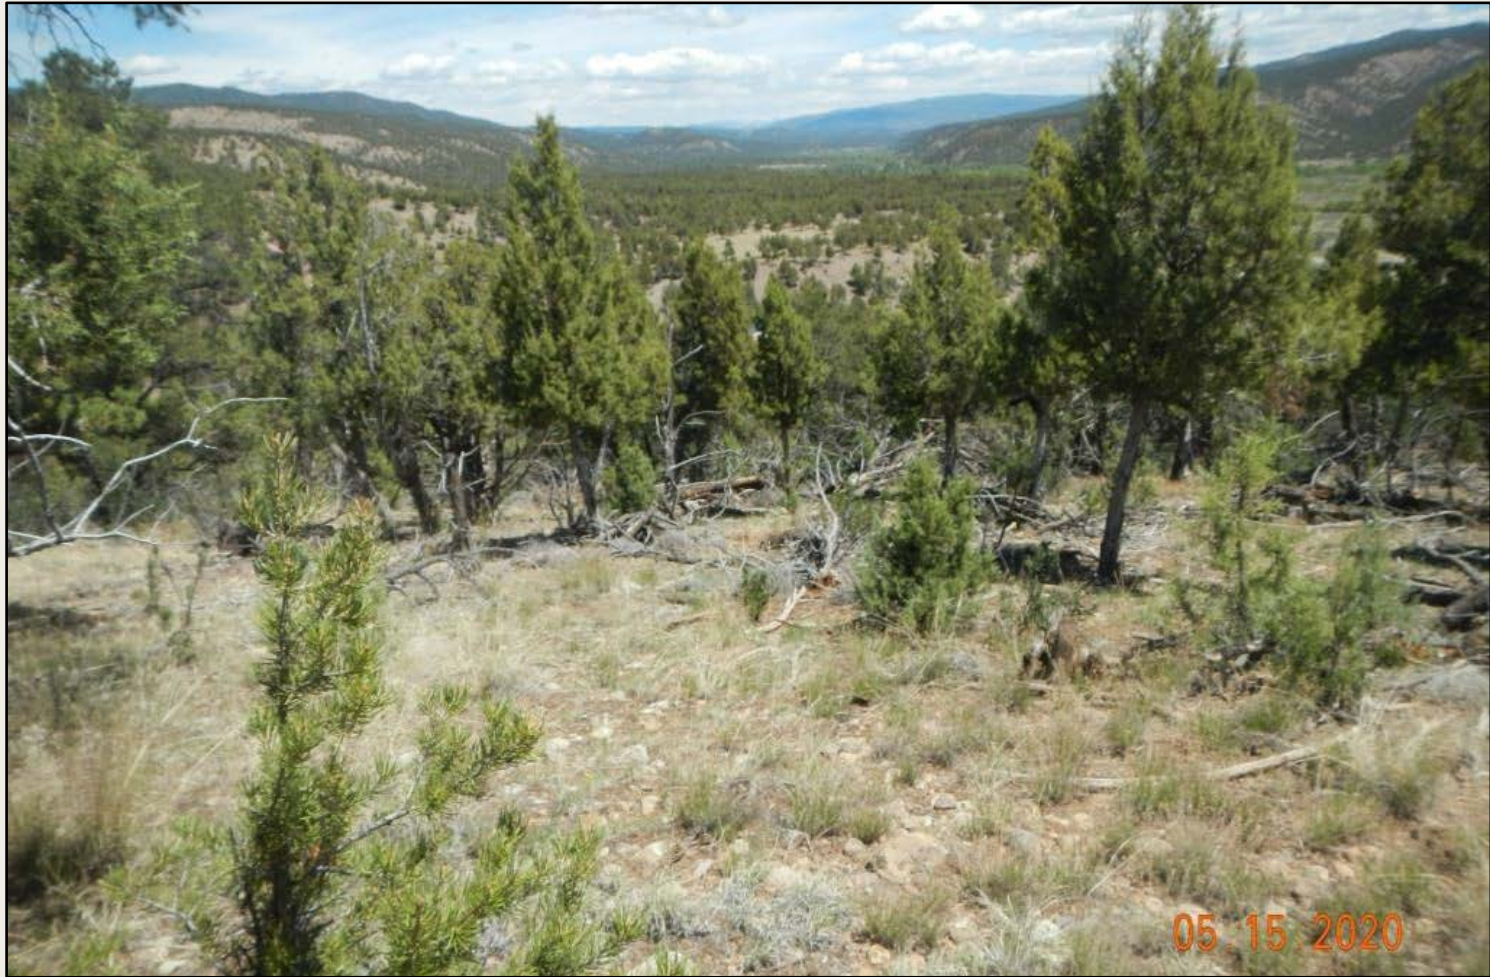
Photo 5. View of reference area vegetation comprised of pinyon juniper woodland with understory of grasses and forbs such as Indian ricegrass, James galleta, and Navajo tea.
