Inspection Photos

Location Name: CAERUS PICEANCE LLC Keinath Federal /9-12H2 (C10OU)

Location ID: 334093

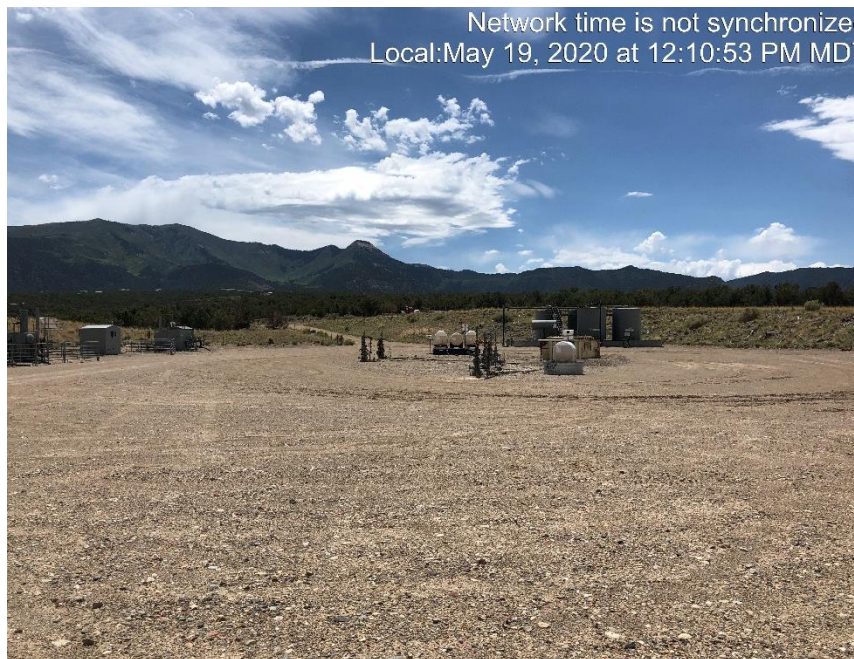
Photo #1213 from NW corner of location.

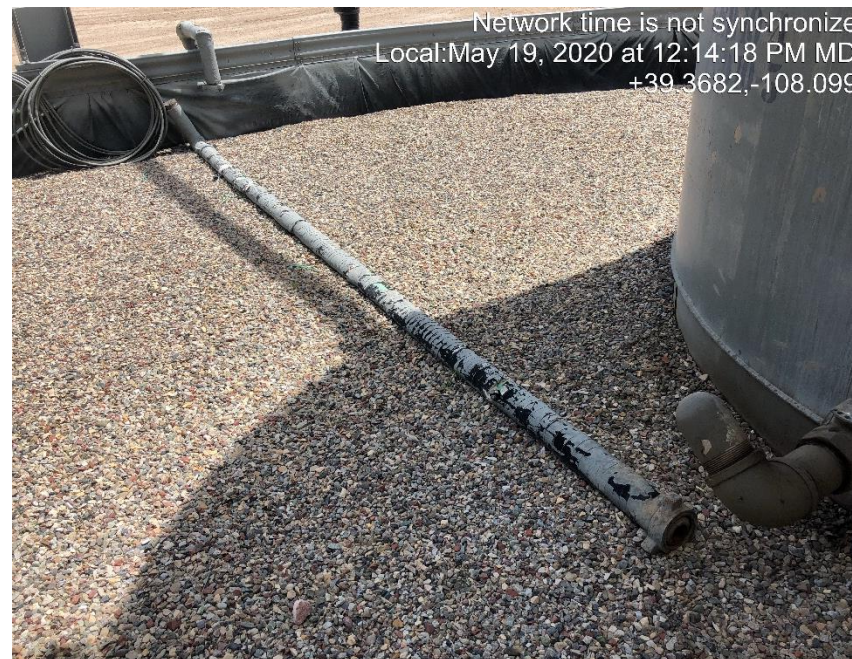
Photo #1214 Multiple unused pieces of pipe in tank containment.

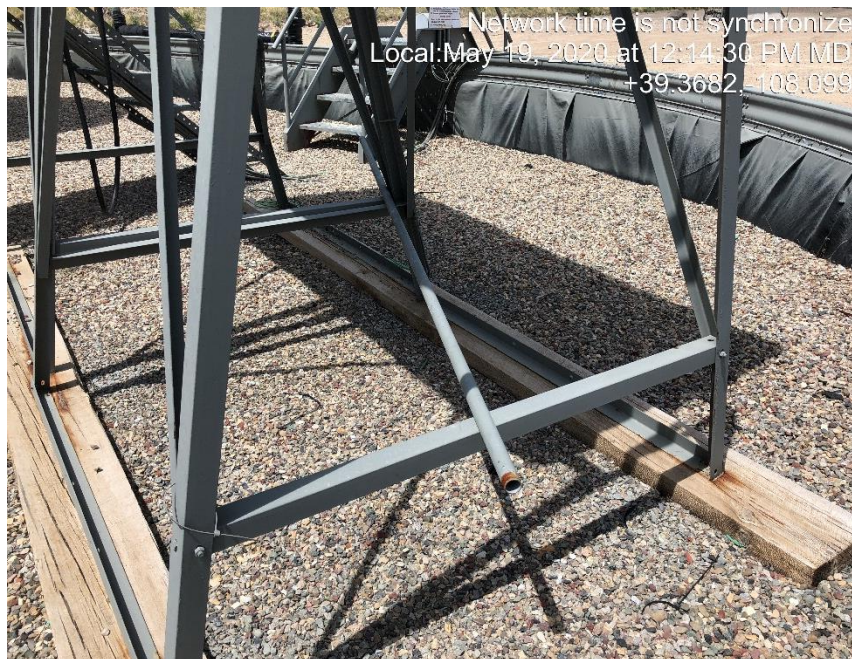
Photo #1215 Multiple unused pieces of pipe in tank containment.

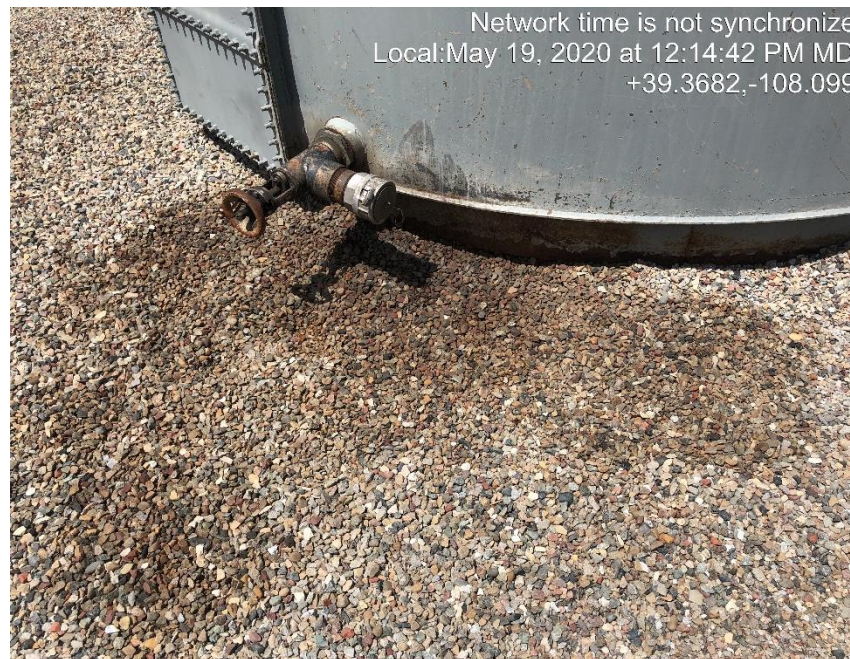
Photo #1216 Stained gravel inside tank containment.

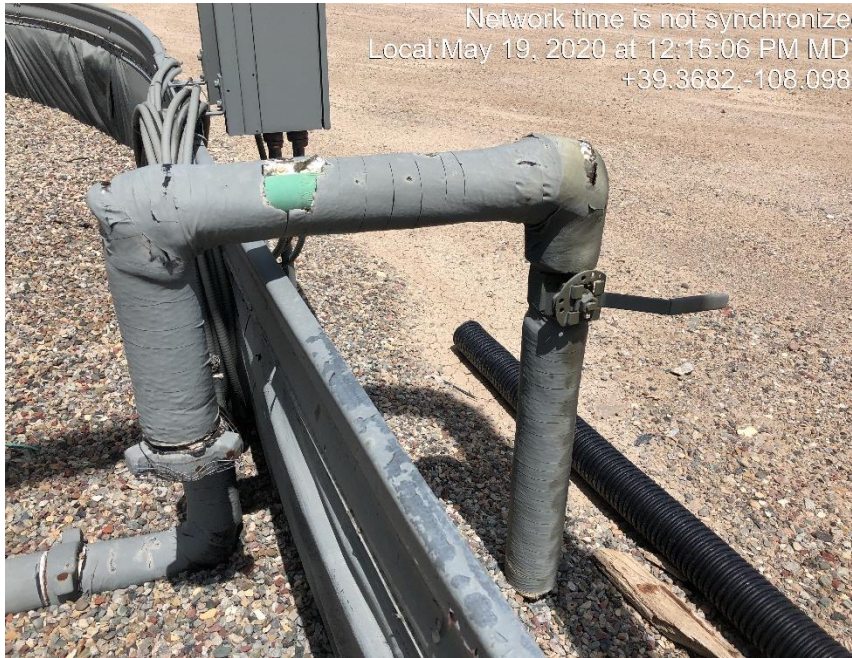
Photo #1217 Flow line riser not LO/TO.
