## Inspection Photos

Location Name: MARALEX RESOURCES INC FEDERAL-68S97W /30SWSW

Location ID: 312470

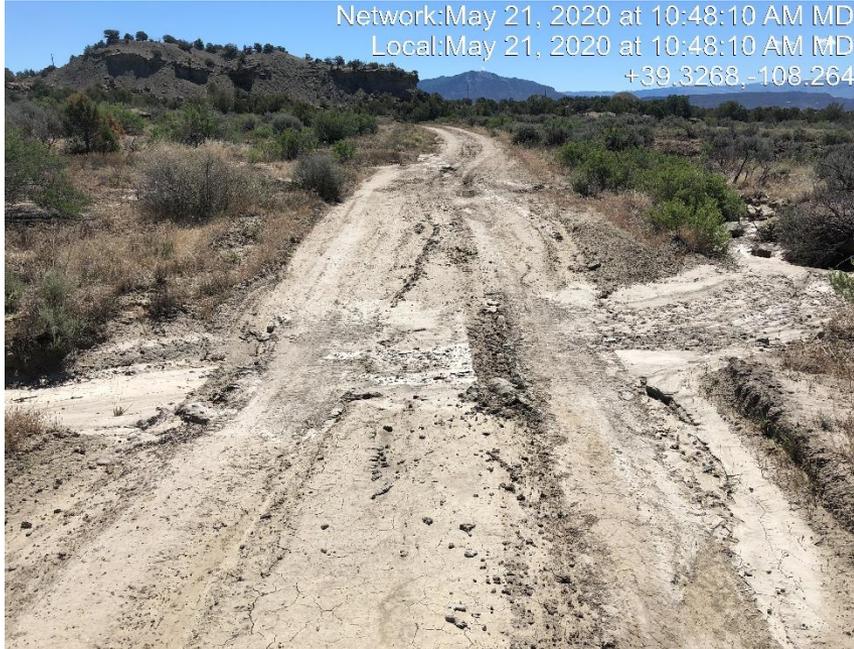
Photo #1233 Access road has not been maintained.

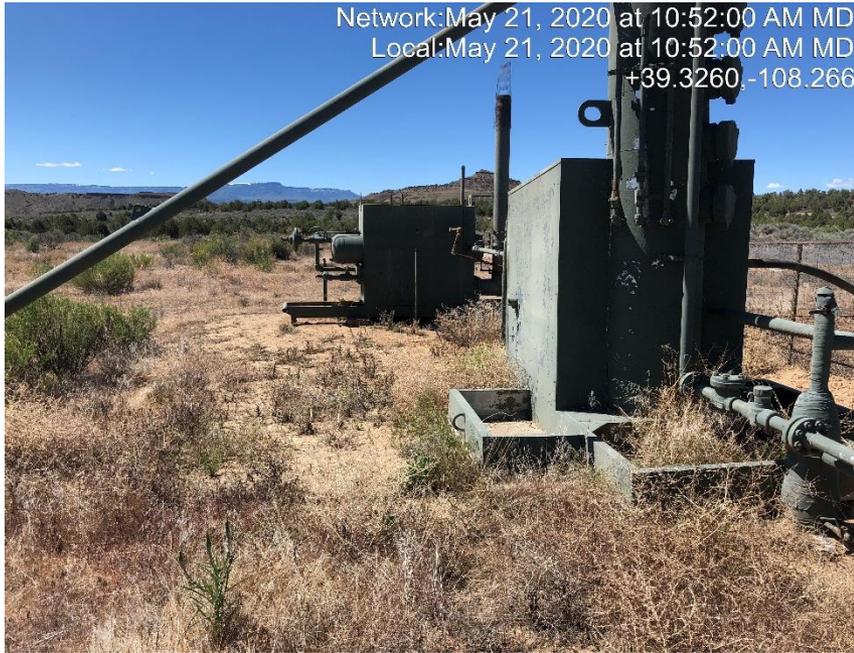
**Photo #1234 Debris around equipment.**

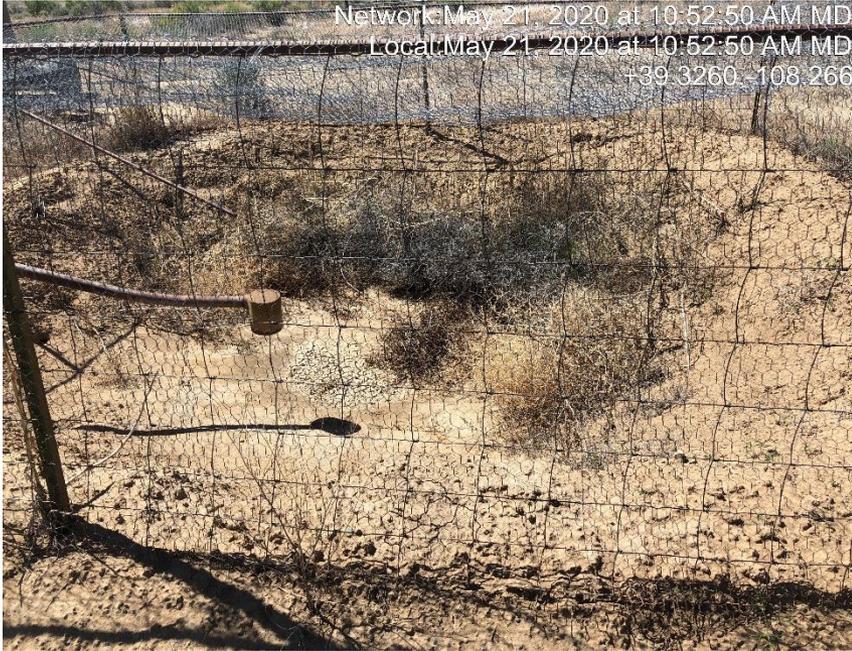
Photo #1236 Debris inside pit.

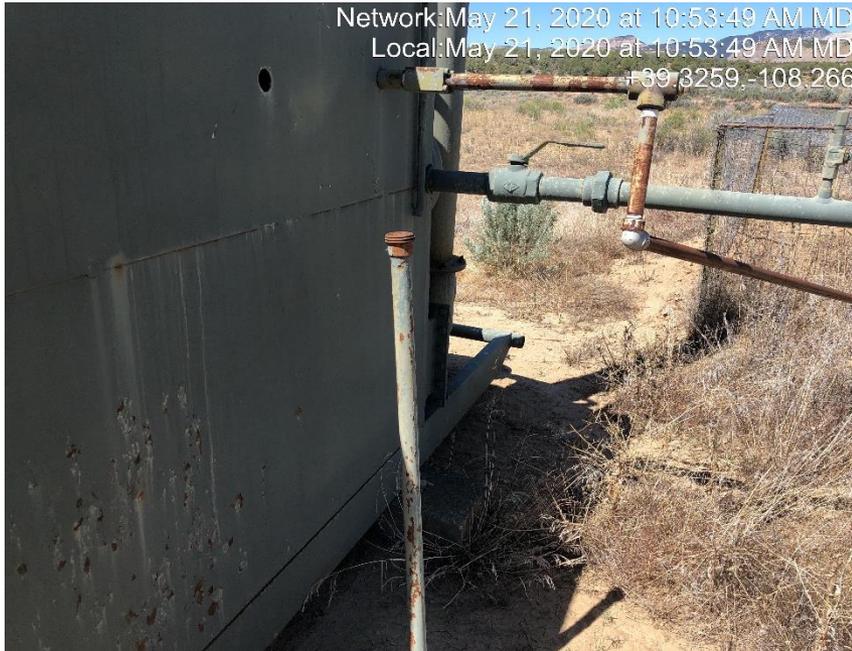
Photo #1237 Flow line risers not LO/TO.
