## Inspection Photos

Location Name: MARALEX RESOURCES INC FEDERAL-68S98W /25NWSE

Location ID:312513

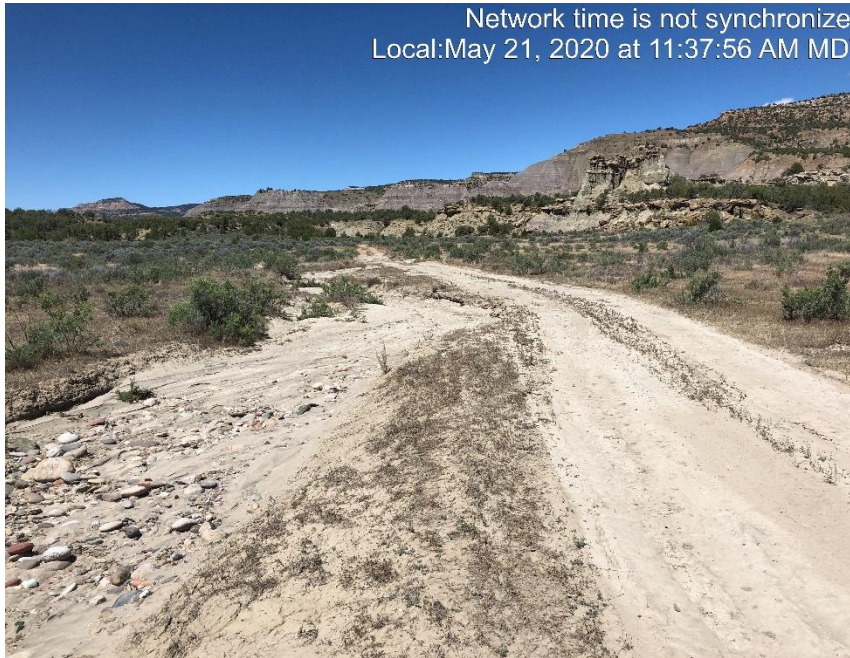
**Photo #1238 Access road has not been maintained.**

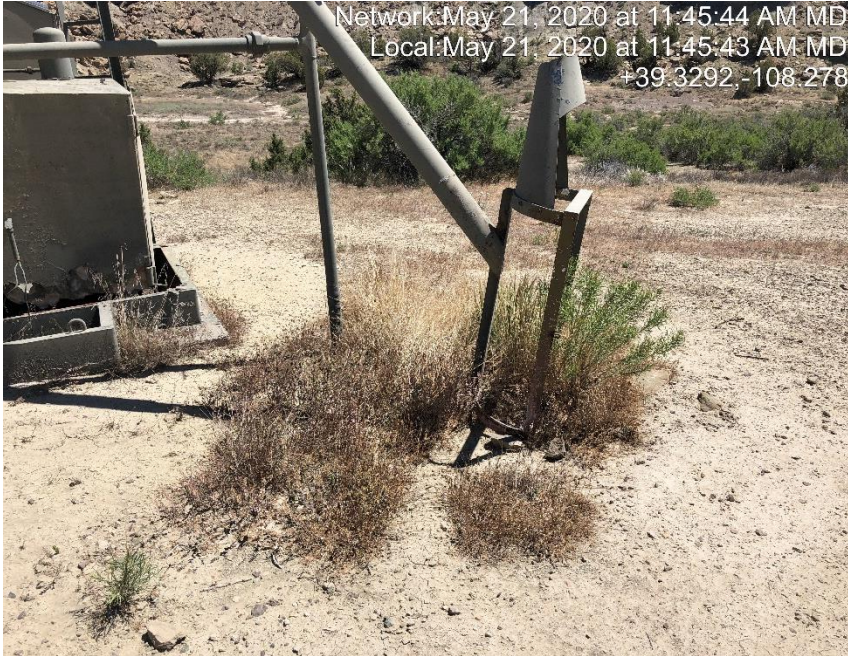
**Photo #1240 Debris around equipment.**

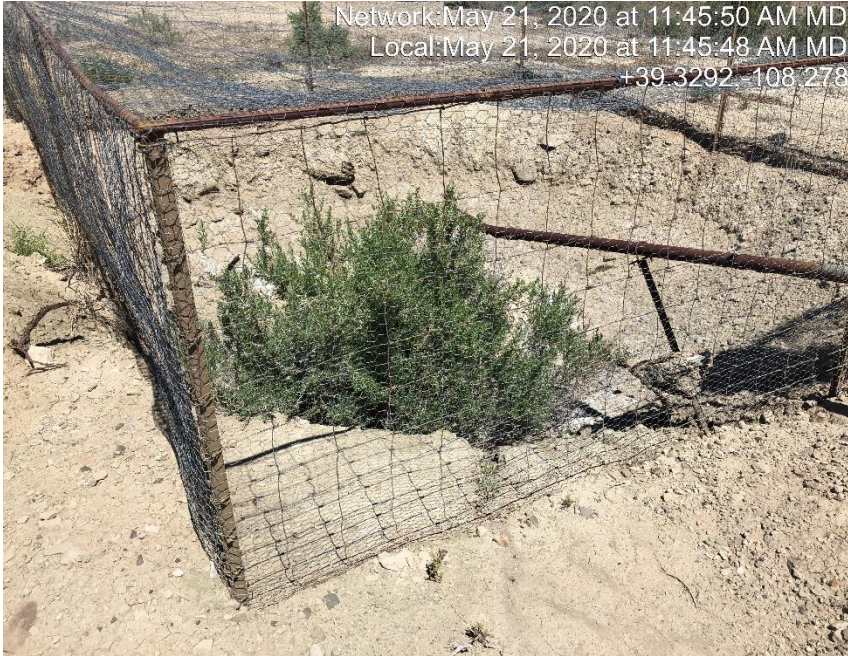
**Photo #1241 Debris inside pit.**
