Inspection Photos

Location Name: MARALEX RESOURCES INC FEDERAL-68S98W /35SEnw

Location ID: 312511

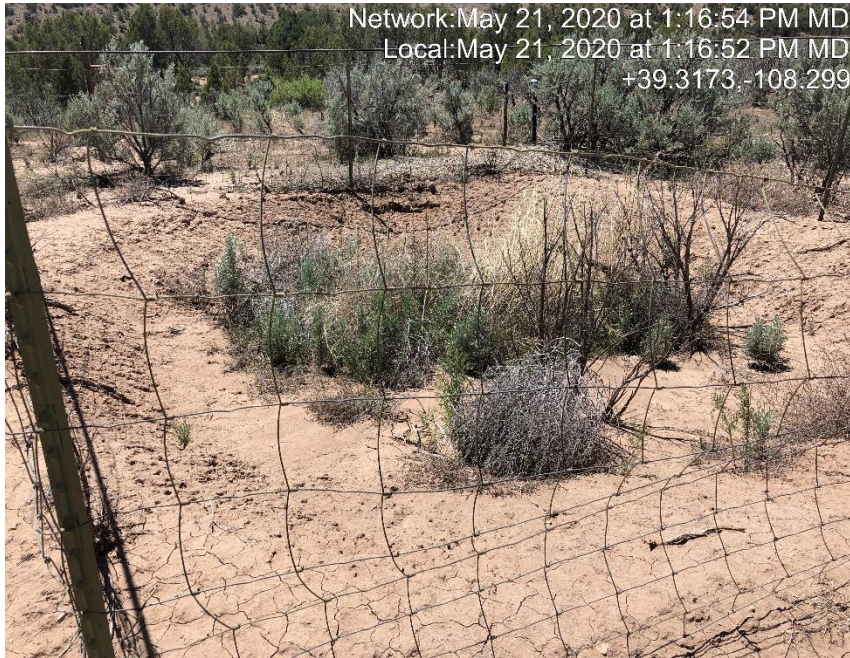
Photo #1243 Debris inside both pits.

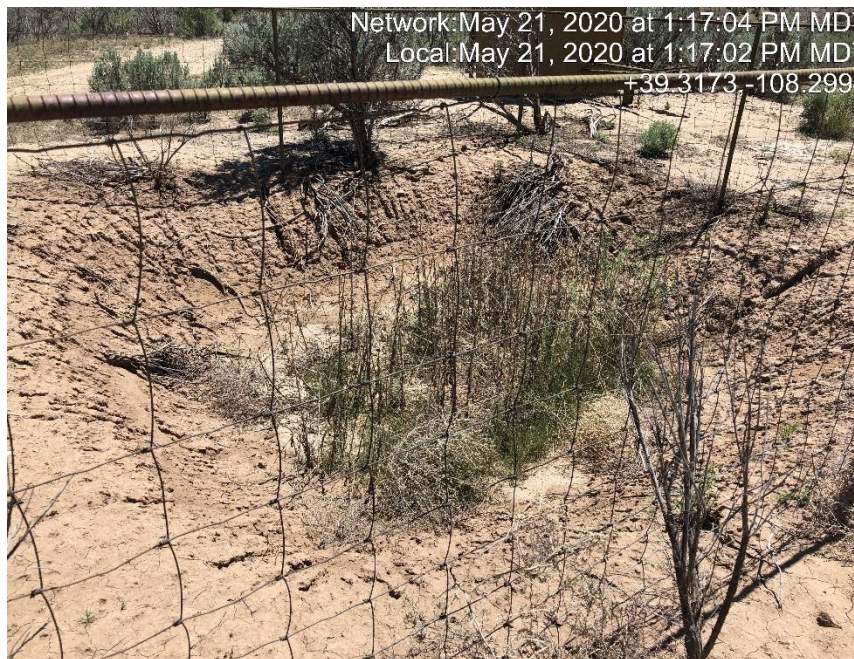
Photo #1244 Debris inside both pits.

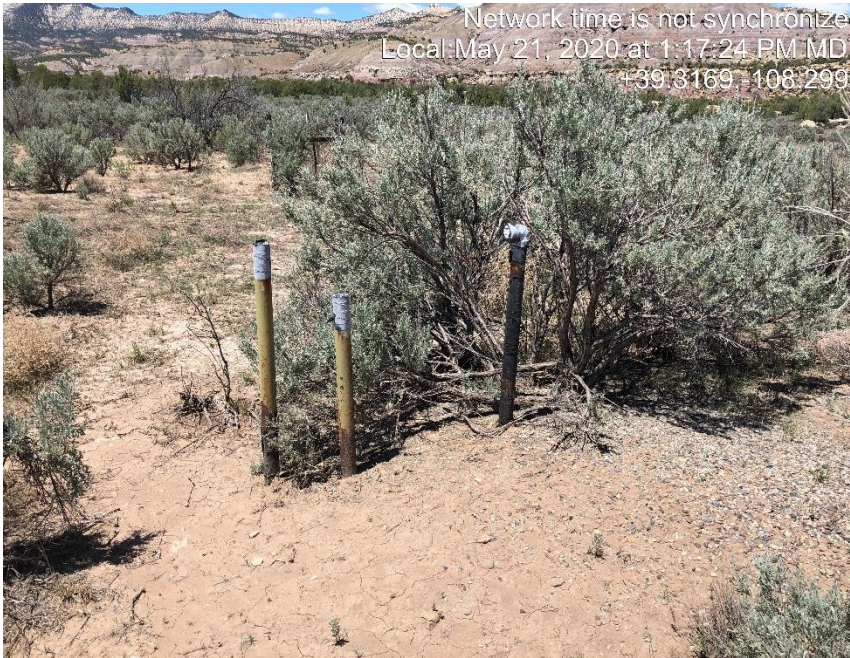
Photo #1245 Multiple flowline risers not LO/TO.

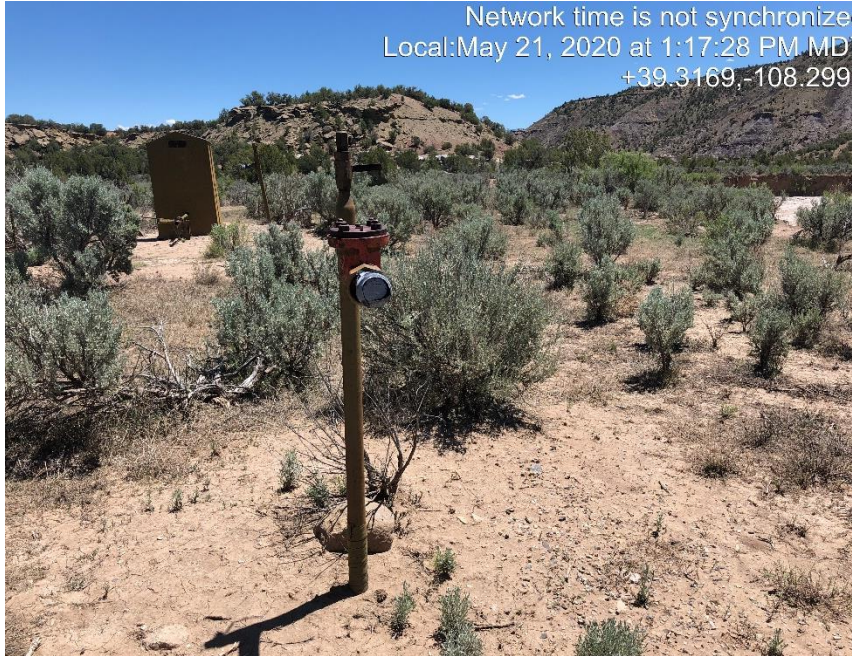
Photo #1246 Multiple flowline risers not LO/TO.

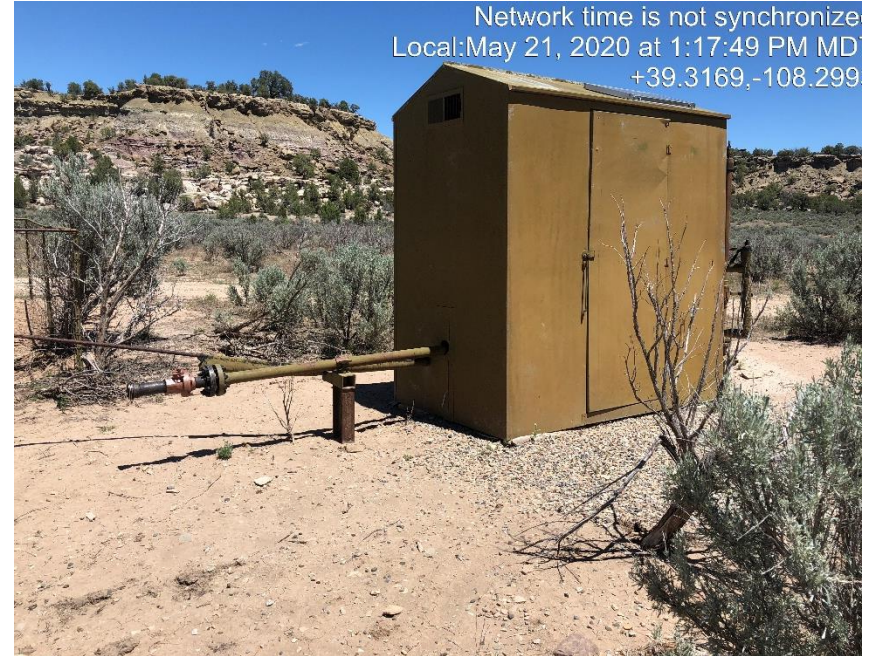
Photo #1247 Unused meter run.
